APPENDIX F

Quarterly Site Inspection Reports

2017 Annual Landfill Report

Subject: 2017 First Quarter Site Inspection

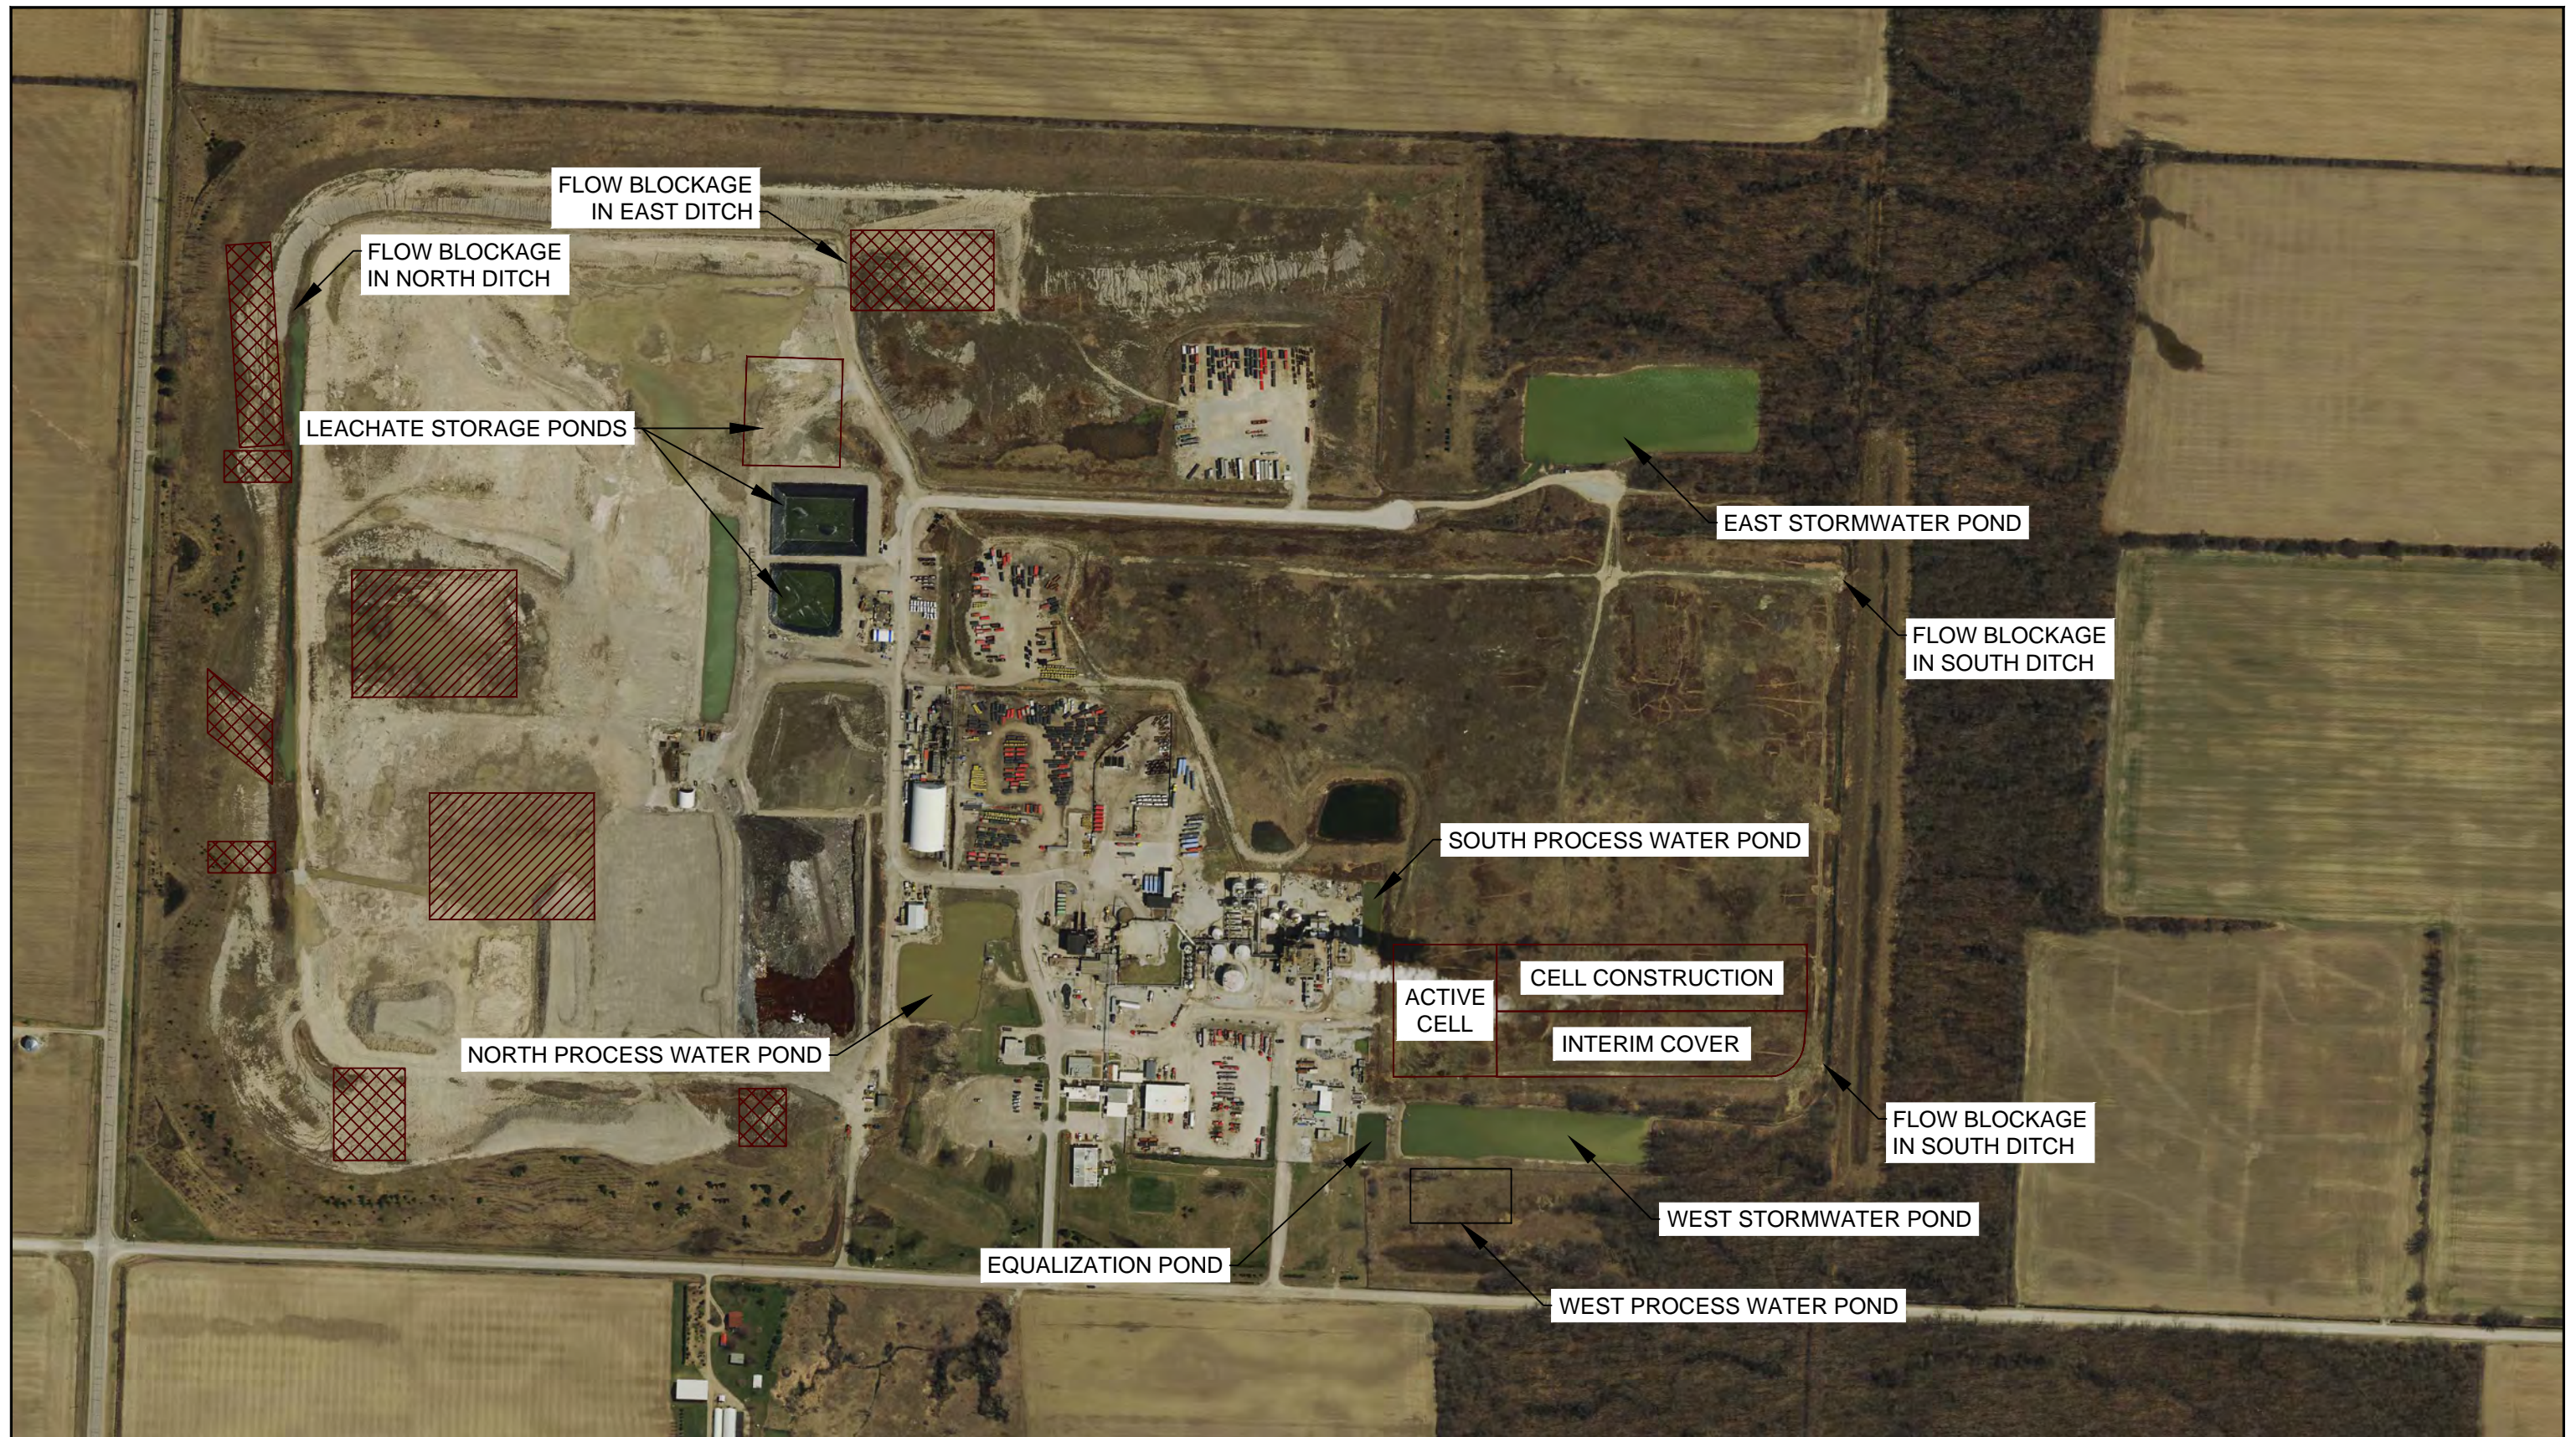
FIGURE 1

- Significant berm erosion was identified immediately west of proposed Cell 21-1. The erosion occurred on the landfill side of the berm, as identified on Figure 1 (previously identified in quarterly reports).
- Multiple larger erosion channels were identified on the landfill side of the north perimeter screening berm, as identified on Figure 1 (previously identified in quarterly reports).
- Minor erosion channels were noted throughout the Perimeter Screening Berms. These channels are prevalent throughout the un-vegetated interior side walls of the western and eastern perimeter screening berms.
- Several large erosion channels were noted on the elevated areas immediately northwest and southeast of the northern portion of the landfill. The erosion channels are located on plateaus/ramps within the screening berm. The erosion channel in the southeast corner extends into the east ditch.

Portions of the interior side of the perimeter screening berms have significant erosion. These areas should be assessed and corrected to minimize erosion into the perimeter ditches. Installation of reinforced ditches from the top of the berm to the perimeter ditches may be a solution for these areas, as well as vegetation of the internal berm slopes.

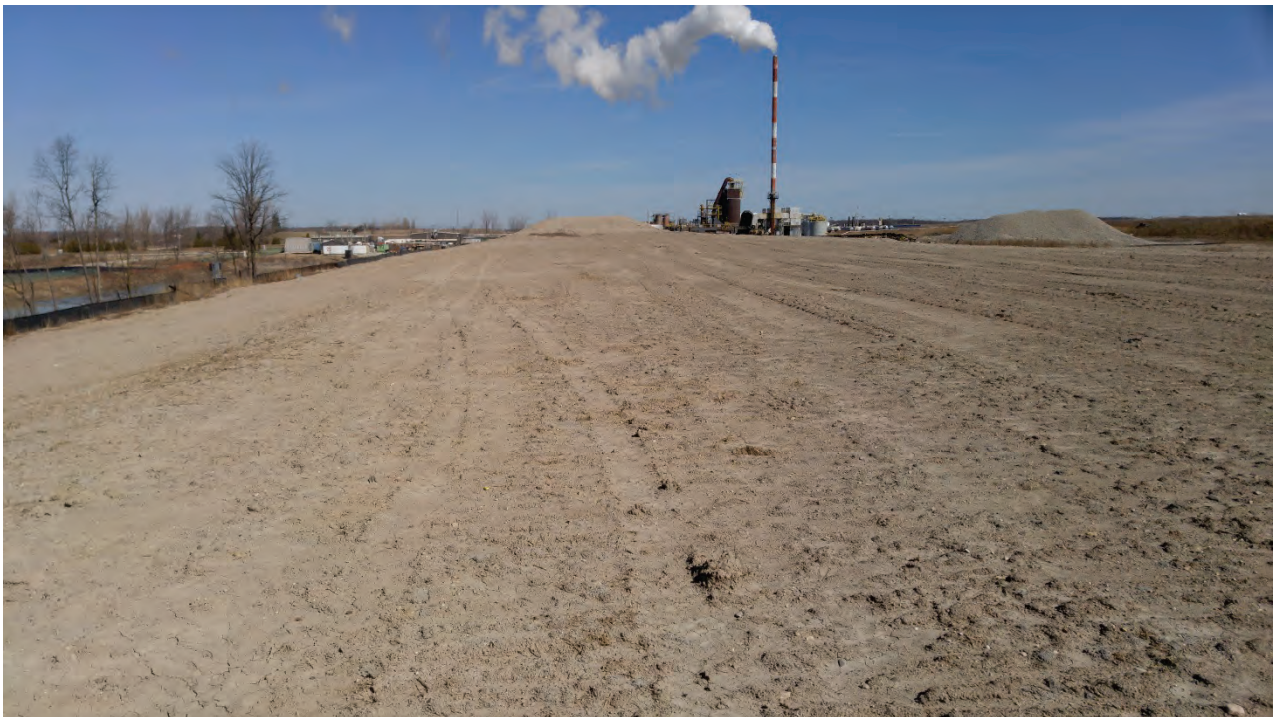
- The active waste tipping face is located in the northern portion of Cell 19-1-2. Waste placement is occurring from north to south, as shown in Photo 1. The northern portion of Cell 19-1-1 remains active.
- The southern portion of Cell 19-1-2 is currently under construction. A ramp has been constructed in the western portion of Subcell 2, terminating at the boundary of Subcell 1 with an elevated platform for offloading of waste received from pre-approved, large-scale waste volume projects and deposited by off-site waste haulage vehicles.
- Waste Transport Route: Site waste haulers are directed around the east and south sides of the Process Area and enter Cell 19-1-2 from the north end on a dedicated haul road from the Waste Receiving Area.

Photo 1 - Active landfilling cell (northern portion of Cell 19-1-2)

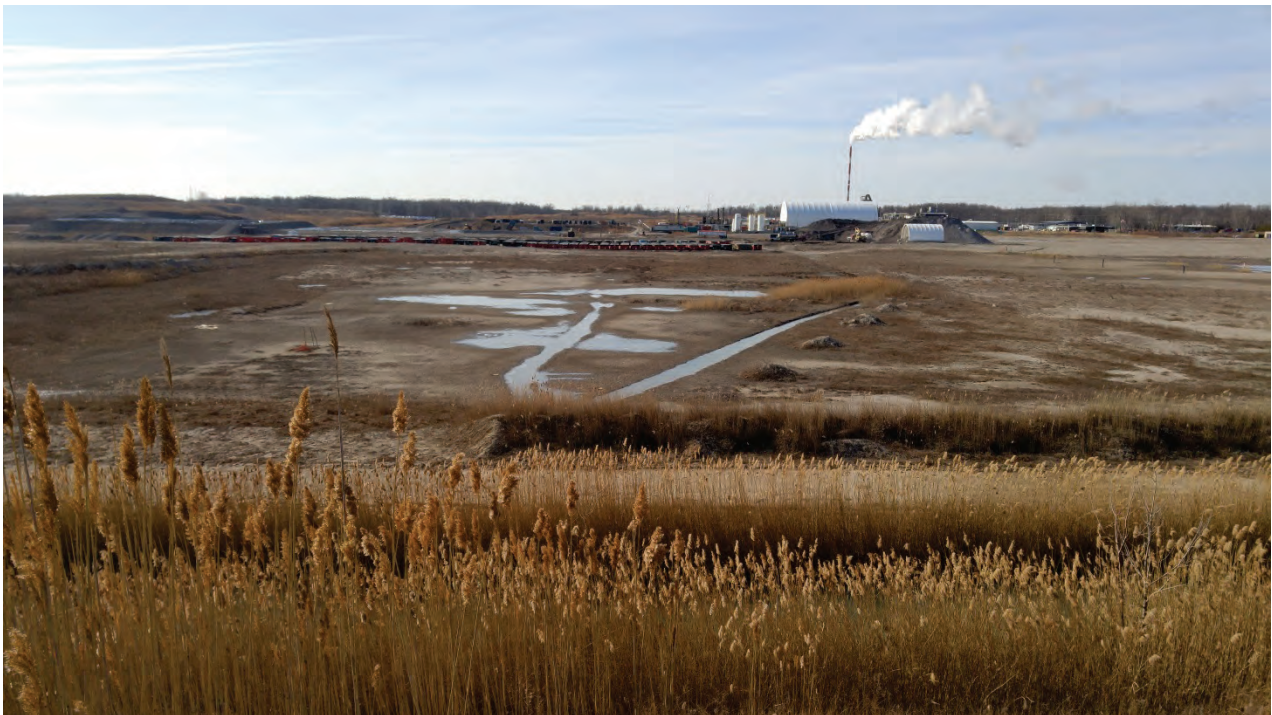
- Shallow ponding was identified, located centrally within the northwest corner of the landfill, as shown on Figure 1 and Photo 3. The ponded area is significantly smaller than during the 2016 fourth quarter inspection due to overall dry conditions on Site. The area has been graded to drain to the north ditch with an internal swale, though at the time of the Inspection, the ponded area was not connected to the internal swale. The internal swale was damp during the Inspection, with no observed standing water.

Photo 3 - Ponding within northwest corner of Site

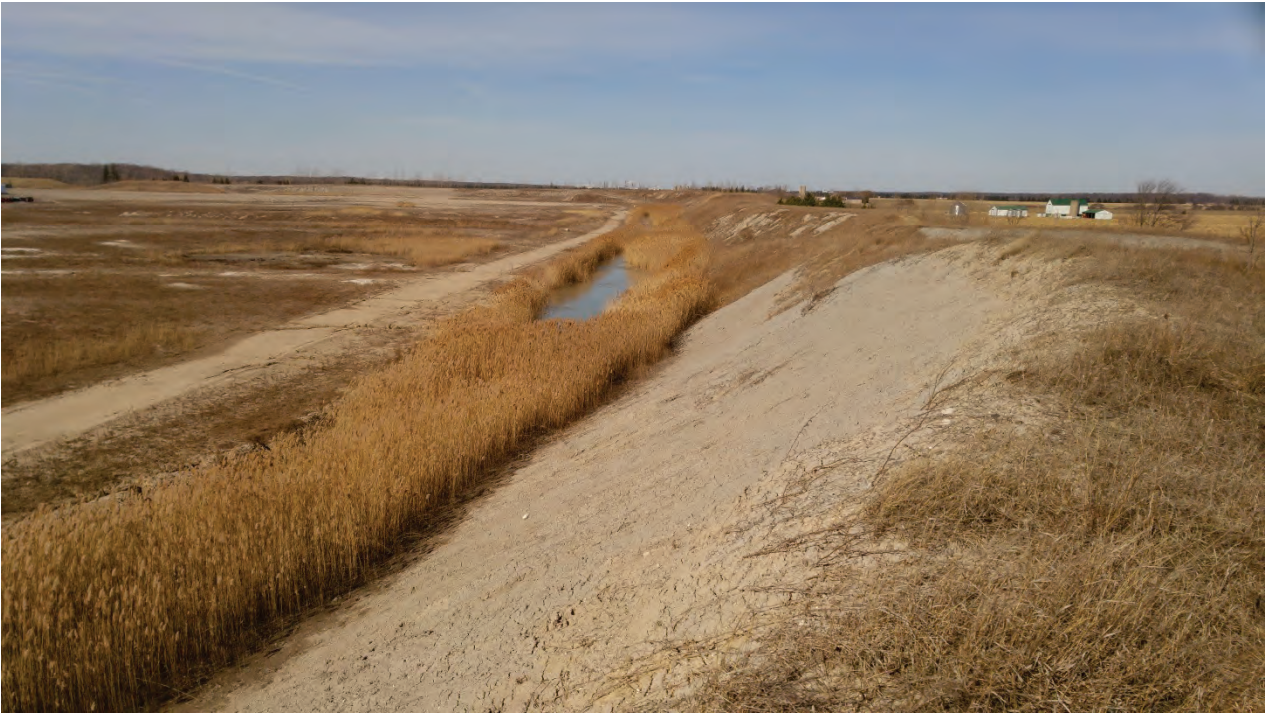
- Another ponded area was noted in the northwest portion of proposed Cell 21-3 (i.e., located centrally in the northern portion of the Site), as shown in Photo 4. Ponding has decreased since the 2016 fourth quarter inspection. Two drainage paths were identified, both of which were nearly full with no observed flow.

Photo 4 - Ponding in northern, central portion of Site

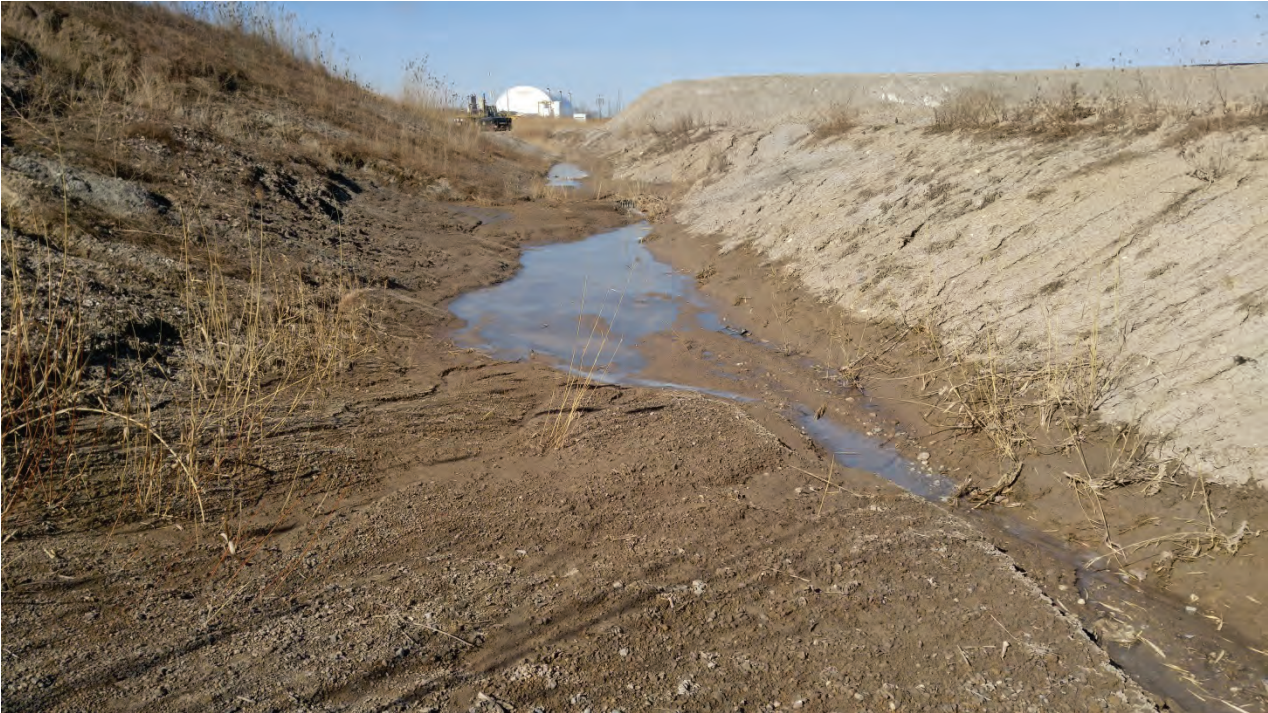
- Water levels continue to be high in the central portion of the north ditch. High water levels in the north ditch have the potential to prohibit the above-noted ponded areas from draining.

Photo 5 - North ditch, surface water blockage

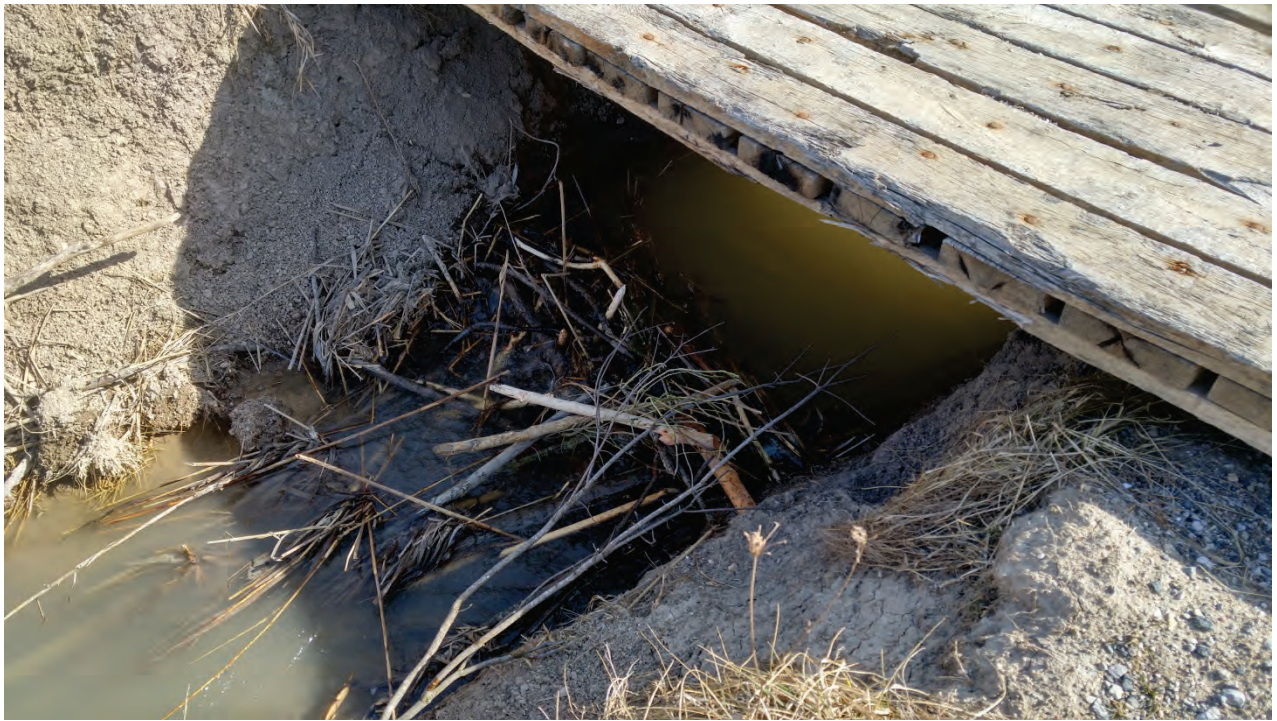
- Significant erosion and sedimentation was identified in the southeast corner of the northern portion of the landfill, limiting water flow, as shown in Photo 6 and Figure 1. Water levels were low to medium in the east ditch and the internal swale to the north, with no observed flow.

Photo 6 - North landfill area, southeast ditch, partial surface water blockage

Maintenance of the perimeter ditches is required to remove areas where sediment has accumulated and is restricting flow of water. Maintenance of the perimeter ditches is a key component to minimize ponding of water on the interim cover and transfer of water to stormwater ponds.

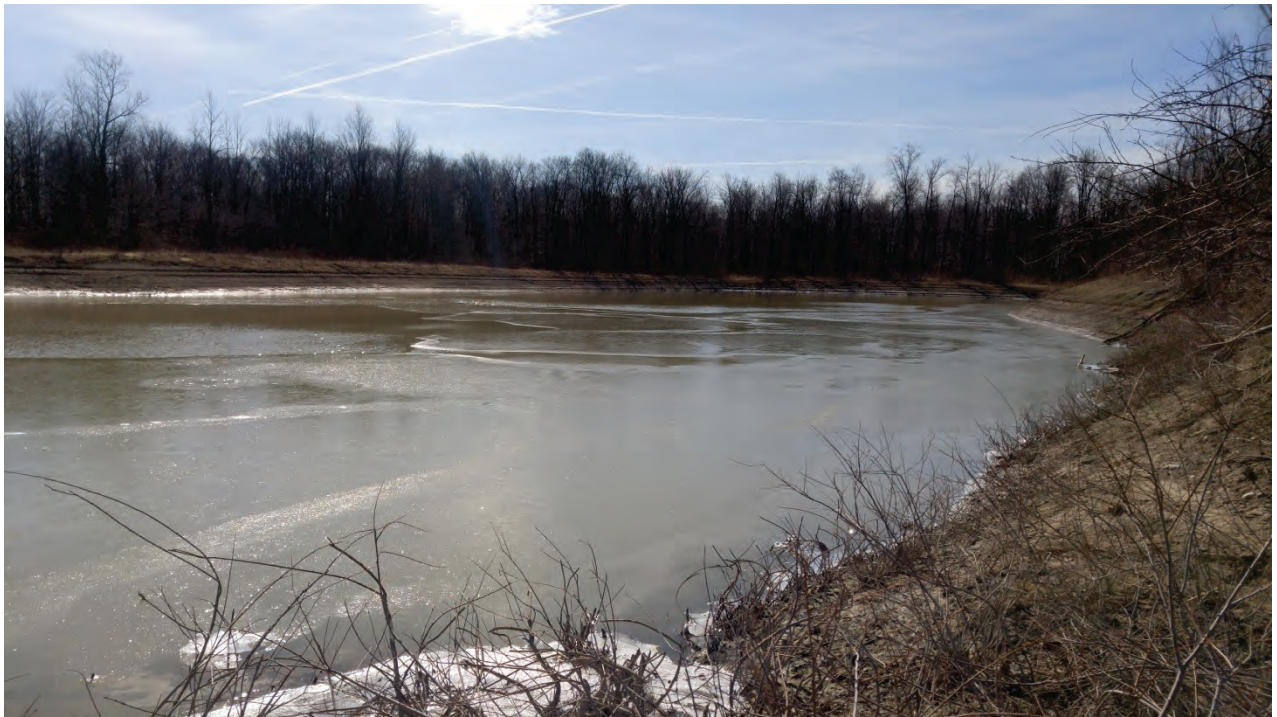
- High water levels were identified in the western portion of the south ditch, with minimal flow noted. Significant sedimentation and accumulation of loose vegetation was identified in the southwest corner of the perimeter ditch, impeding flow of water toward the West Surface Water Pond, as shown in Photo 8.

Photo 8 - Southwest ditch, surface water blockage

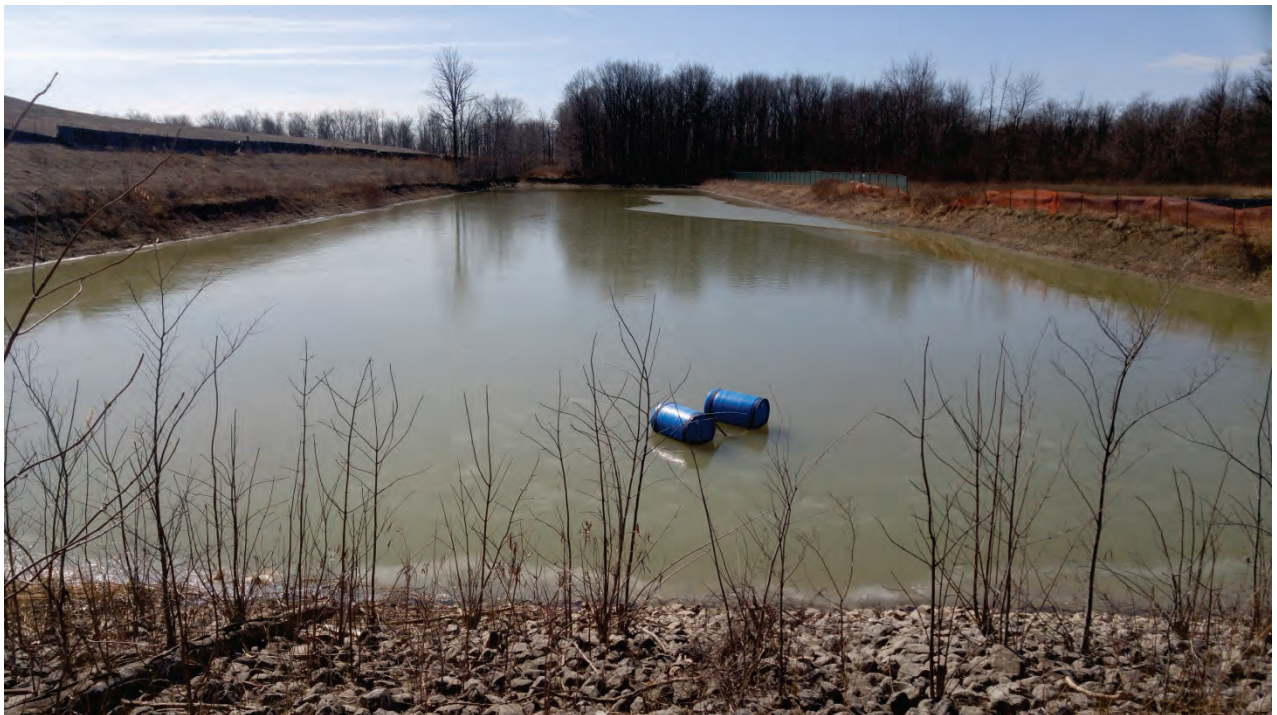
- Water levels within the East Surface Water Pond were very low, well below the baseline of vegetation.
- Little to no flow was observed entering the East Surface Water Pond.
- The pump at the East Surface Water Pond was in operation at the time of the Inspection.

Photo 9 - East Surface Water Pond

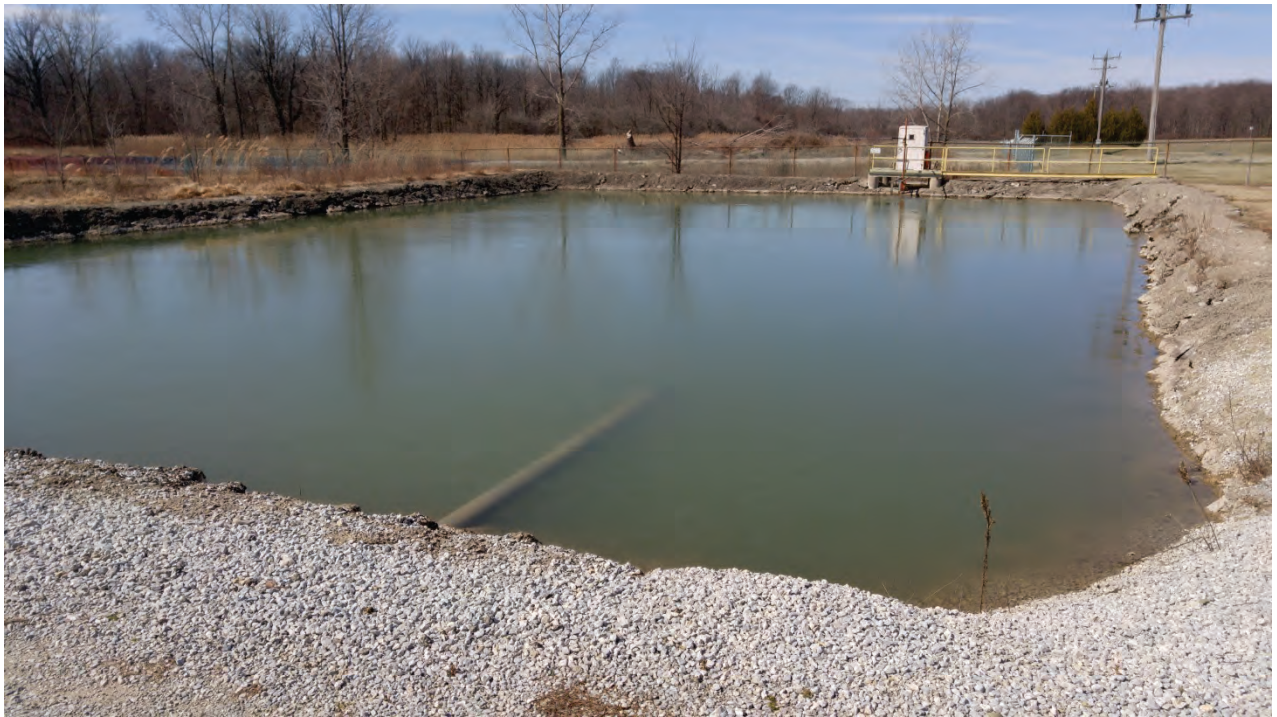
- Water levels within the West Surface Water Pond were low.
- Minimal to no flow was observed entering the West Surface Water Pond. This is a result of sedimentation in the southwest corner of the perimeter ditch.

Photo 10 - West Surface Water Pond

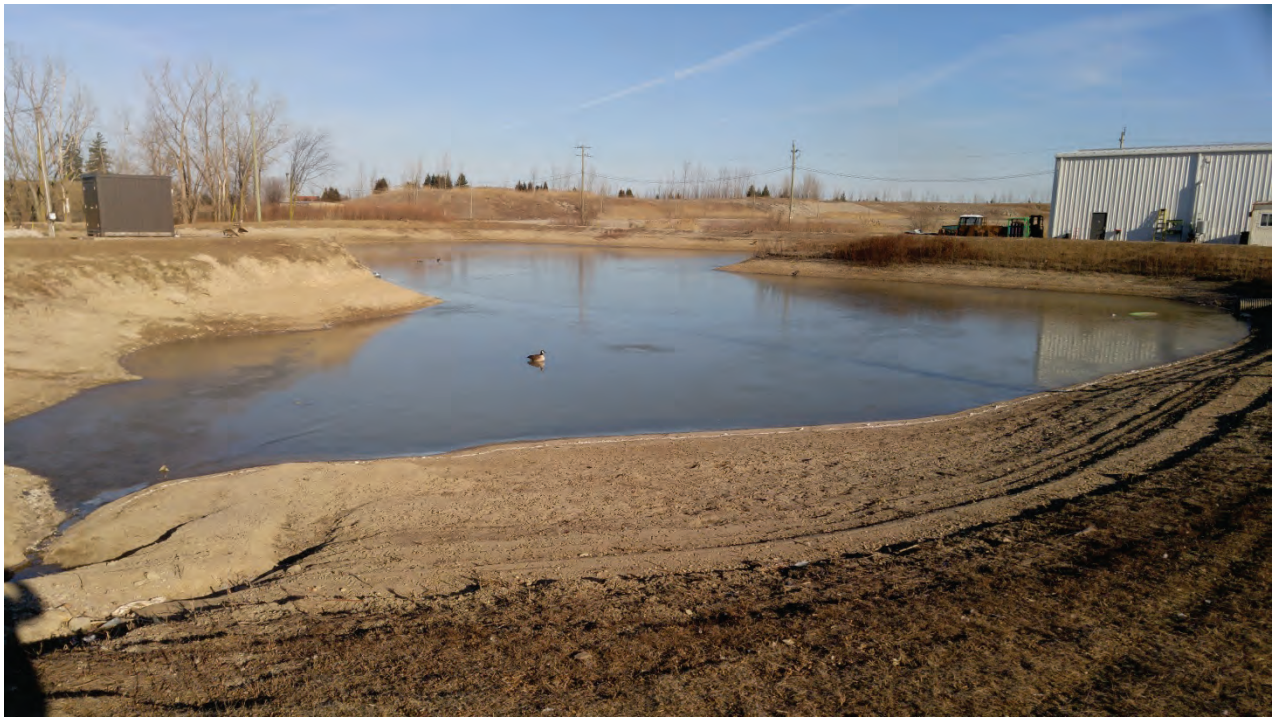
- Water and ice was present in the process water ditch feeding the North Process Water Pond at the time of the Inspection. As shown in Photo 12, the ditch that feeds this, located immediately south of the Household Hazardous Waste Depot (HHW Depot), was full. Little to no flow toward the pond was observed. Significant sediment buildup was noted in the rip rap. It is recommended that sediment be removed from the ditch, including the ditch in front of the HHW Depot, and rip rap be re-instated where required due to sediment removal activities.

- It was also noted that the west end of the culvert beneath the North Process Water Pond access driveway is partially crushed. Repair should be evaluated during repairs to the ditch as recommended above.

Photo 12 - North Process Water Pond ditch

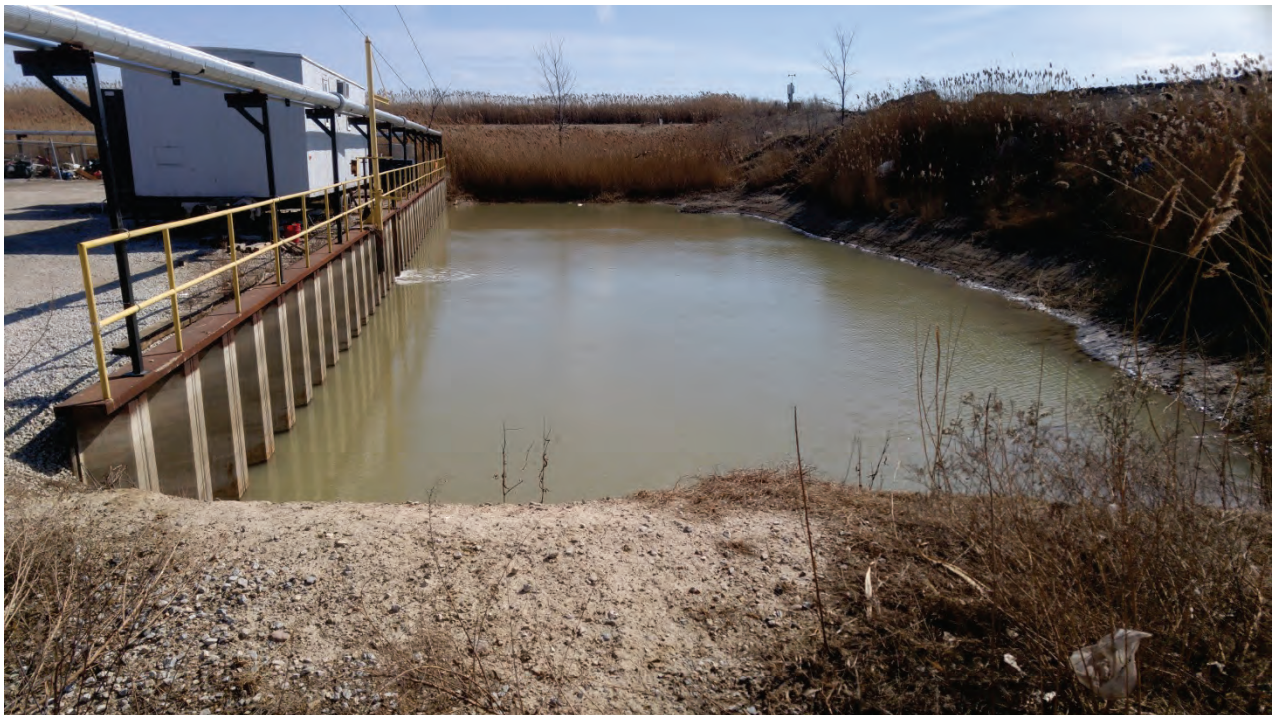
- The water level within the North Process Water Pond was very low, well below the ditch inlet and culvert outlets.
- It was not noted if the pump at the North Process Water Pond was running at the time of the inspection.
- A washout was noted in the southeast corner of the North Process Water Pond.

Photo 13 - North Process Water Pond

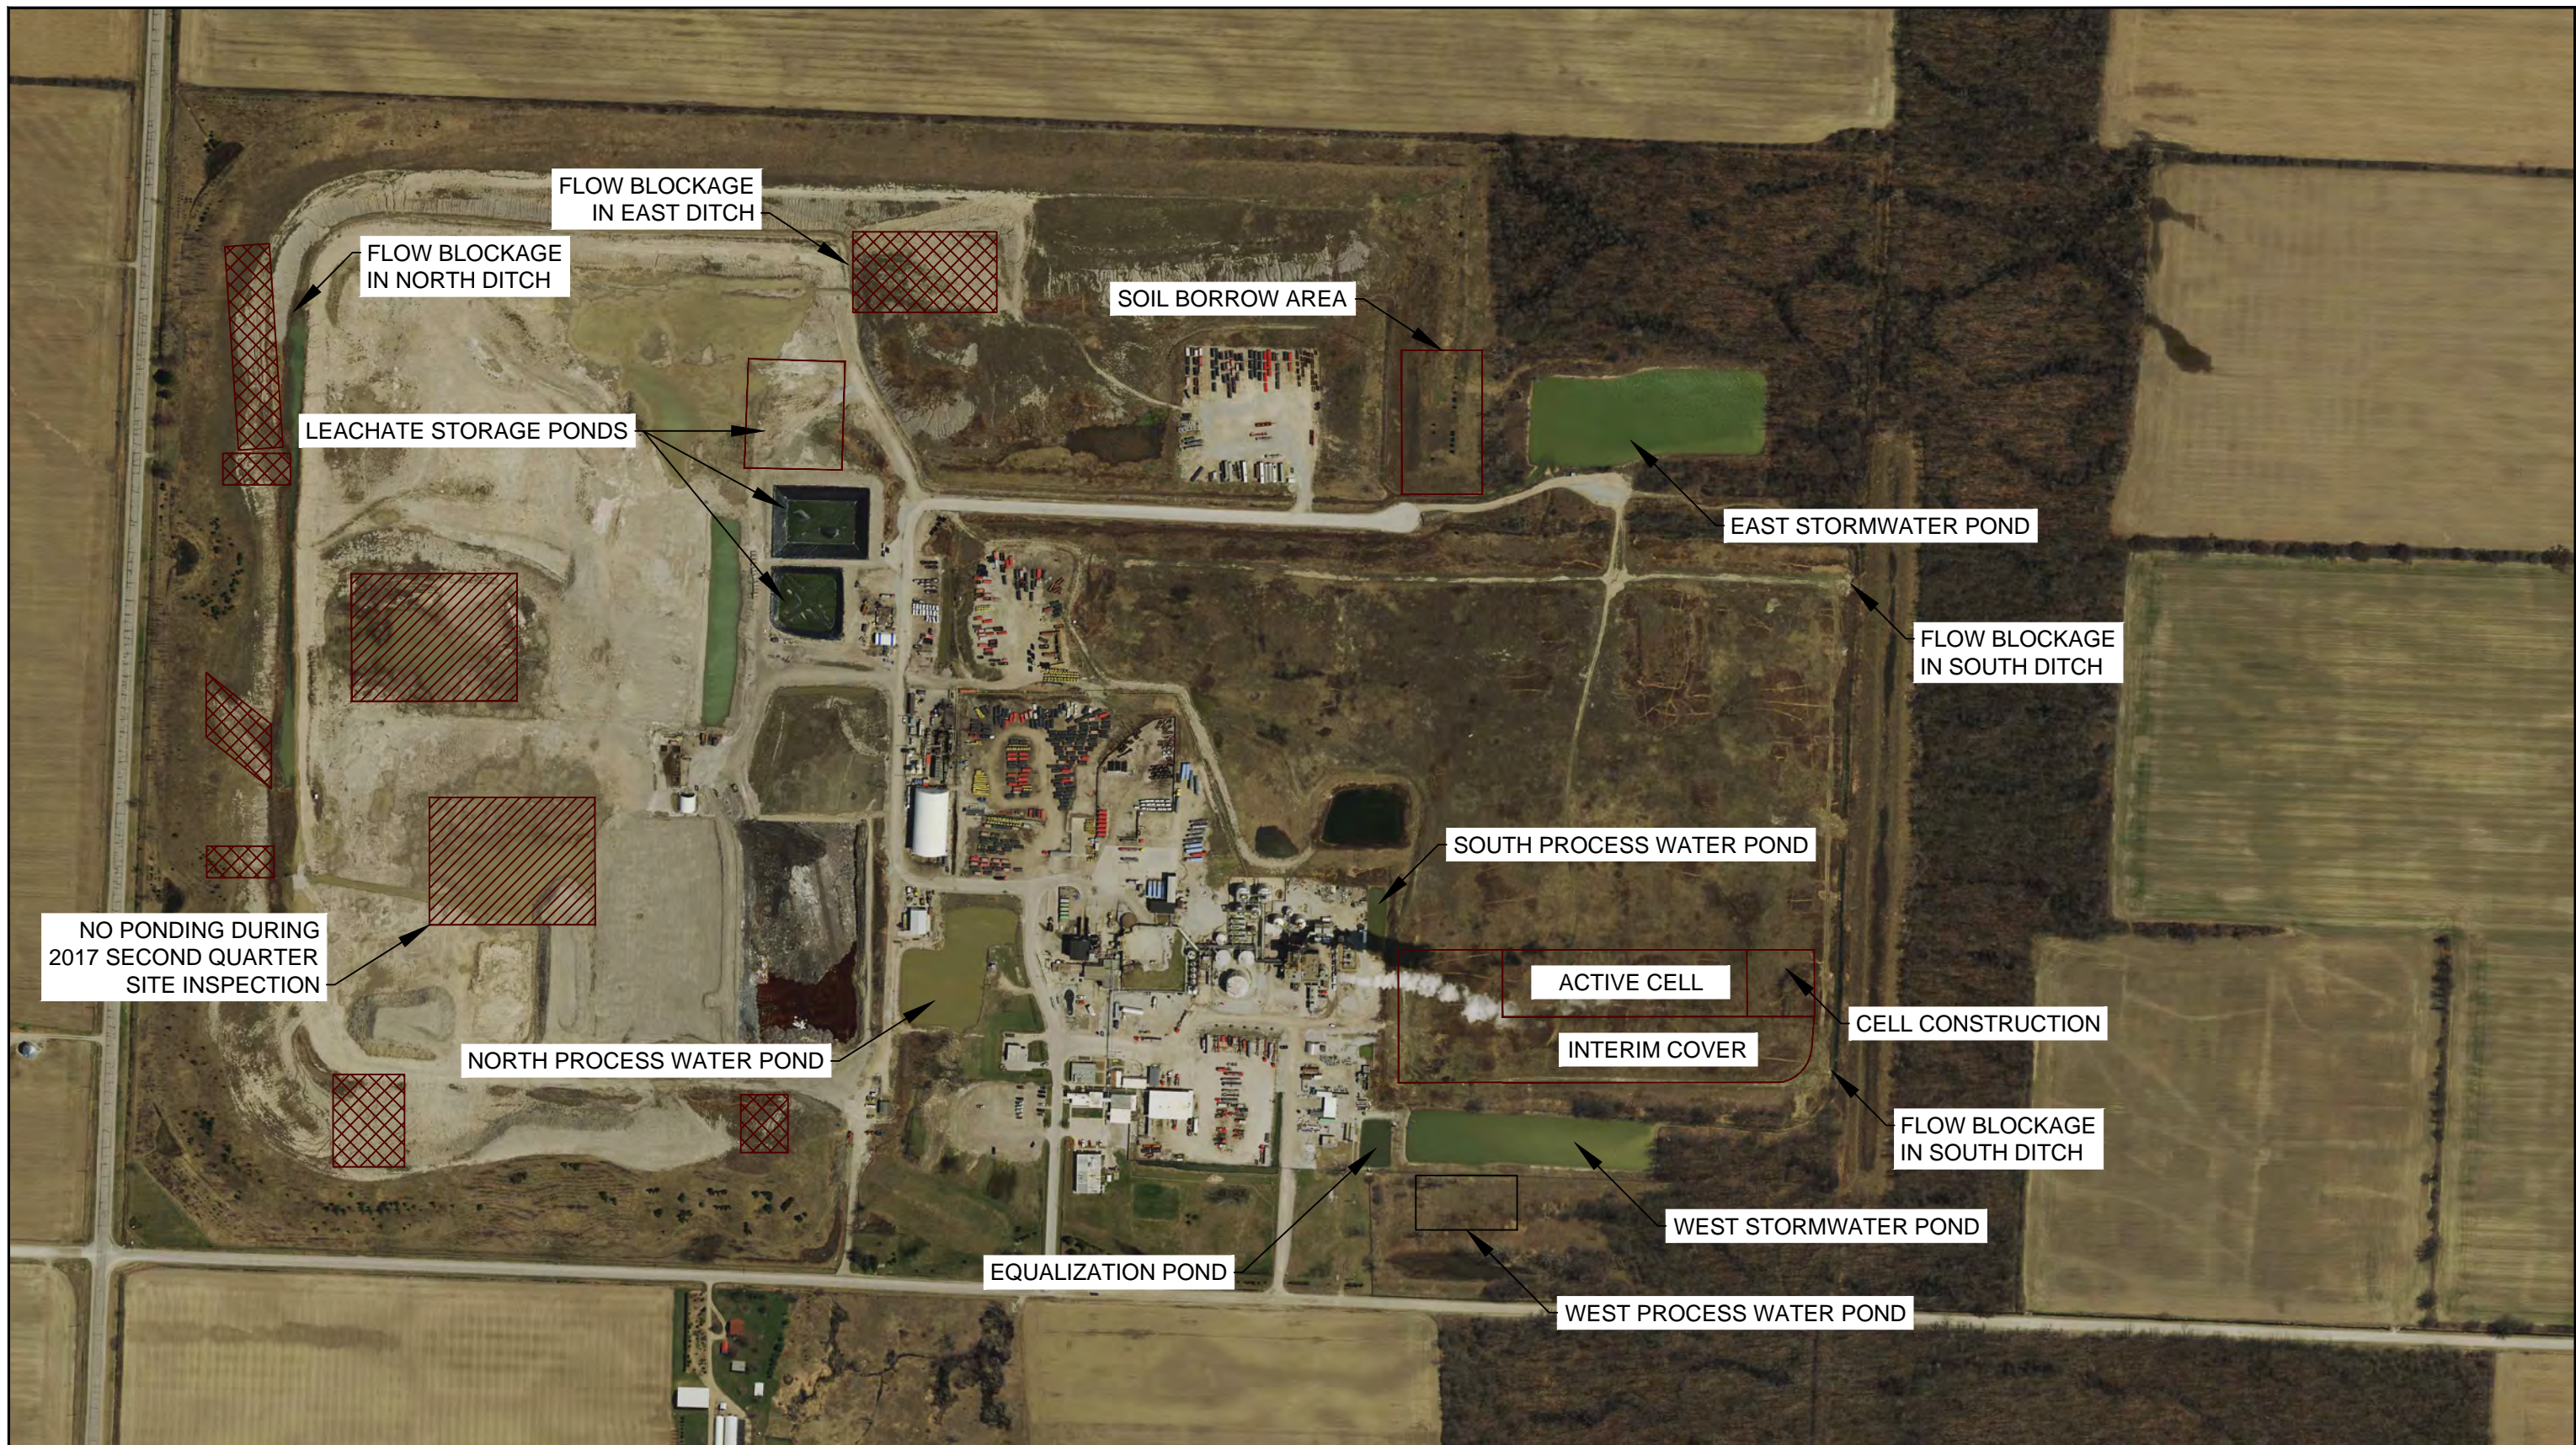
FIGURE 1

- Significant berm erosion was identified immediately west of proposed Cell 21-1. The erosion occurred on the landfill side of the berm, as identified on Figure 1 (previously identified in quarterly reports).
- Multiple larger erosion channels were identified on the landfill side of the north perimeter screening berm, as identified on Figure 1 (previously identified in quarterly reports).
- Minor erosion channels were noted throughout the Perimeter Screening Berms. These channels are prevalent throughout the un-vegetated interior side walls of the western and eastern perimeter screening berms.
- Several large erosion channels were noted on the elevated areas immediately northwest and southeast of the northern portion of the landfill. The erosion channels are located on plateaus/ramps within the screening berm. The erosion channel in the southeast corner extends into the east ditch.

- Significant erosion was identified in the southeast corner of the northern portion of the landfill, resulting in sedimentation of the perimeter ditch and limited water flow, as shown in Photo 6 and Figure 1. Water levels were low to medium in the east ditch and the internal swale to the north, with no observed flow.

Portions of the interior side of the perimeter screening berms have significant erosion. These areas should be assessed and corrected to minimize erosion into the perimeter ditches. Installation of reinforced ditches from the top of the berm to the perimeter ditches may be a solution for these areas, as well as vegetation of the internal berm slopes.

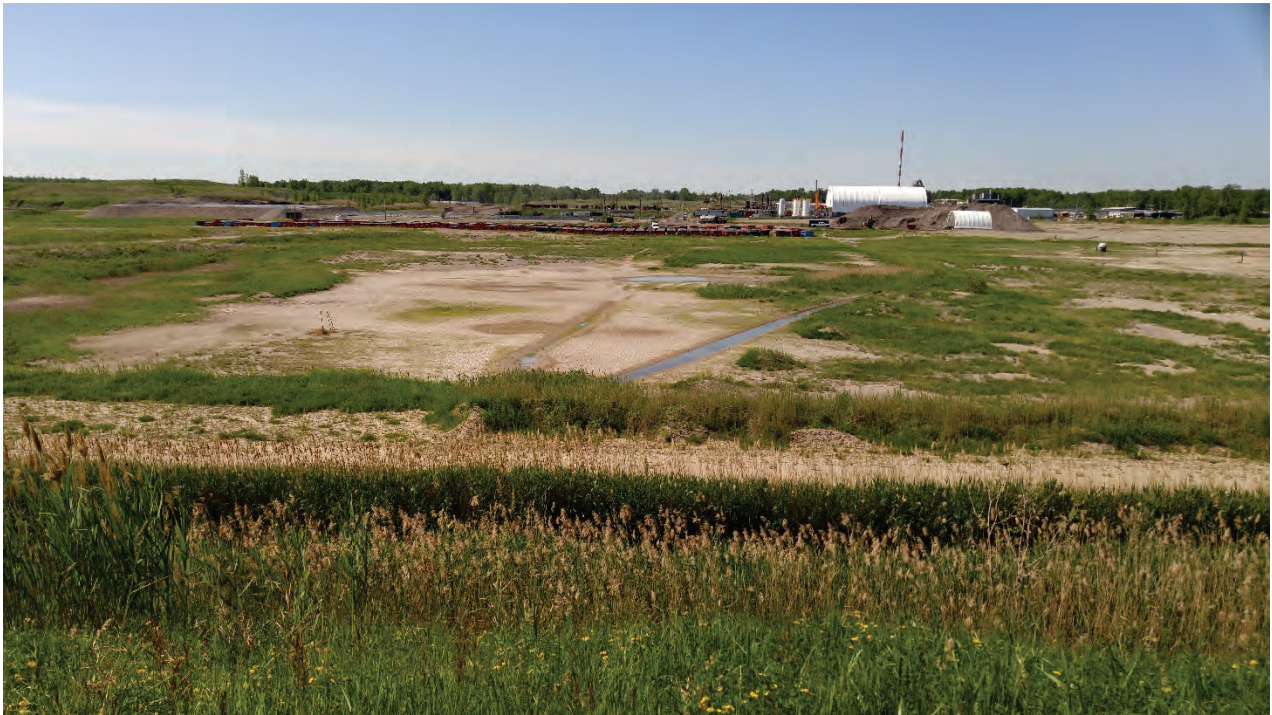
- No ponding was identified within the northwest corner of the landfill, where ponding is generally present (location as shown on Figure 1 and Photo 3). The area was damp to dry during the Inspection. The area has been graded to drain to the north ditch with an internal swale. The internal swale was dry during the Inspection, with no observed standing water.

Photo 3 - Ponding within northwest corner of Site

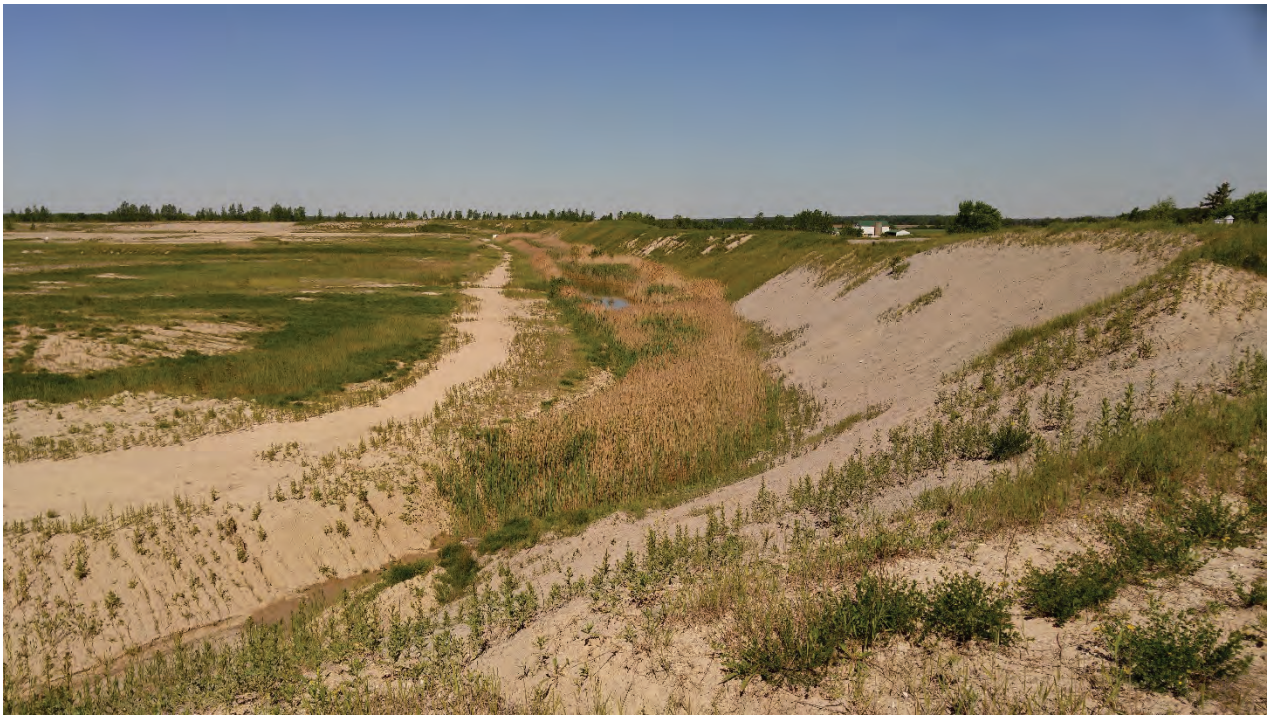
- Very minor ponding was noted in the northwest portion of proposed Cell 21-3 (i.e., located centrally in the northern portion of the Site), as shown in Photo 4. Ponding has decreased since the 2017 first quarter inspection. Two drainage paths were identified, one of which was full, while the other was damp with minor standing water noted. No flow was observed.

Photo 4 - Ponding in northern, central portion of Site

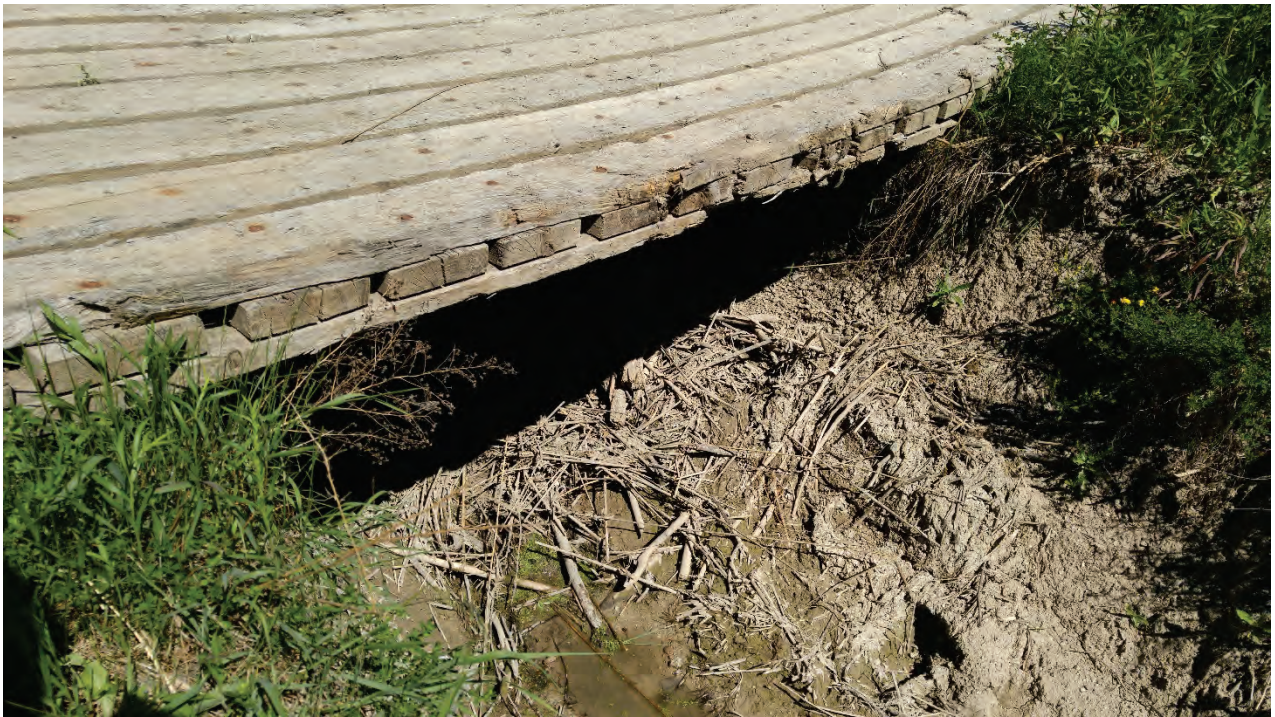
Photo 6 - North landfill area, southeast ditch, partial surface water blockage

Maintenance of the perimeter ditches is required to remove areas where sediment has accumulated and is restricting flow of water. Maintenance of the perimeter ditches is a key component to minimize ponding of water on the interim cover and transfer of water to stormwater ponds.

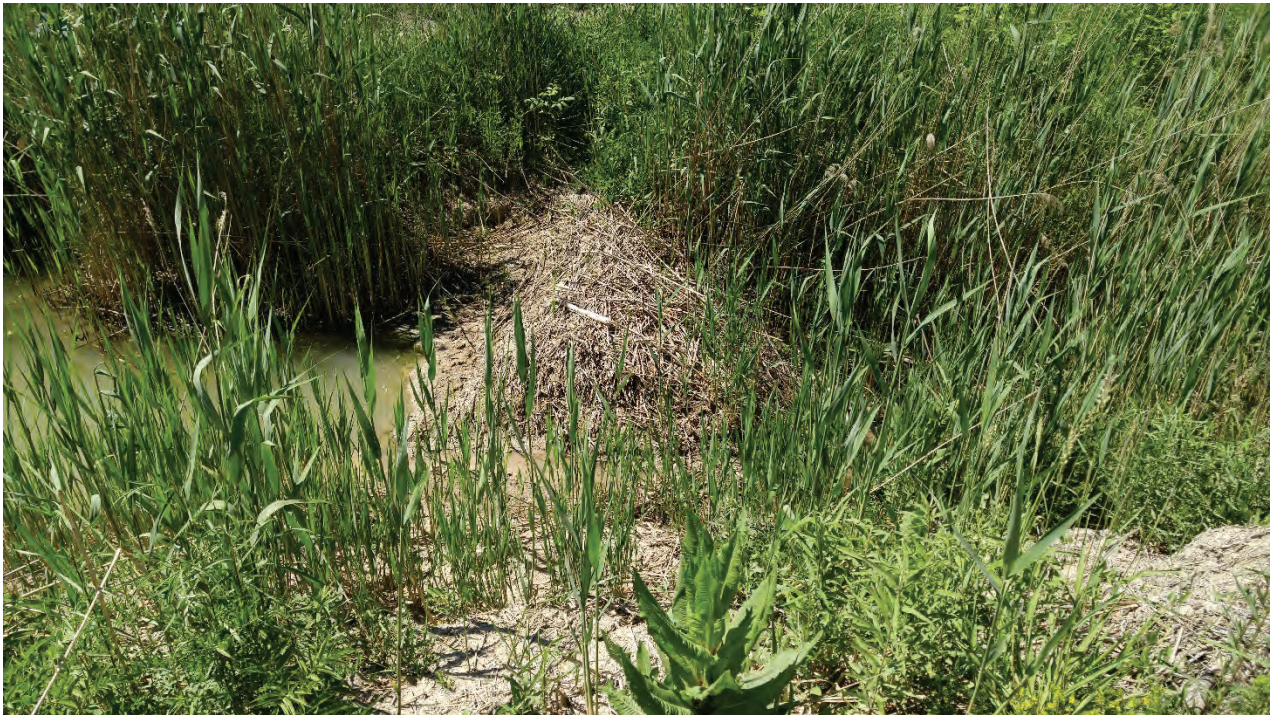
- The flow break in the south ditch has been re-established, immediately west of the access bridge located at Gate 6. The blockage is the result of wildlife activity (i.e., beavers), as shown in Photo 7. During the post-Inspection discussion, it was noted that the wildlife concerns have been addressed and the remaining dams will be removed.

Photo 7 - South ditch, surface water blockage west of access bridge
