APPENDIX F

Quarterly Site Inspection Reports

2017 Annual Landfill Report

Subject: 2017 First Quarter Site Inspection

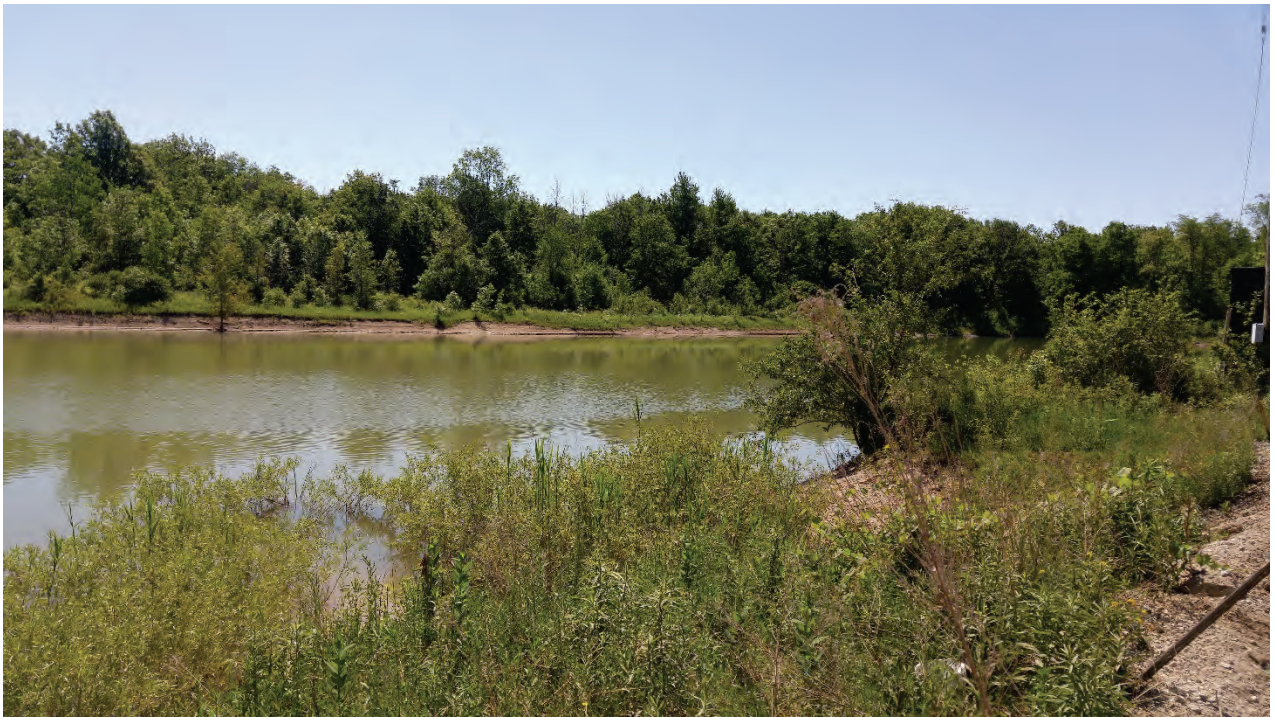
- High water levels were identified in the western portion of the south ditch, with minimal flow noted. Significant sedimentation and accumulation of loose vegetation was identified in the southwest corner of the perimeter ditch, impeding flow of water toward the West Surface Water Pond, as shown in Photo 8. A small channel is present within the blockage, allowing minimal flow.

Photo 8 - Southwest ditch, surface water blockage

Maintenance of the perimeter ditches is required to remove areas where sediment has accumulated and is restricting flow of water. Maintenance of the perimeter ditches is a key component to minimize ponding of water on the interim cover and transfer of water to stormwater ponds.

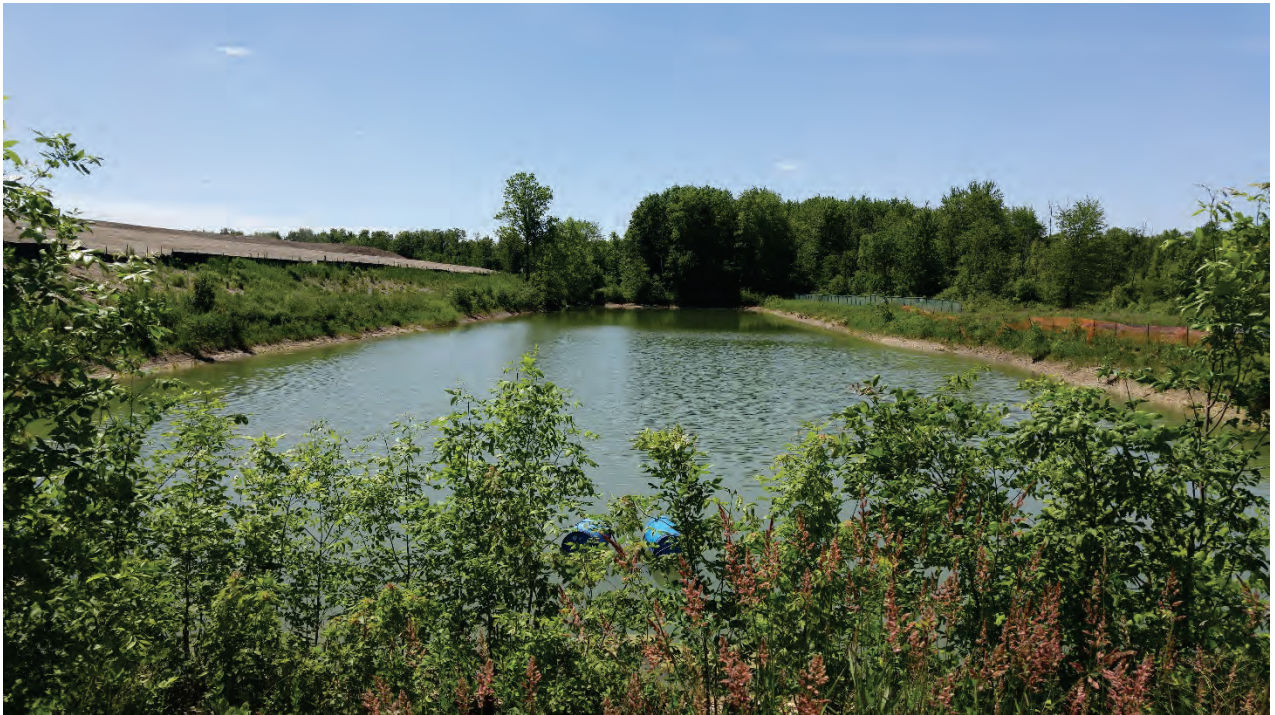
- Water levels within the East Surface Water Pond were very high, extending nearly to the baseline of vegetation. This is the result of several significant rainfall events in May 2017.
- Little to no flow was observed entering the East Surface Water Pond.
- The pump at the East Surface Water Pond was not in operation at the time of the Inspection.

Photo 9 - East Surface Water Pond

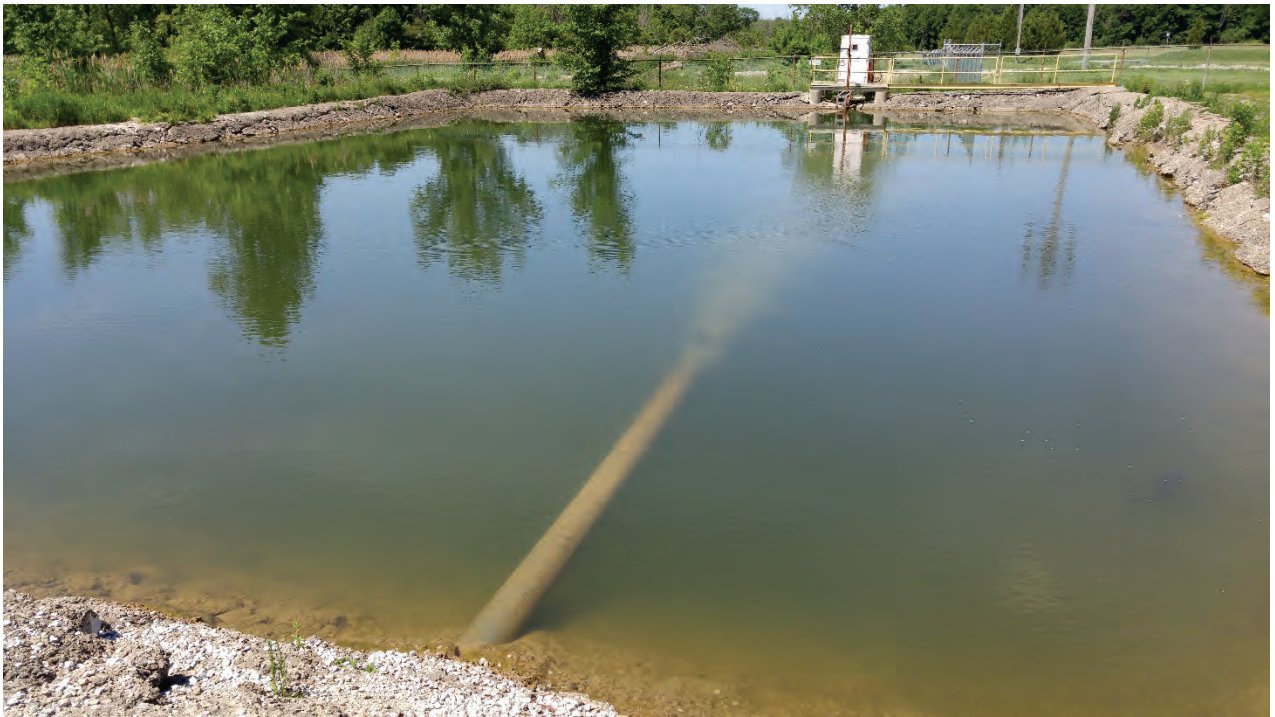
- Water levels within the West Surface Water Pond were high, extending nearly to the baseline of vegetation.
- Minimal to no flow was observed entering the West Surface Water Pond. This is a result of sedimentation in the southwest corner of the perimeter ditch.
- The pump at the West Surface Water Pond was in operation at the time of the Inspection.

Photo 10 - West Surface Water Pond

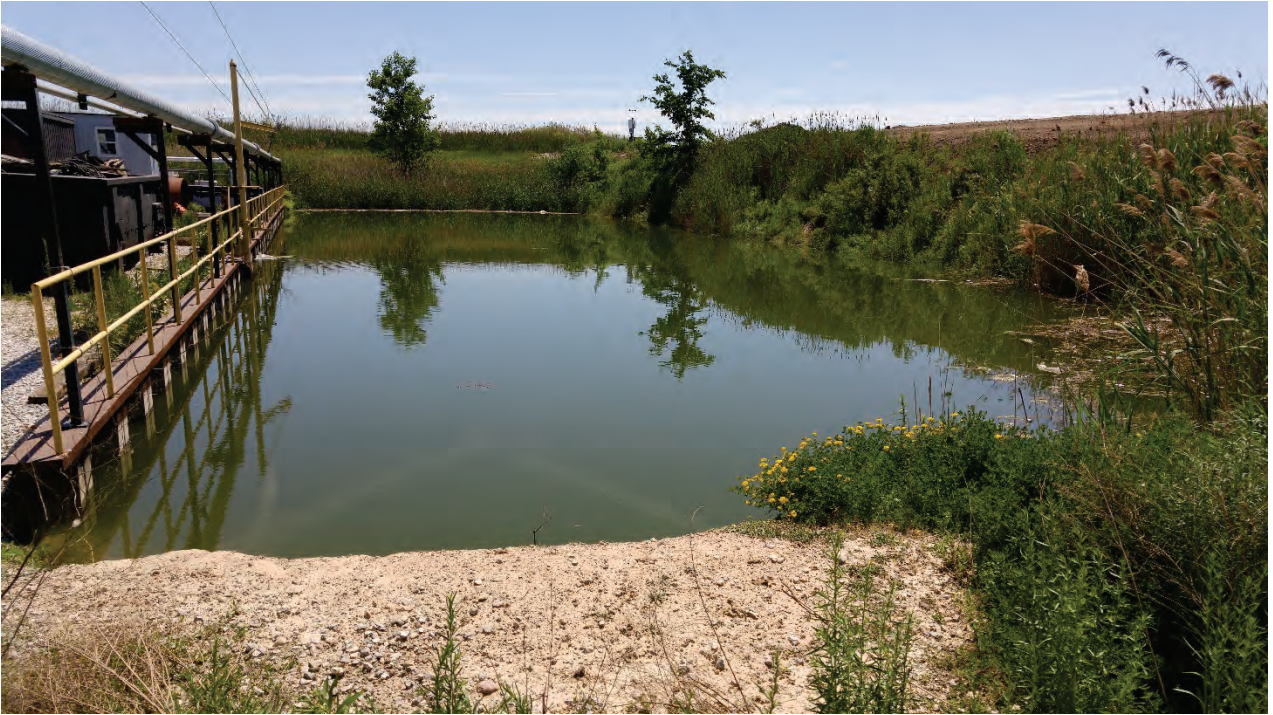
- A significant washout was noted in the southeast corner of the North Process Water Pond. Some large rip rap has been placed in the washout, however, repair of the side slope is necessary.

Photo 13 - North Process Water Pond

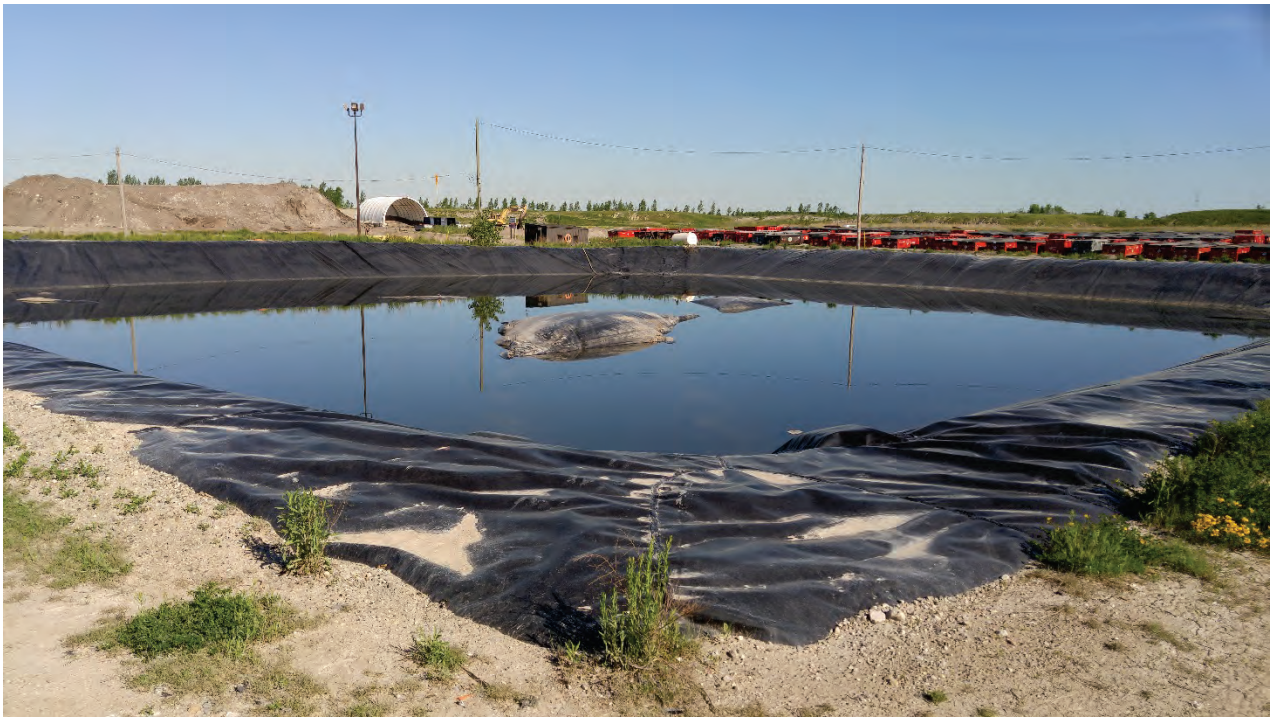
- The water level within the South Process Water Pond was very high, nearly completely full. It was noted that this area is also receiving clean runoff from east of the active landfill area.

Photo 14 - South Process Water Pond

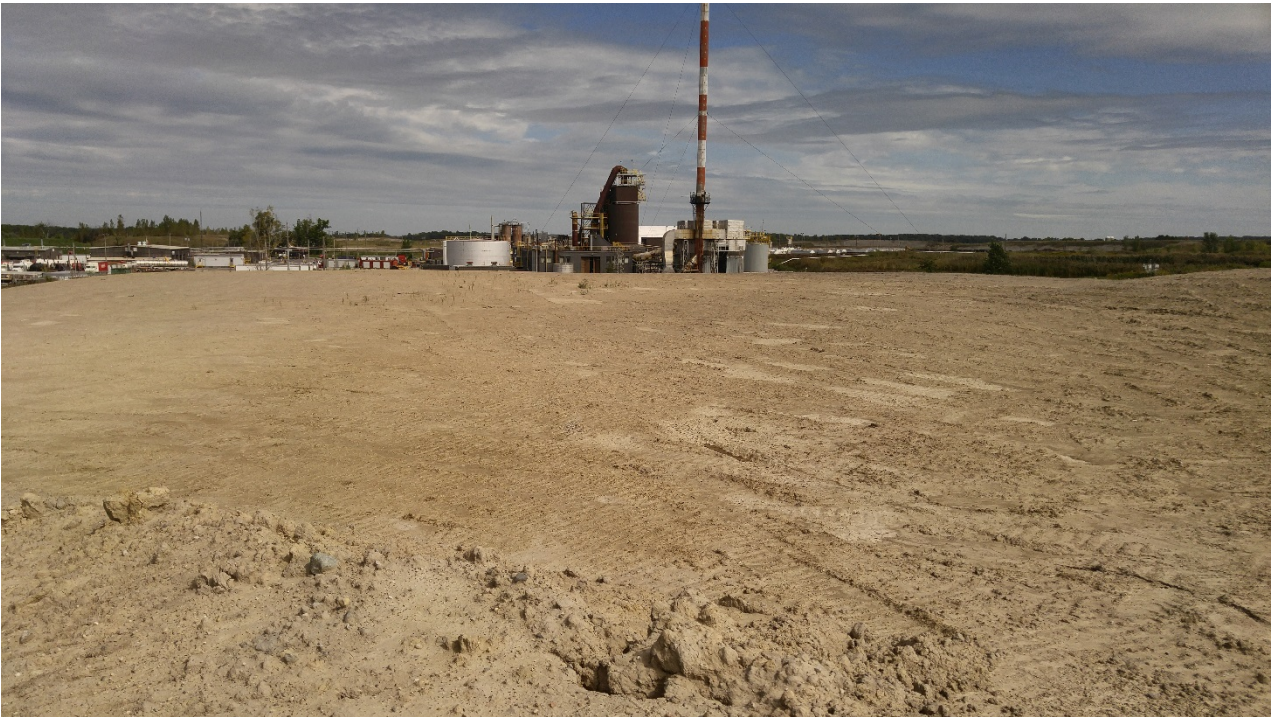
- The active waste tipping face is located in the central portion of Cell 19-1-2 and is referred to as 19-1-2B. Waste placement is occurring from north to south, as shown in Photo 1. The northern portion of Cells 19-1-1 and 19-1-2 (hereinafter referred to as 19-1-2A) are no longer active. Odour was noted in the immediate vicinity of the active landfill area.
- The southern portion of Cell 19-1-2 (19-1-2C) is currently under construction.
- Waste Transport Route: Site waste haulers are directed around the east side of the Process Area and enter Cell 19-1-2B from the east side, located at the northern end of the active area, on a dedicated haul road from the Waste Receiving Area.

Photo 1 - Active landfilling cell (southern portion of Cell 19-1-2)
