2018 Quarterly Site Inspections

Clean Harbors Lambton Facility
4090 Telfer Road, Corunna, Ontario

Clean Harbors Canada, Inc.

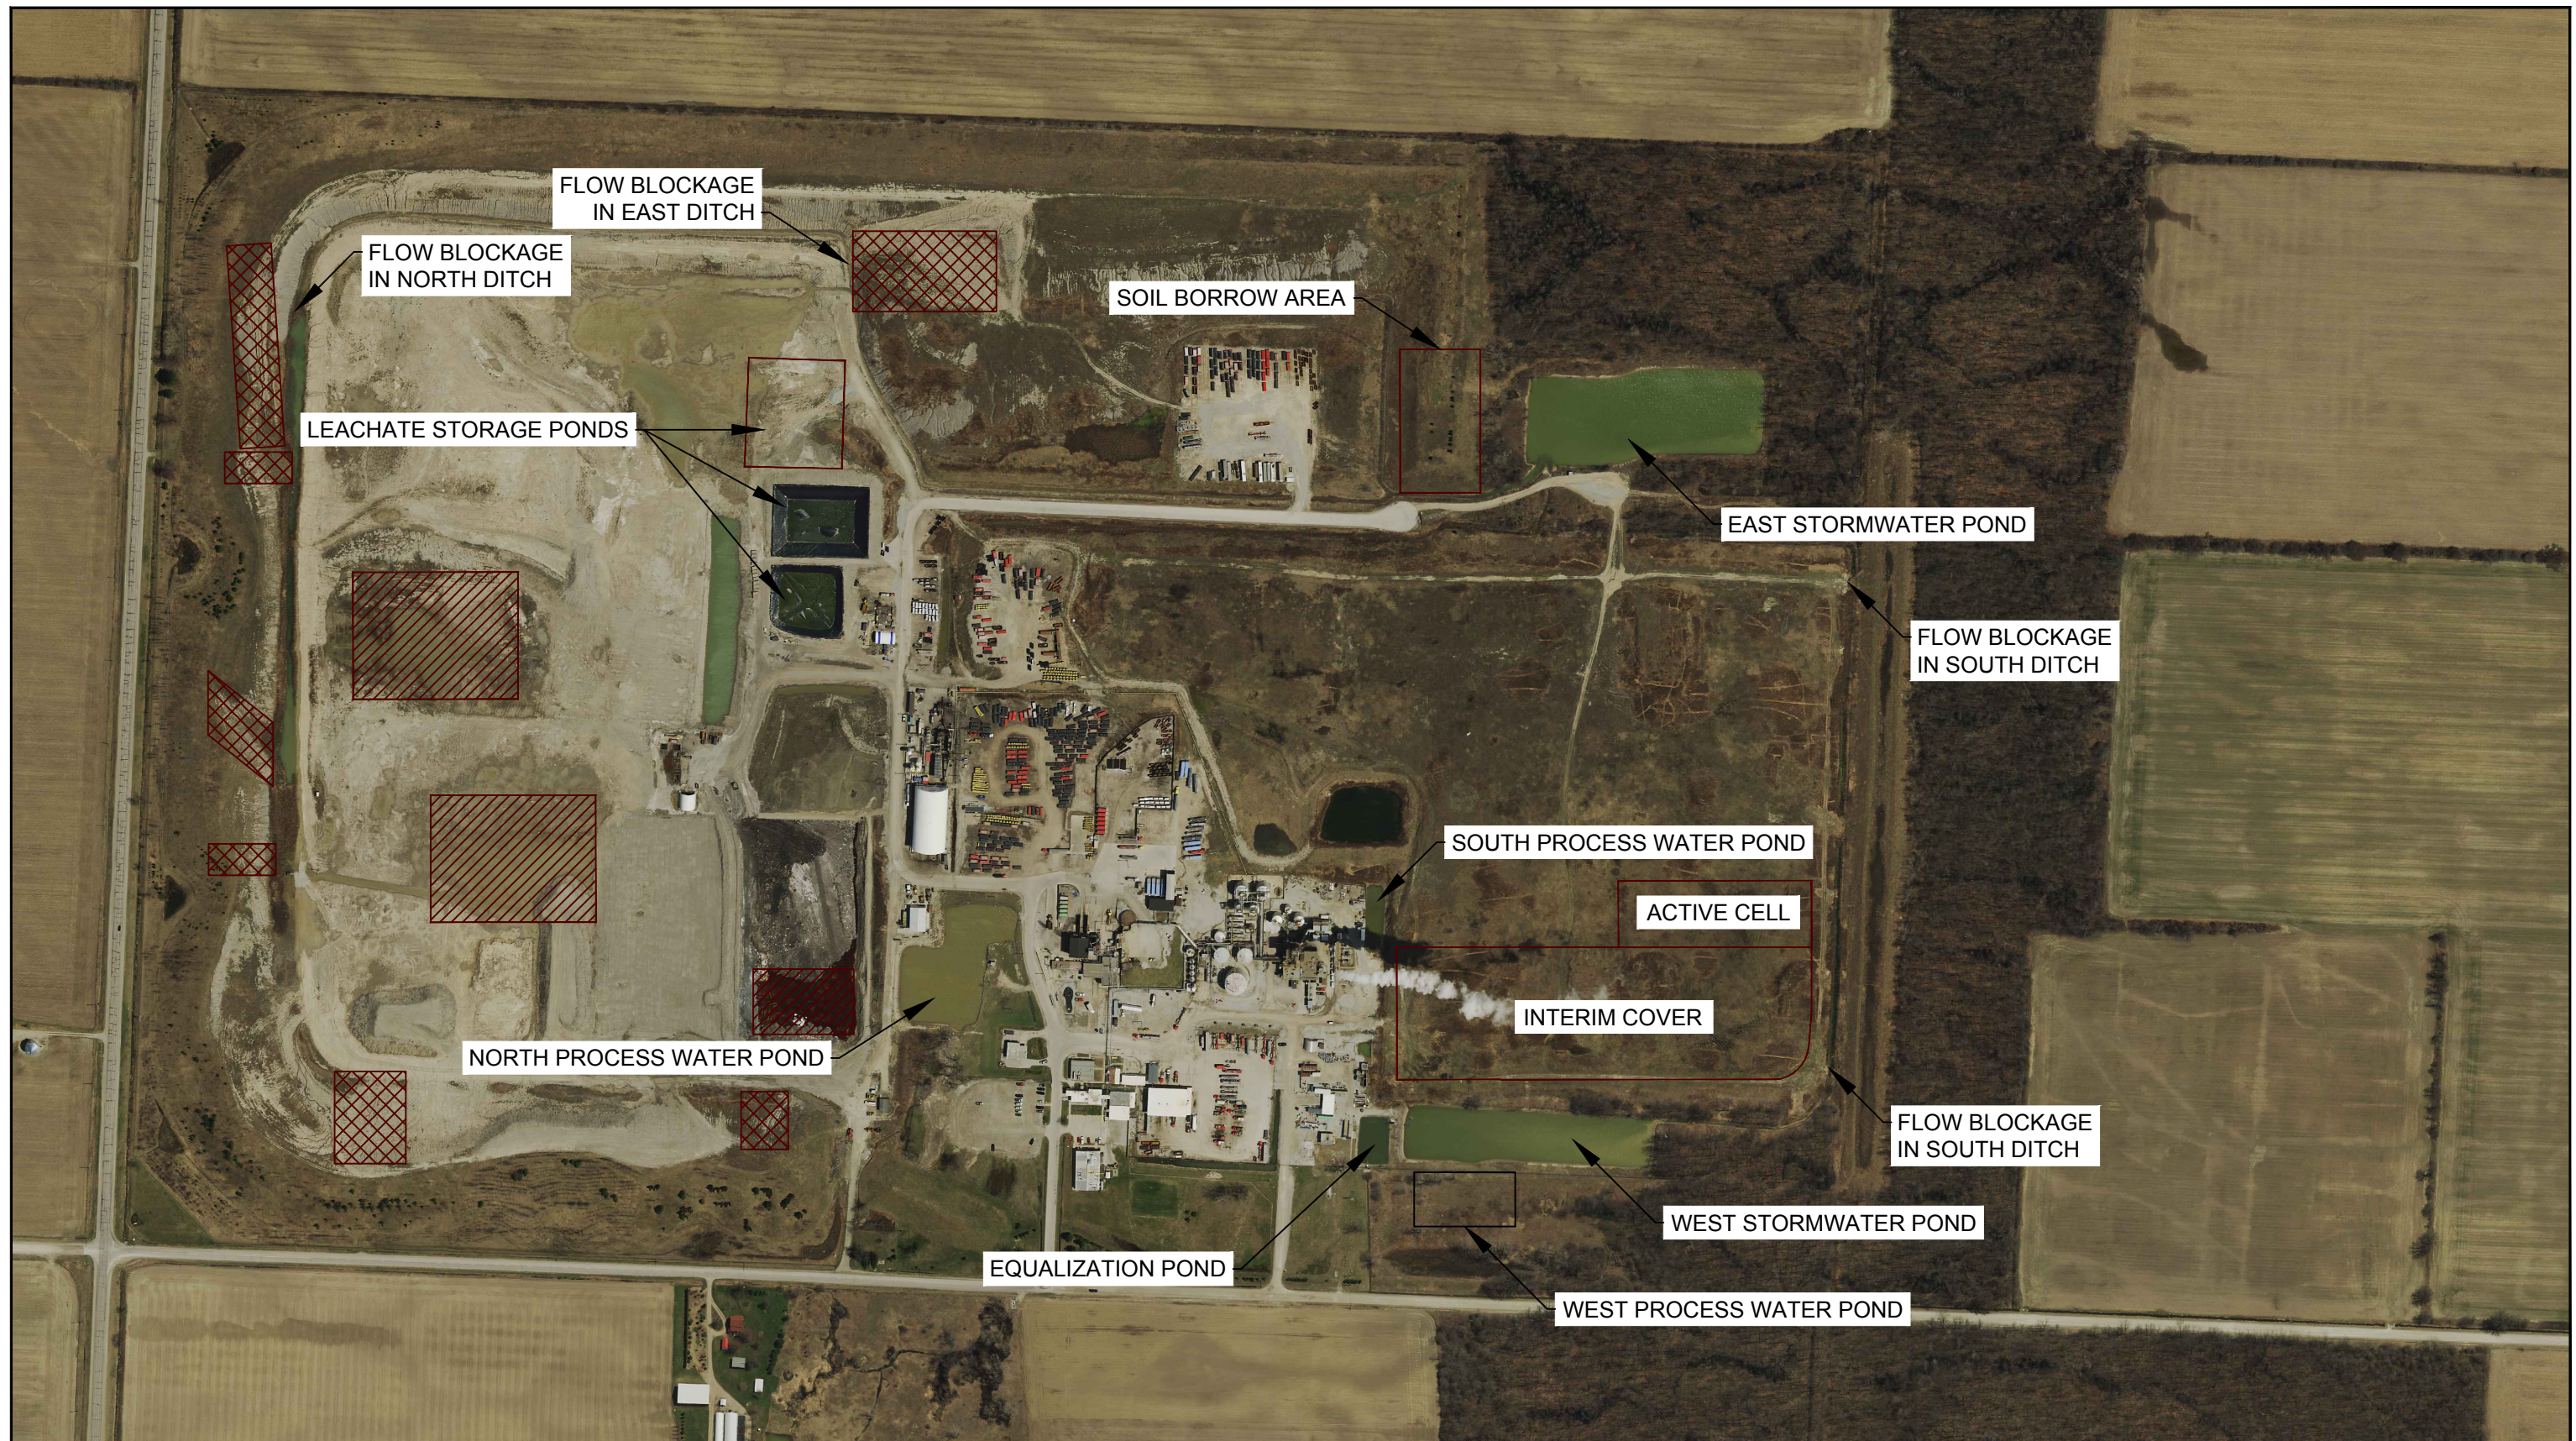
FIGURE 1

- Significant erosion was identified in the southeast corner of the OLA, resulting in sedimentation of the perimeter ditch and limited water flow, as shown in Photo 7 and Figure 1. Low levels of standing water were observed in the southeast ditch and the internal swale to the north.

LEGEND:
 LARGE EROSION CHANNELS
 LARGE AREAS OF SURFACE WATER PONDING

Portions of the interior side of the perimeter screening berms have significant erosion. These areas should be assessed and corrected to minimize erosion into the perimeter ditches. Installation of reinforced ditches from the top of berm to the perimeter ditches may be a solution for these areas, as well as vegetation of the internal berm slopes.

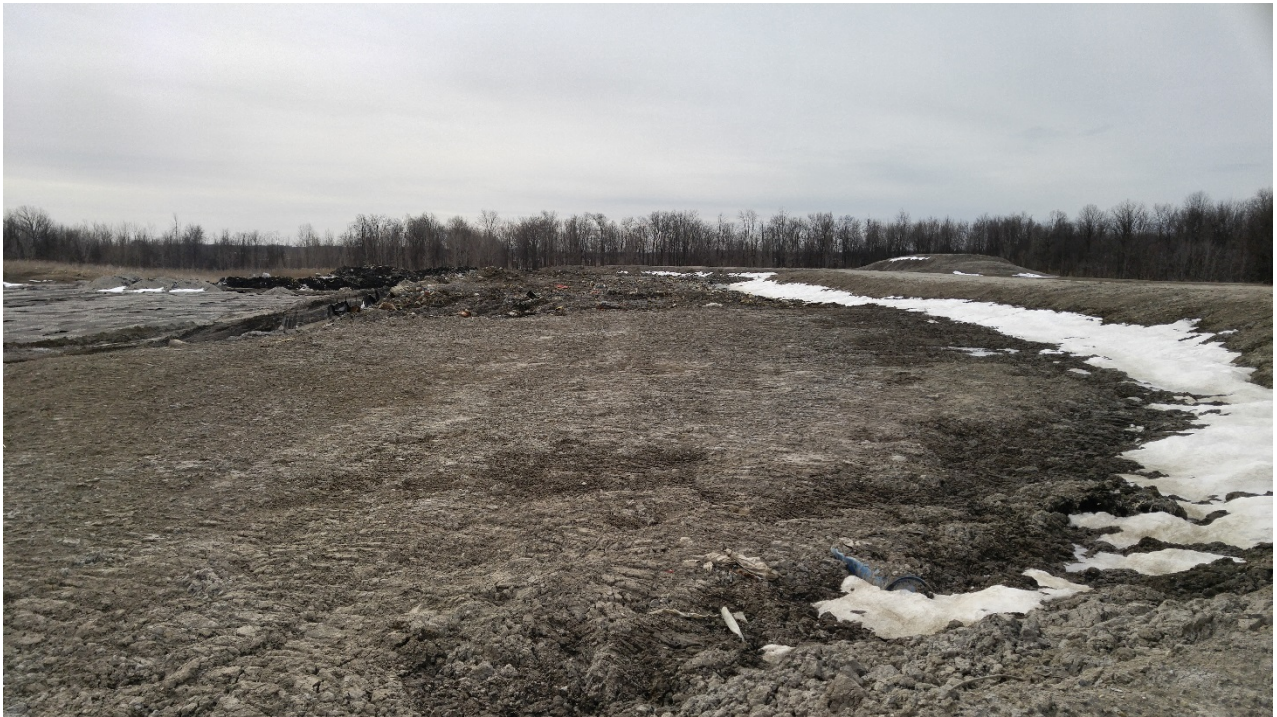
- The active waste tipping face is located in the southern portion of Cell 19-1-3 and is referred to as 19-1-3C. Waste placement is occurring from south to north, as shown in Photo 1. The southern portion of Cell 19-1-2 is no longer active. Odour was noted in the immediate vicinity of the active landfilling area.
- Construction of the southern half of Cell 19-1-3 has been completed. The northern portion is not currently under construction.
- Waste Transport Route: Site waste haulers are directed around the east side of the Process Area and enter Cell 19-1-3C from the east side, located at the north end of the constructed cell, on a dedicated haul road from the Waste Receiving Area.

Photo 1 - Active landfilling cell (southern portion of Cell 19-1-3)

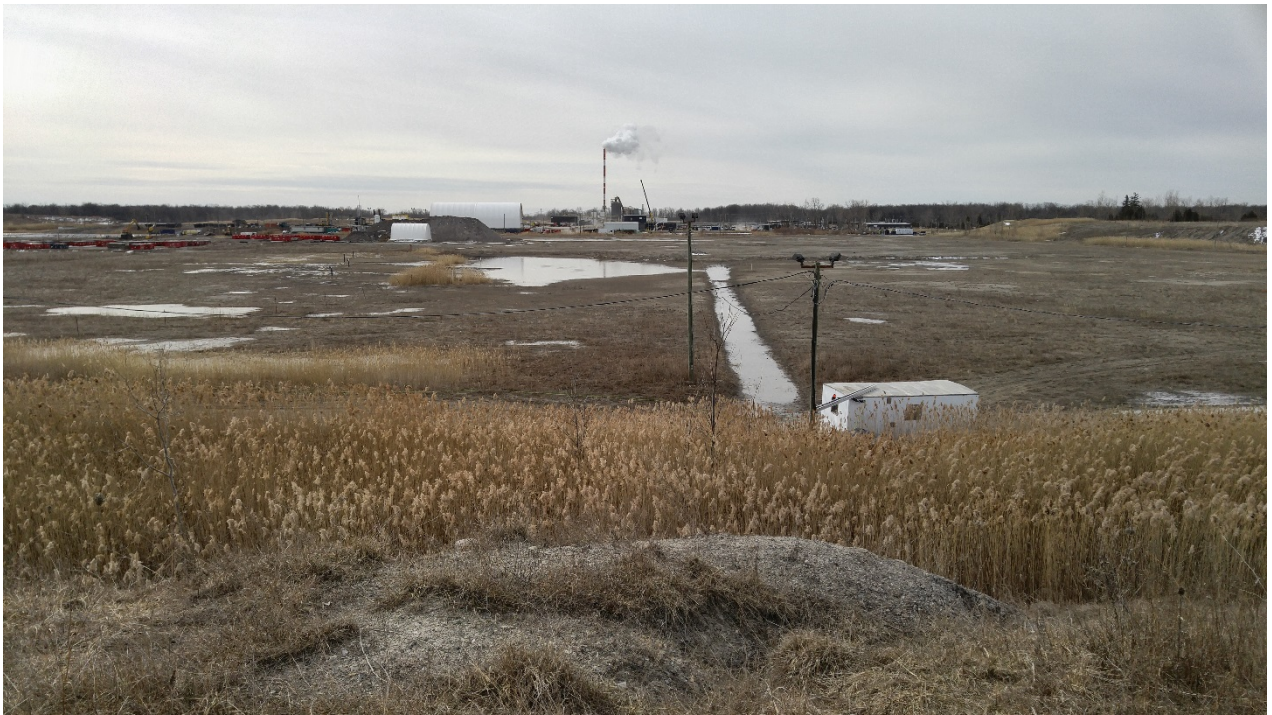
- The majority of the Site has received an interim cap, with the exception of the active landfilling area (Cell 19-1-3C).
- Cells 19-1-1 and 19-1-2A have received interim cap.
- Cells 19-1-2B and 19-1-2C have received daily cover, with miscellaneous debris noted in the cover. The daily cover of Cells 19-1-2B and 19-1-2C is shown in Photo 2.

Photo 2 - Interim cap placement, southern portion of Cell 19-1-2

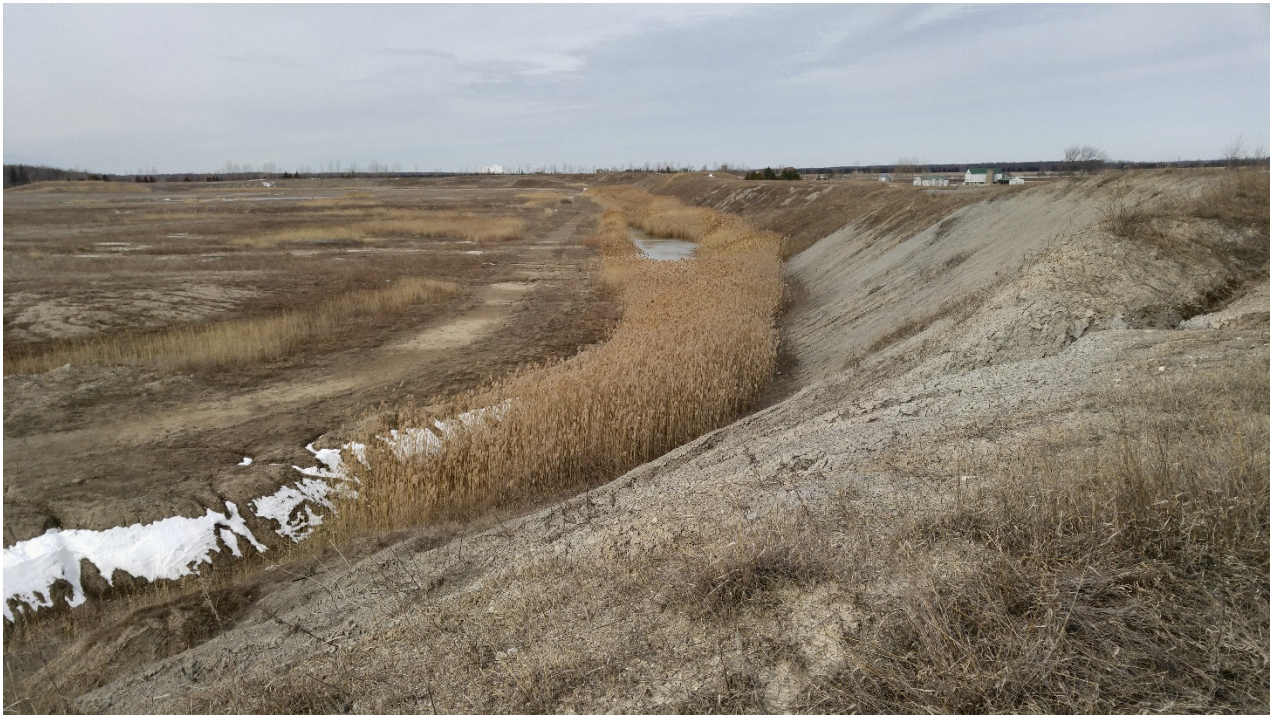
- Water levels continue to be high in the central portion of the north ditch, as shown in Photo 5. High water levels in the north ditch have the potential to prohibit the above-noted ponded areas from draining during wetter periods.

Photo 5 - High water levels in central portion of north perimeter ditch

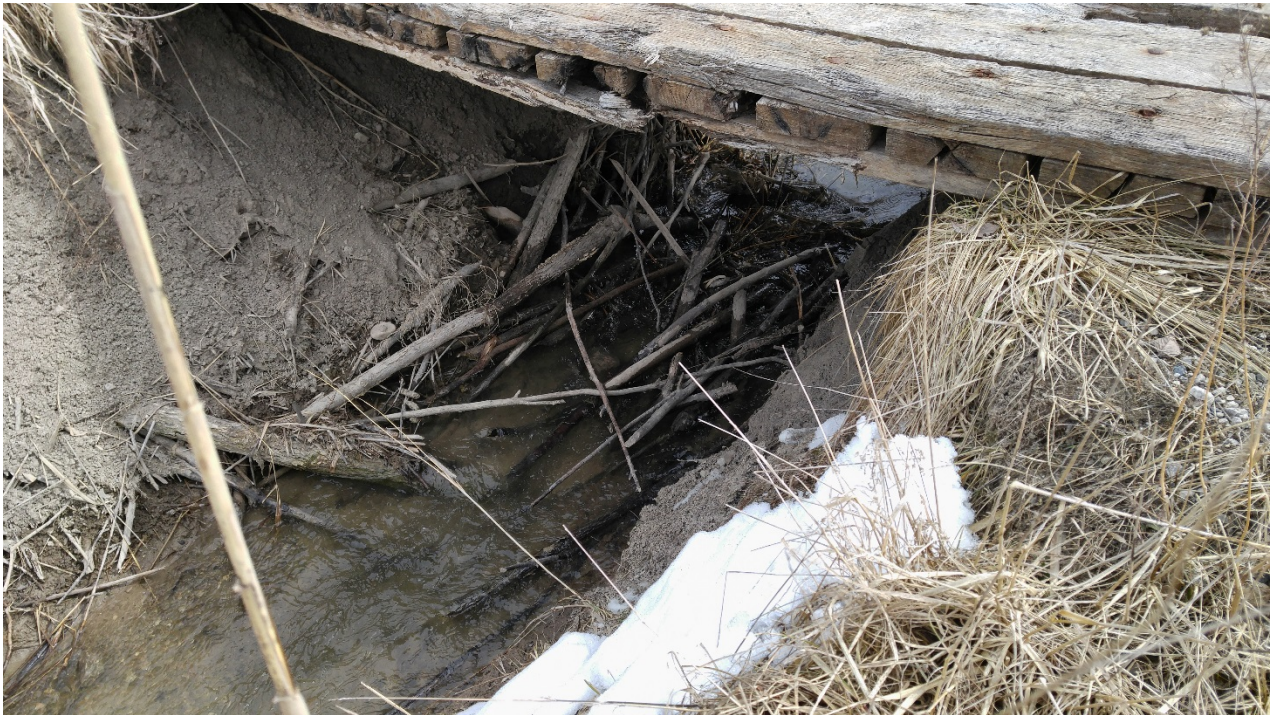
Photo 7 - North landfill area, southeast ditch, partial surface water blockage

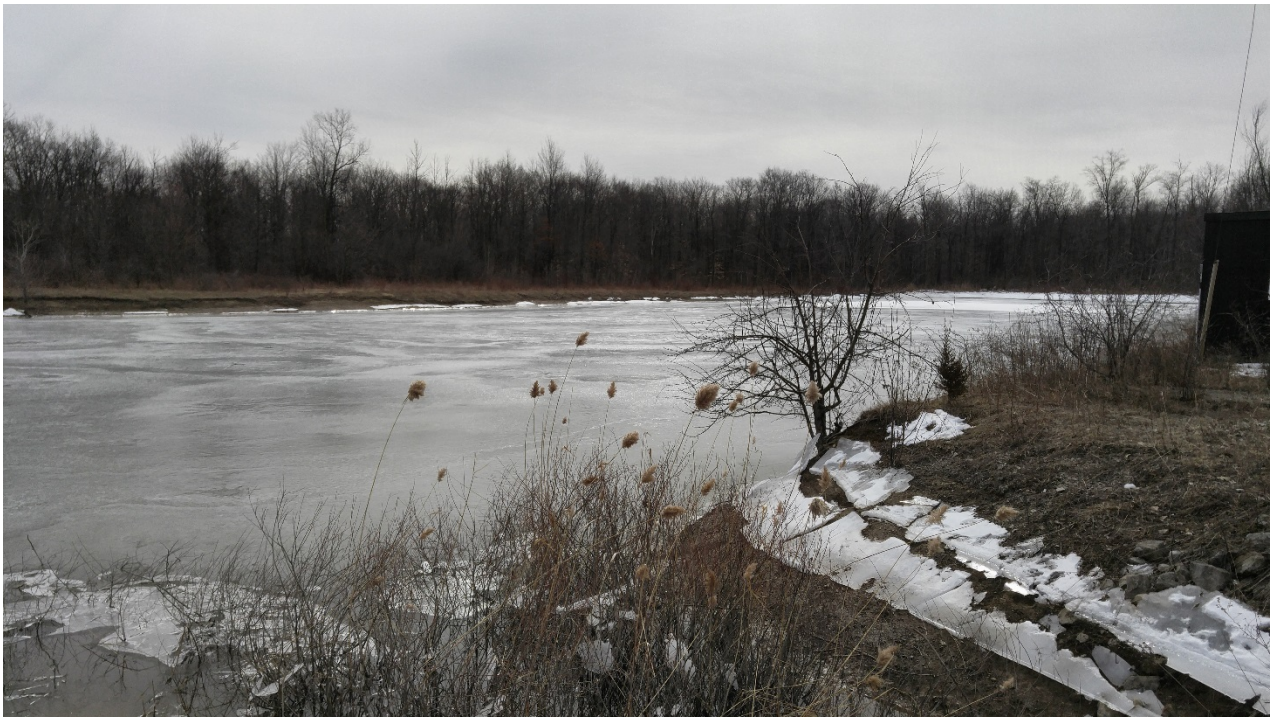
- There is a flow break in the south ditch, beneath the access bridge located at Gate 6. The blockage is the result of wildlife activity (i.e., beavers), as shown in Photo 8. Flow was noted through the dam, due to high water levels overtopping the dam. During a previous inspection, it was noted that removed beaver was caught and removed from the Site; however, it appears as though another beaver has arrived at Site.

Photo 8 - South ditch, surface water blockage west of access bridge

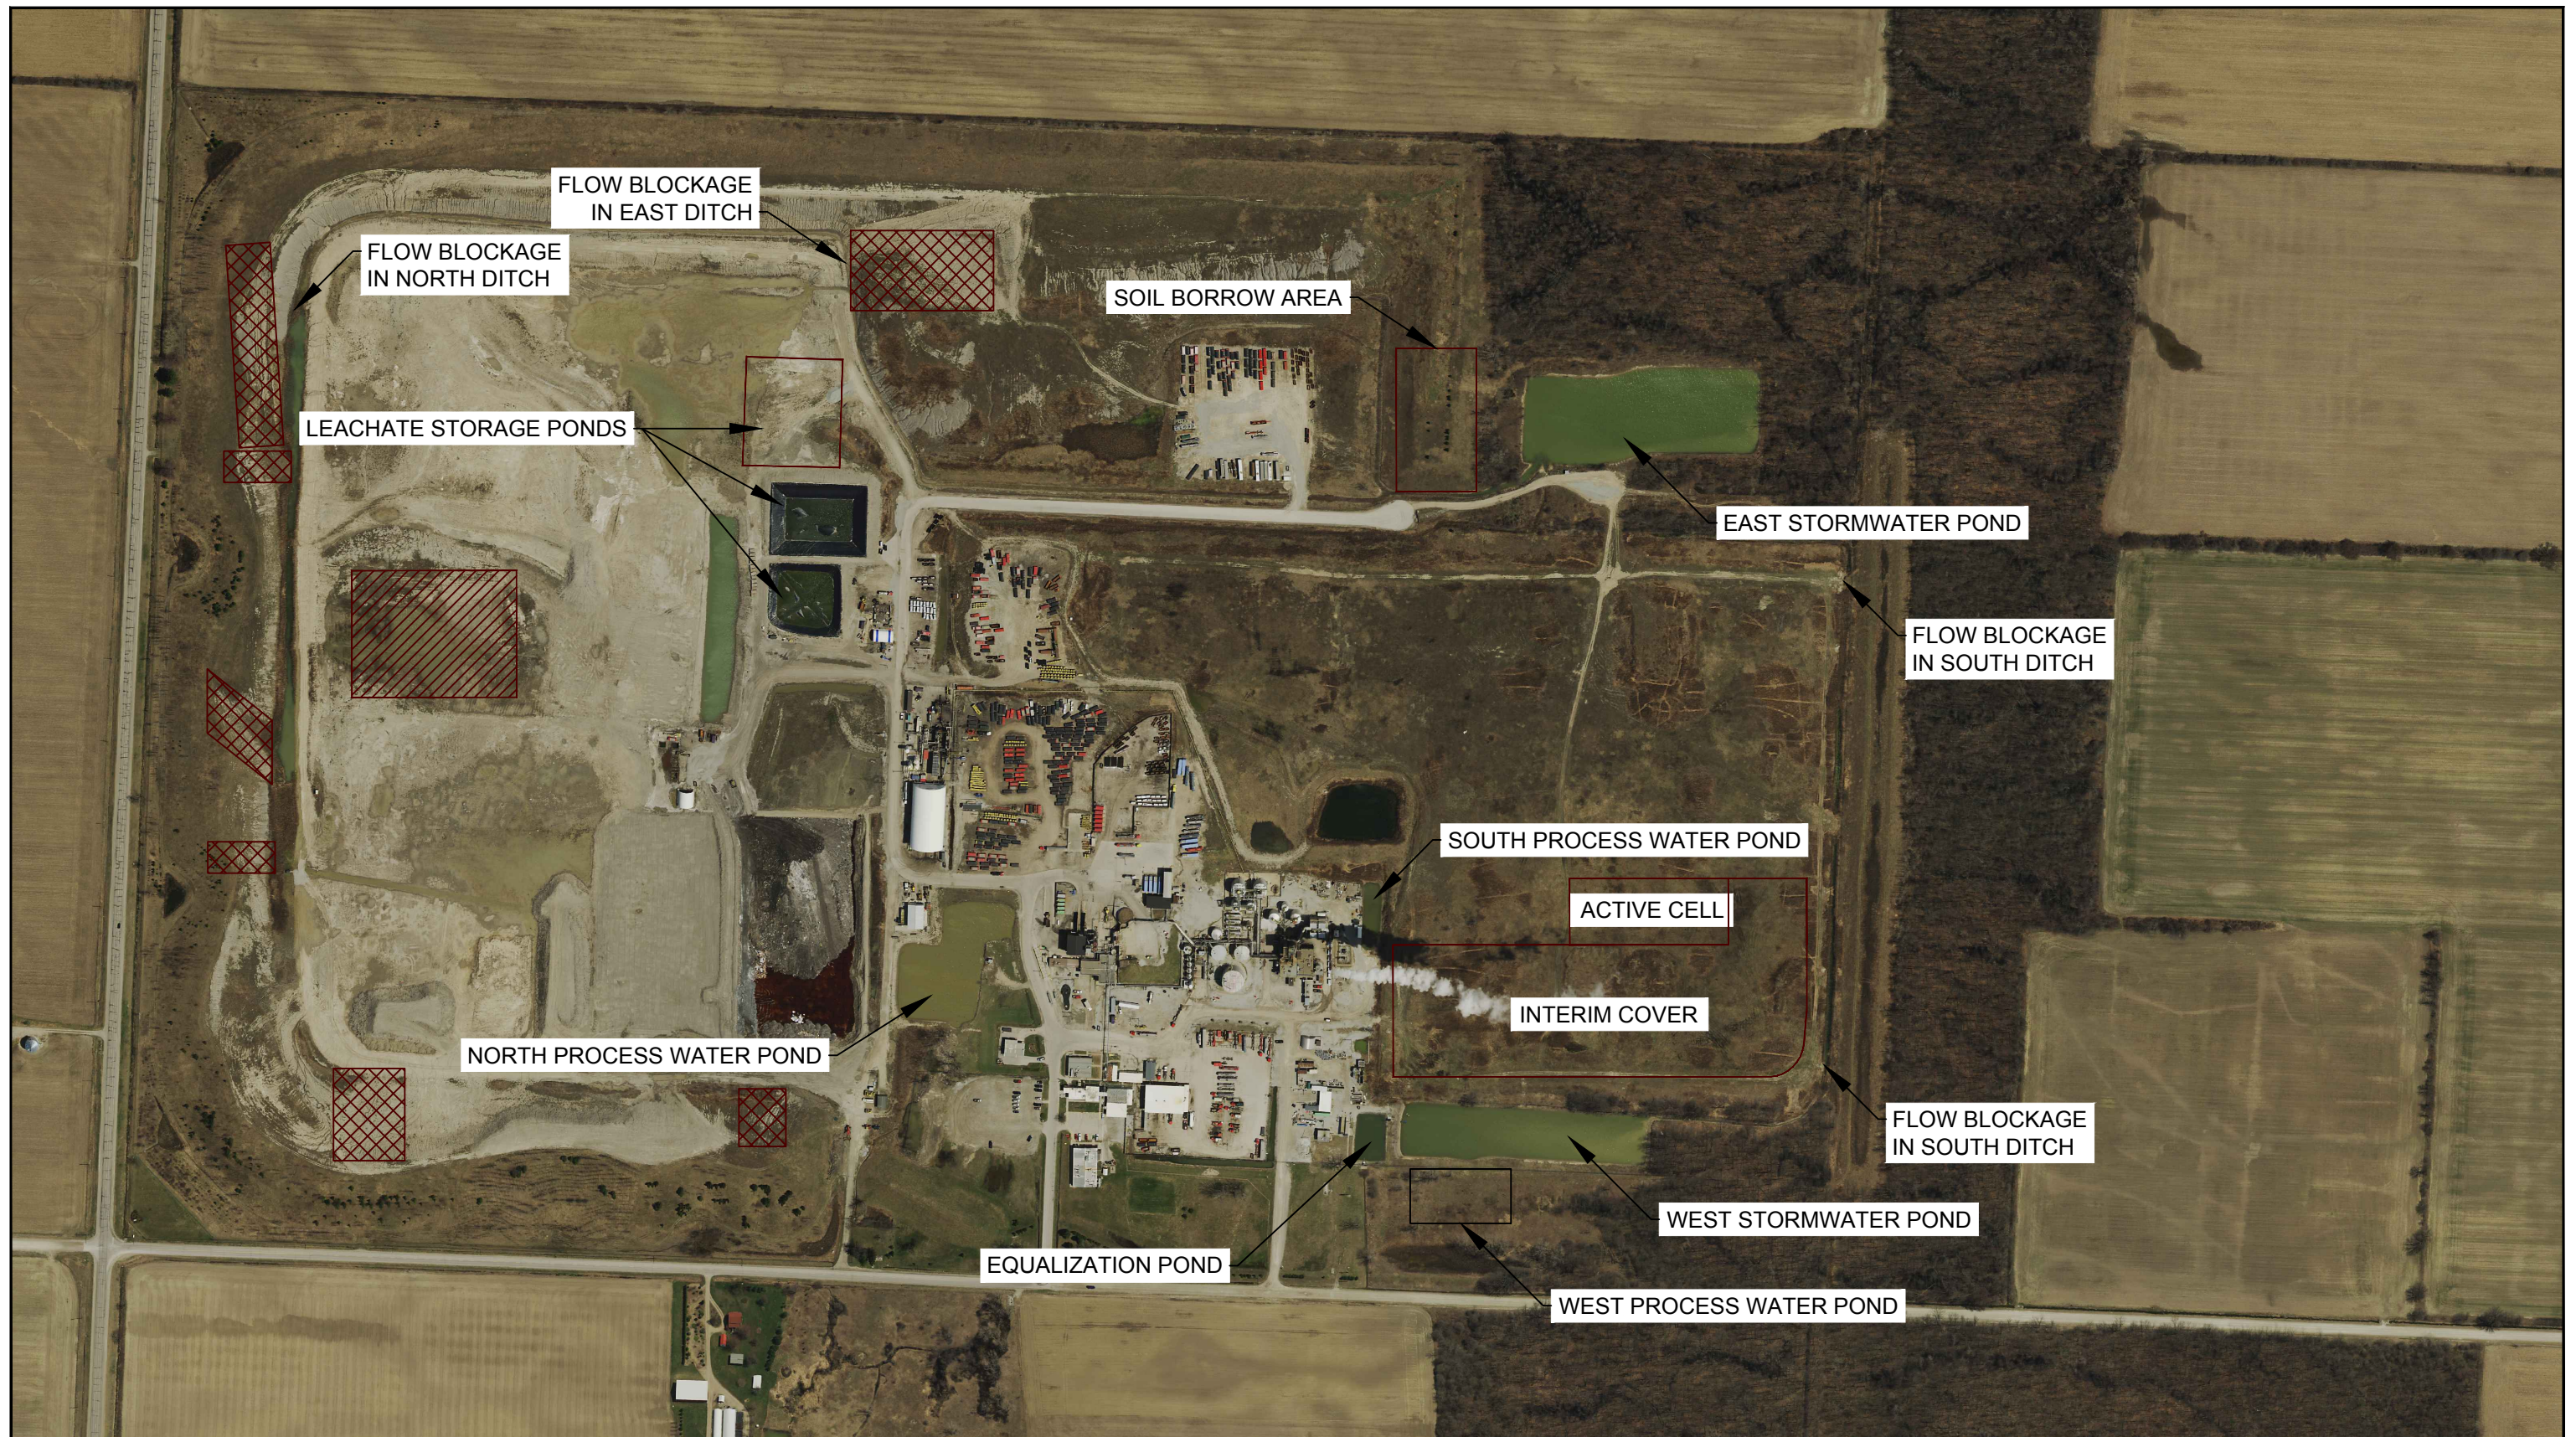
FIGURE 1

- Significant erosion was identified in the southeast corner of the OLA, resulting in sedimentation of the perimeter ditch and limited water flow, as shown in Photo 7 and Figure 1. Minimal standing water was observed in the southeast ditch and the internal swale to the north.

LEGEND:
 LARGE EROSION CHANNELS
 LARGE AREAS OF SURFACE WATER PONDING

Portions of the interior side of the perimeter screening berms have significant erosion. These areas should be assessed and corrected to minimize erosion into the perimeter ditches. Installation of reinforced ditches from the top of berm to the perimeter ditches may be a solution for these areas, as well as vegetation of the internal berm slopes.

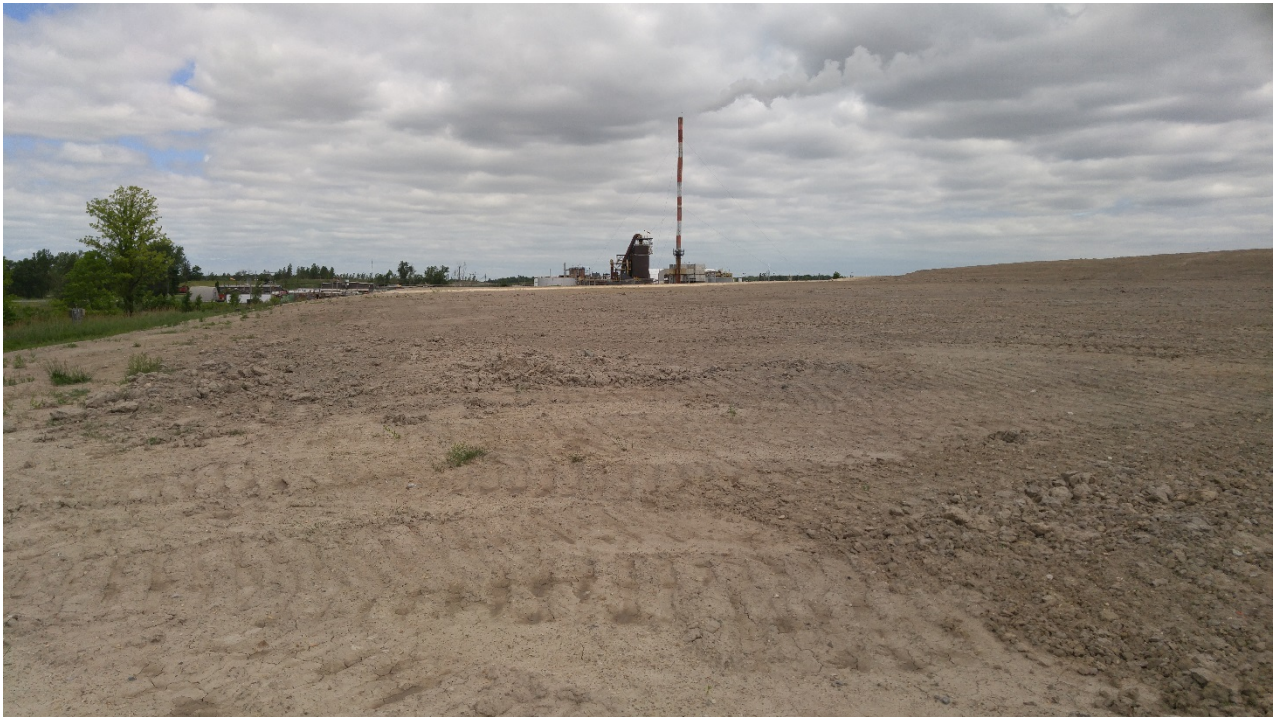
- The active waste tipping face is located in the central portion of Cell 19-1-3 and is referred to as 19-1-3B. Waste placement is occurring from south to north, as shown in Photo 1. Odour was noted in the immediate vicinity of the active landfilling area.
- Construction of the southern half of Cell 19-1-3 has been completed. The northern portion is not currently constructed.
- Waste Transport Route: Site waste haulers are directed around the east side of the Process Area and enter Cell 19-1-3B from the east side, located at the north end of the constructed cell, on a dedicated haul road from the Waste Receiving Area.

Photo 1 - Active landfilling cell (southern portion of Cell 19-1-3)

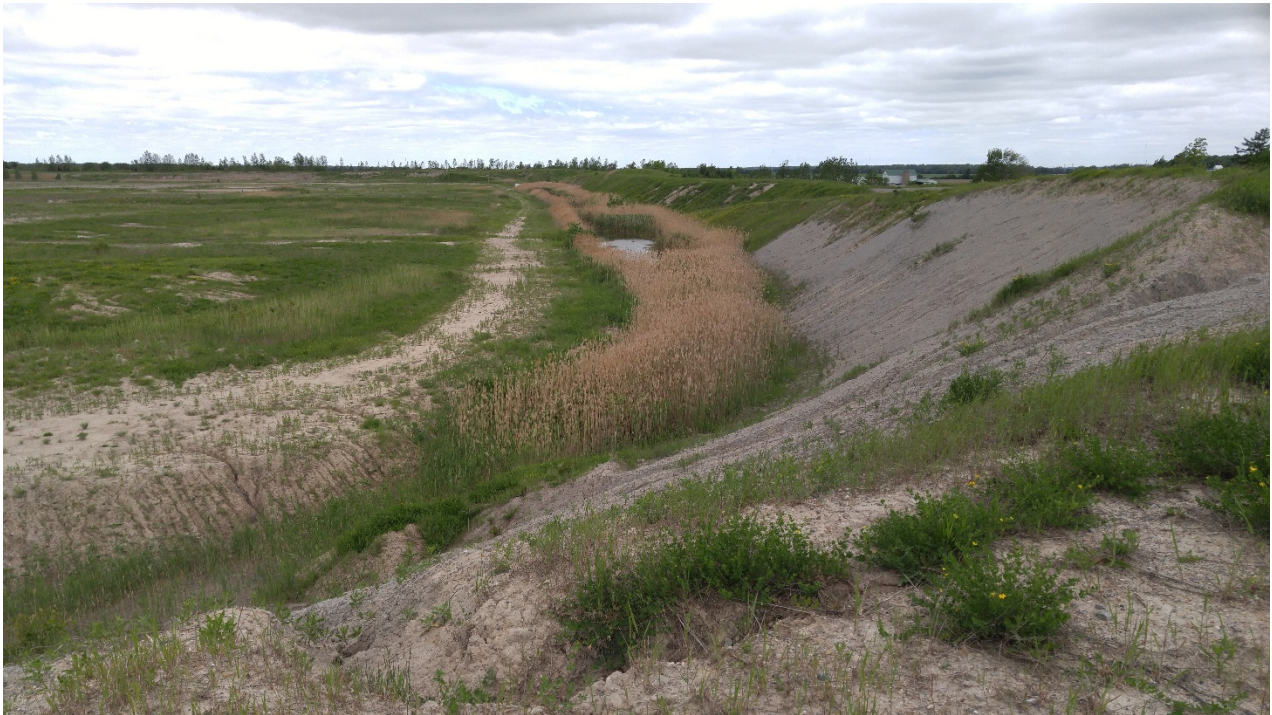
Photo 5 - High water levels in central portion of north perimeter ditch

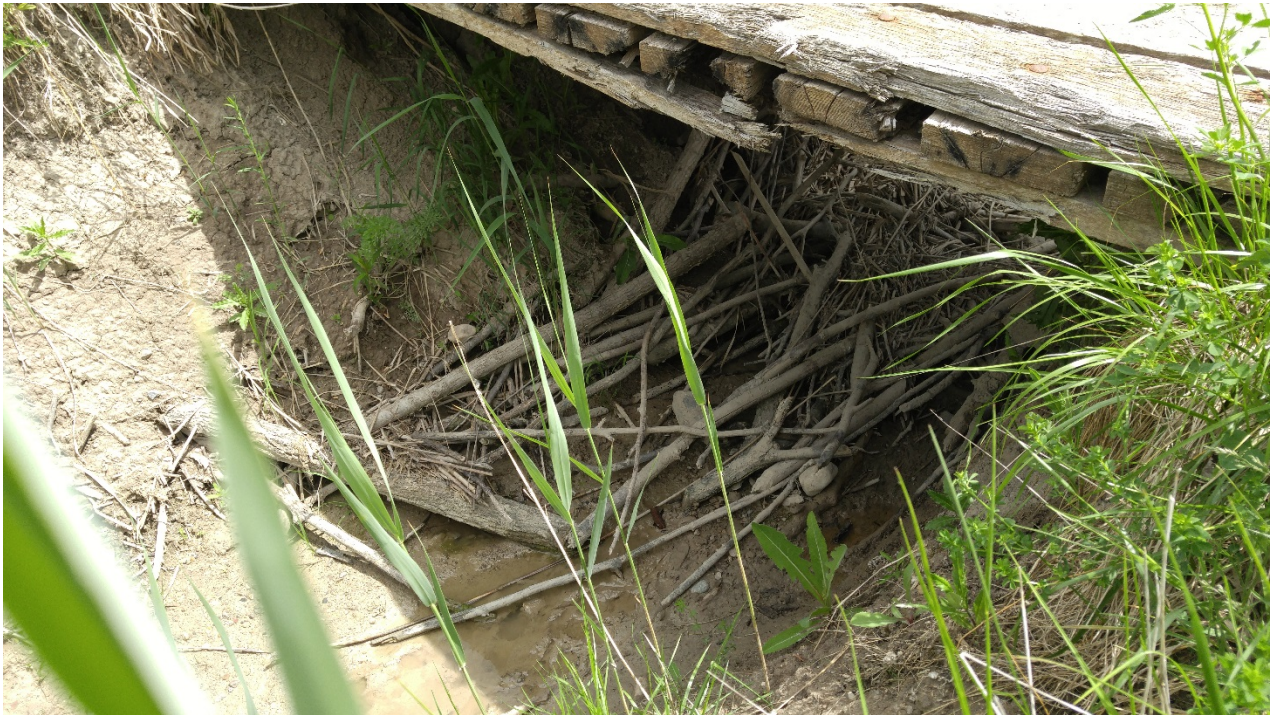
Photo 7 - North landfill area, southeast ditch, partial surface water blockage

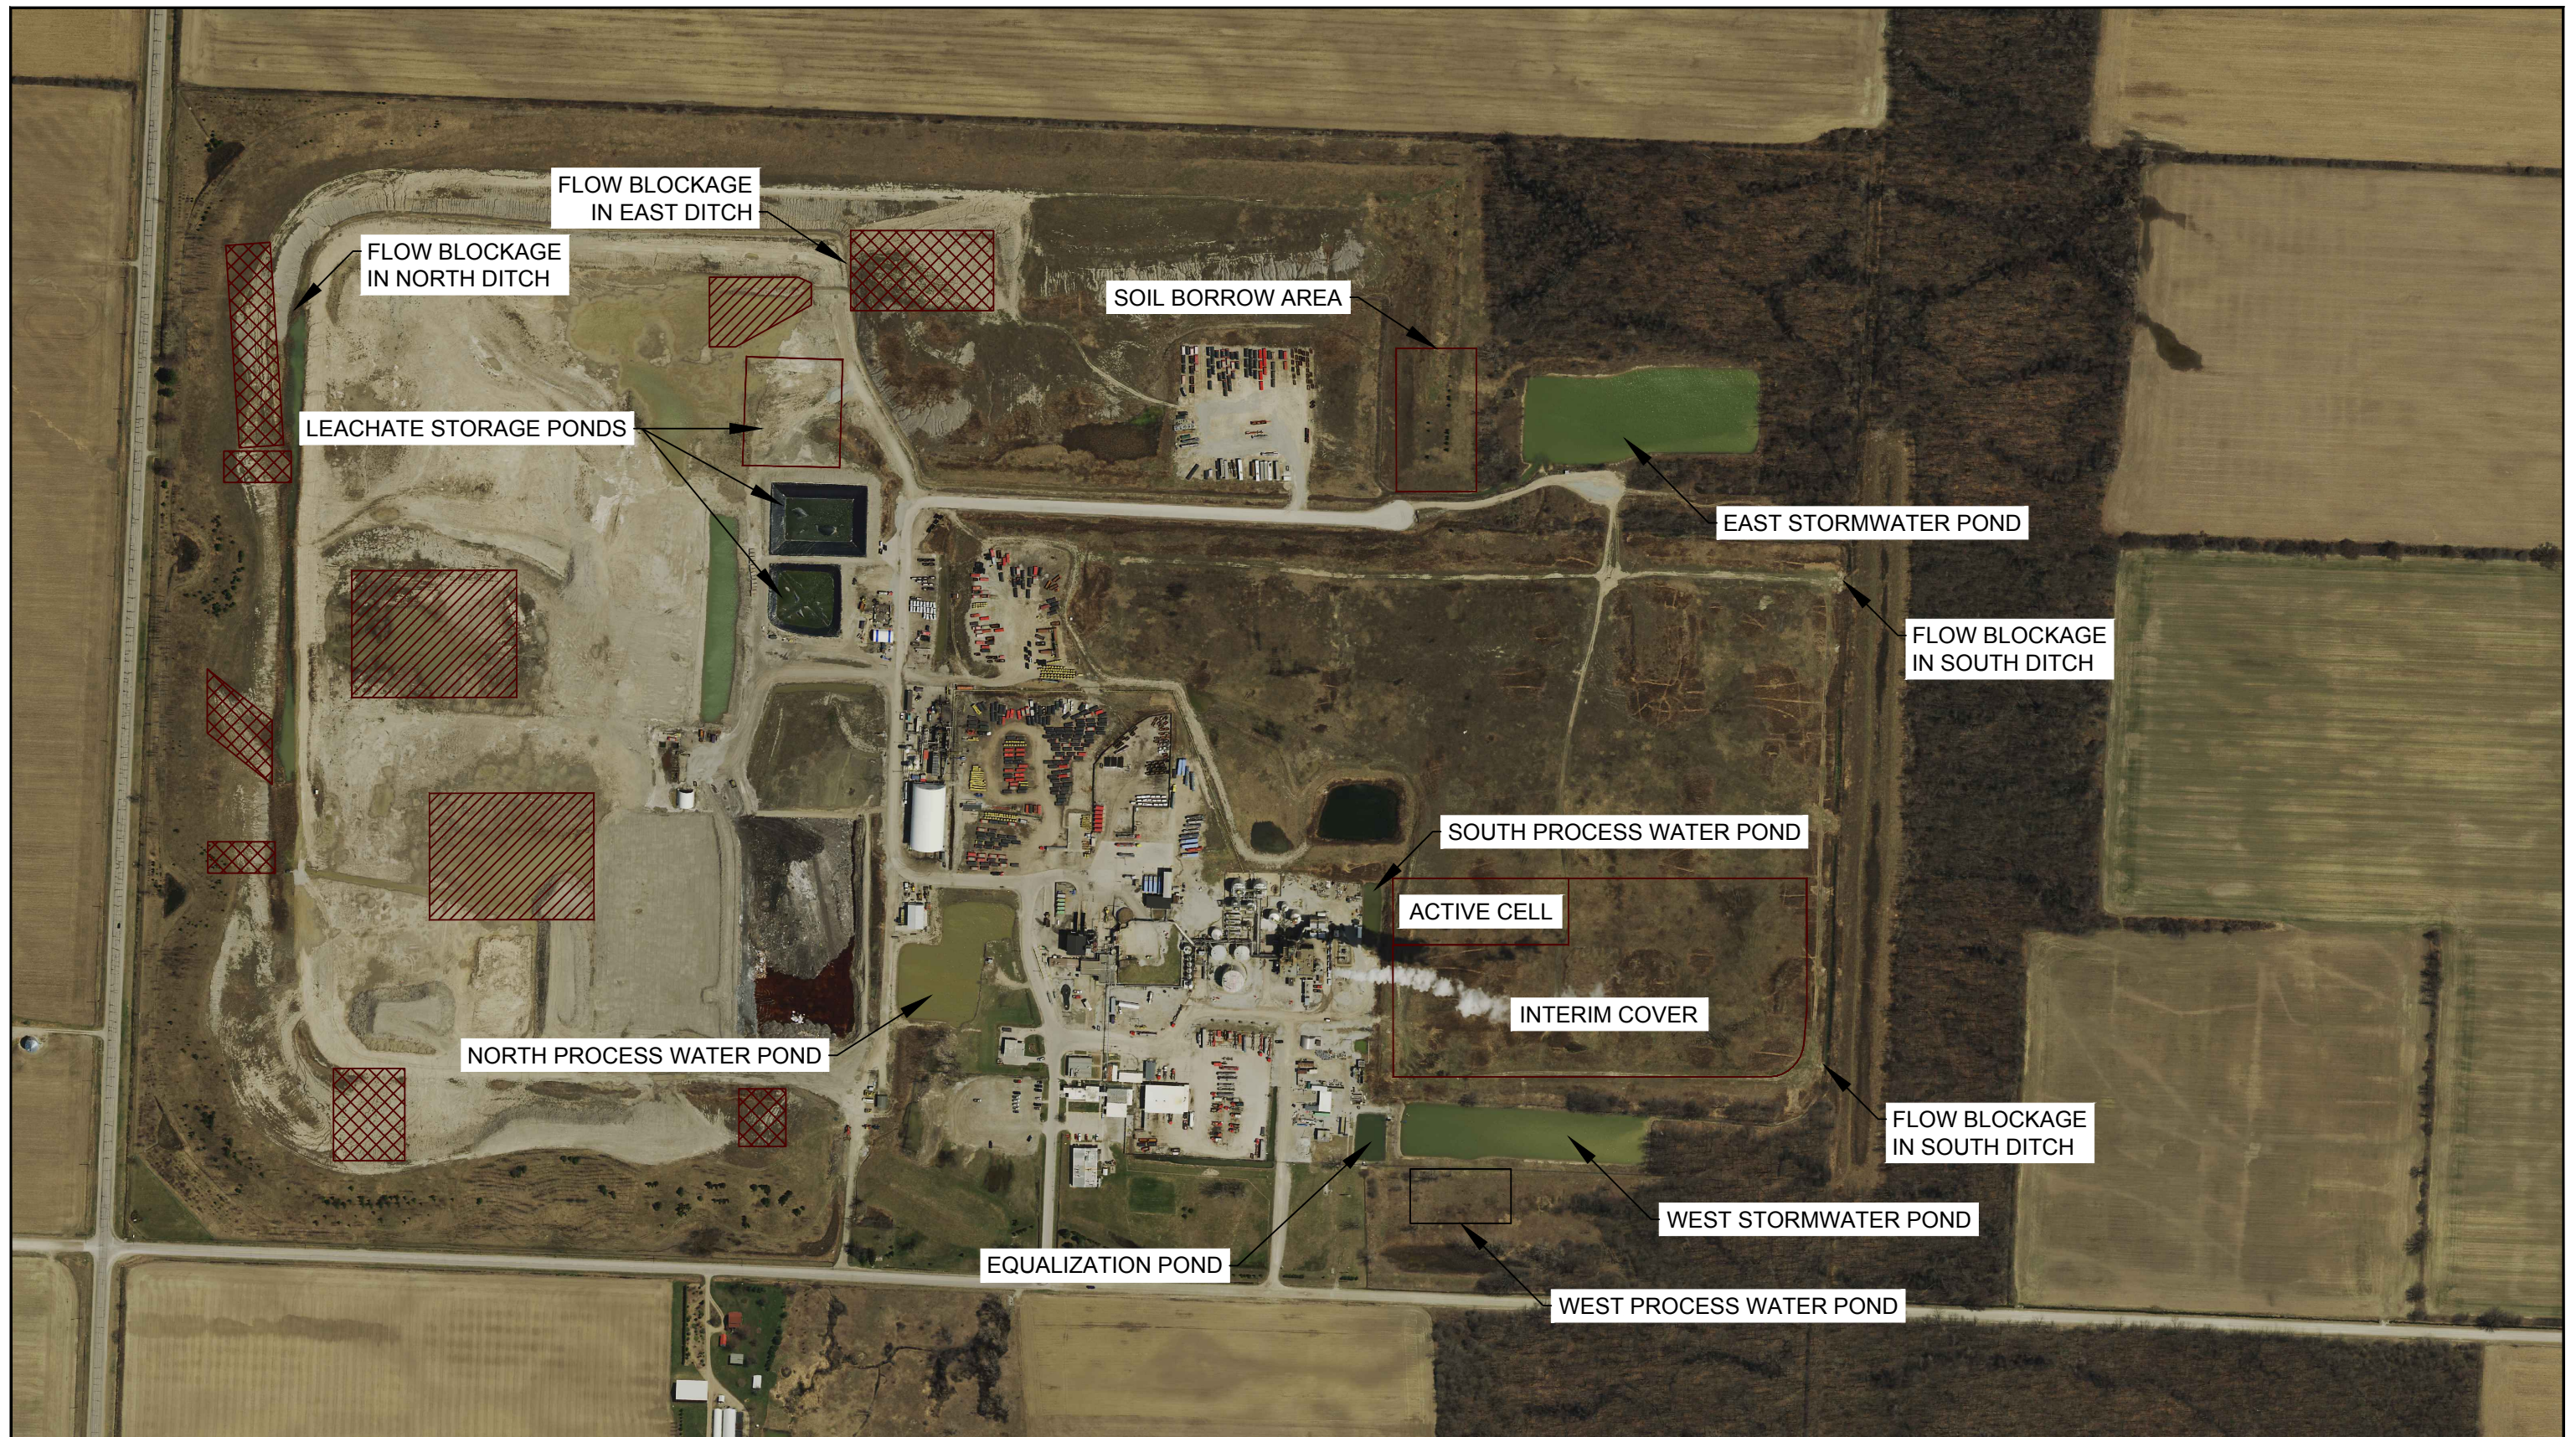
FIGURE 1

LARGE EROSION CHANNELS

Portions of the interior side of the perimeter screening berms have significant erosion. These areas should be assessed and corrected to minimize erosion into the perimeter ditches. Installation of reinforced ditches from the top of berm to the perimeter ditches may be a solution for these areas, as well as vegetation of the internal berm slopes.
