2019 Quarterly Site Inspections

Clean Harbors Lambton Facility
4090 Telfer Road, Corunna, Ontario

Clean Harbors Canada, Inc.

Subject: 2019 First Quarter Site Inspection

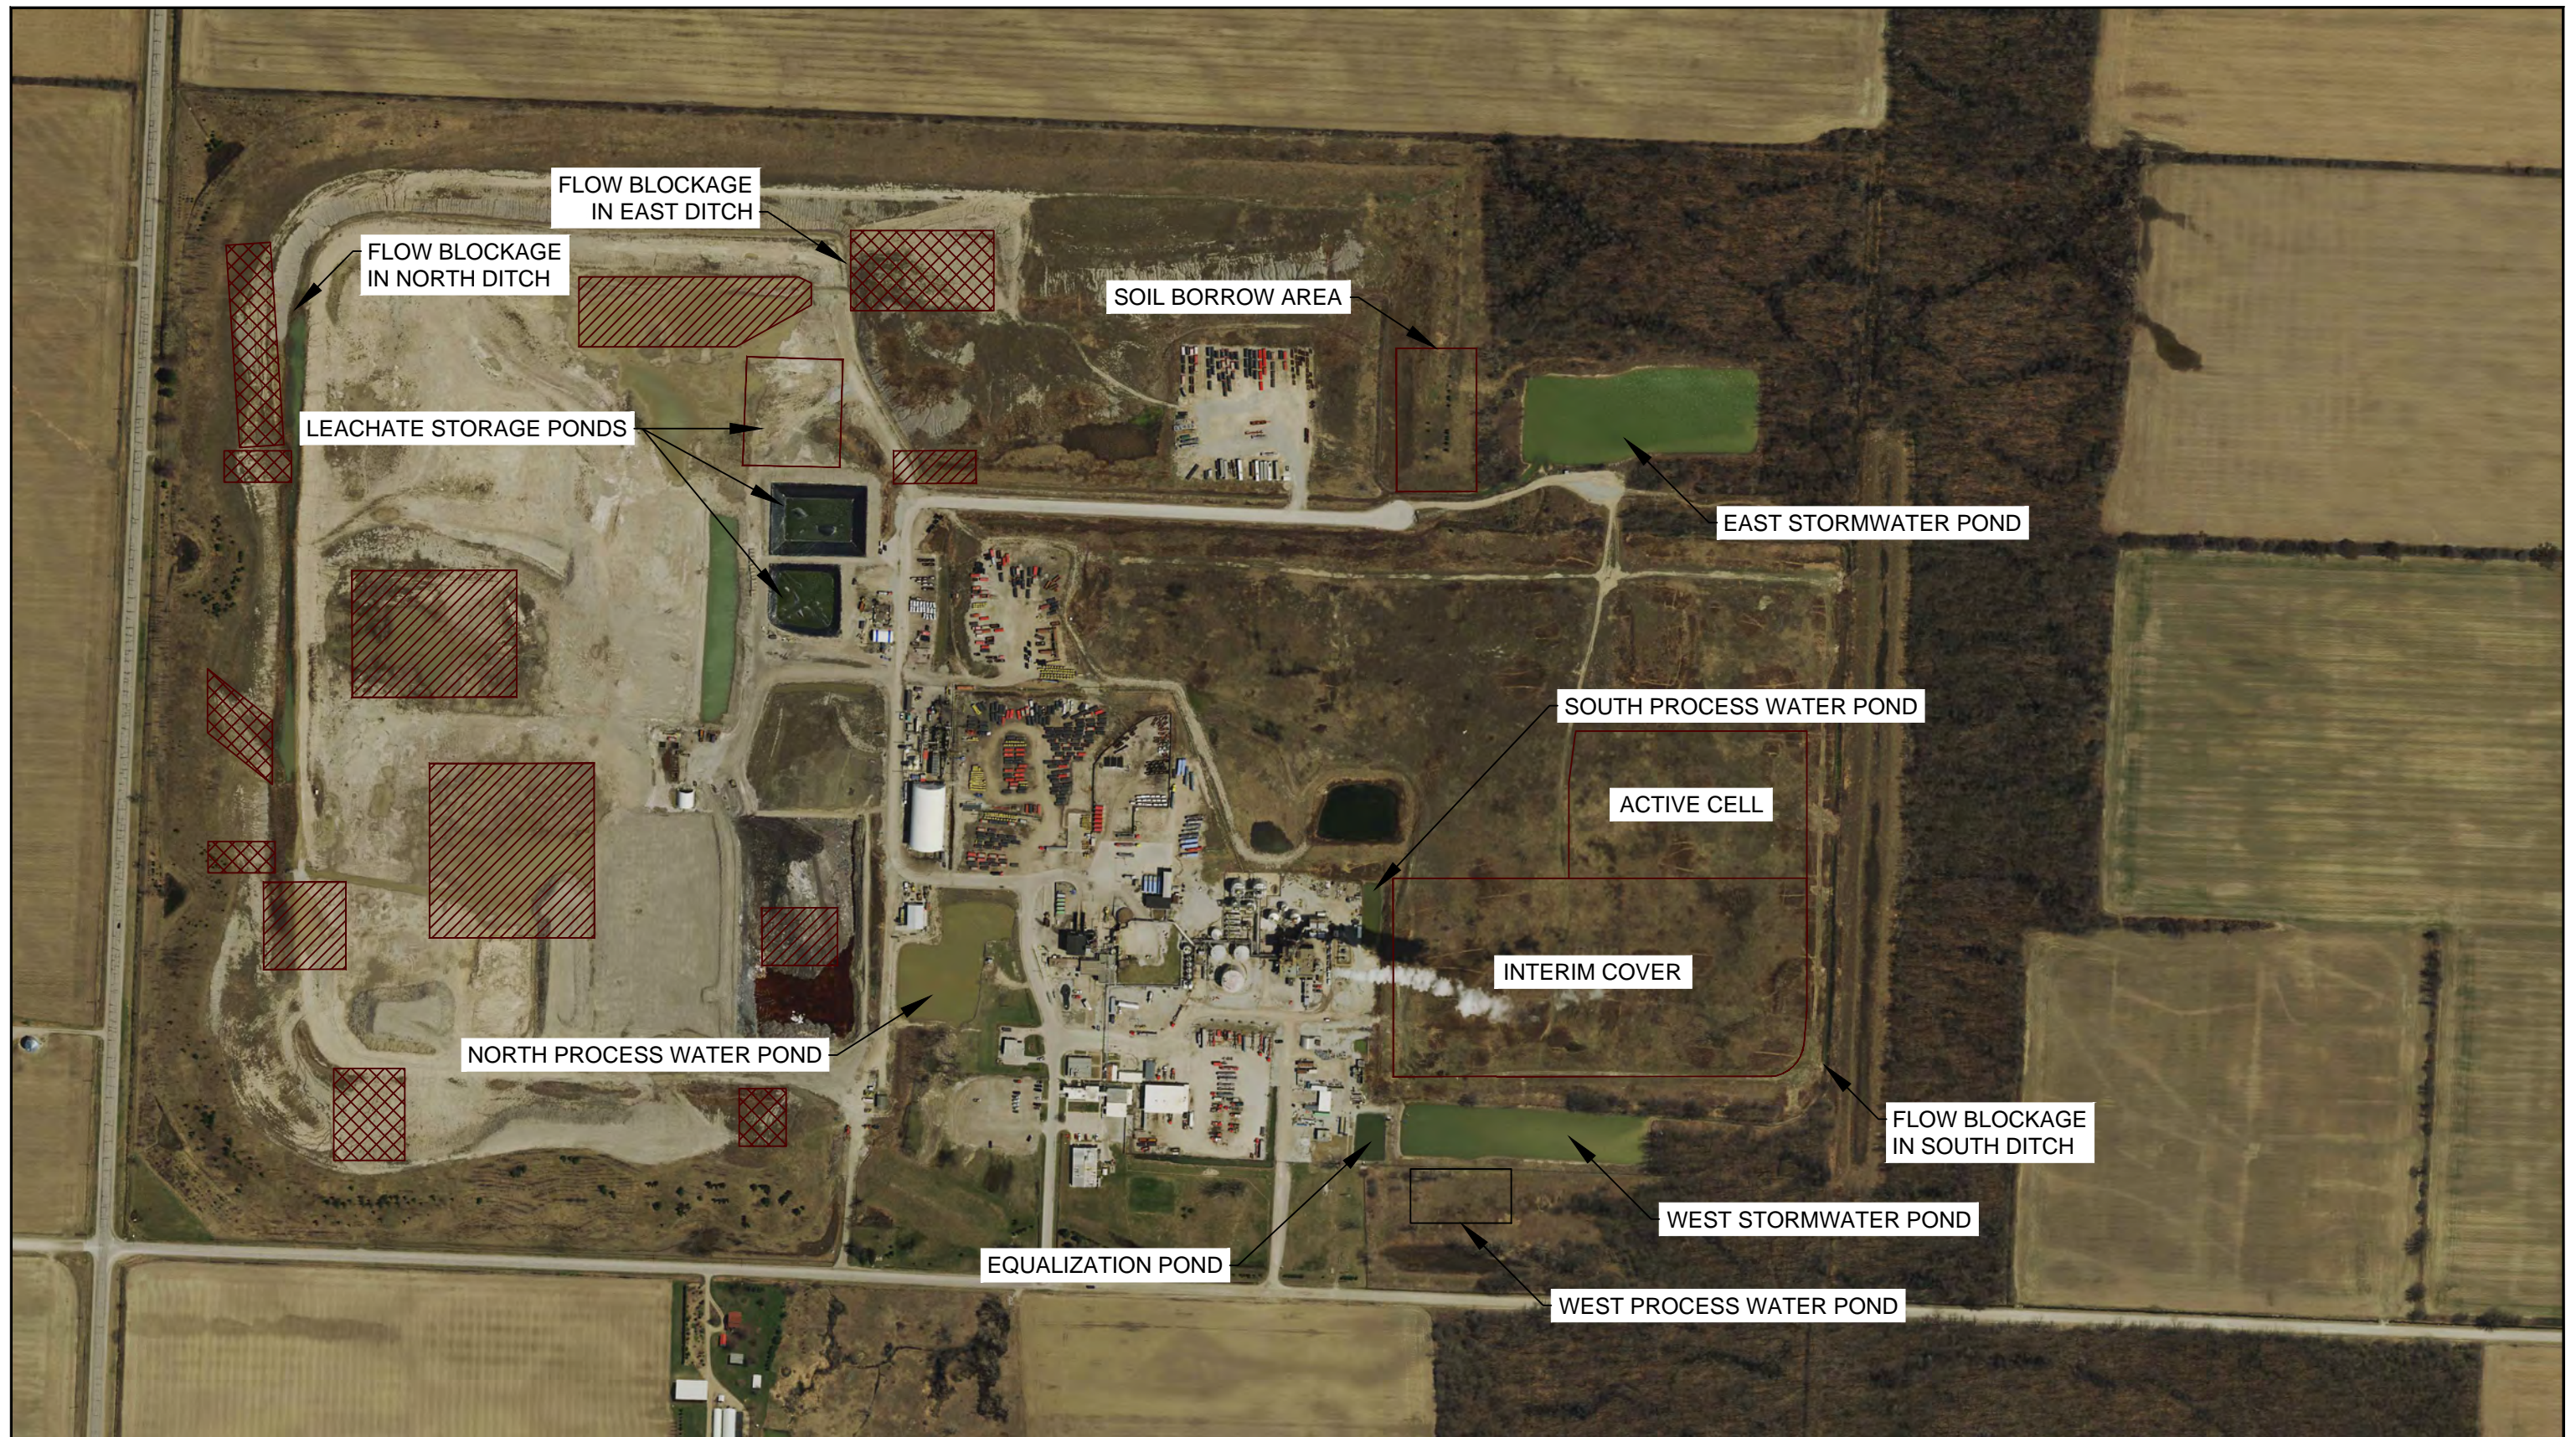
FIGURE 1

- Several large erosion channels were noted on the elevated areas immediately northwest and southeast of the northern portion of the landfill. The erosion channels are located on plateaus/ramps within the screening berm. The erosion channels in the southeast corner extends into the east perimeter ditch.

- Significant erosion was identified in the southeast corner of the OLA, resulting in sedimentation of the perimeter ditch and limited water flow, as shown in Photo 7 and Figure 1. Water levels were sufficient to overtop the sedimentation, resulting in limited flow. Standing water was observed in the internal swale and low-lying area to the north, as shown in Photo 8 and Figure 1.

Portions of the interior side of the perimeter screening berms have significant erosion. These areas should be assessed and corrected to minimize erosion into the perimeter ditches. Installation of reinforced ditches from the top of berm to the perimeter ditches may be a solution for these areas, as well as vegetation of the internal berm slopes.

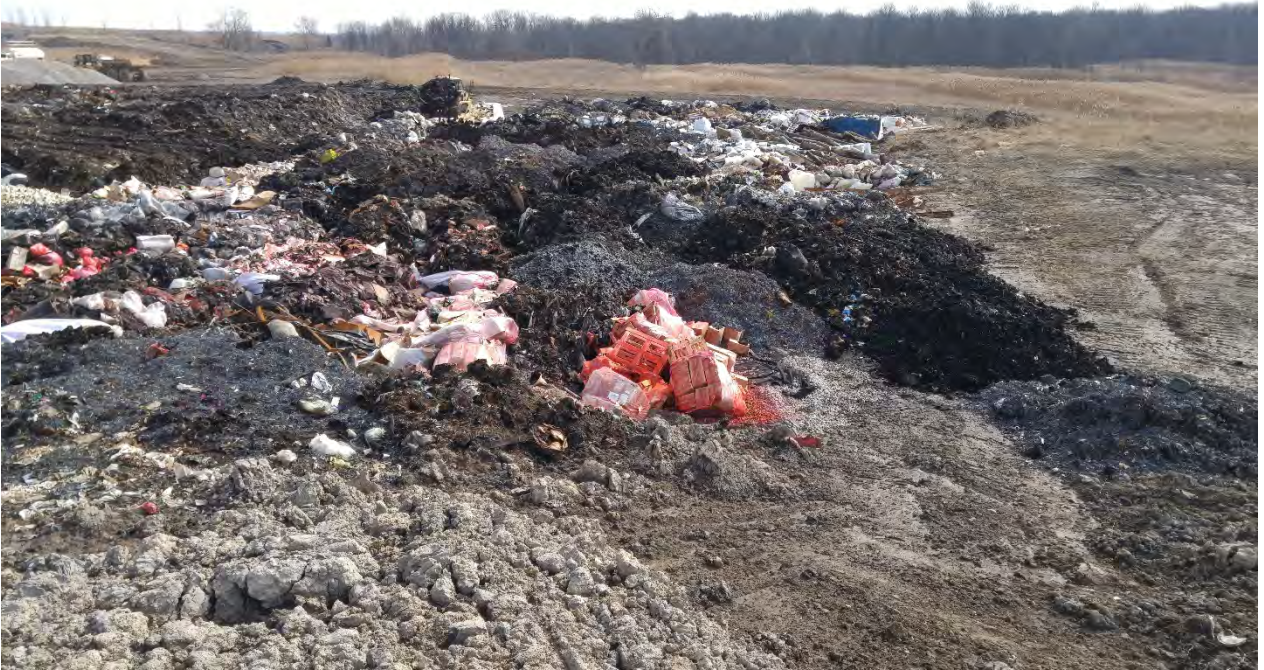
- The active waste tipping face is located in Cell 19-2A. Waste placement is generally occurring from north to south, as shown in Photo 1. Odour was noted in the immediate vicinity of the active landfilling area.
- Construction of Cell 19-2A is complete, with tie-in to previously landfilled area at higher elevation.
- Waste Transport Route: Site waste haulers are directed around the east side of the Process Area and enter Cell 19-2A from the east side, located at the centrally within the active landfilling area, on a dedicated haul road from the Waste Receiving Area.

Photo 1 - Active landfilling cell, Cell 19-2A

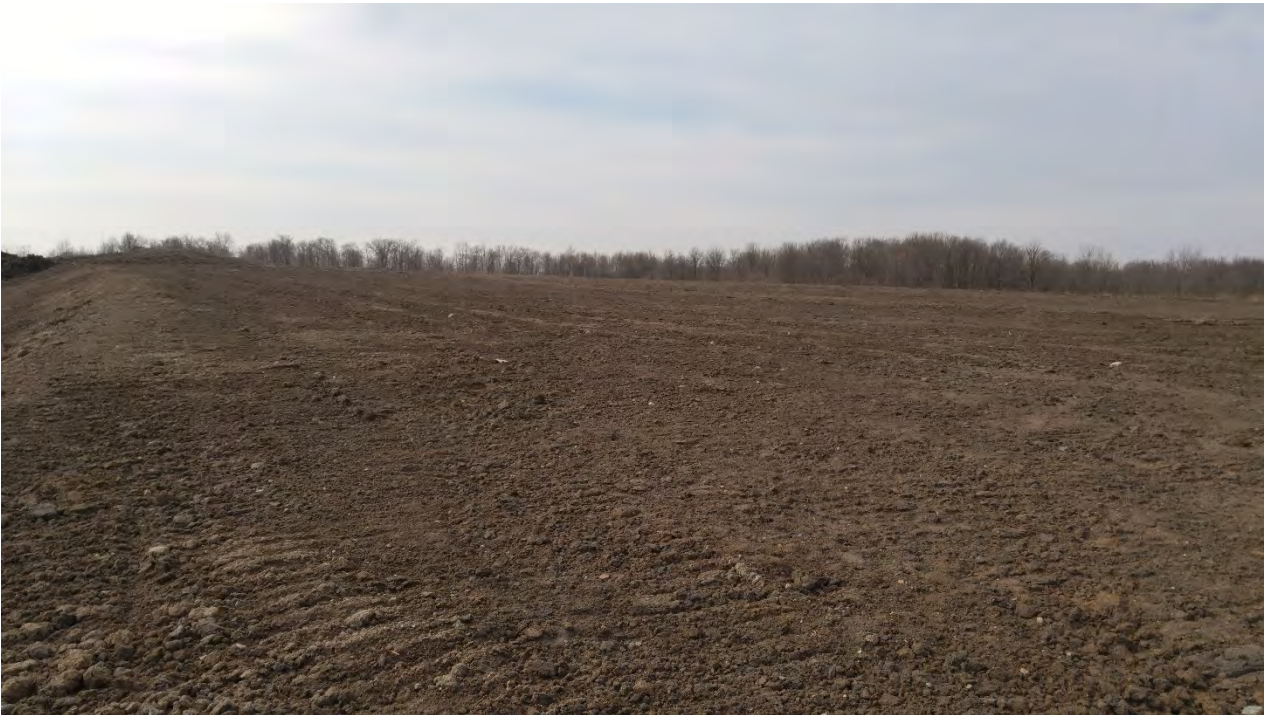
Photo 2 - Interim cap placement, Cell 19-1

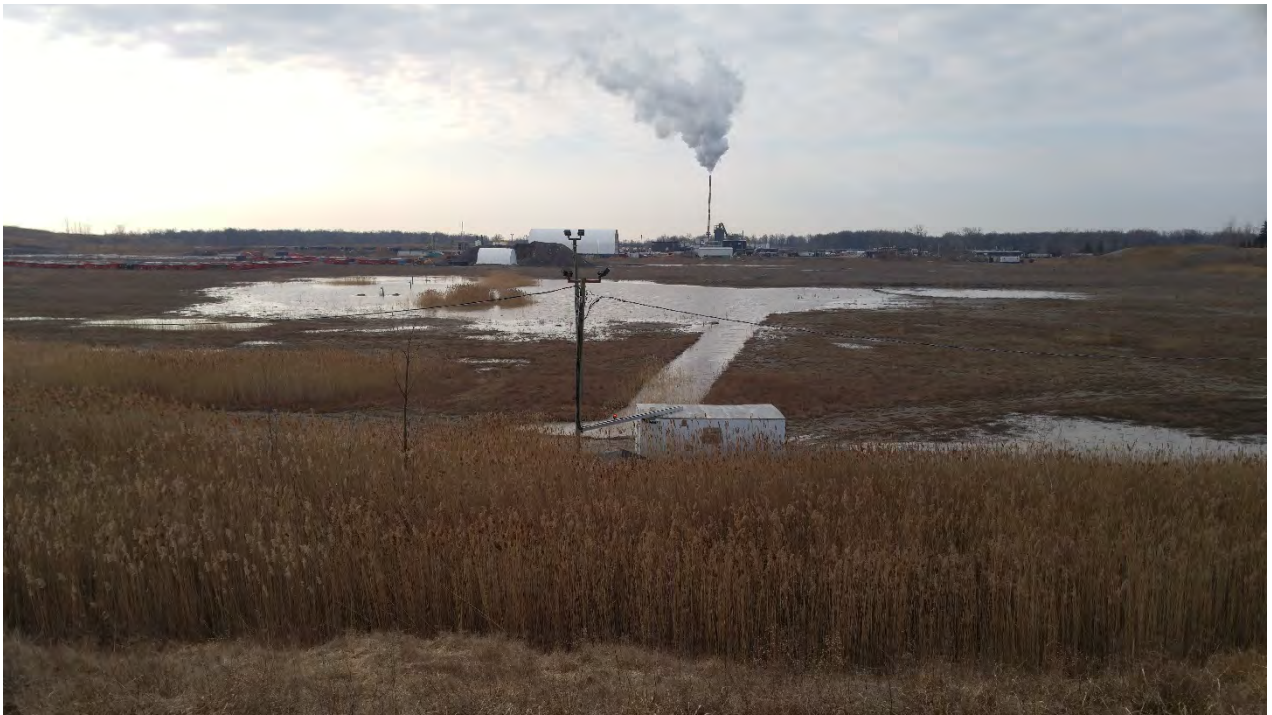
- A large area of standing water was identified within the northwest corner of the OLA, as shown on Figure 1 and Photo 3. The area has been graded to drain to the north ditch with an internal swale. The internal swale was full, with no observed flow during the Inspection.

Photo 3 - Standing water in northwest corner of Site

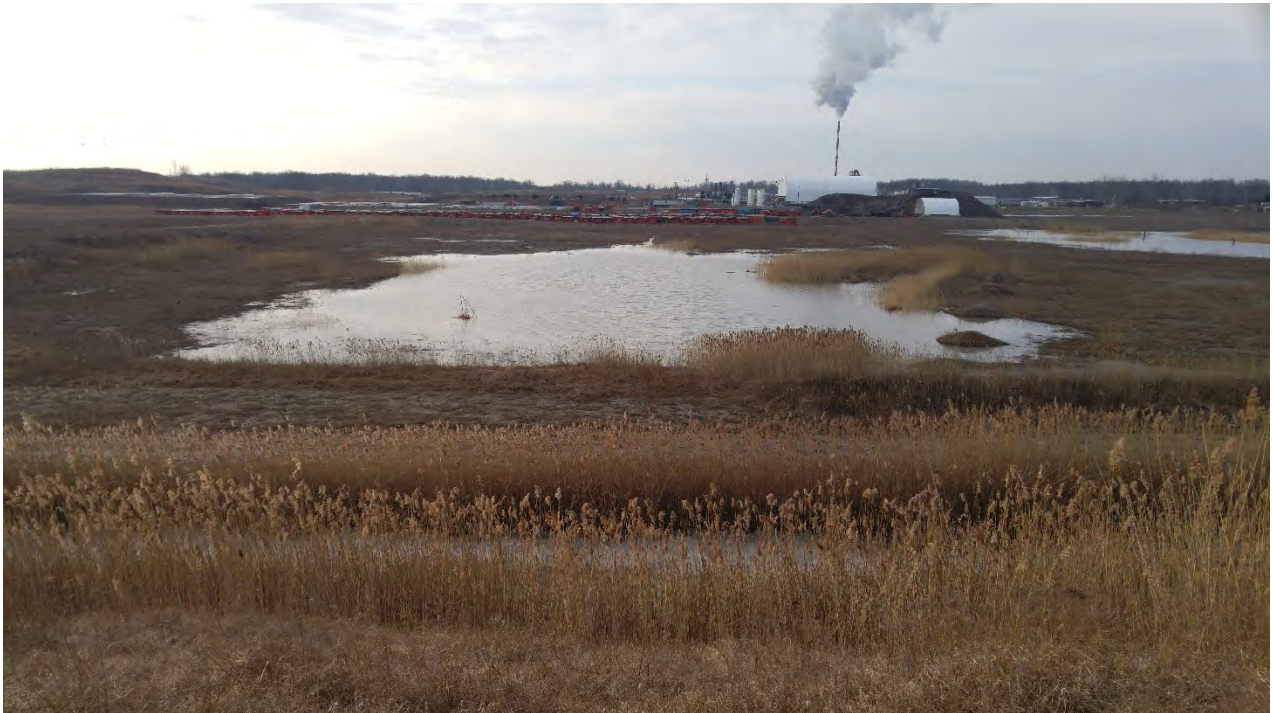
- A large area of standing water was noted in the northwest portion of proposed Cell 21-3 (i.e., located centrally in the northern portion of the Site), as shown in Photo 4. The two drainage paths were under water during the Inspection, with no observed flow.

Photo 4 - Standing water in northern, central portion of Site

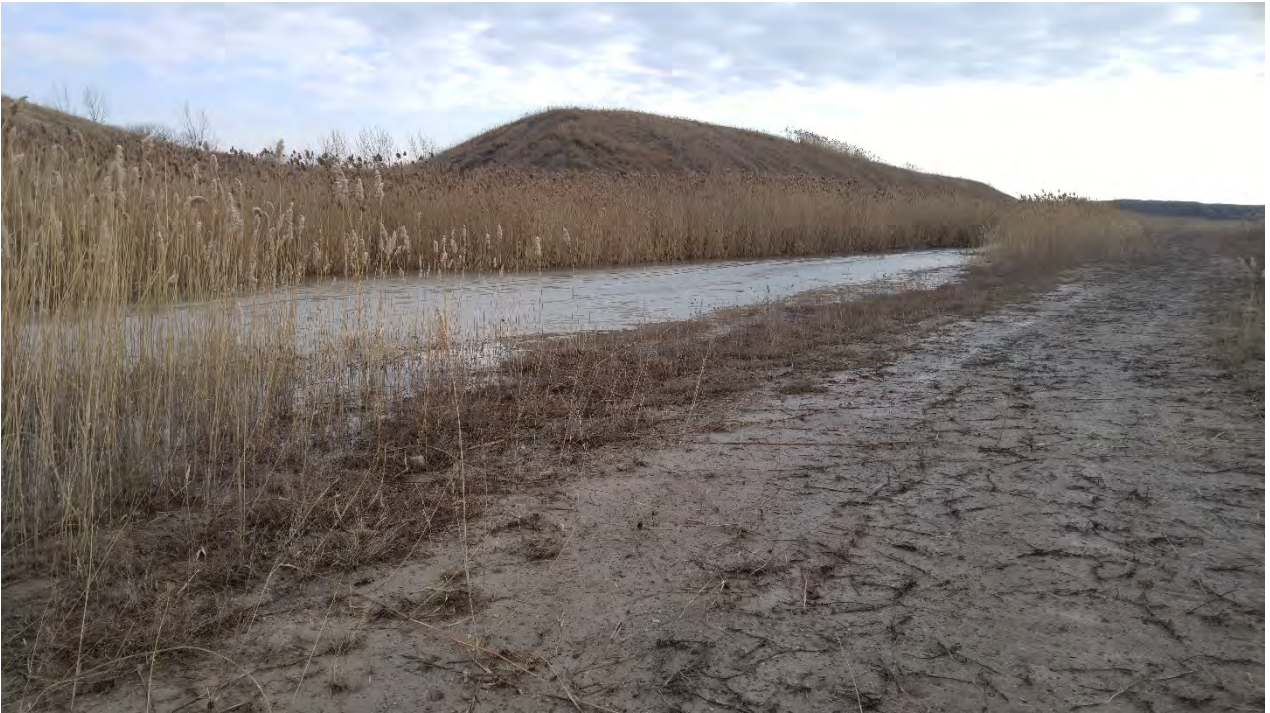
Photo 5 - High water levels in central portion of north perimeter ditch, ice cover

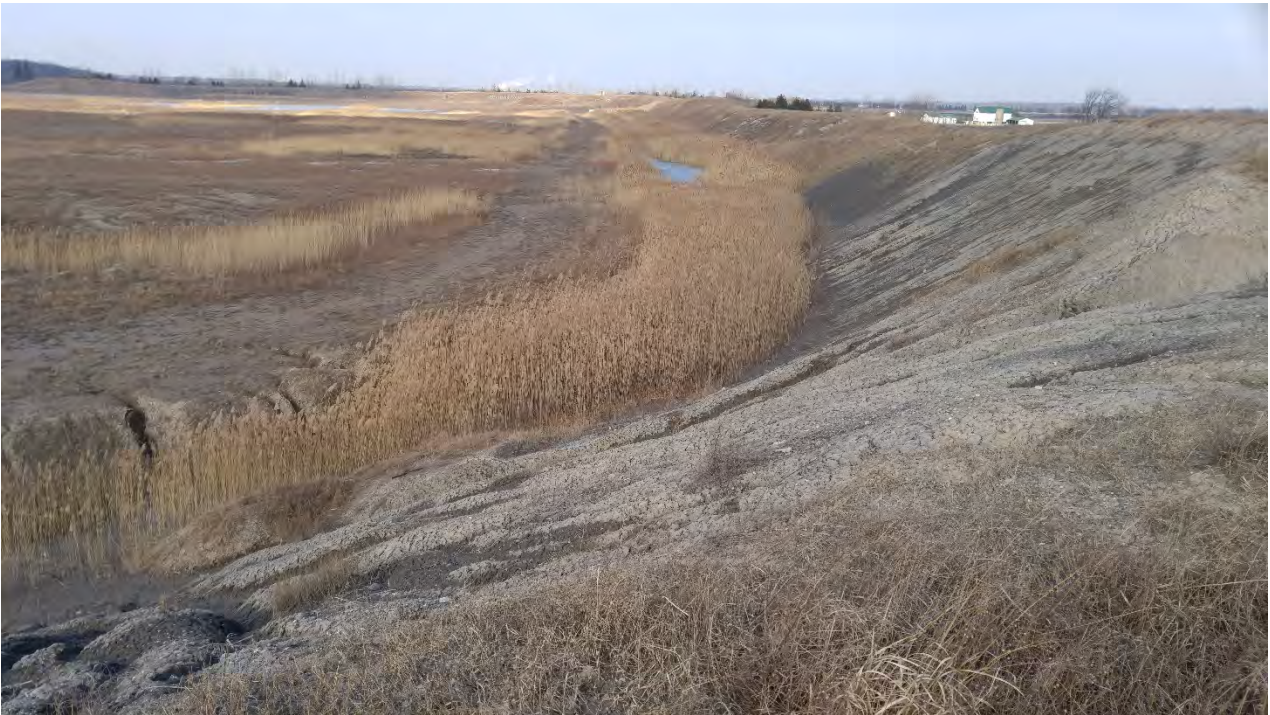
Photo 6 - North ditch, surface water blockage

Maintenance of the perimeter ditches is required to remove areas where sediment has accumulated and is restricting flow of water. Maintenance of the perimeter ditches is a key component to minimize standing water on the interim cover and promote transfer of water to surface water ponds. It is recommended that perimeter ditch maintenance be undertaken to remove blockages as noted. The maintenance work should minimize the potential for flooding during storm events.

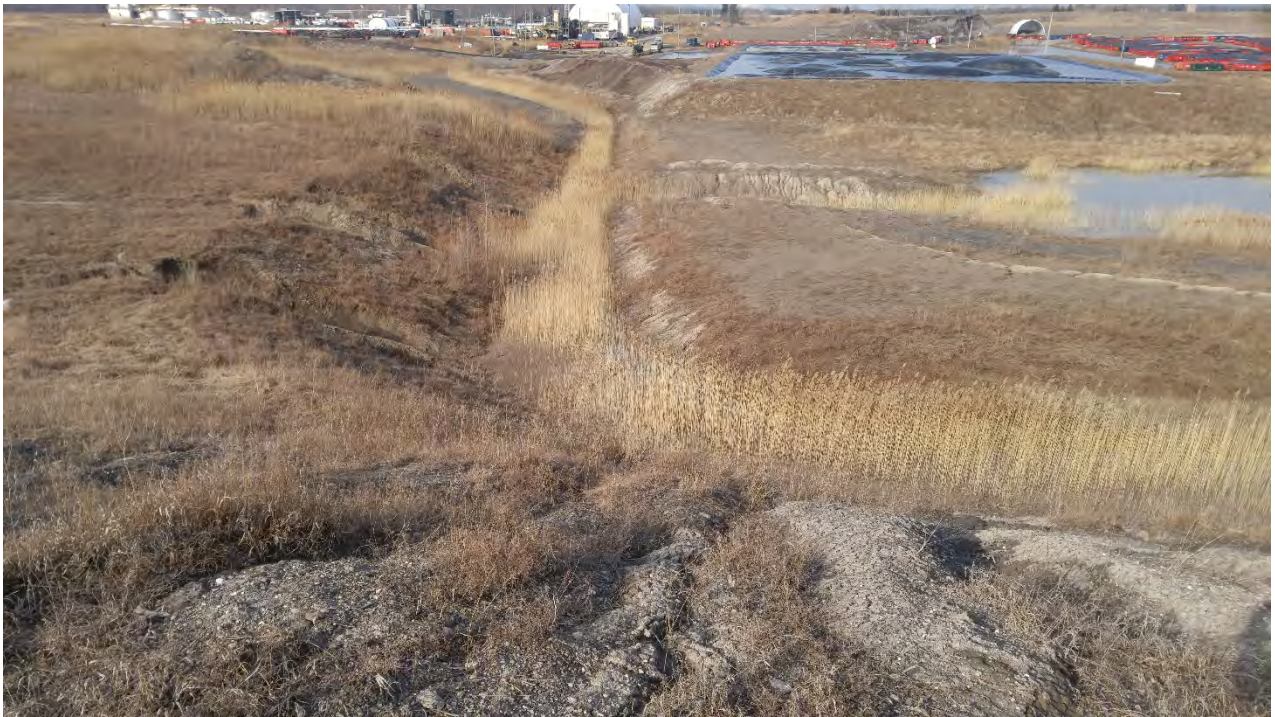
Photo 7 - North landfill area, southeast ditch, partial surface water blockage

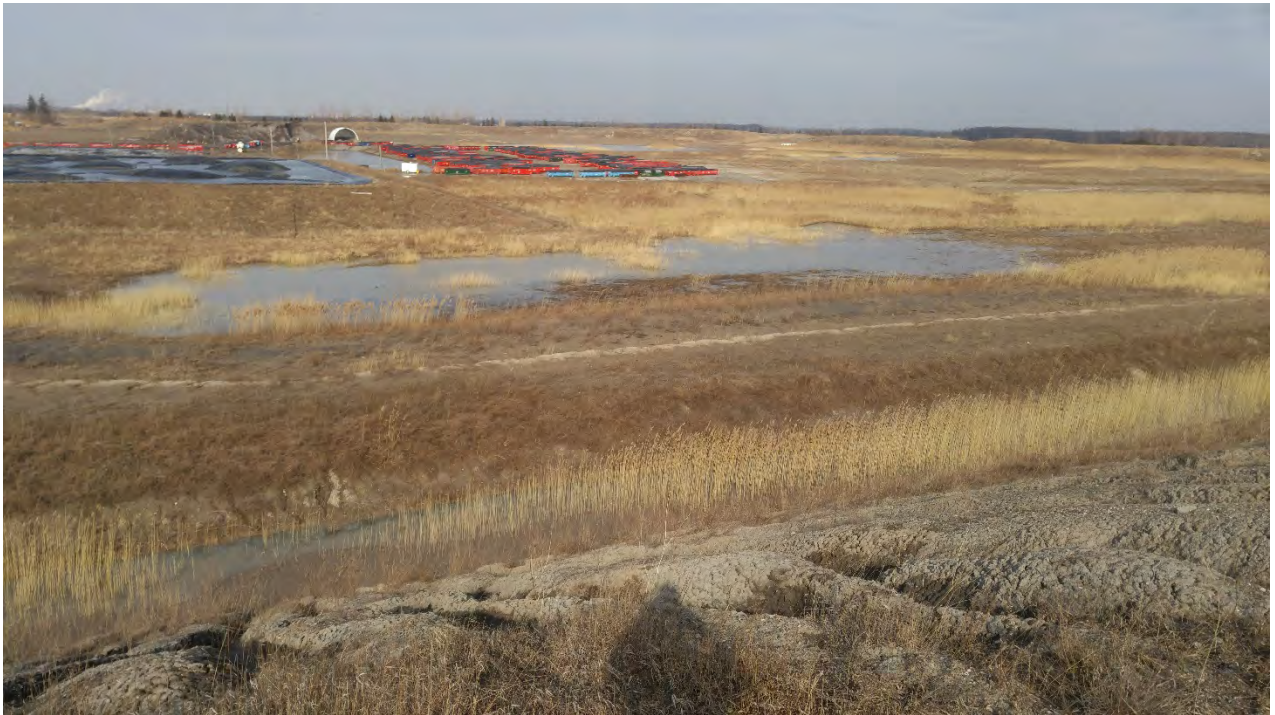
Photo 8 - Standing water in southeast corner of north landfill area

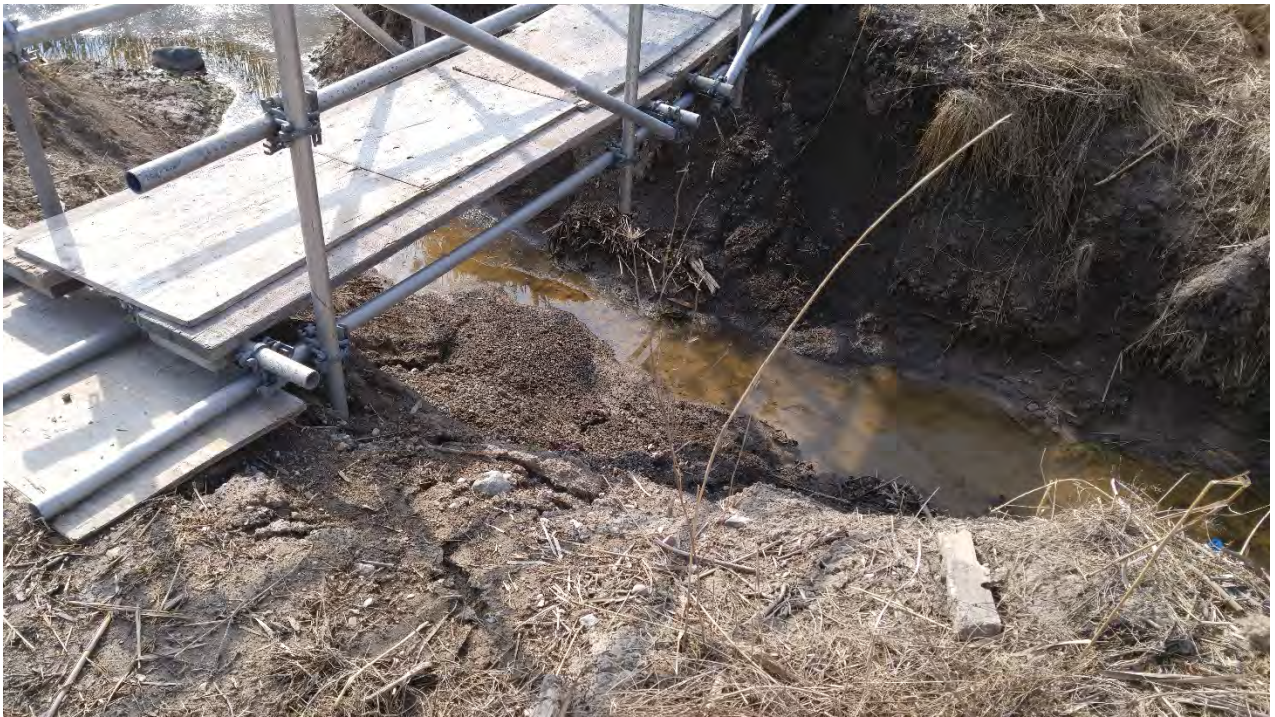
- The previously noted flow break in the south ditch (the result of wildlife activity - specifically beavers), located at the Gate 6 access bridge, has been removed. Sedimentation remains beneath the bridge. As shown in Photo 9, water levels were low to moderate, with limited observed flow, primarily due to ice cover east of the bridge.

Photo 9 - South ditch, surface water blockage removed

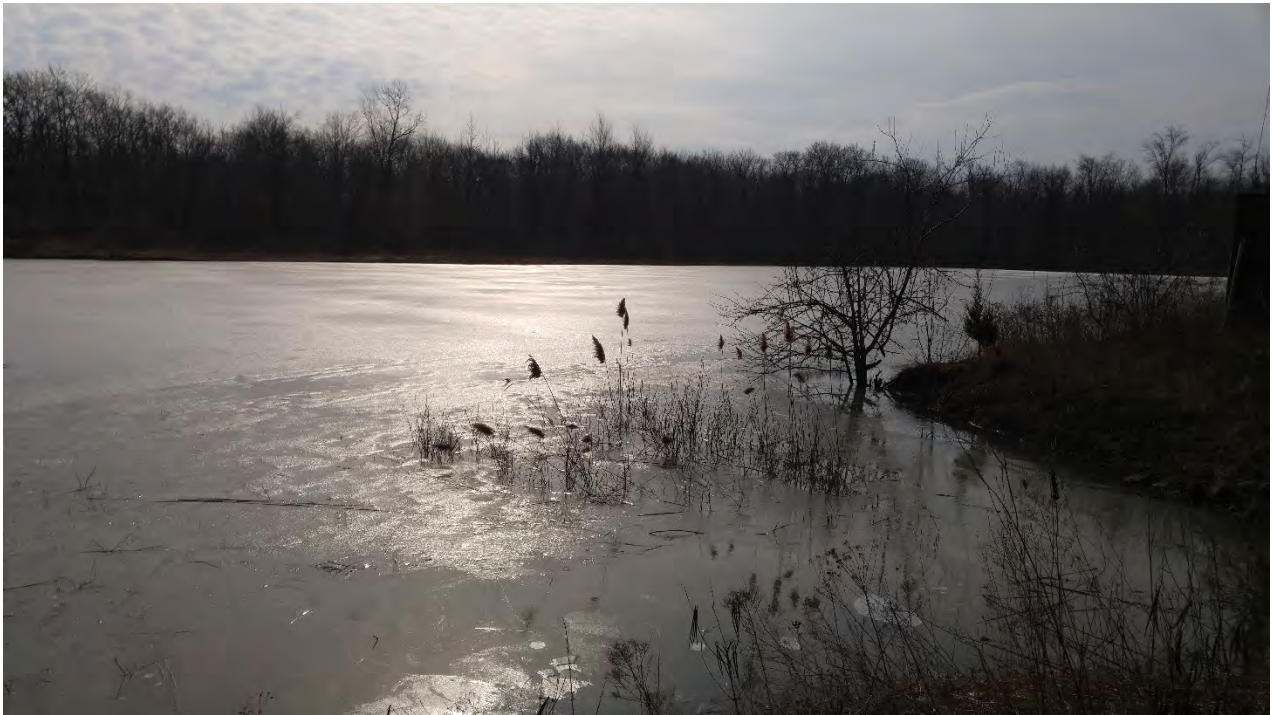
- Water levels within the East Surface Water Pond were very high.
- No flow was observed entering the East Surface Water Pond due to ice cover.
- The pump at the East Surface Water Pond was not in operation at the time of Inspection.

Photo 10 - East Surface Water Pond

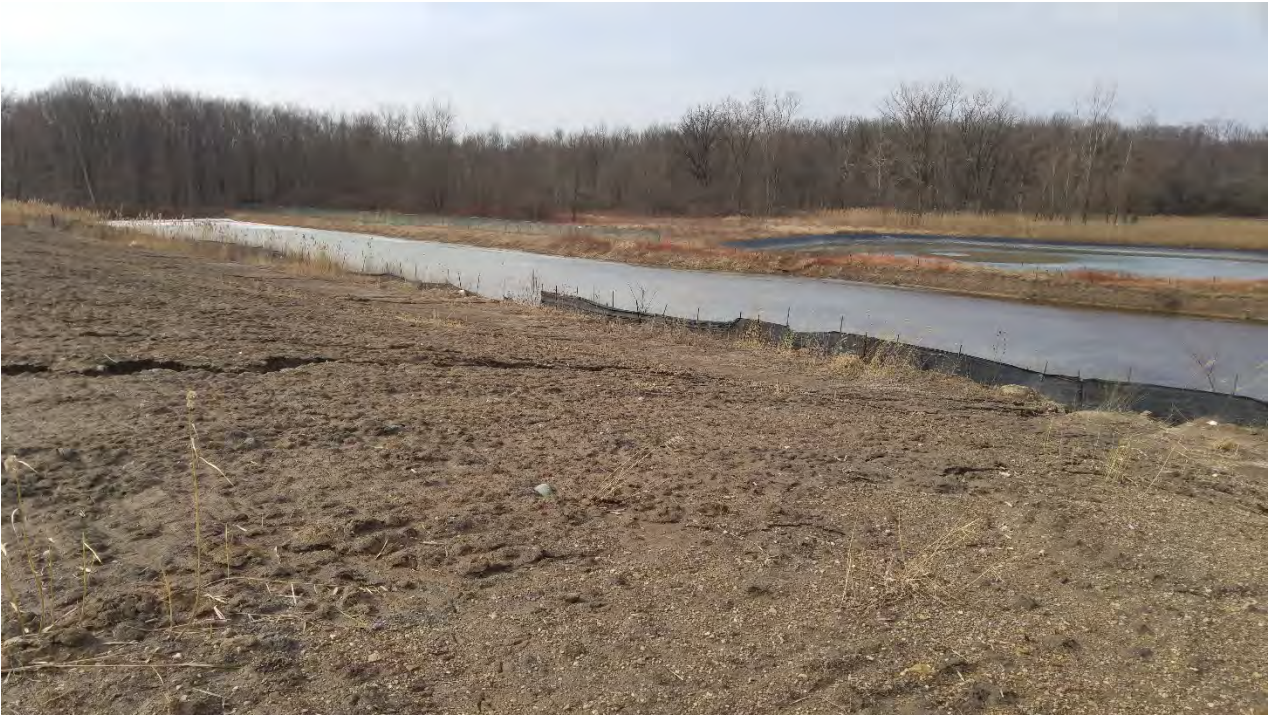
- Water levels within the West Surface Water Pond were moderate to high, with the majority of the pond covered by ice.
- No flow was observed entering the West Surface Water Pond.
- The pump at the West Surface Water Pond was in operation at the time of Inspection.

Photo 11 - West Surface Water Pond

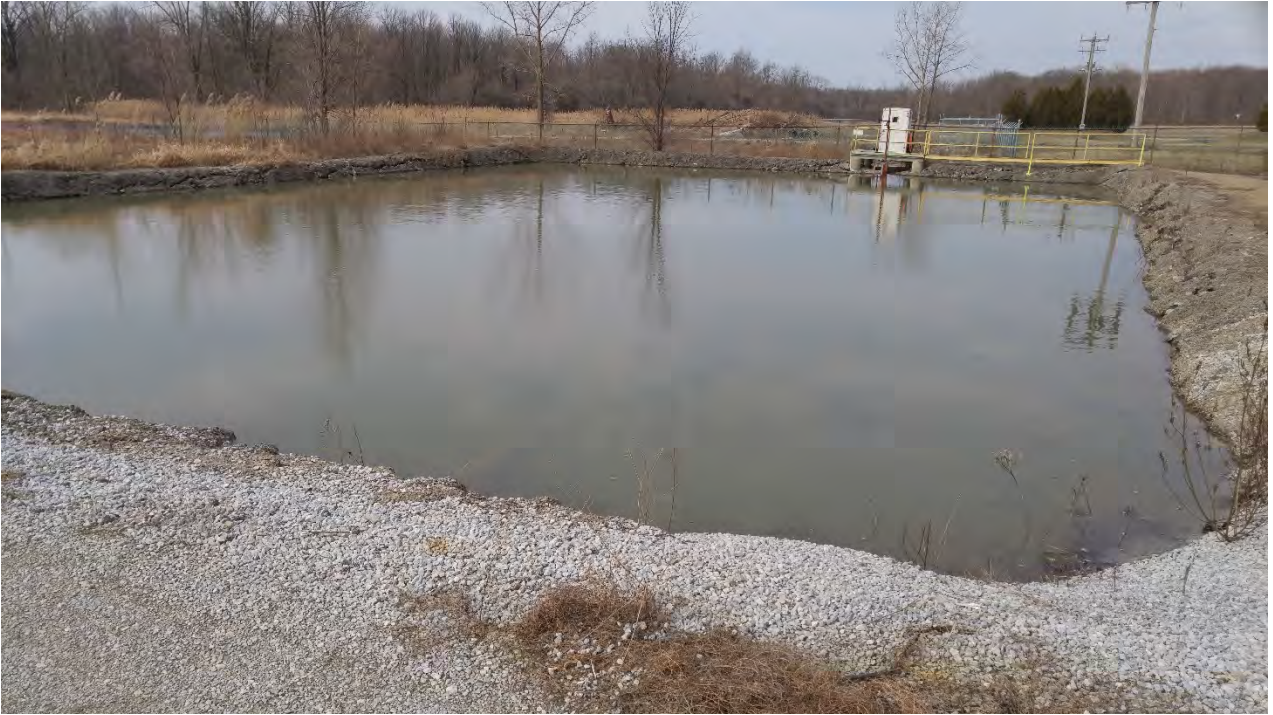
- Water levels within the Equalization Pond were moderate to high. Flow was not observed entering the Equalization Pond at the time of Inspection.
- Cracking and sloughing of the concrete side walls of the Equalization Pond was observed during the Inspection.
- Fish were not observed within the Equalization Pond.

Photo 12 - Equalization Pond

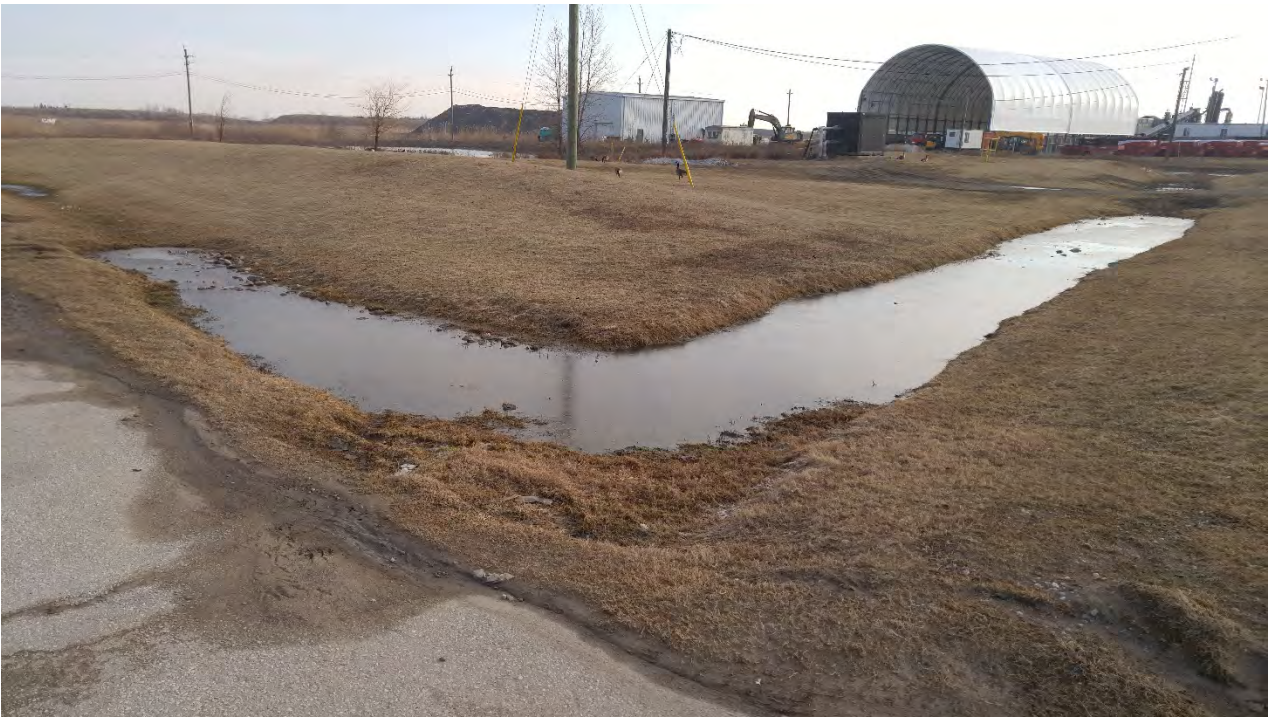
- High water levels were noted in the ditches adjacent to the Household Hazardous Waste Depot. The ditches feeding the North Process Water Pond directly exhibited moderate water levels, as shown in Photo 13. Prior inspections identified sedimentation and culvert damage in these ditches, impeding flow and resulting in standing water within the ditches. It is recommended that sediment be removed and culvert(s) be repaired as necessary to promote drainage.

Photo 13 - North Process Water Pond ditch

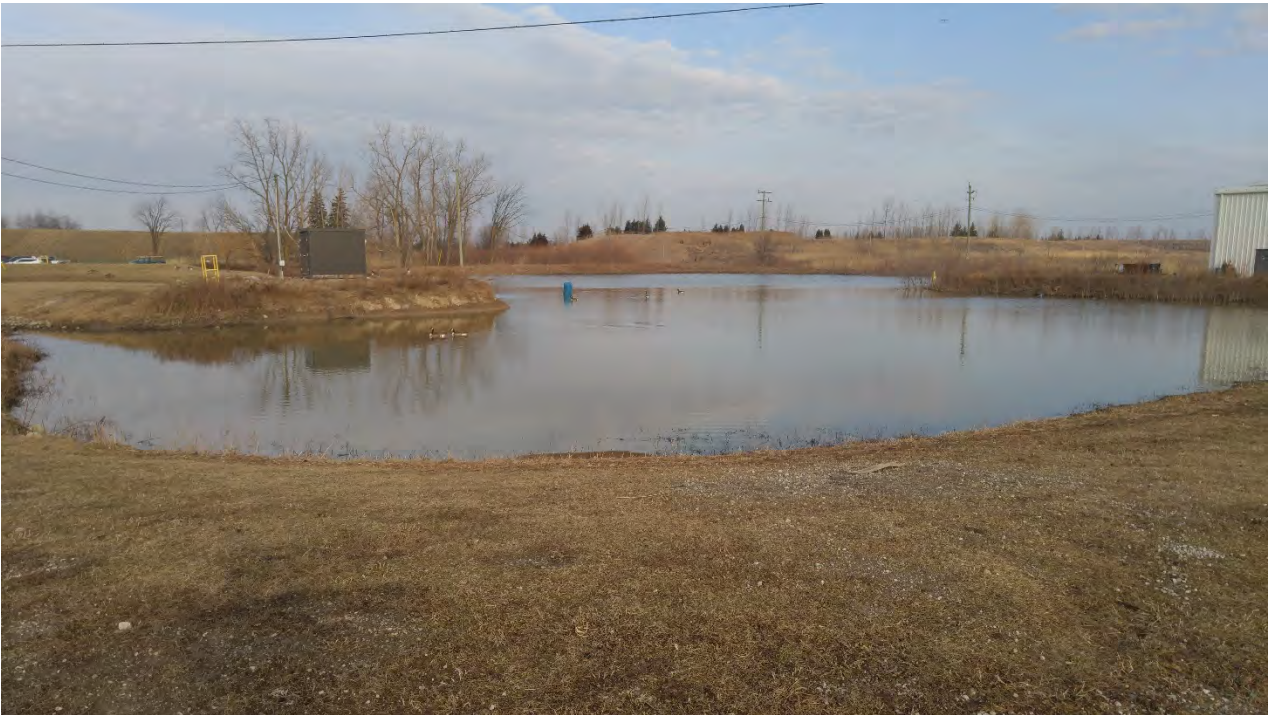
- The water level within the North Process Water Pond was high, level with the base of the inlet ditch.
- The pump at the North Process Water Pond was running at the time of the inspection.
- During previous inspections, a significant washout was observed in the southeast corner of the North Process Water Pond. This washout was not visible at the time of inspection, due to high water levels.

Photo 14 - North Process Water Pond

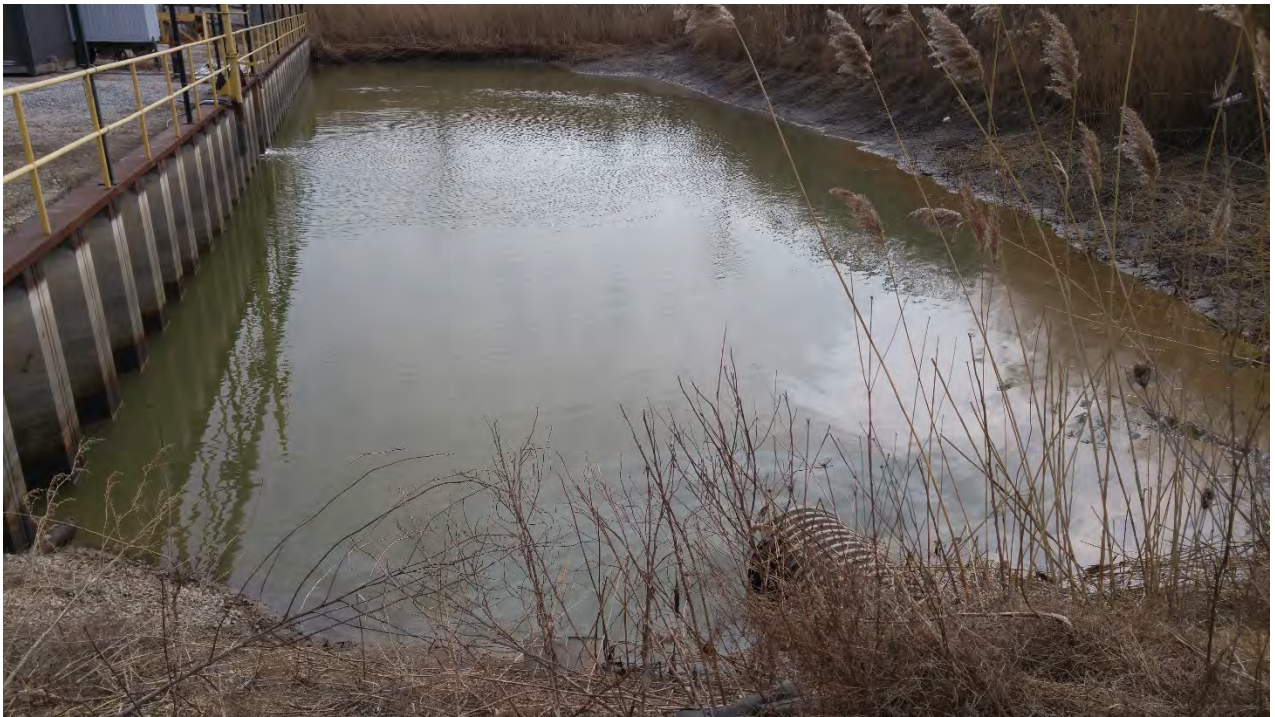
- The water level within the South Process Water Pond was medium to low.
- The South Process Water Pond also receives runoff from east of the active landfill area. No standing or flowing water was observed in this area during the inspection.

Photo 15 - South Process Water Pond

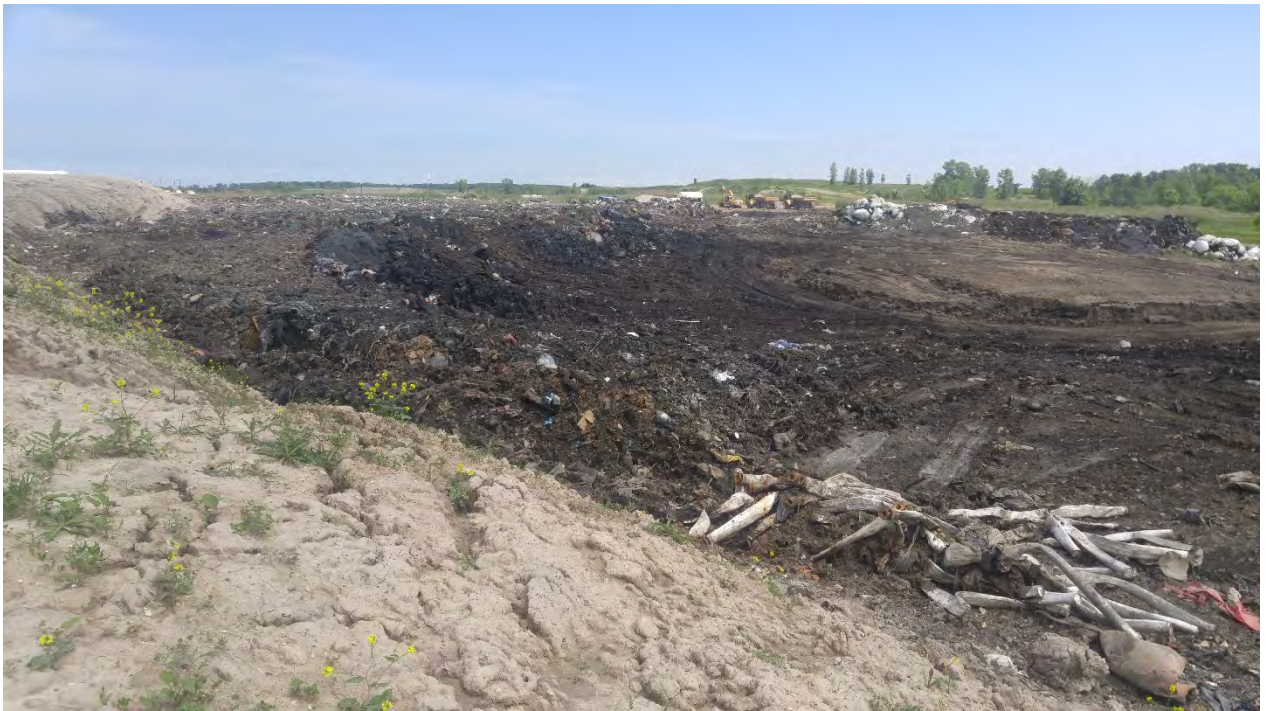
- The active waste tipping face is located in Cell 19-2A. Waste placement is generally occurring from north to south, as shown in Photo 1. Odour was noted in the immediate vicinity of the active landfilling area.
- Construction of Cell 19-2A is complete.
- Waste Transport Route: Site waste haulers are directed around the east side of the Process Area and enter Cell 19-2A from the east side, located centrally within the active landfilling area, on a dedicated haul road from the Waste Receiving Area.

Photo 1 - Active landfilling cell, Cell 19-2A

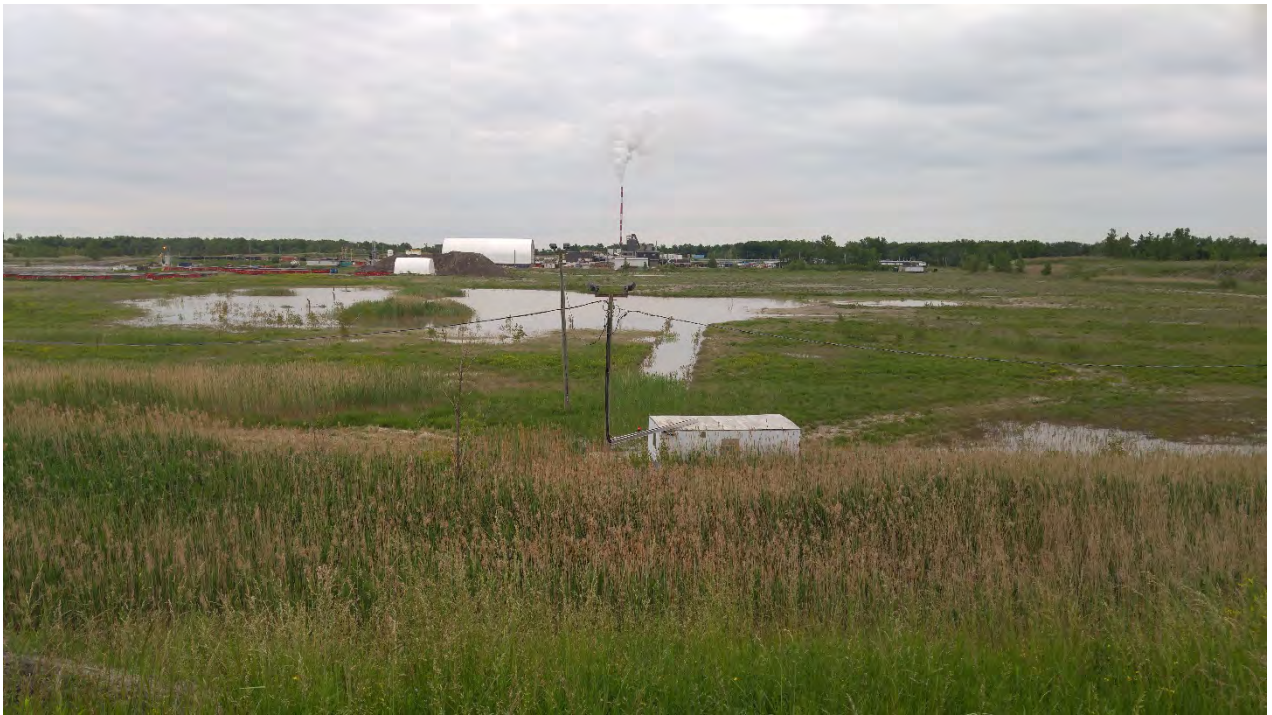
- A large area of standing water was identified within the northwest corner of the OLA, as shown on Figure 1 and Photo 3. The area has been graded to drain to the north ditch with an internal swale. The internal swale was full, with no observed flow during the Inspection.

Photo 3 - Standing water in northwest corner of Site

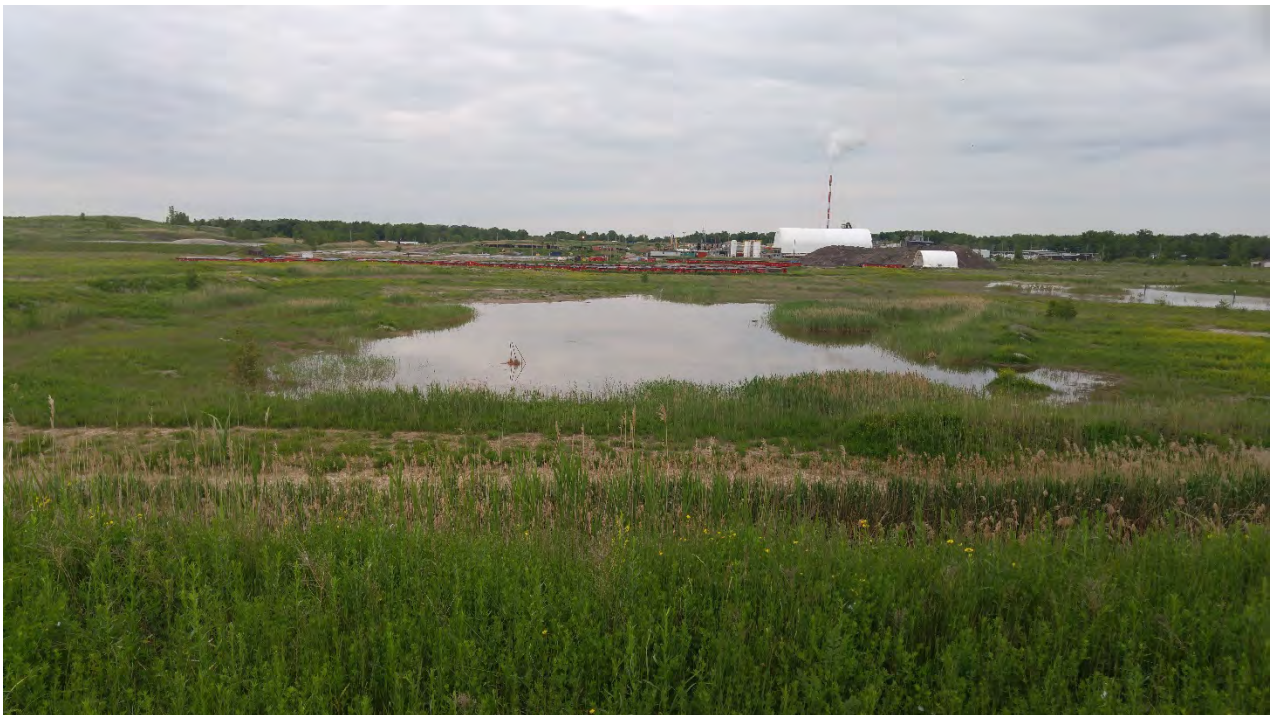
- A large area of standing water was noted in the northwest portion of proposed Cell 21-3 (i.e., located centrally in the northern portion of the Site), as shown in Photo 4. The two drainage paths were under water during the Inspection, with no observed flow.

Photo 4 - Standing water in northern, central portion of Site

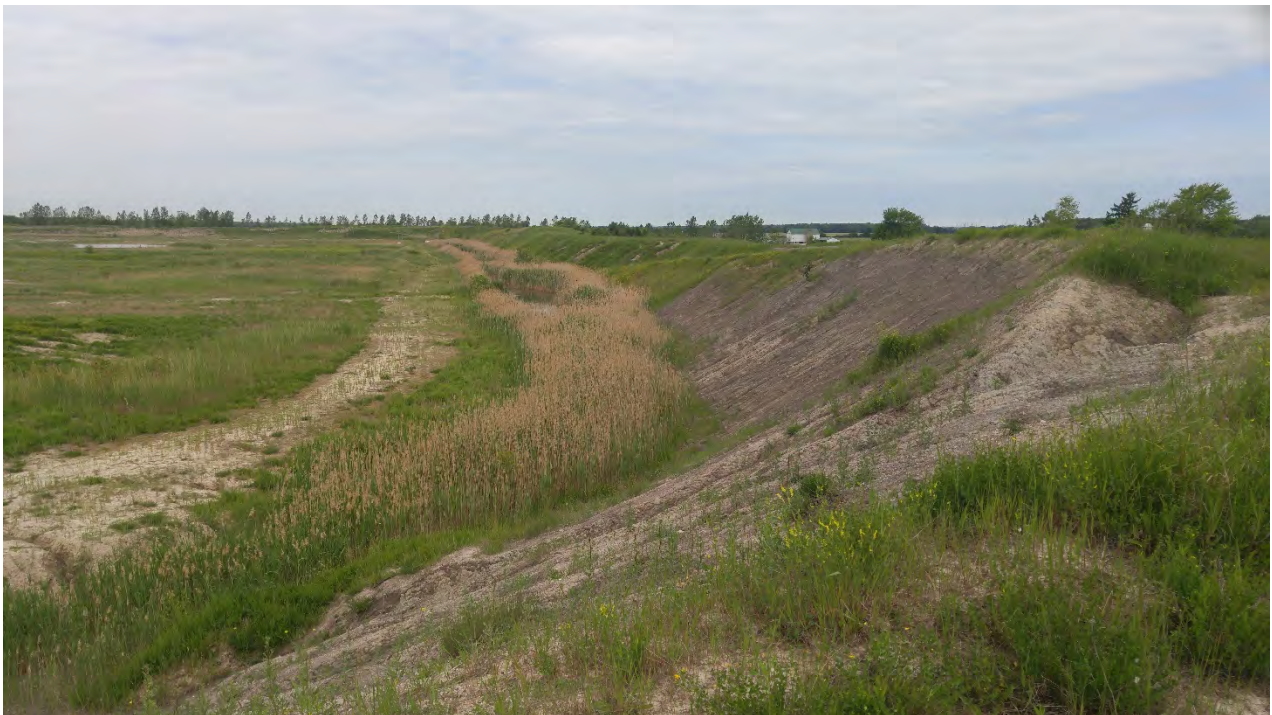
Photo 6 - North ditch, surface water blockage
