2019 Quarterly Site Inspections

Clean Harbors Lambton Facility
4090 Telfer Road, Corunna, Ontario

Clean Harbors Canada, Inc.

Subject: 2019 First Quarter Site Inspection

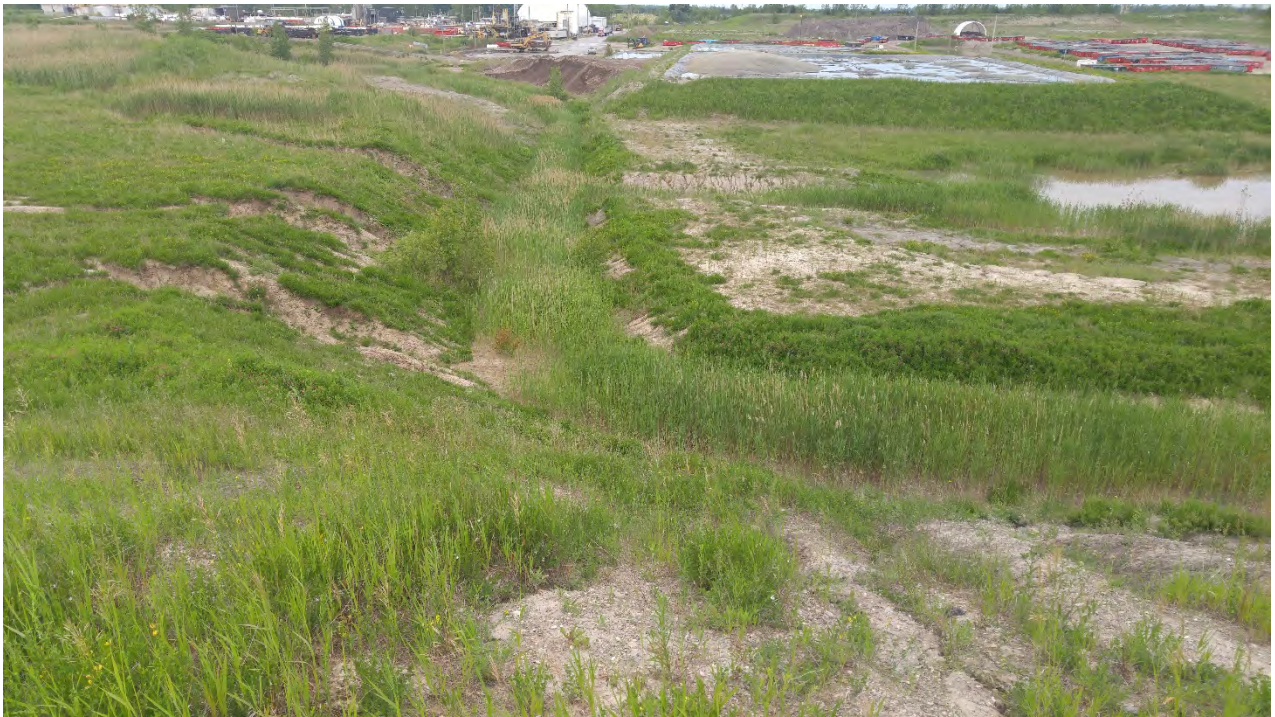
- Significant erosion was identified in the southeast corner of the OLA, resulting in sedimentation of the perimeter ditch and limited water flow, as shown in Photo 7 and Figure 1. This portion of ditch was generally damp, with minimal standing water noted and dense wetland vegetation. Standing water was observed in the internal swale and low-lying area to the north, as shown in Photo 8 and Figure 1.

Photo 7 - North landfill area, southeast ditch, partial surface water blockage

Portions of the interior side of the perimeter screening berms have significant erosion. These areas should be assessed and corrected to minimize erosion into the perimeter ditches. Installation of reinforced ditches from the top of berm to the perimeter ditches may be a solution for these areas, as well as vegetation of the internal berm slopes.

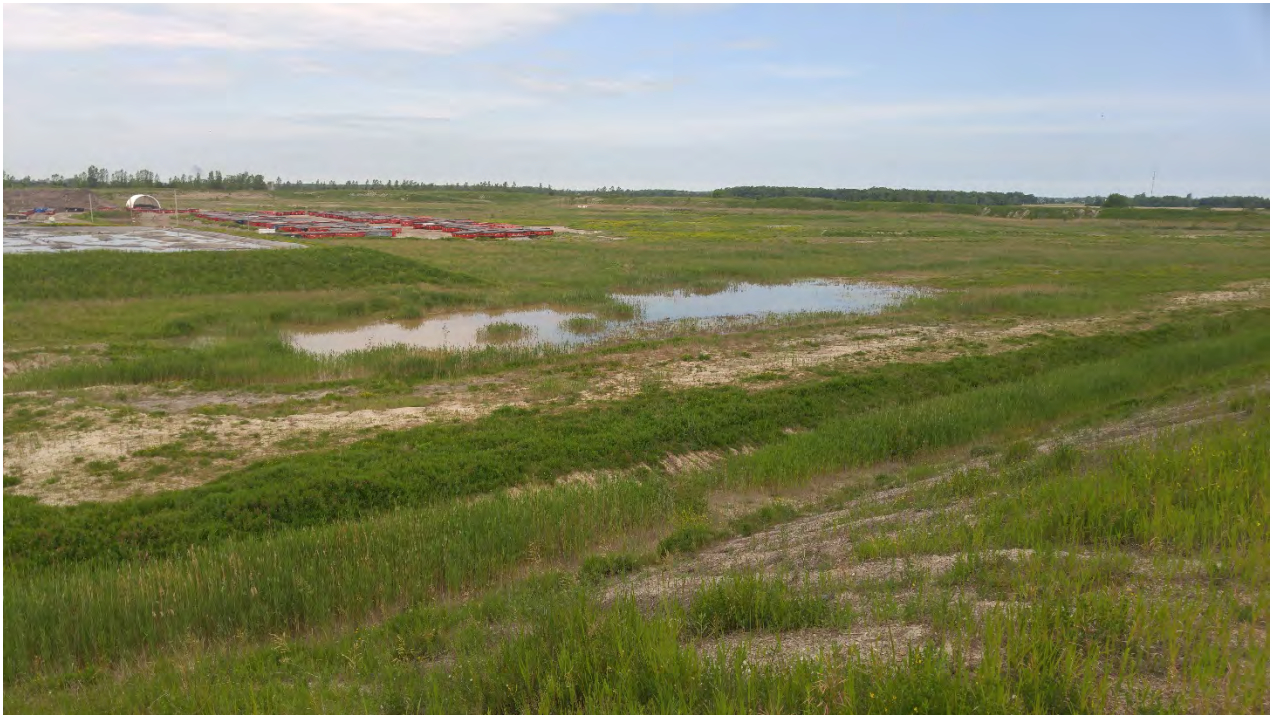
Photo 8 - Standing water in southeast corner of north landfill area

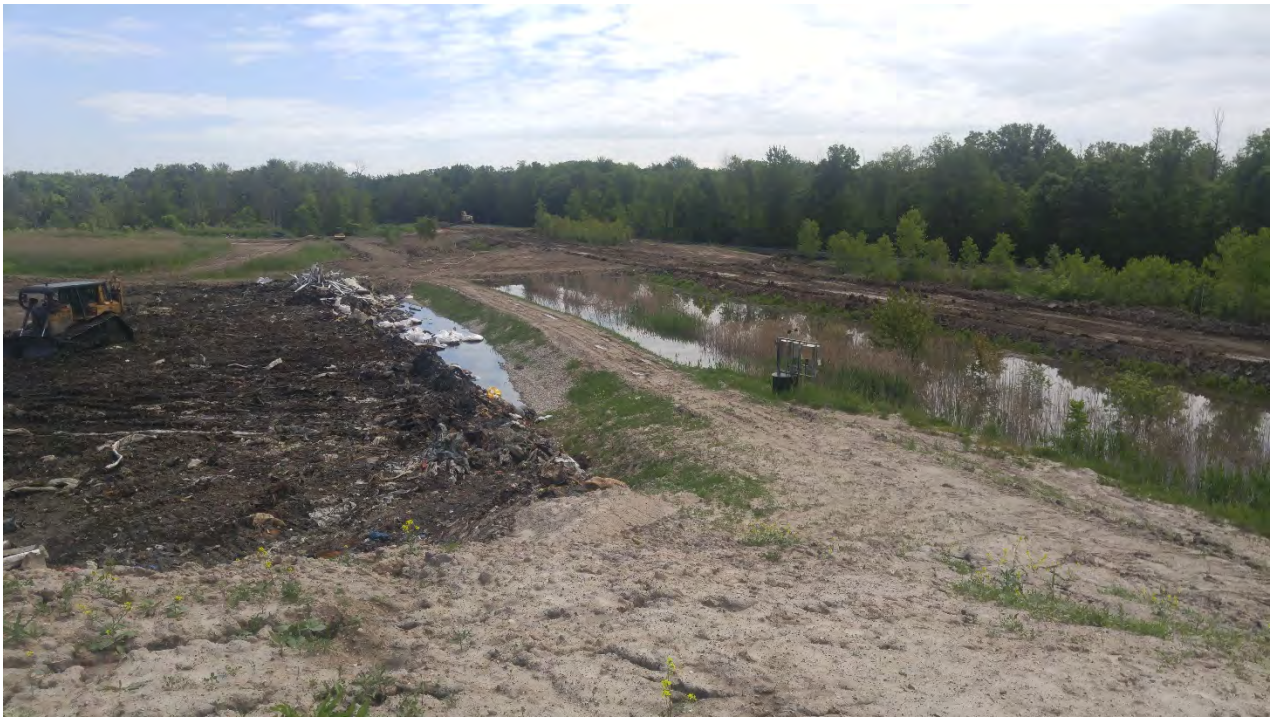
Photo 9 - South ditch remediation

Remediation works are being undertaken along the south ditch, in accordance with Provincial Officer's Order No. 2681-BCPKUJ. During these works, water is being pumped directly from the East Surface Water Pond to the West Surface Water Pond, bypassing the south ditch entirely. Water from the former south ditch is being treated and if acceptable, will be discharged to the West Surface Water Pond.

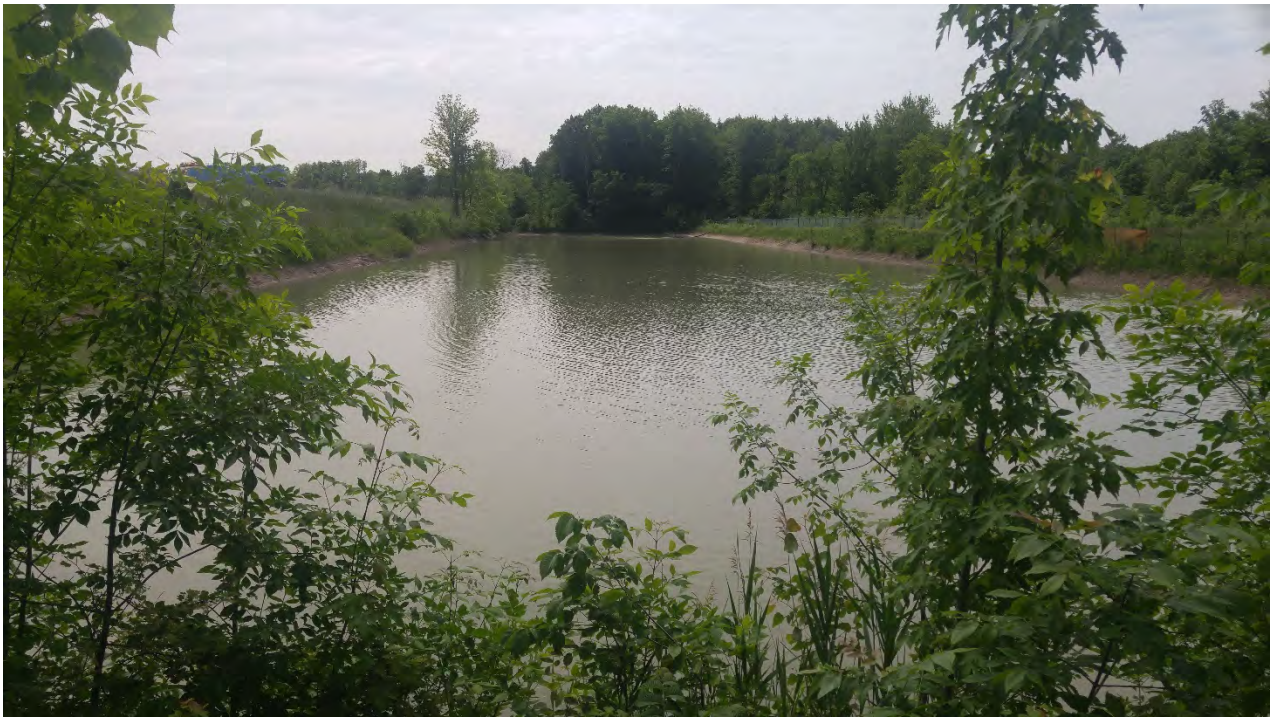
- Water was observed entering the West Surface Water Pond, resulting from pumping efforts at the East Surface Water Pond and West Process Water Pond.
- The pump at the West Surface Water Pond was in operation at the time of Inspection.

Photo 11 - West Surface Water Pond

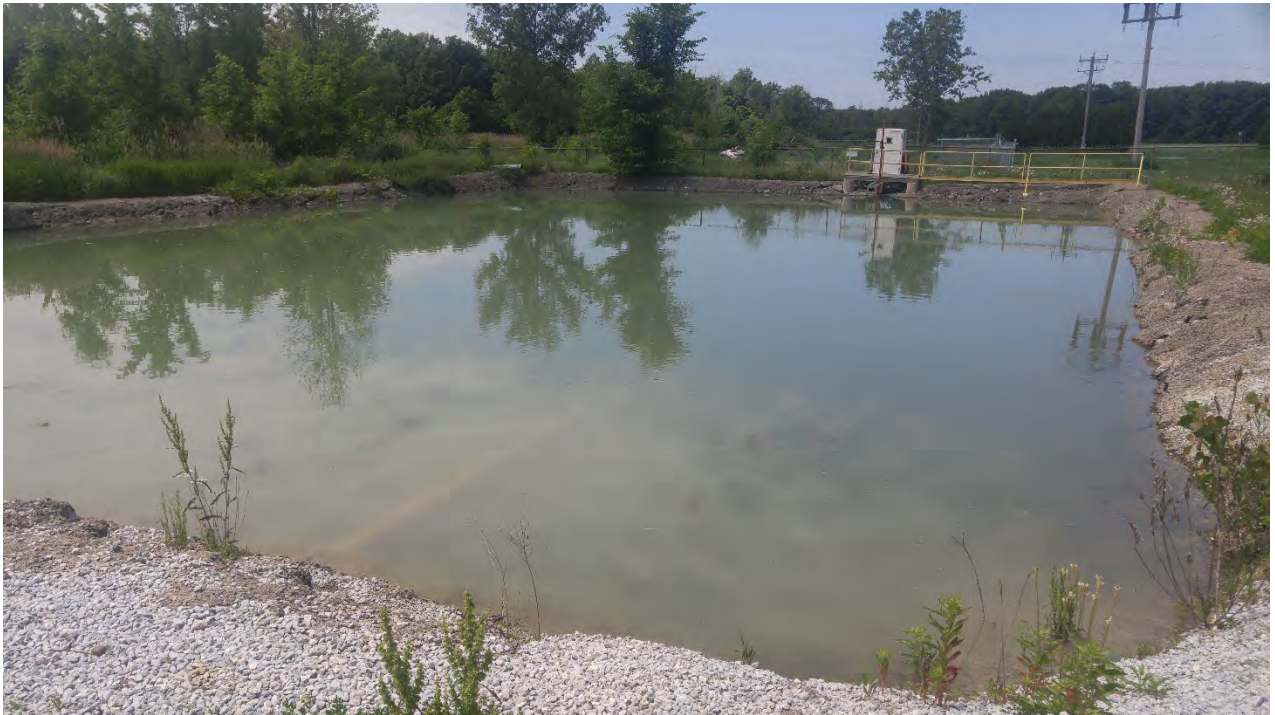
- Water levels within the Equalization Pond were very high. Flow was not observed entering the Equalization Pond at the time of Inspection.
- Cracking and sloughing of the concrete side walls of the Equalization Pond was observed during the Inspection.
- Fish were observed within the Equalization Pond.

Photo 12 - Equalization Pond

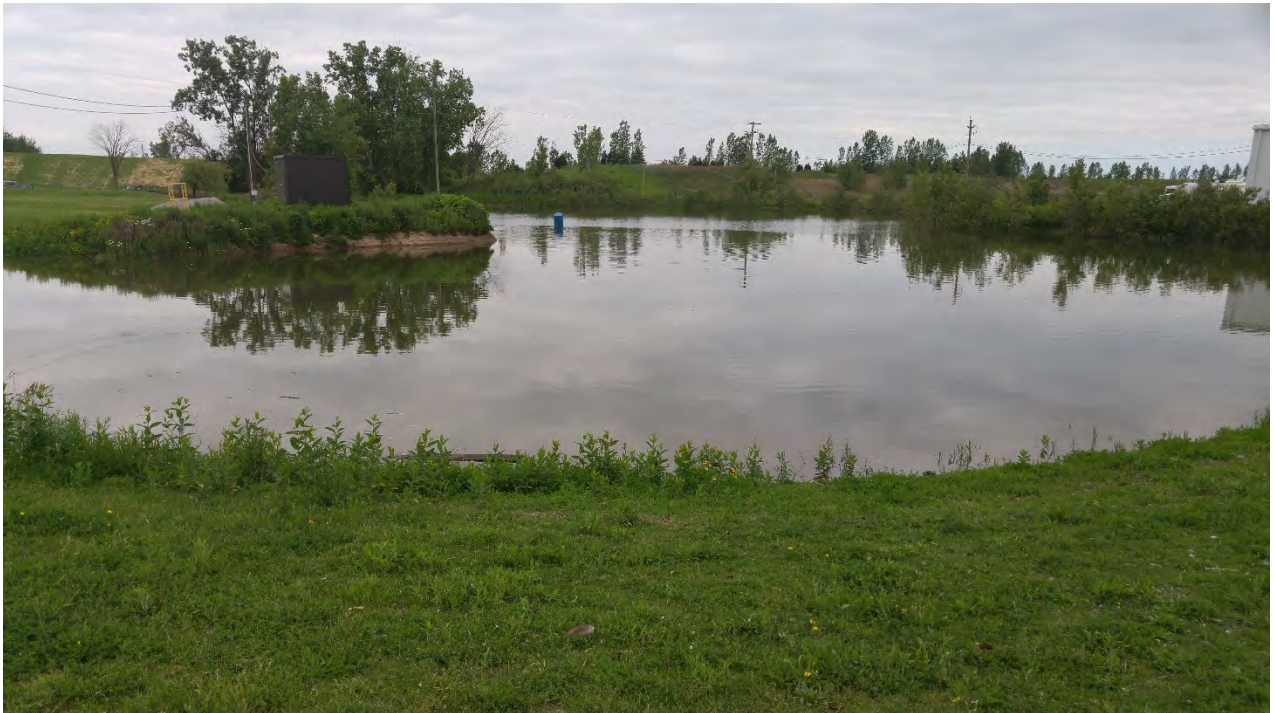
- The water level within the North Process Water Pond was very high, above the base of the inlet ditch.
- The pump at the North Process Water Pond was running at the time of the Inspection.
- During previous inspections, a significant washout was observed in the southeast corner of the North Process Water Pond. This washout was not visible at the time of inspection, due to high water levels.

Photo 14 - North Process Water Pond

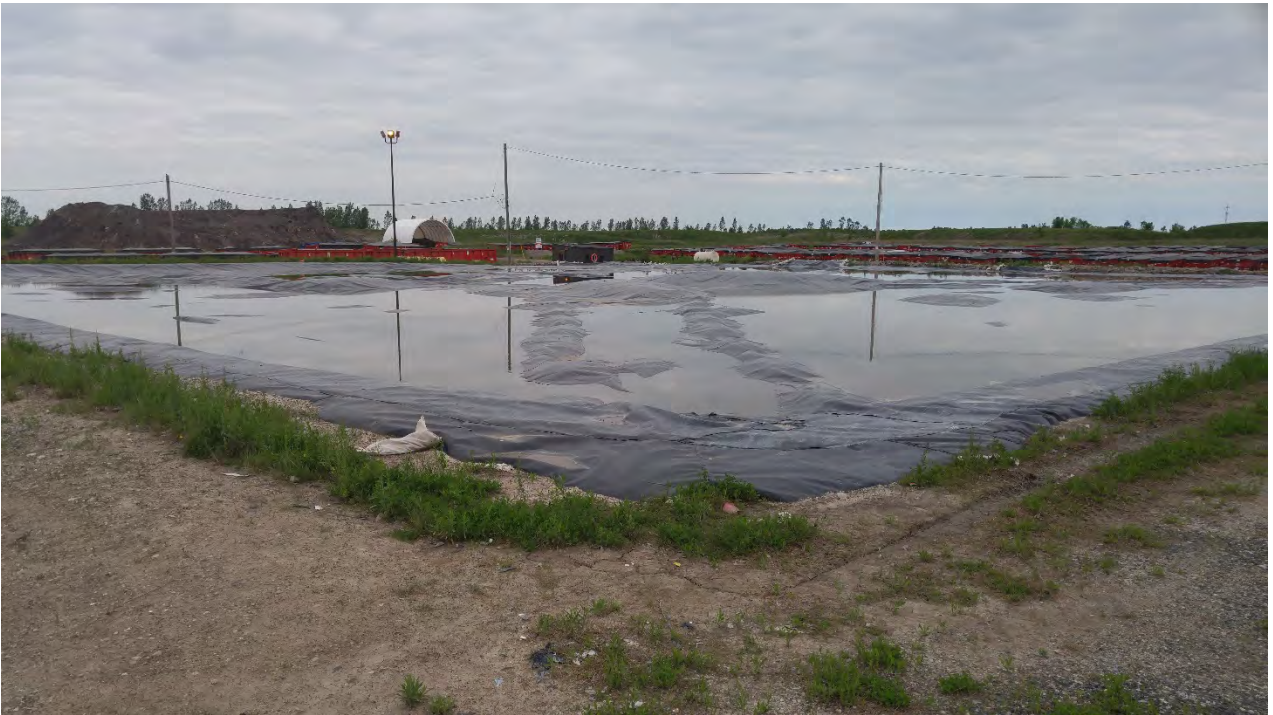
- The South Leachate Reservoir is equipped with a permanent floating cover. The floating cover was repaired during the second quarter via installation of a new polyethylene layer on the existing cover. The South Reservoir is currently being used for leachate storage, with leachate pumped from the New Leachate Reservoir. The South Leachate Reservoir was full.
- Clean Harbors maintains a record of the volume of leachate within the South Leachate Reservoir.

Photo 16 - South Leachate Reservoir

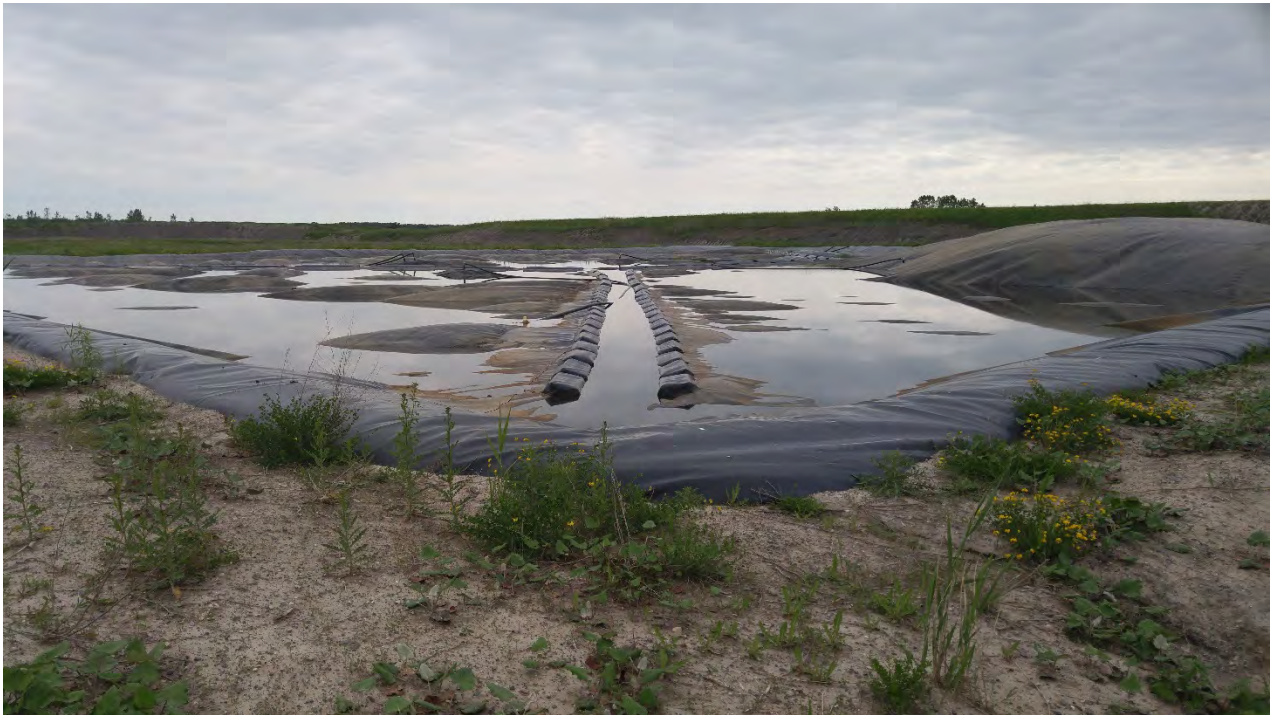
Reservoir as required. The new Leachate Reservoir is full. A large air pocket was observed in the floating cover.

Photo 18 - New Leachate Reservoir

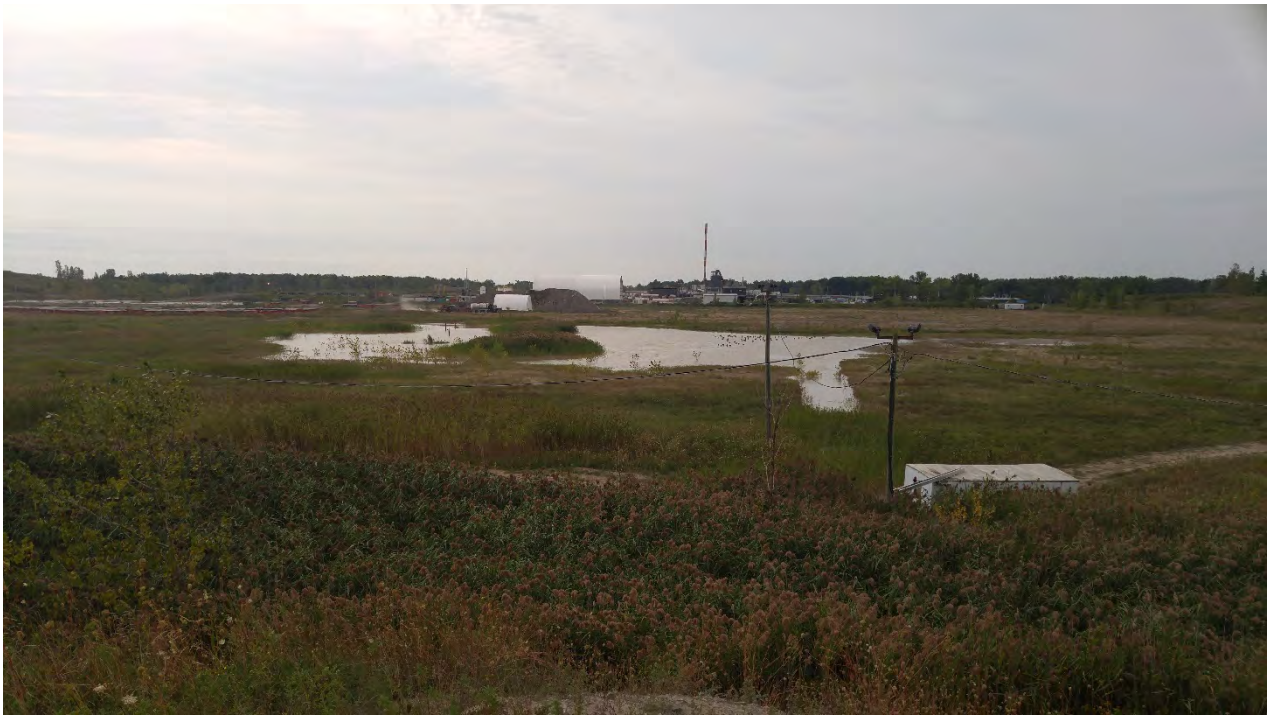
Photo 3 - Standing water in northwest corner of Site

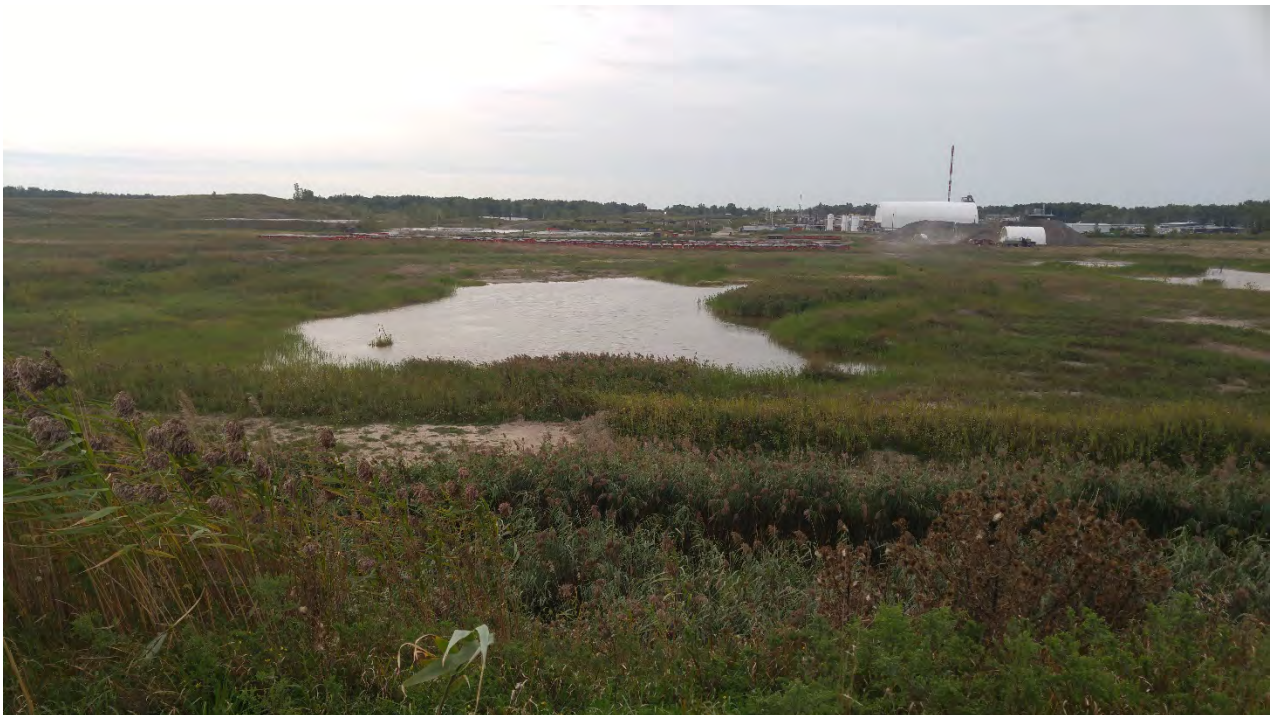
Photo 4 - Standing water in northern, central portion of Site

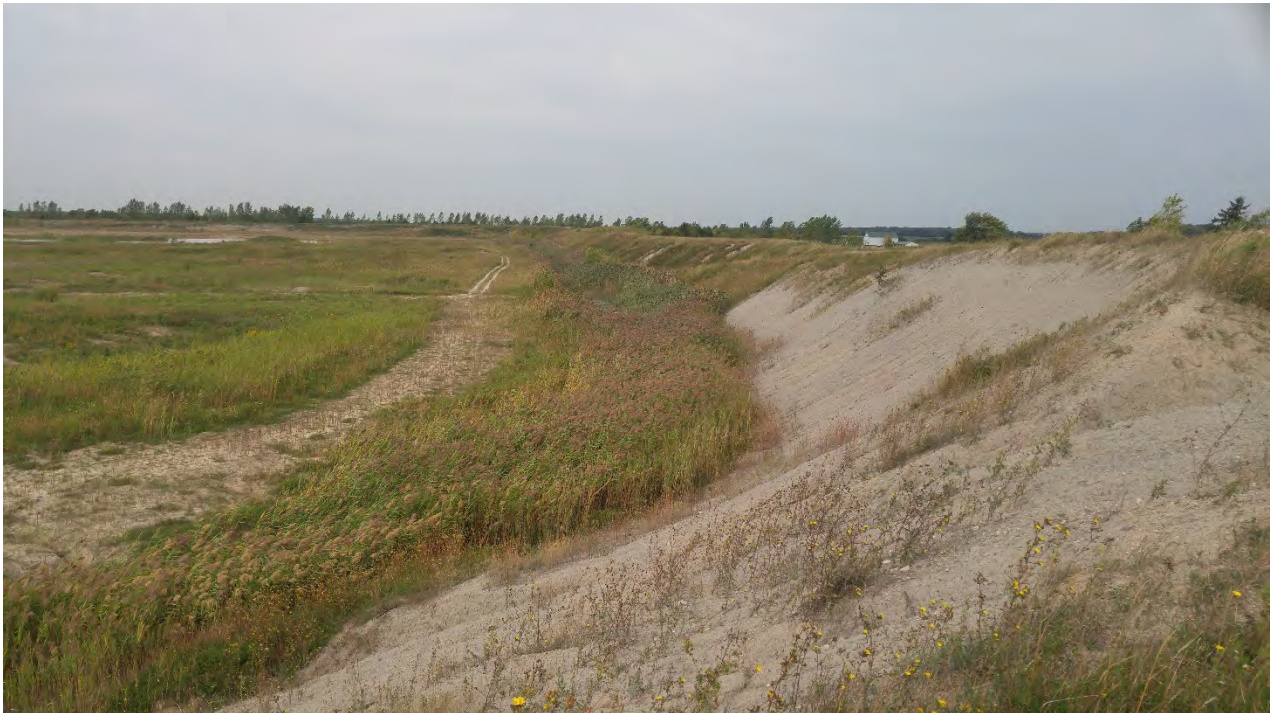
Photo 6 - North ditch, surface water blockage

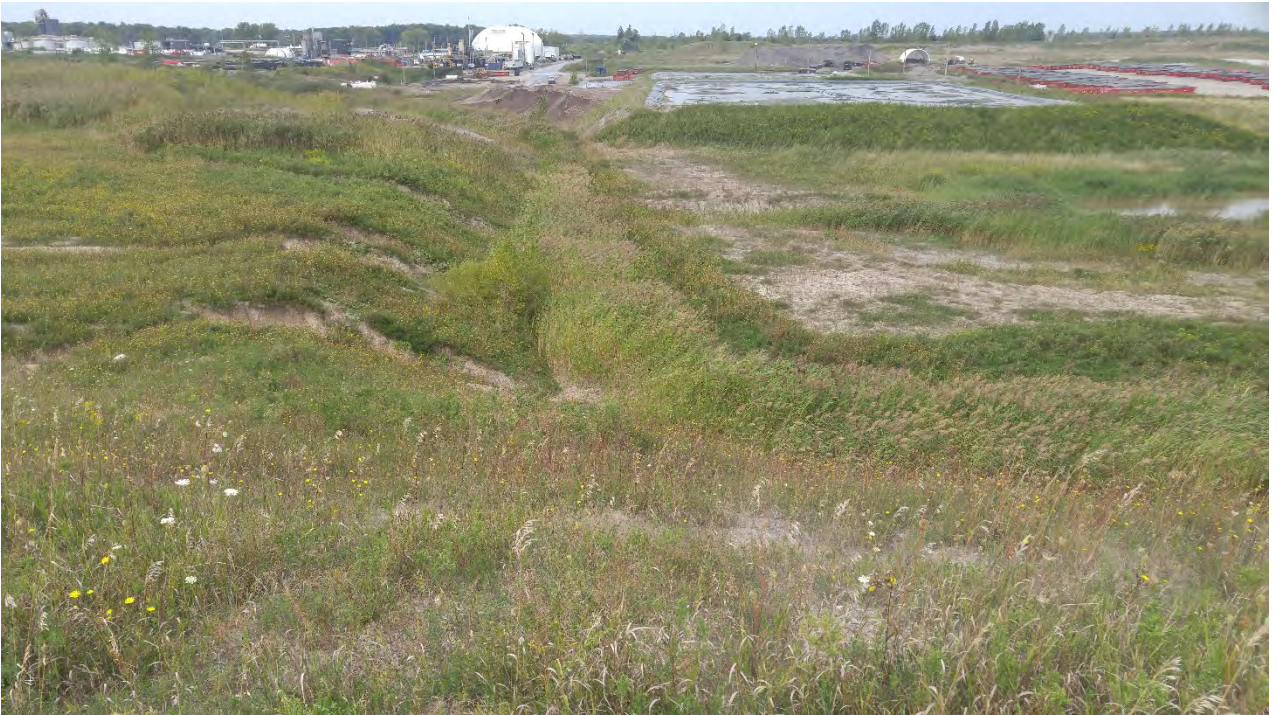
Photo 7 - Original Landfill Area, southeast ditch, partial surface water blockage

Portions of the interior side of the perimeter screening berms have significant erosion. These areas should be assessed and corrected to minimize erosion into the perimeter ditches. Installation of reinforced ditches from the top of berm to the perimeter ditches may be a solution for these areas, as well as vegetation of the internal berm slopes.

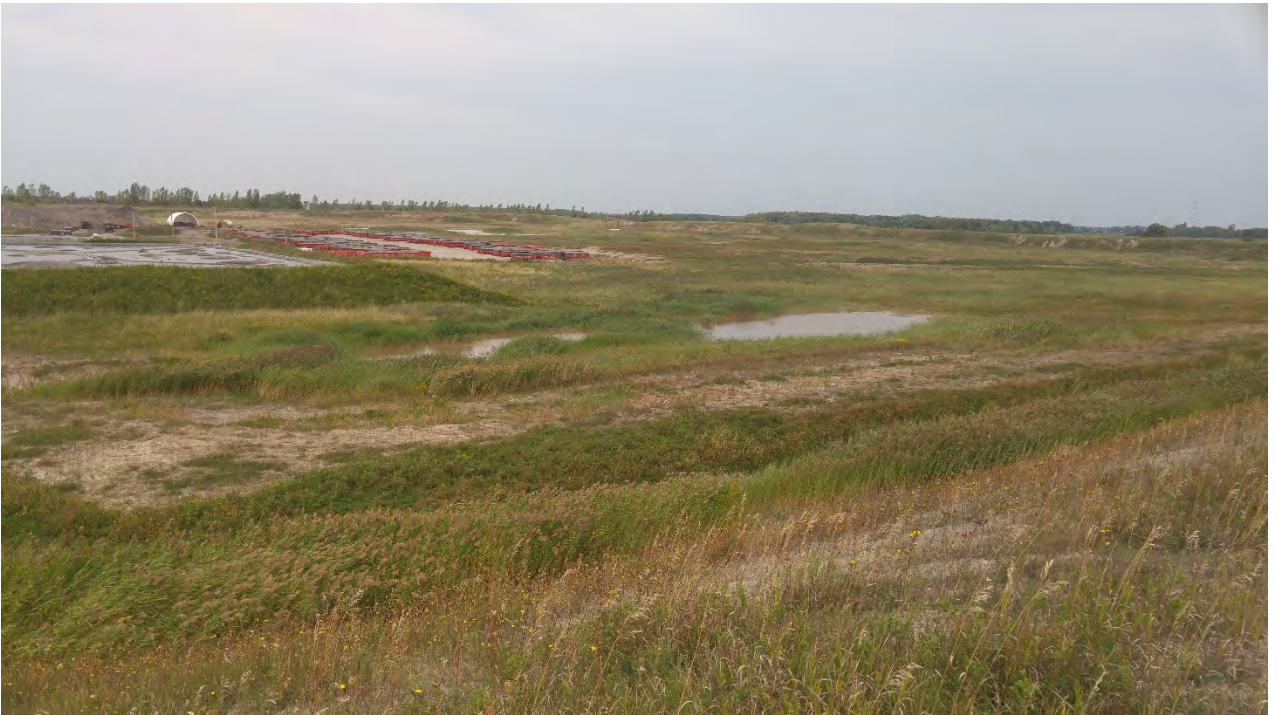
Photo 8 - Standing water in southeast corner of Original Landfill Area

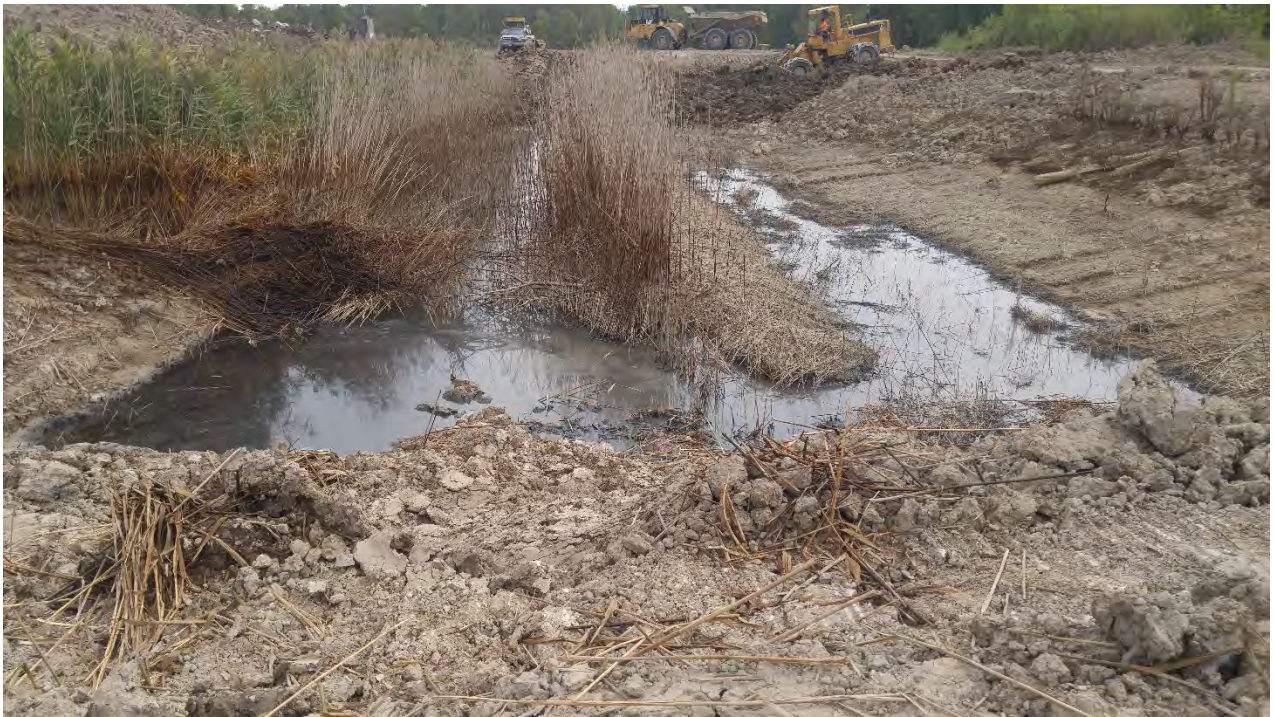
Photo 9 - South ditch remediation

Remediation works are being undertaken along the south ditch, in accordance with Provincial Officer's Order No. 2681-BCPKUJ. During these works, water is being pumped directly from the East Surface Water Pond to the West Surface Water Pond, bypassing the south ditch entirely. Water from the former south ditch is being treated and if acceptable, will be discharged to the West Surface Water Pond.

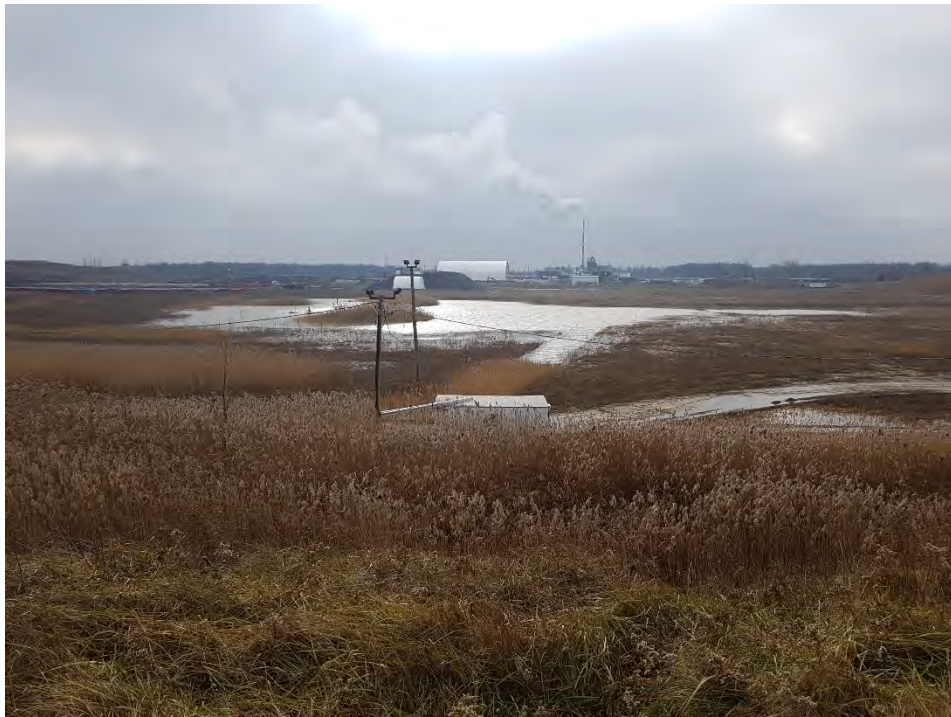
Photo 7 - Standing water in northwest corner of Site

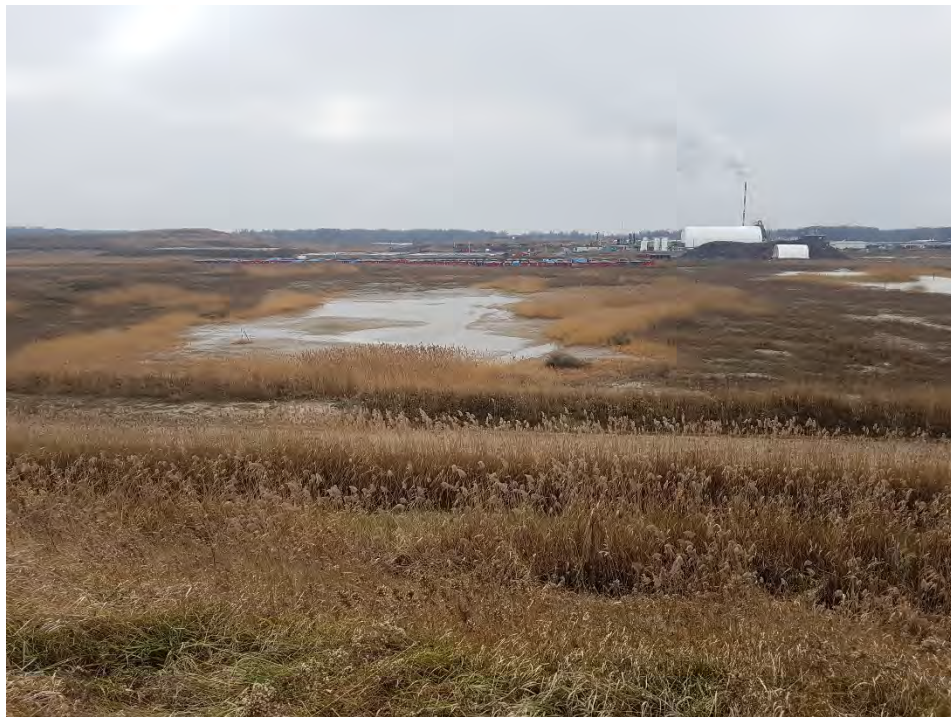
Photo 8 - Standing water in northern, central portion of Site

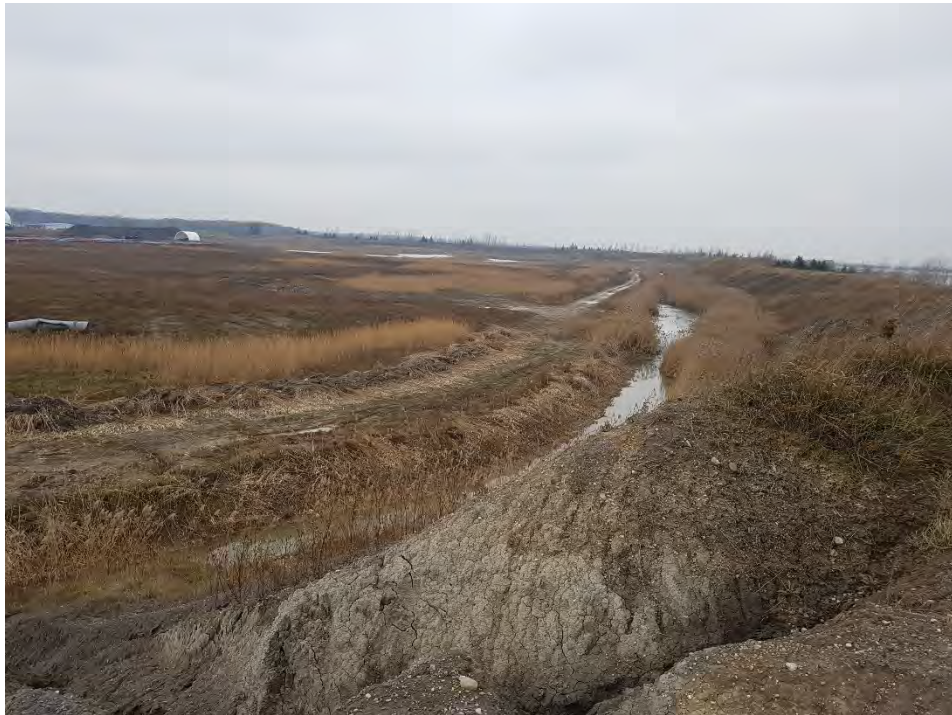
Photo 10 - North ditch, sitting surface water

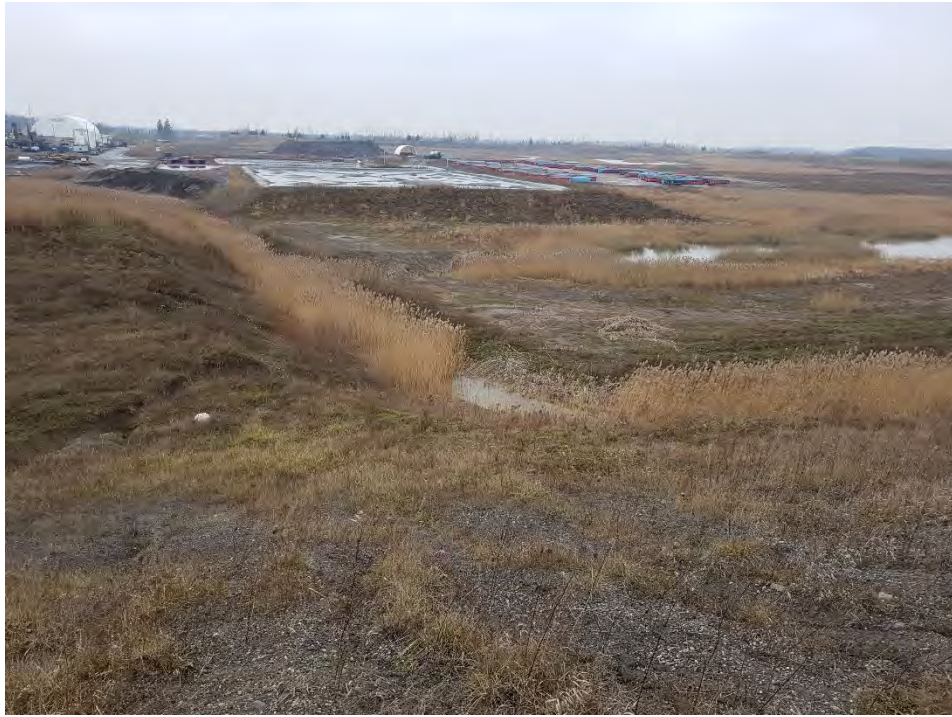
Photo 11 - Original Landfill Area, southeast ditch, sitting surface water

Remediation works have been completed along the south ditch, in accordance with Provincial Officer's Order No. 2681-BCPKUJ. Grading or ditching south of cell 19-1 and 19-2 can minimize standing water.

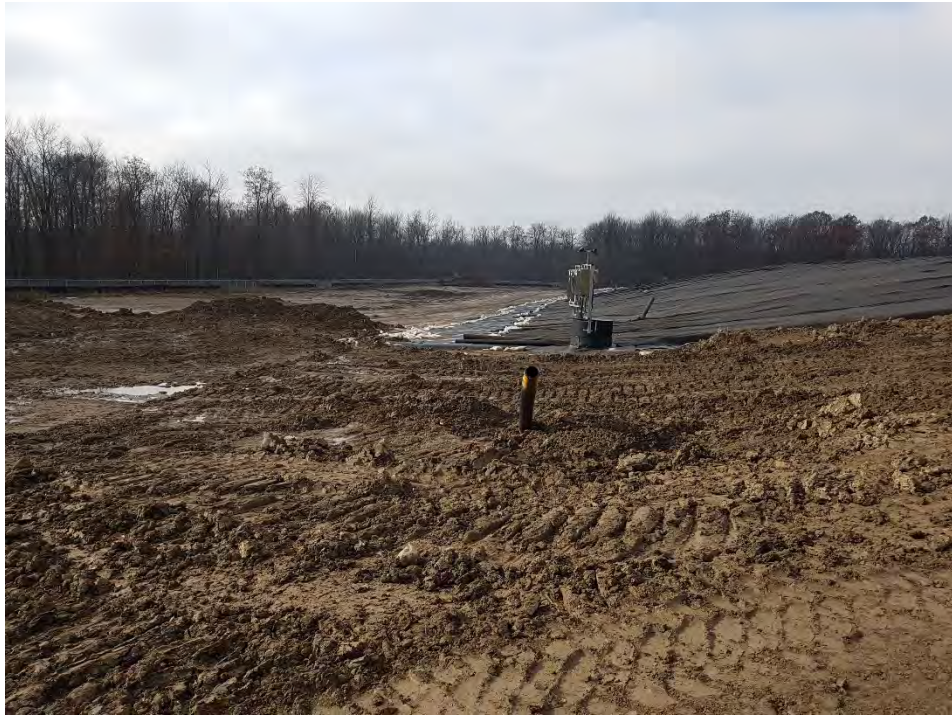
Photo 13 – Completed south ditch remediation
