Geotechnical Evaluation and Remedial Plan

**Cell 20-1, Slope Issues - Clean Harbors
Lambton Facility Landfill Corunna, Ontario**

Clean Harbors Canada, Inc.

November 12, 2021

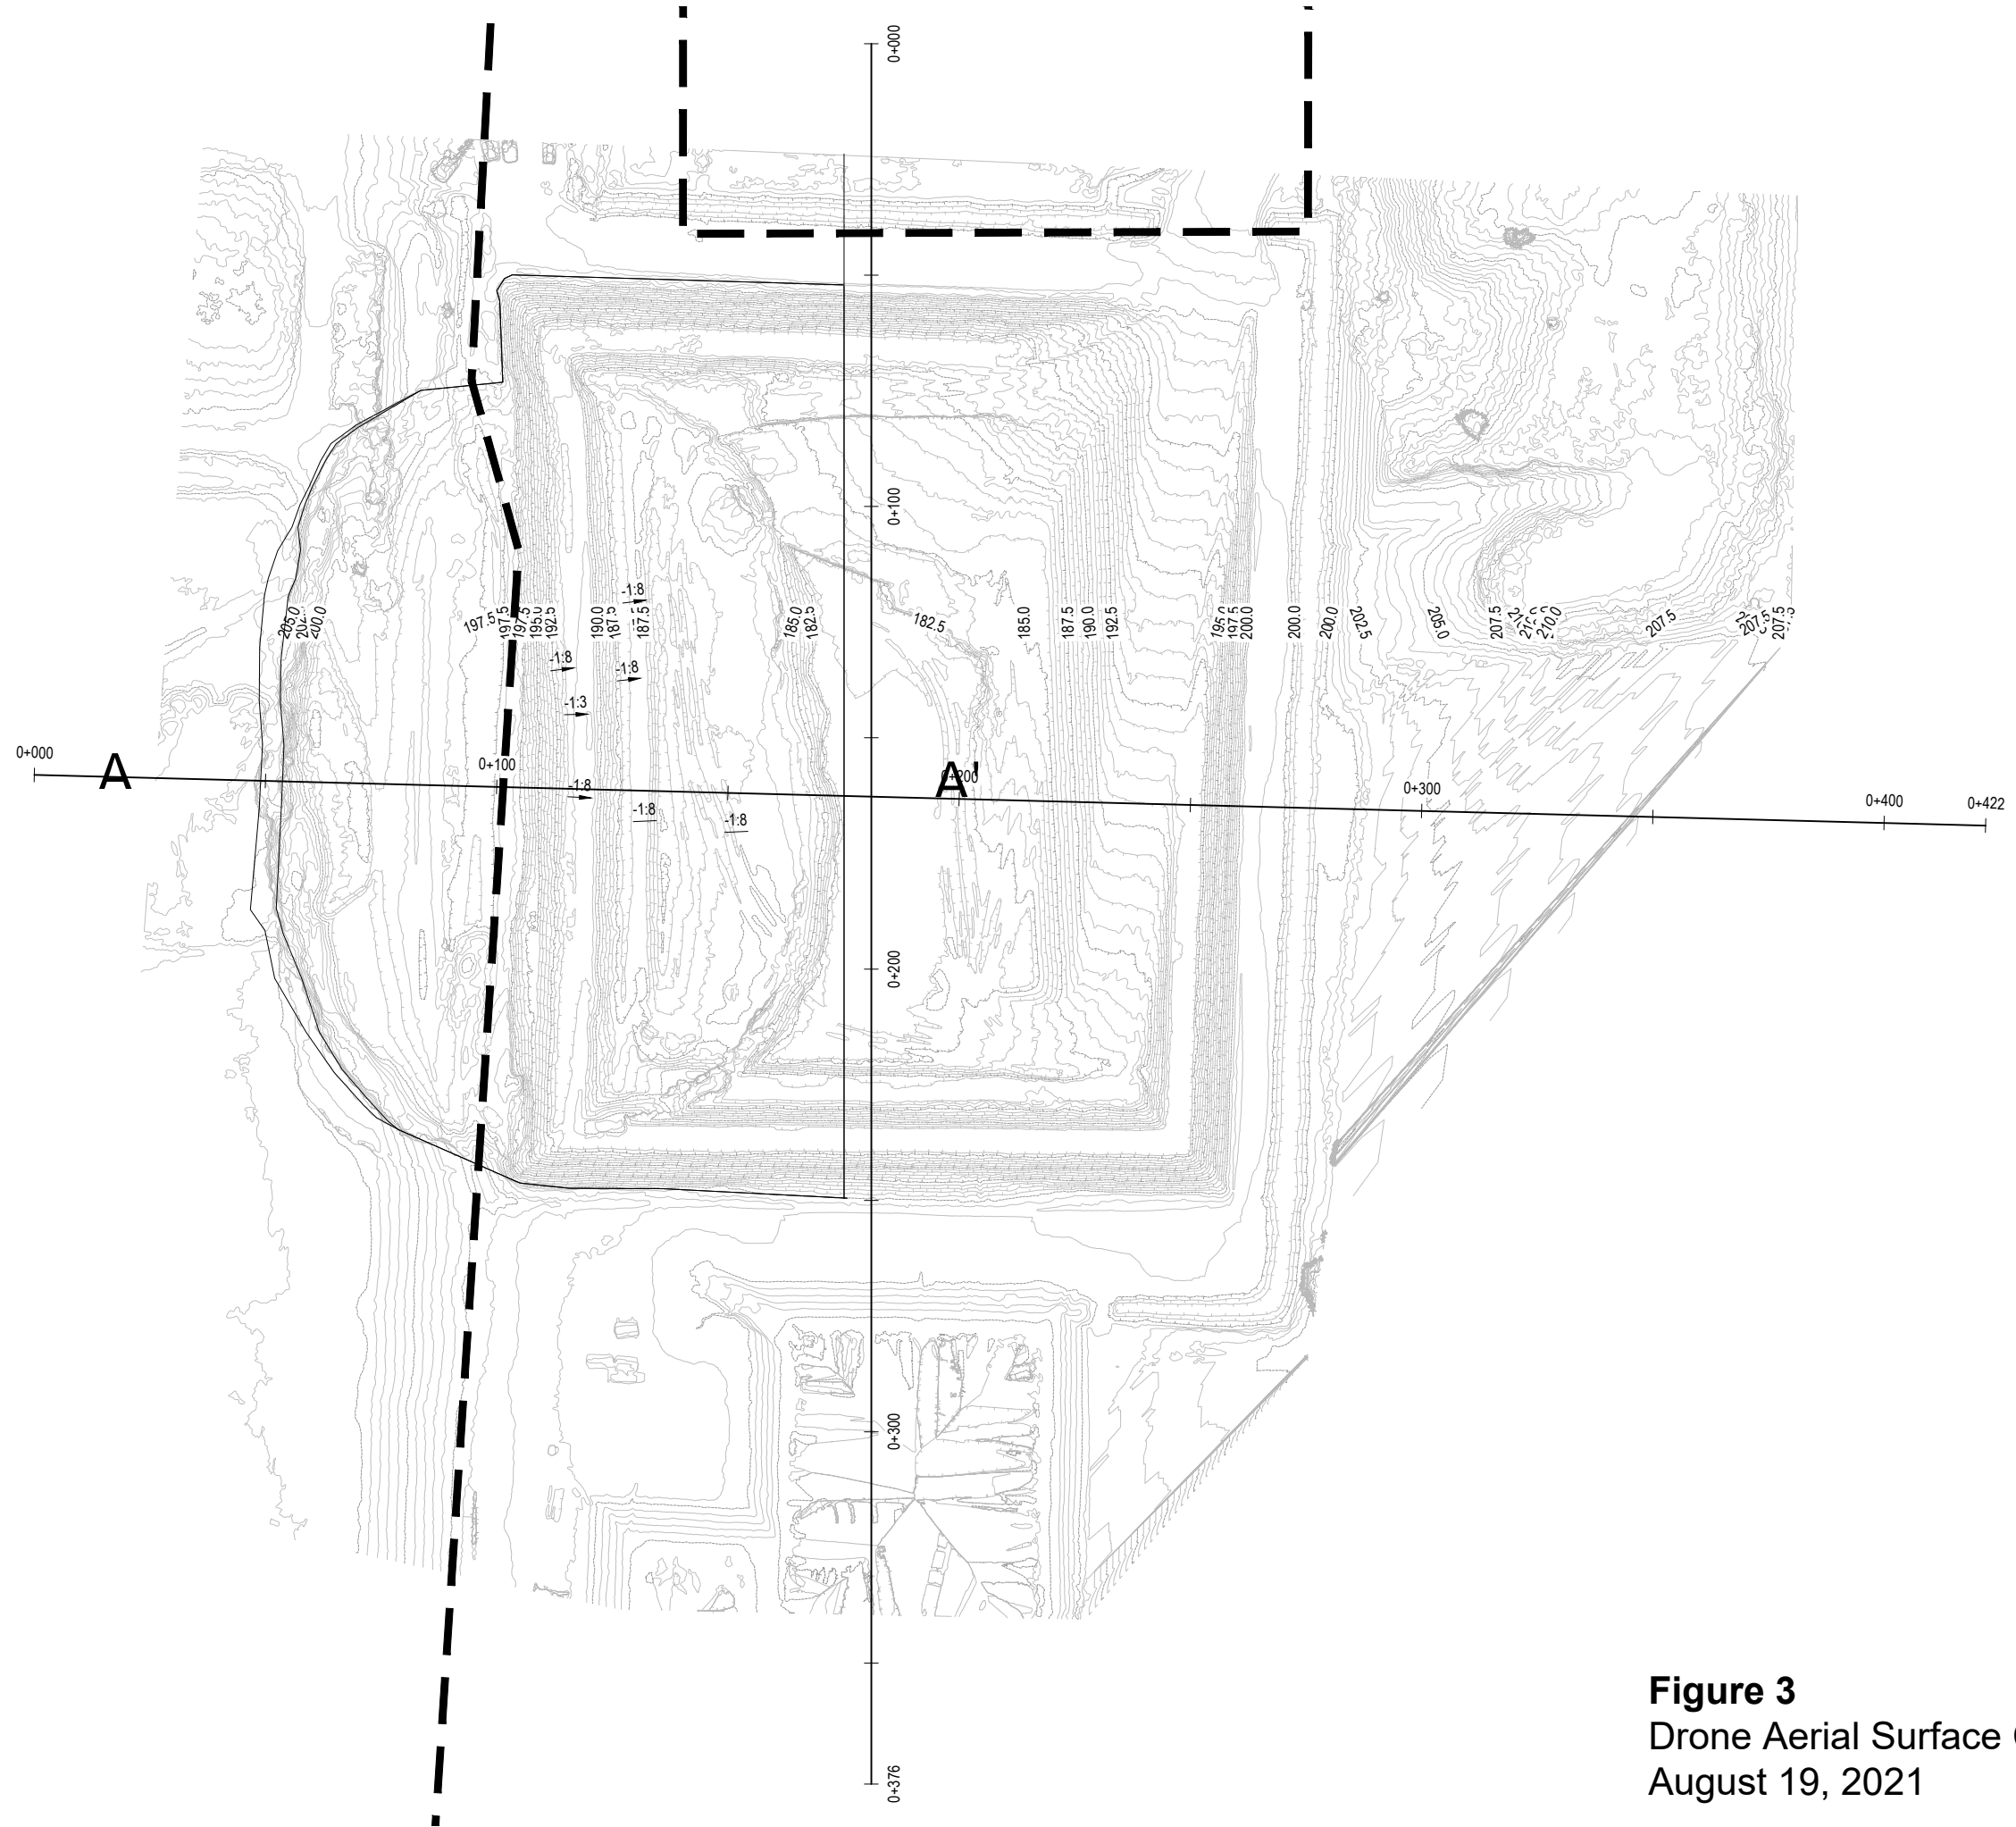
Figure 3
Drone Aerial Surface Contours
August 19, 2021

Based on visual observations of the Slope Issues, the movement of the slope was considered to be rotational in nature. The horizontal benches excavated on the west side slope were visually rotated upwards, and the floor of the Cell had been rotated and pushed upwards. GHD's initial estimates of the approximate centre of rotational arcs

matched the drone survey data and are shown on Figure 3. These preliminary rotational surfaces were further evaluated using slope stability modelling software. GHD re-inspected the slope on August 19. Following this re-inspection and an evaluation of the data obtained through the drone survey, GHD has determined that any movement of the slope had stopped by August 19. There is no evidence that any leachate escaped the Cell into the natural environment. Following discussions with Clean Harbors management and out of an abundance of caution, GHD recommended the construction of a north-south berm east of the bulge to contain leachate that was observed in the base of the Cell. In addition to further leachate protection, this berm also provides part of a stabilizing clay buttress in the floor of the cell, at the toe of the slope, as a measure to prevent further slope movement. Construction of this berm and clay buttress began on August 20 and was substantially completed by September 30. The Geotechnical Engineer inspected the work on September 30 and GHD completed an additional drone survey on October 13. Both the Geotechnical Engineer's inspection and the October 13 drone survey support a conclusion that the slope has stabilized, as neither showed any evidence of further movement and both instead show that the slope is reinforced and stabilized by the newly constructed berm and clay buttress.

Cross-sections modelled for the analyses were similar those evaluated prior to the design and construction of Cell 20-1. The cross-section location for the slope issue analysis is shown as A-A' on Figure 3

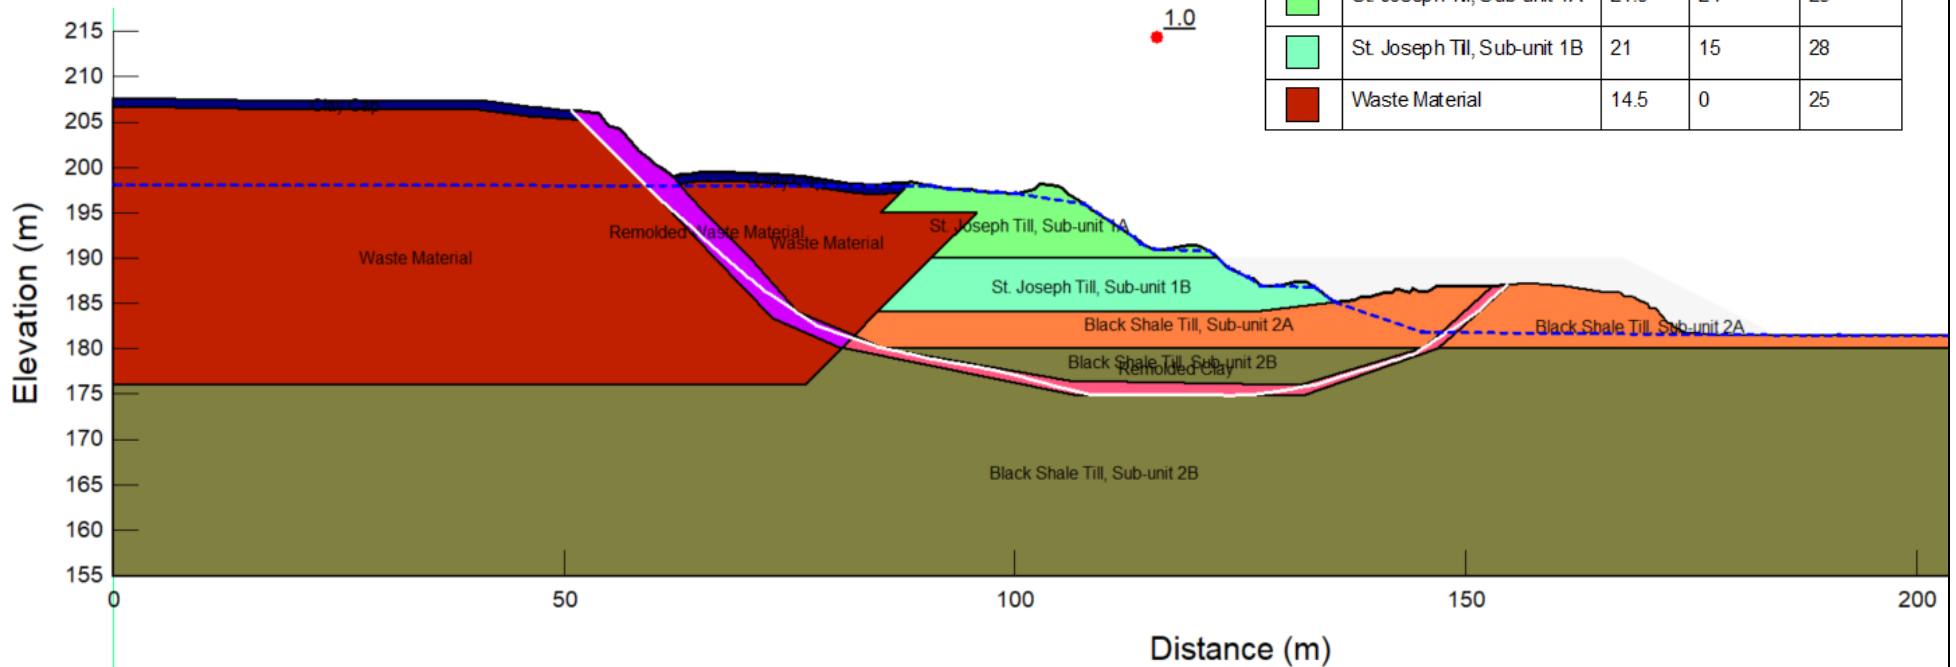
Figure 5
West Slope Issue- Back Calculation Analysis of
Rotated Surface

The rotational movement of the slope will have caused a weakened (or remoulded) clay zone along the path of the rotational movement. This weakened clay layer was simulated in the model, as shown on Figure 5 (remoulded clay layer), along the estimated rotational surface that was preliminarily determined from the aerial drone survey. The shear strength of this weakened zone was back-calculated, using a “back-analysis” approach, by reducing the strength of the weakened zone until an FS of approximately 1.0 was achieved in the model. This model was then used to evaluate the improvement in the FS by construction of the clay buttress. Initial modelling of the buttress constructed to about Elevation 190 m, shows that the FS would increase from about 1.0, to about 1.46, in its fully constructed state (see Figure 6). This FS is considered acceptable to ensure long term stable conditions of the failed slope. These results were presented at a virtual meeting with the MECP on October 13. During the meeting, Clean Harbors requested permission to regrade the waste in the area of the Slope Issues, with the goal of covering any exposed waste with a clay cap, and regrading the area to minimize surface water infiltration into the waste. GHD

Client :	Clean Harbors Canada Inc.	
Projet :	Cell 20-1 Slope Issues	
Reference :	44985	
Location :	West Slope	
Analysis :	Static Drained	F.S : 1.0

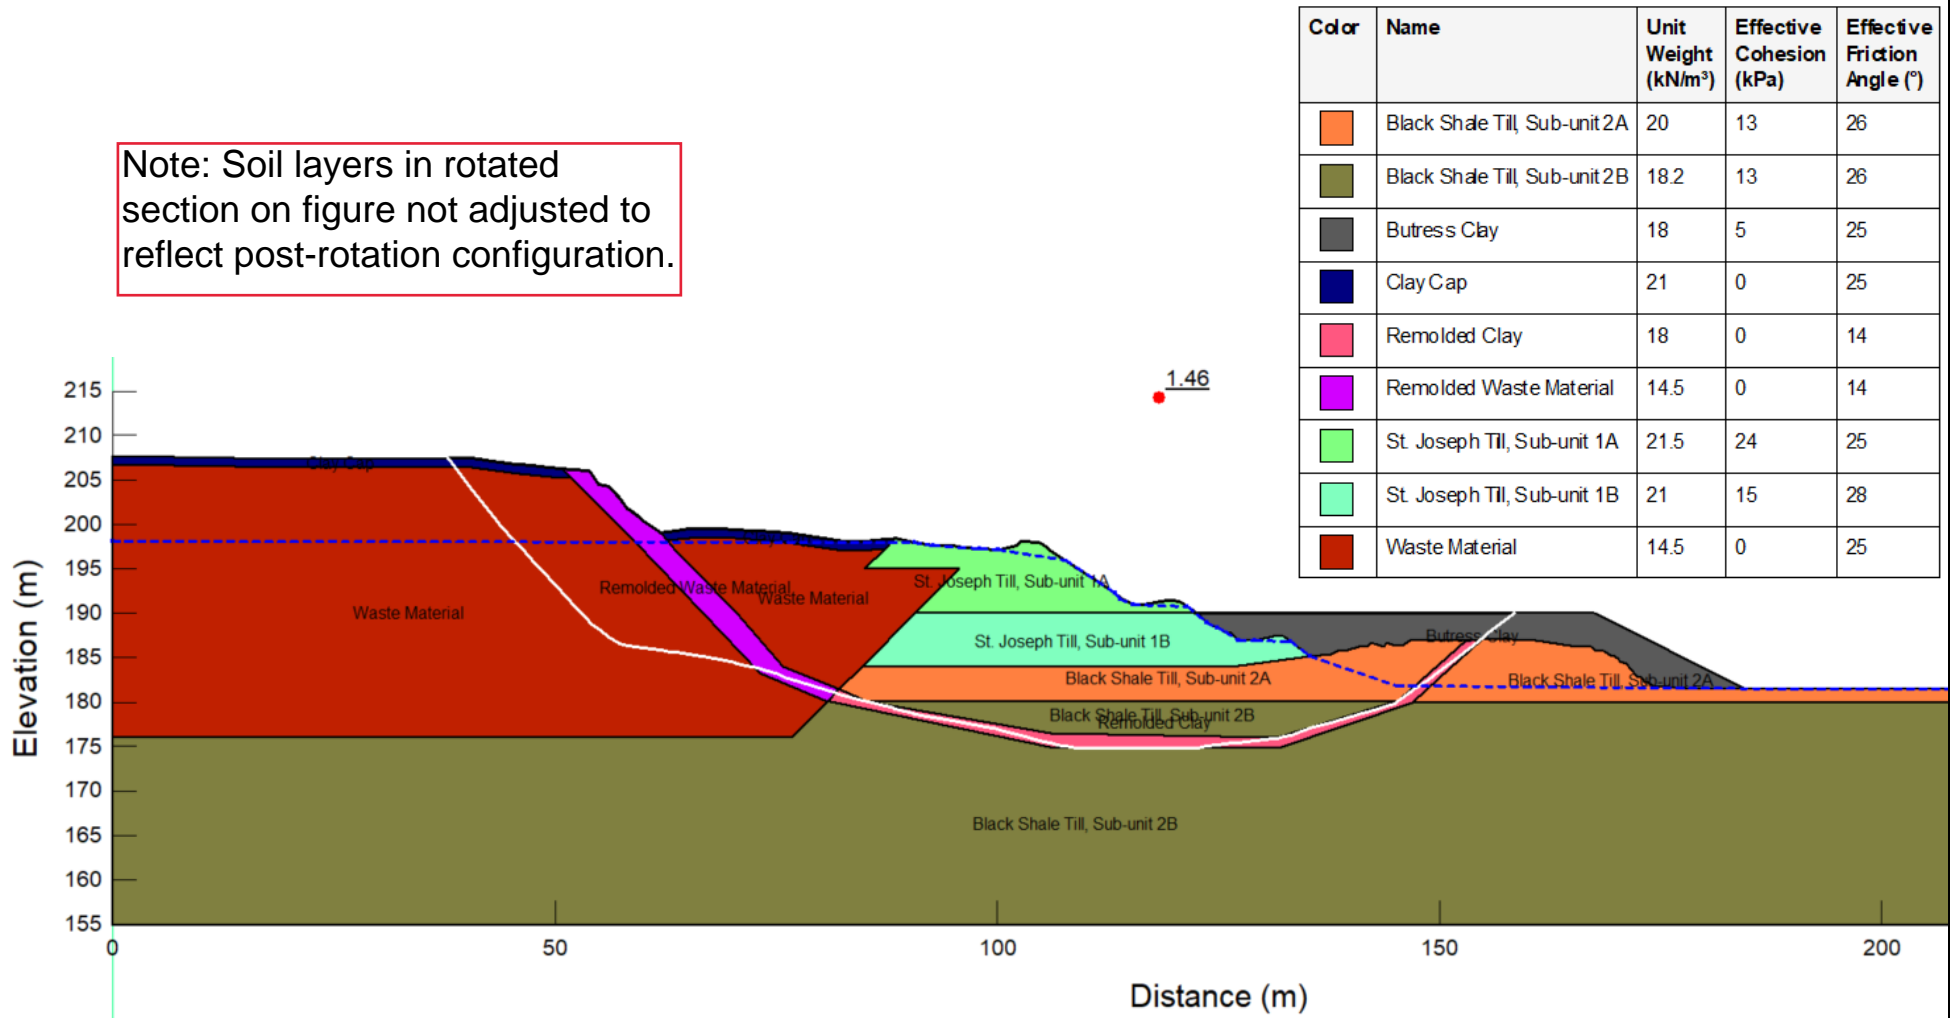
Figure 6
West Slope- Proposed Buttress Stabilization

Client :	Clean Harbors Canada Inc.	
Projet :	Cell 20-1 Slope Issues	
Reference :	44985	
Location :	West Slope	
Analysis :	Static Drained	F.S : 1.46

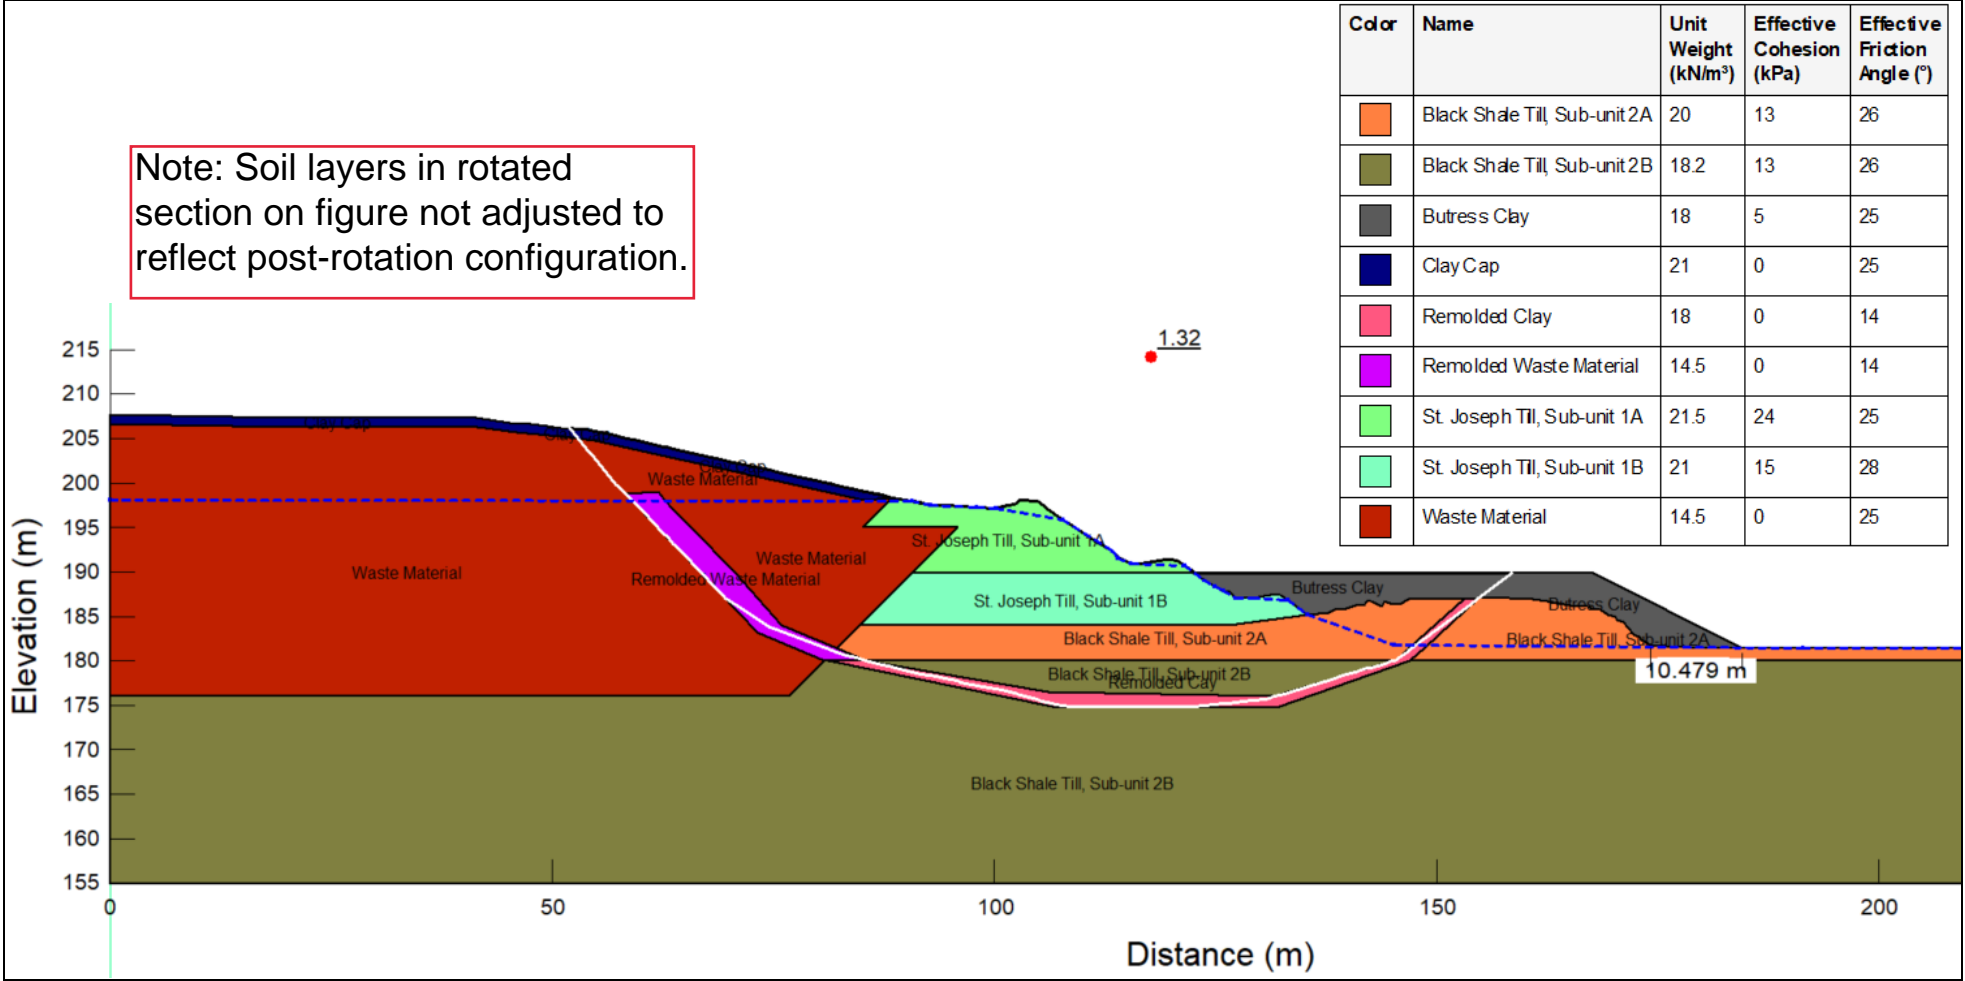
Figure 7
West Slope- Buttress Stabilization and Pre-1986 Waste Cell Graded and Capped

modelled the regraded effort, and the results are shown on Figure 7. The FS for this condition is approximately 1.32 which, based on the requirements outlined in the abovementioned Canadian Foundation Engineering Manual indicates that this work could be done without affecting the stability of the slope.

Client :	Clean Harbors Canada Inc.	
Projet :	Cell 20 Slope Issues	
Reference :	44985	
Location :	West Slope	
Analysis :	Static Drained	F.S : 1.32

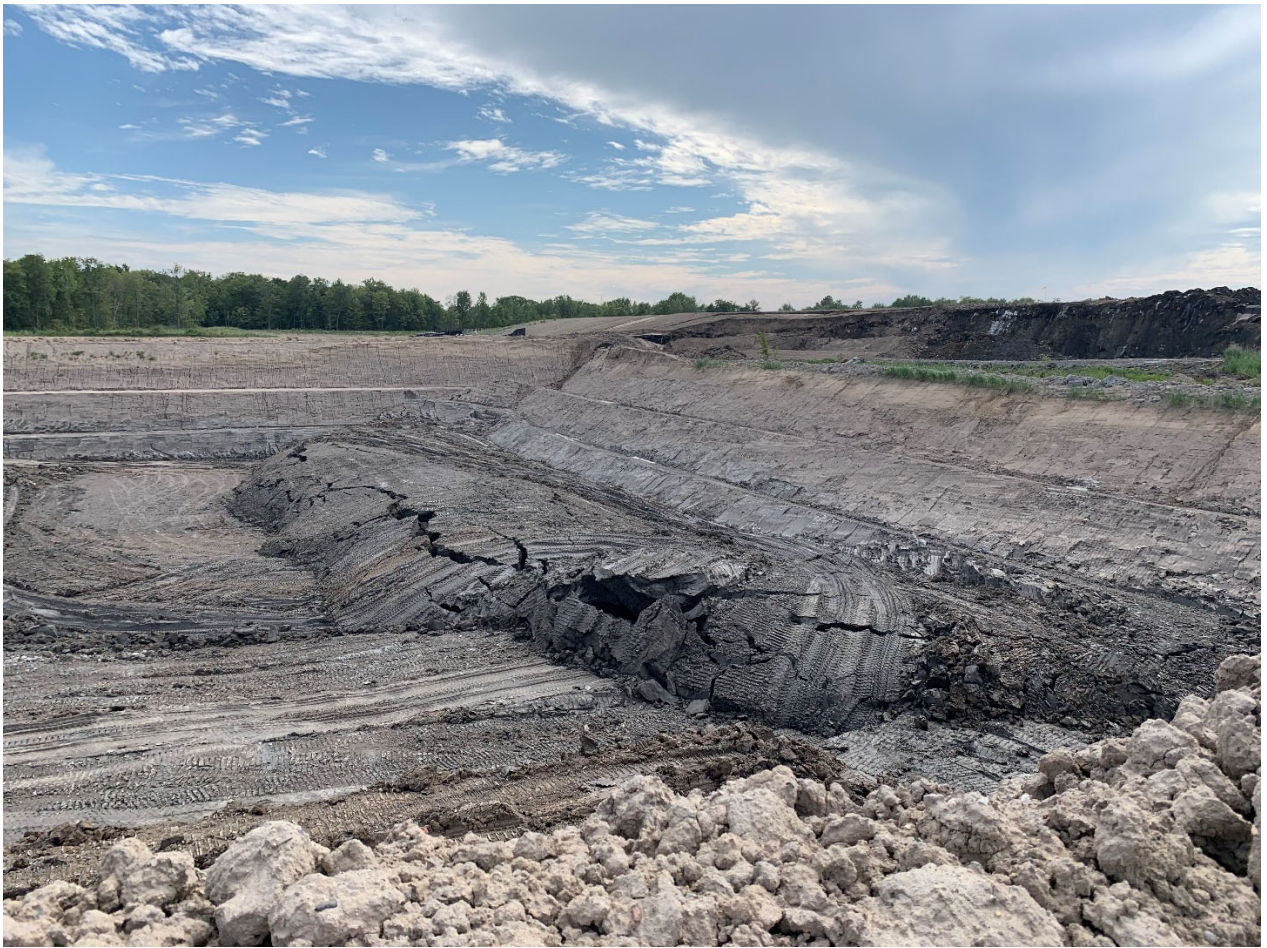
Photo 1- West Side wall of Cell 20-1, after slope movement, August 18, 2021.

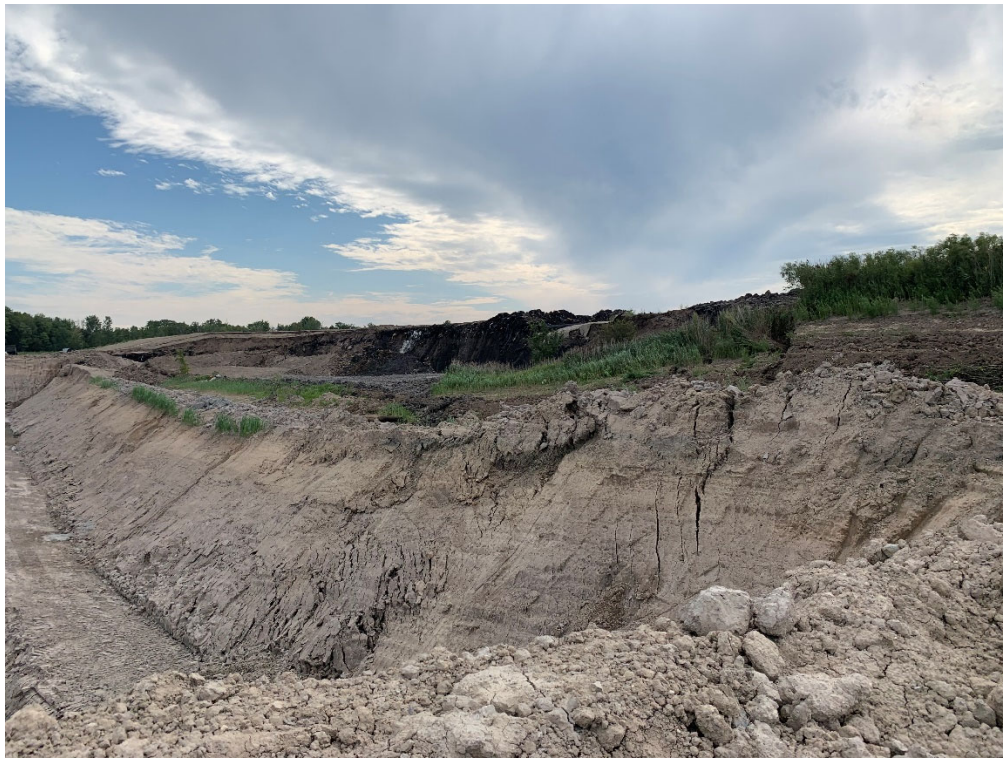
Photo 2- West side wall of Cell 20-1, looking south, August 18, 2021.

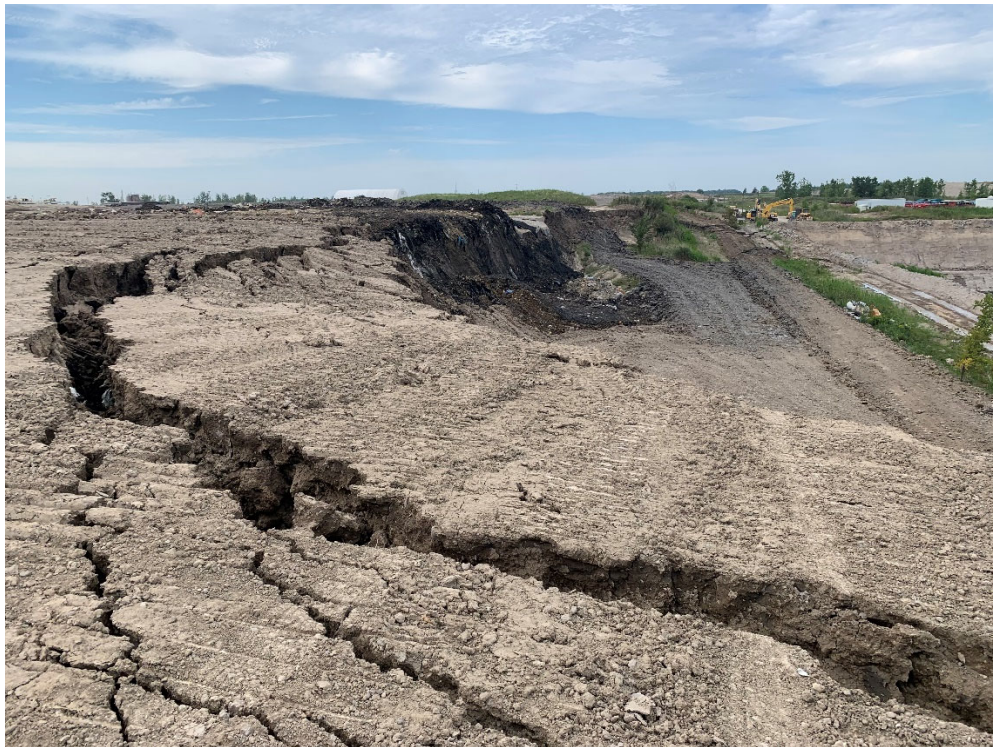
Photo 3- Top of Slide Area, looking north, August 18, 2021.

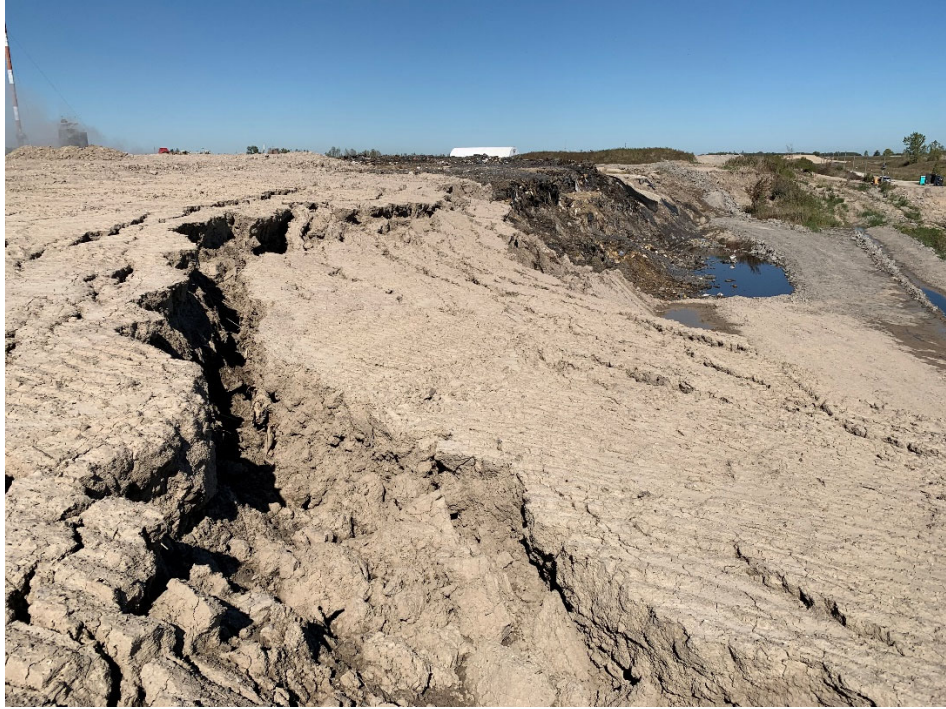
Photo 4- Top of Slide Area, looking north, September 30, 2021.

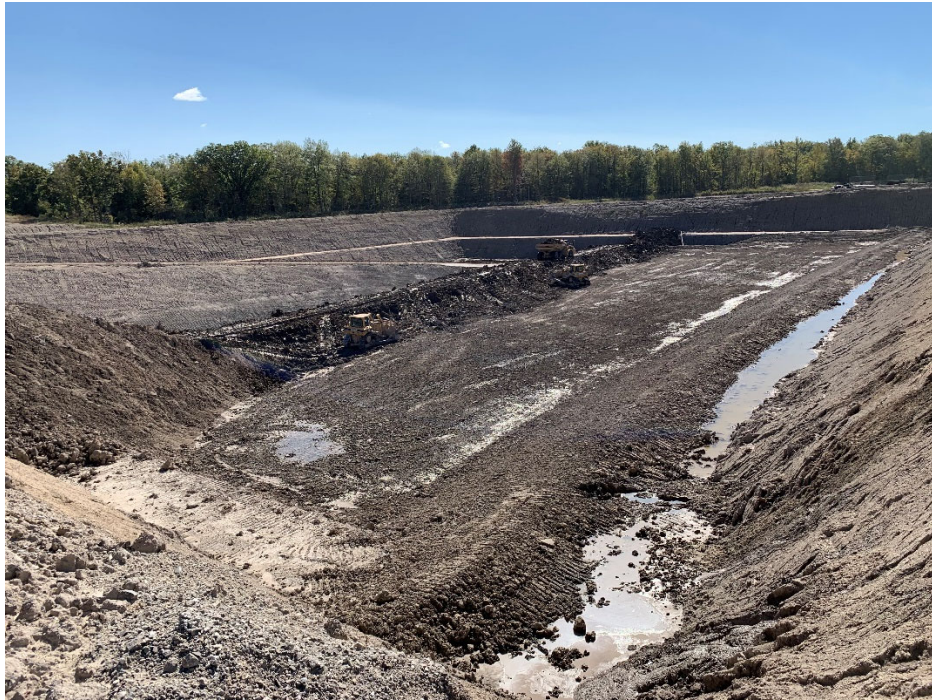
Photo 5- Completed buttness, looking southeast, September 30, 2021.

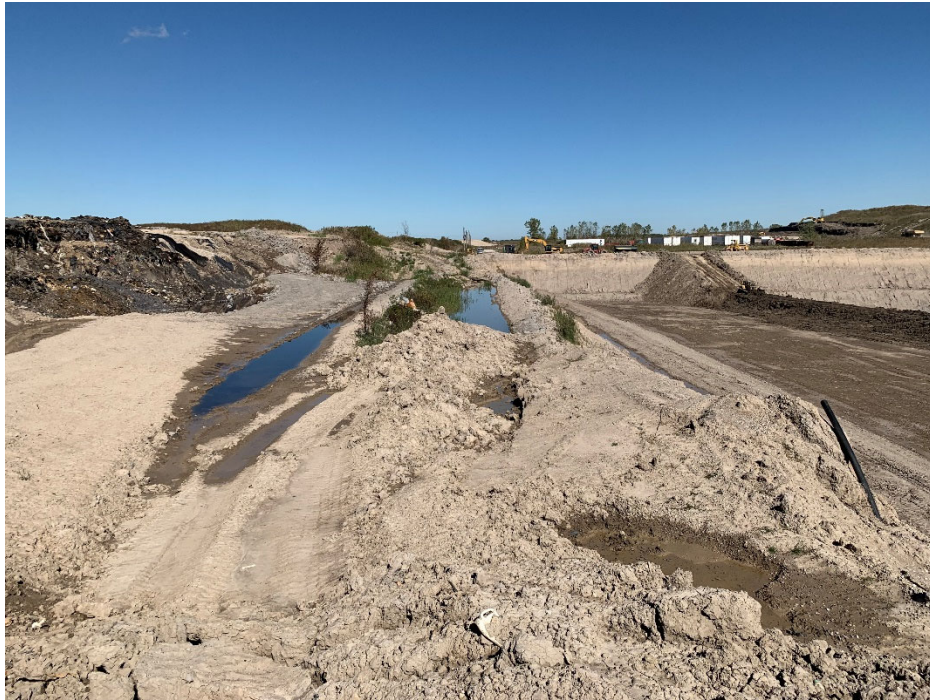
Photo 6- Completed buttness, looking north, September 30, 2021.

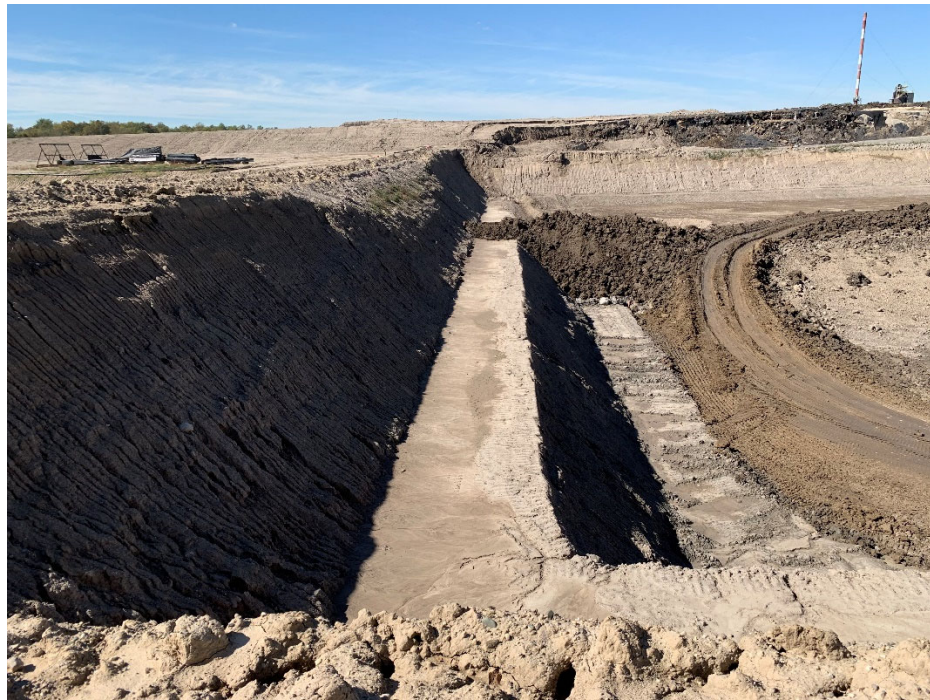
Photo 7- South sidewall, looking west, September 30, 2021.
