**THURBER** ENGINEERING LTD.

December 23, 2021

**GEOTECHNICAL PEER REVIEW  
GHD GEOTECHNICAL EVALUATION AND REMEDIAL PLAN  
CELL 20-1 SLOPE STABILITY ISSUES  
CLEAN HARBORS LAMBTON LANDFILL FACILITY  
CORUNNA, ONTARIO**

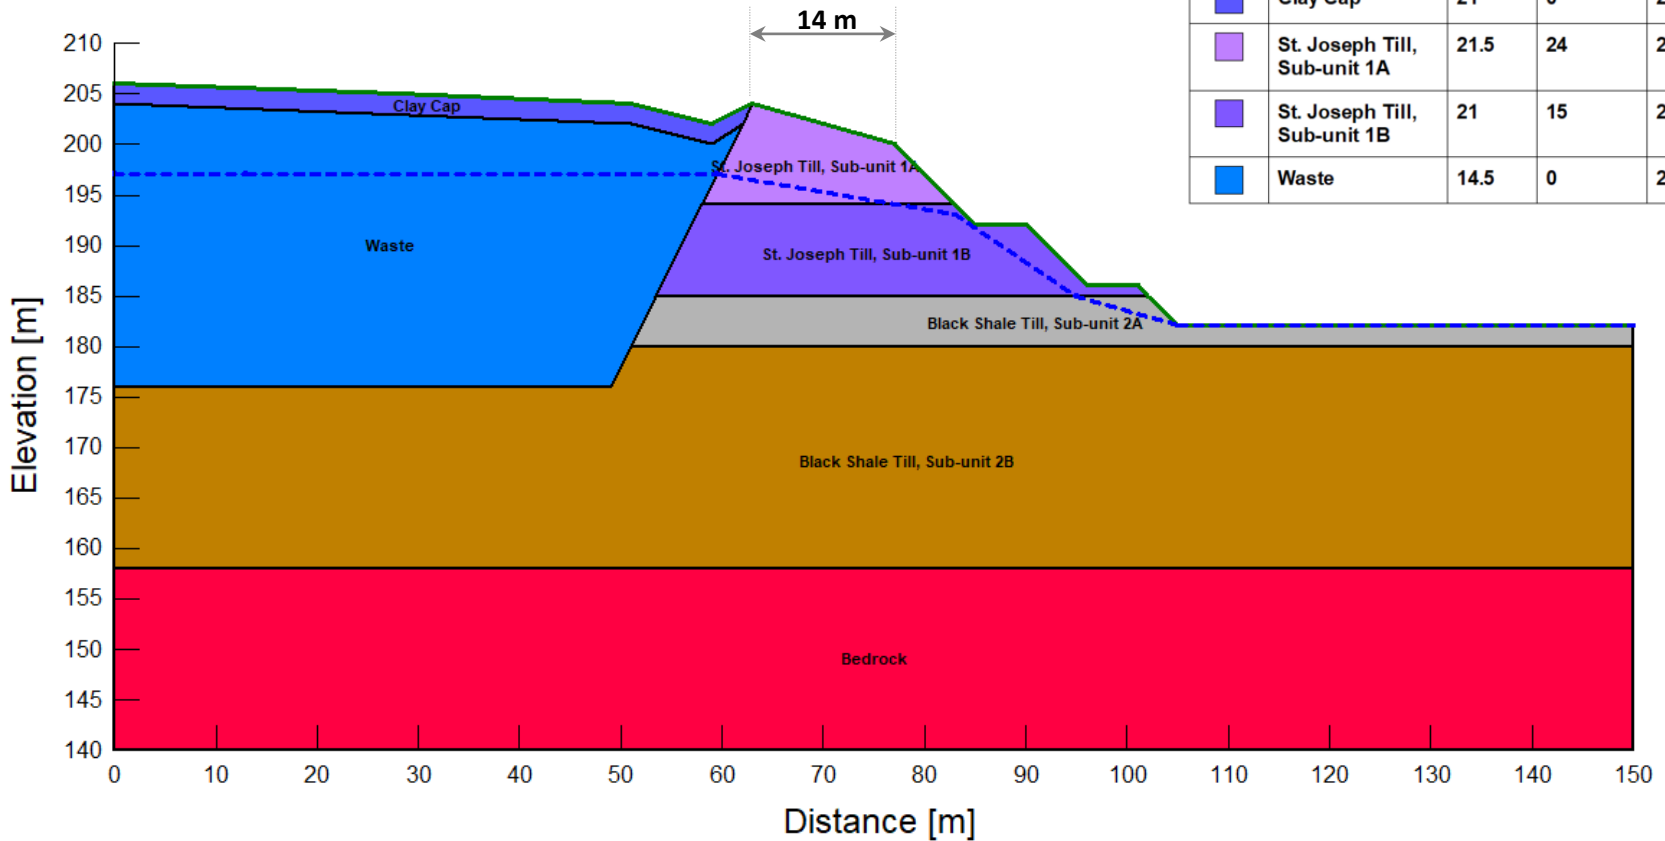
Figure 1 presents the general arrangement of grades and soil units. We have assumed similar grades as presented in the GHD Design Report. We have also used the same lower bound parameters used in the GHD Report, however, have included the bedrock layer which was missing in the GHD assessment. The location and depth of waste fill in the pre-1986 cell is approximated based on available data.

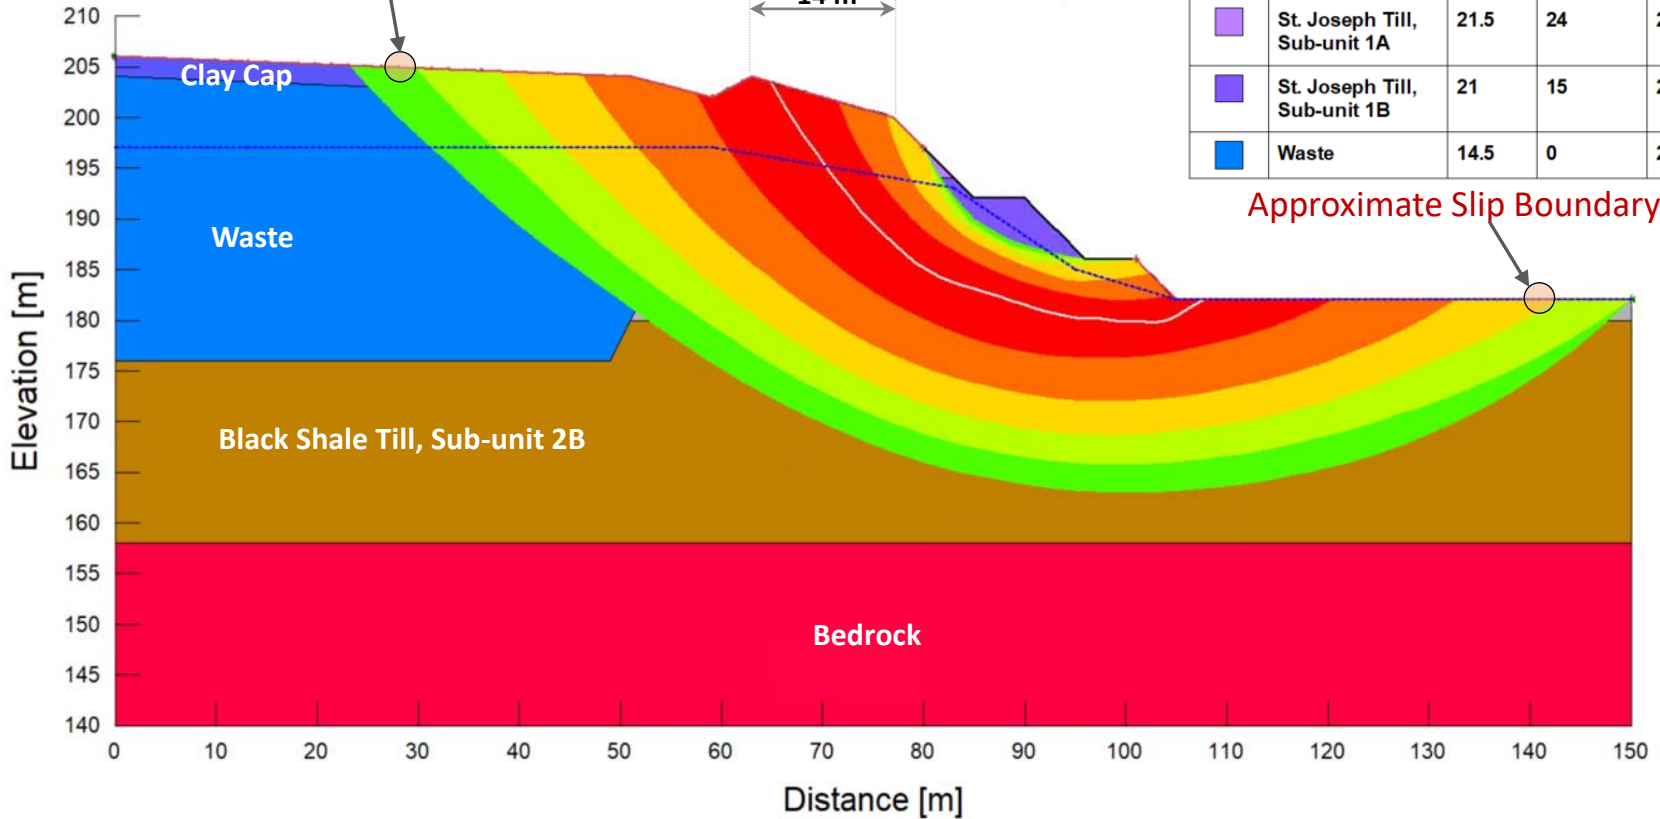
Figure 2 presents the results of the failure model without considering hydrostatic uplift from the bedrock aquifer. The minimum factor of safety (FOS) is 1.04, which is below the design target of 1.3.

Ignoring Bedrock  
Artesian Pressure

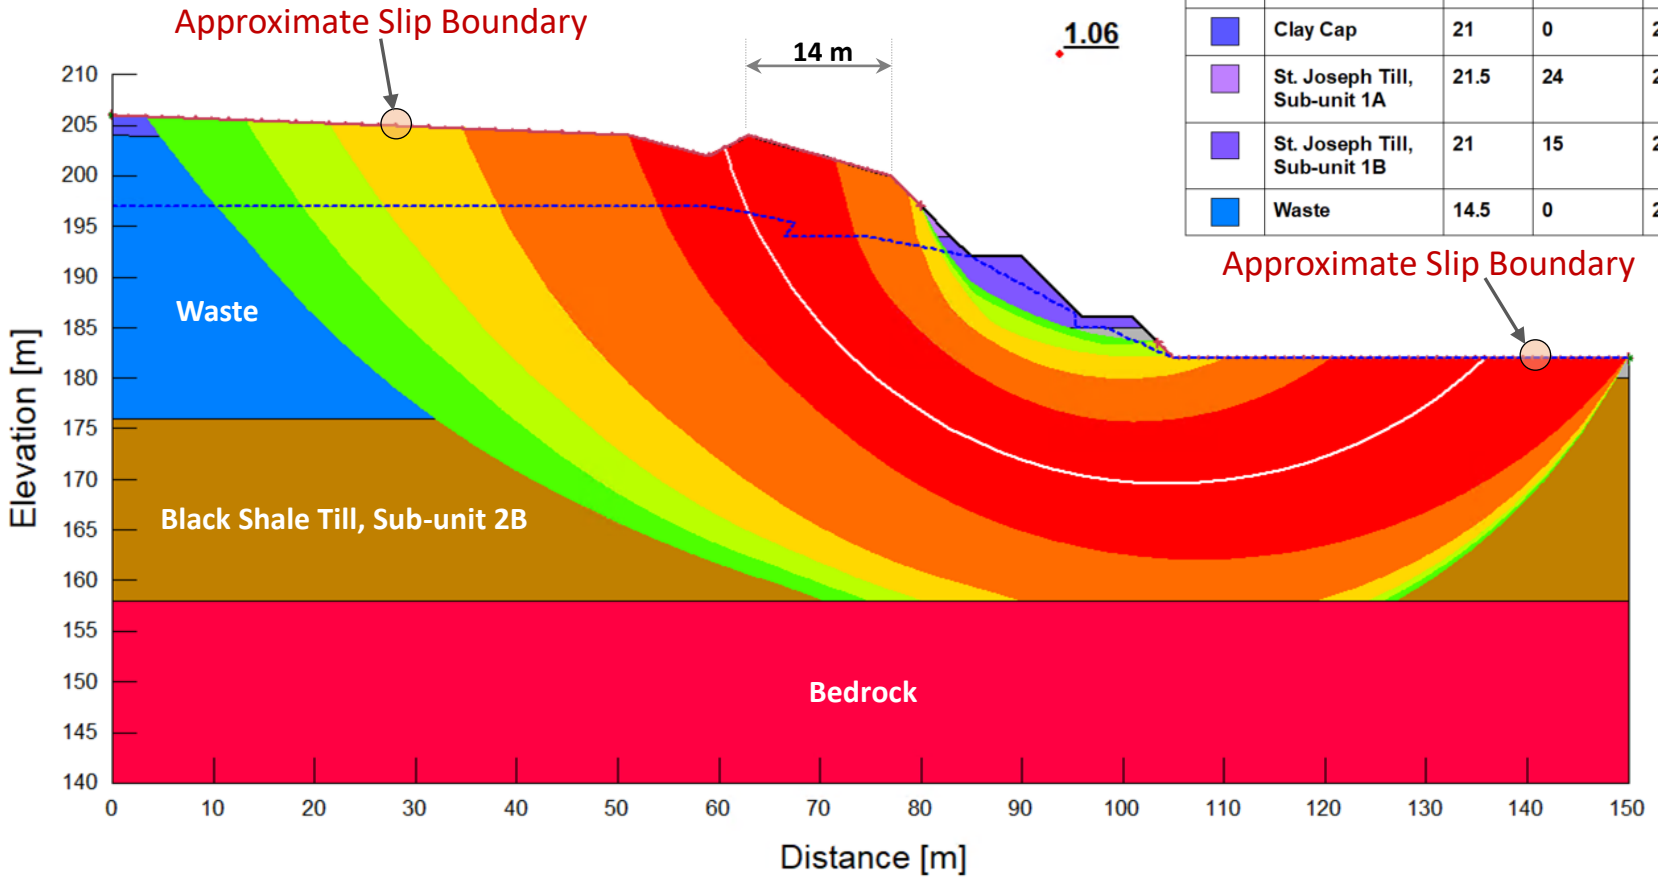
**Figure 3**

Figure 3 presents the further effect of uplift for the hydrostatic aquifer. The minimum FOS is 1.06. More important, the modelling shows that the assessment of the ground conditions using the hydrostatic uplift presents a possible failure scenario which is similar in extent as the actual event. Overall, this modelling shows that the failure surface selected by GHD may not be correct. We recommend that GHD complete further stability assessment assuming at least two additional deeper failure surfaces.

Including Bedrock  
Artesian Pressure
