2021 Quarterly Site Inspections

Clean Harbors Lambton Facility

Clean Harbors Canada Inc.

February 22, 2022

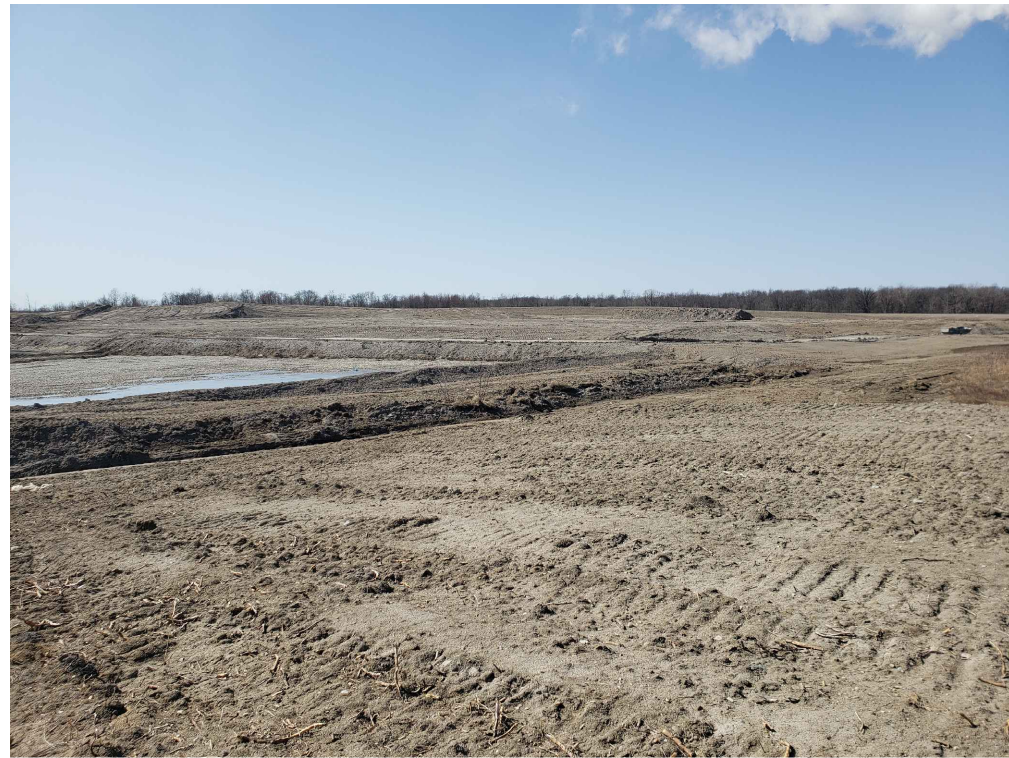
1 CELL 19-3A AND 19-3B
Fig 3A

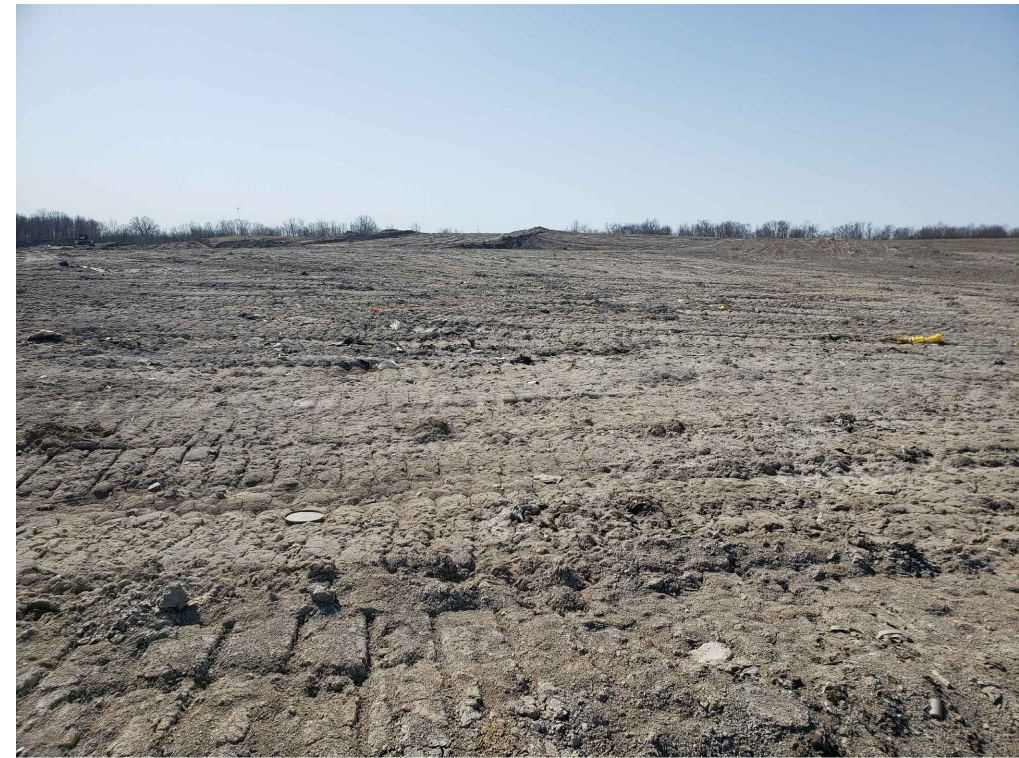
2 CELL 19-3B INTERIM COVER
Fig 3A

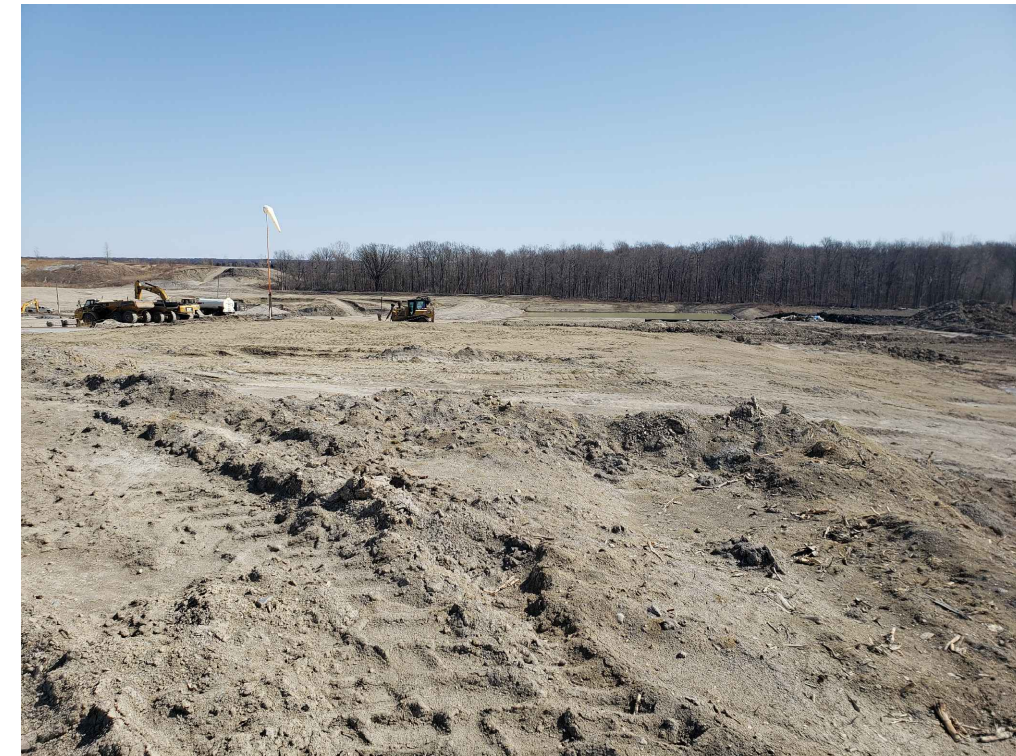
4 CELL 19-2D AND 19-2G
Fig 3A

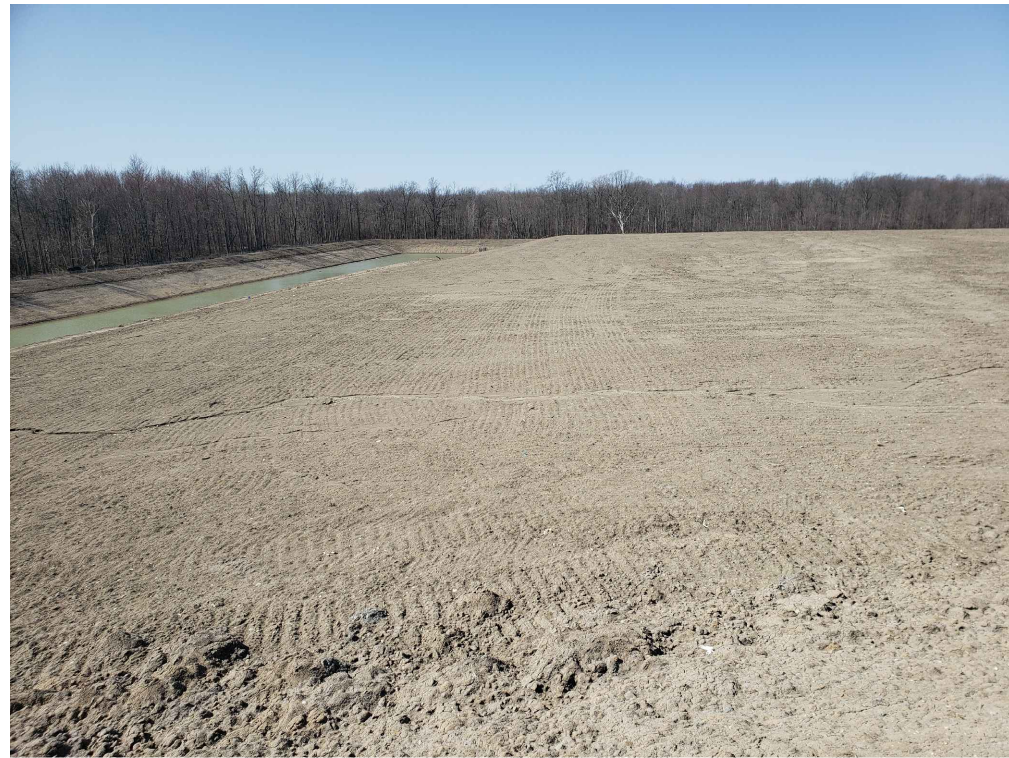
5 FINAL COVER - TOPSOIL PLACEMENT CELL 19-1
Fig 3A

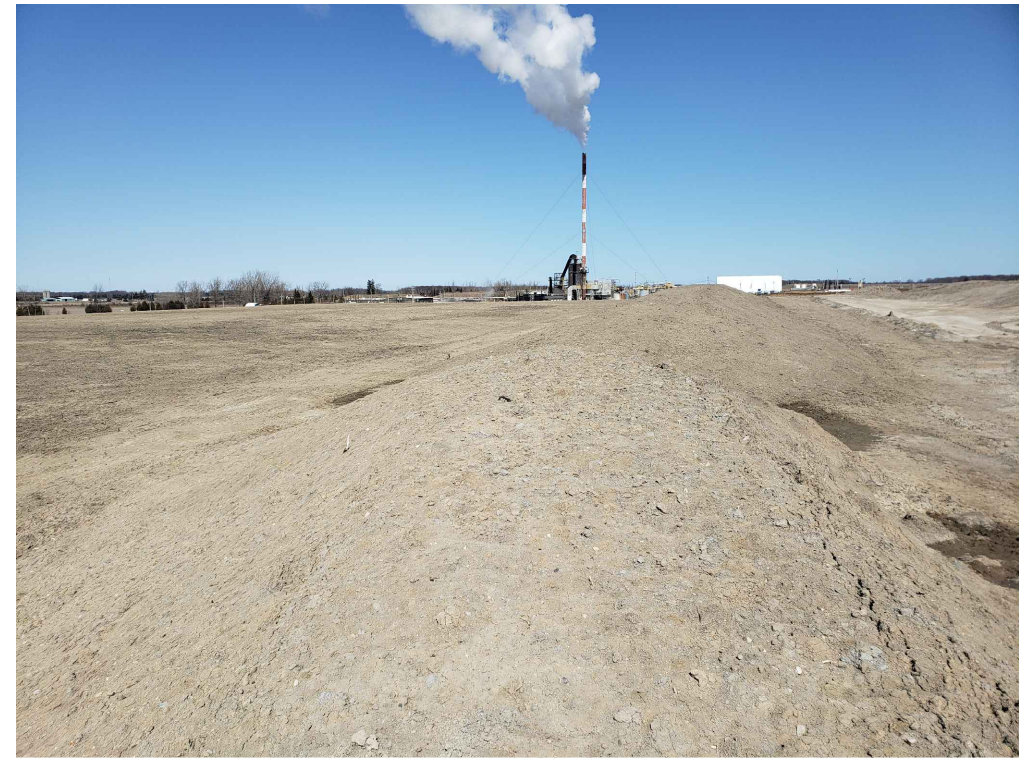
6 FINAL COVER - TOPSOIL PLACEMENT CELL 19-1
Fig 3A

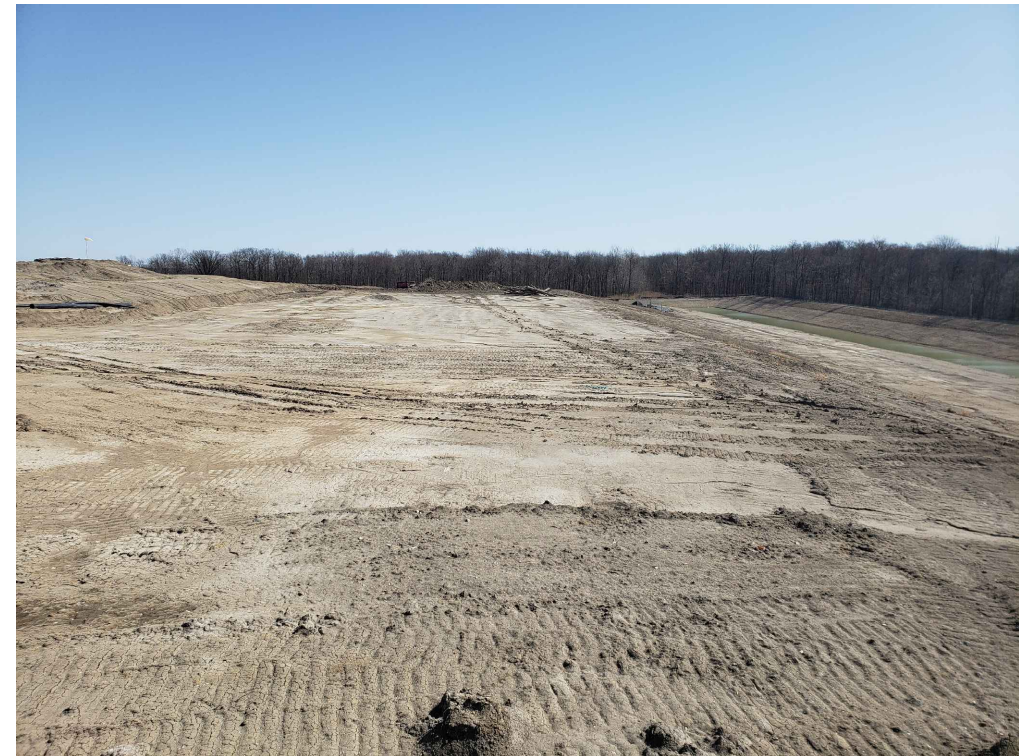
8 CELL 19-2 CLAY STOCKPILE AND INTERIM COVER
Fig 3A

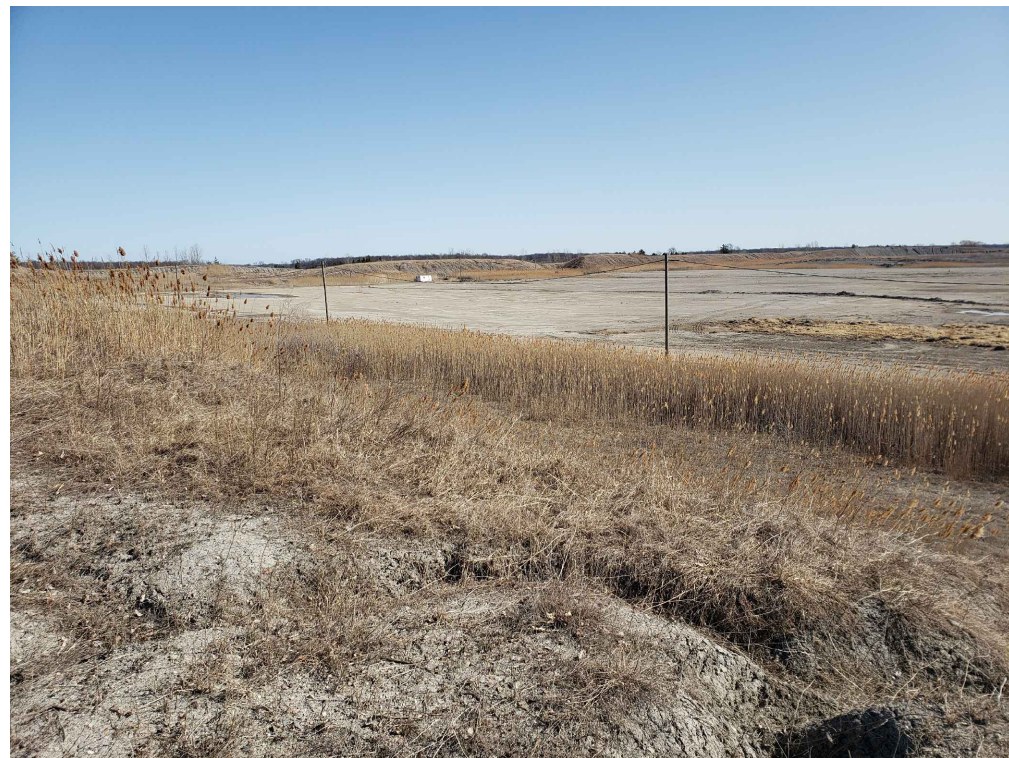
9 REGRADED NORTH AREA
Fig 4A

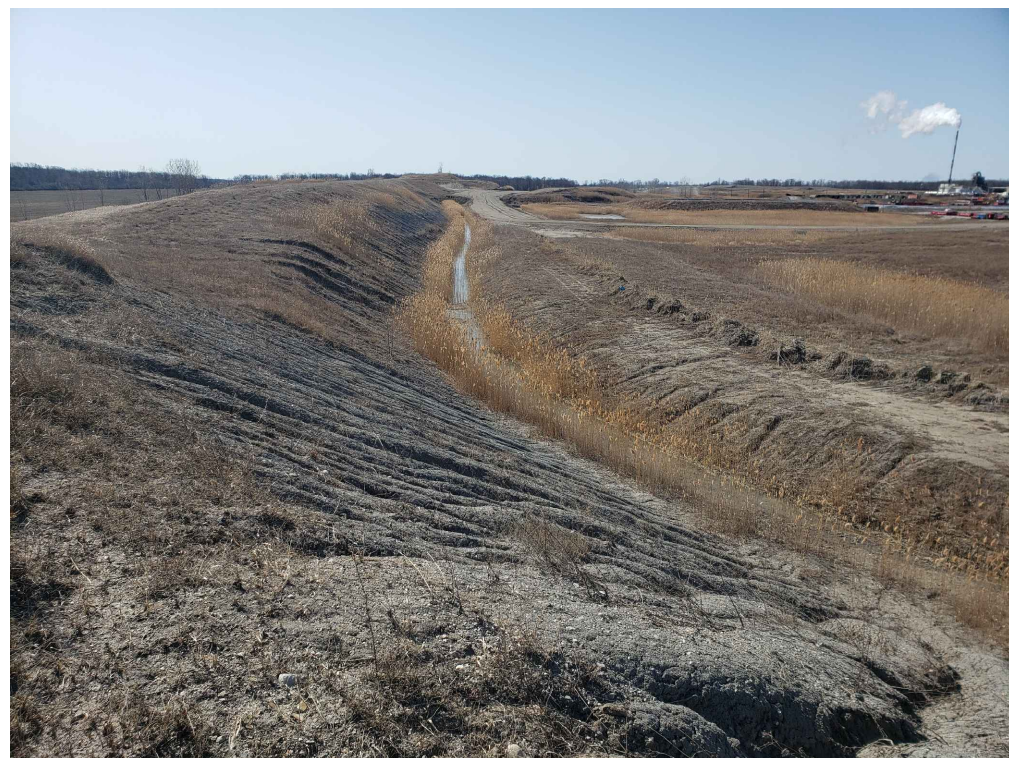
11 EROSION CHANNELS ALONG EAST PERIMETER BERM
Fig 4A

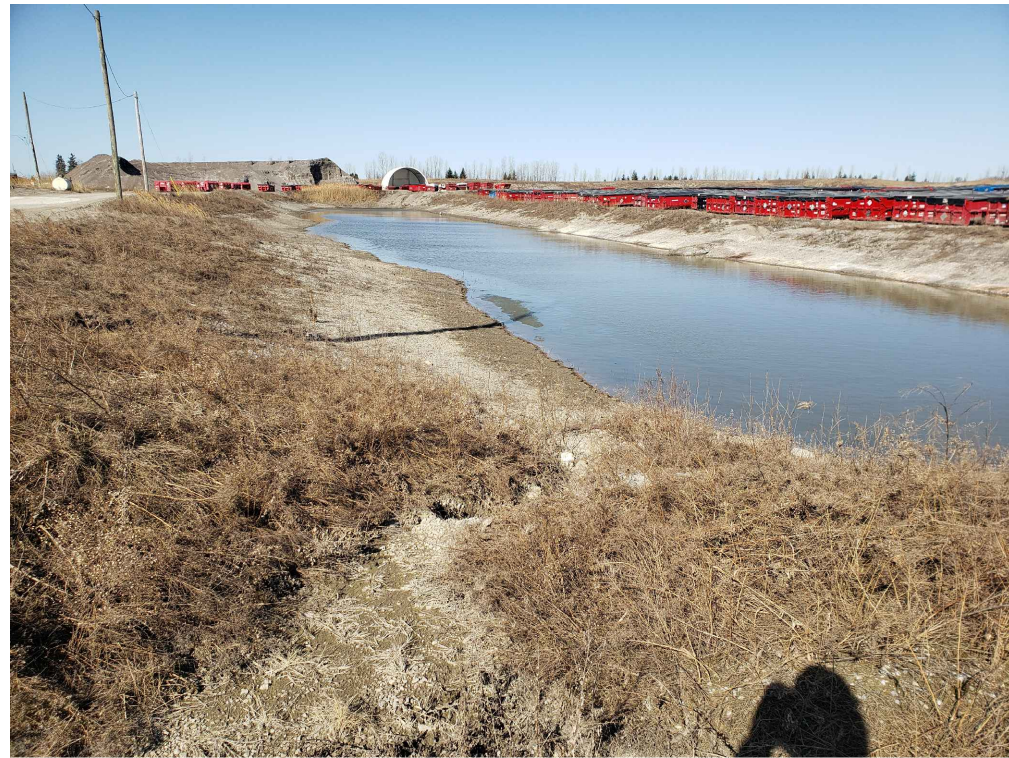
13 EAST PROCESS POND
Fig 4A

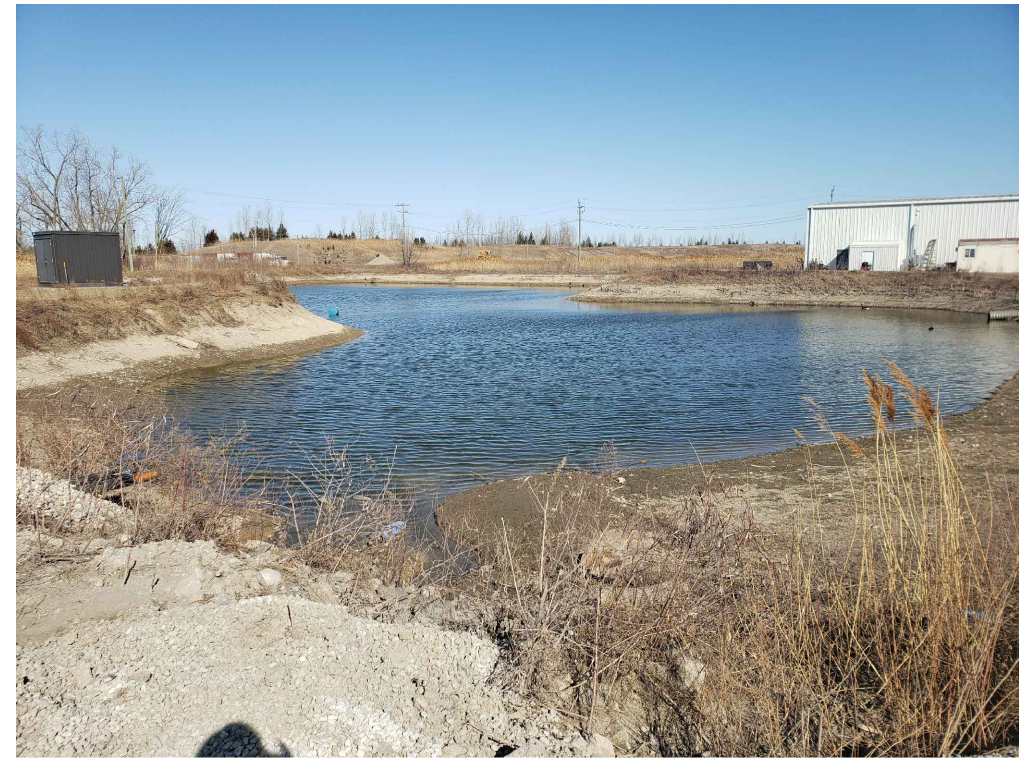
14 NORTH PROCESS POND
Fig 4A

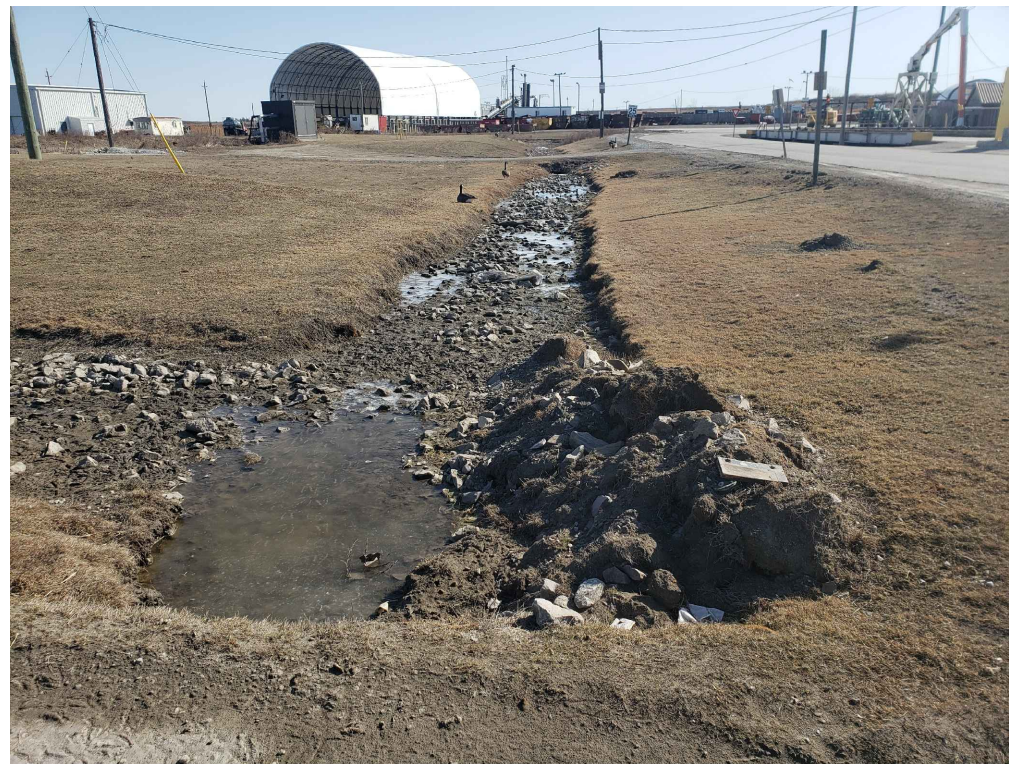
15 PROCESS DITCH
Fig 4A

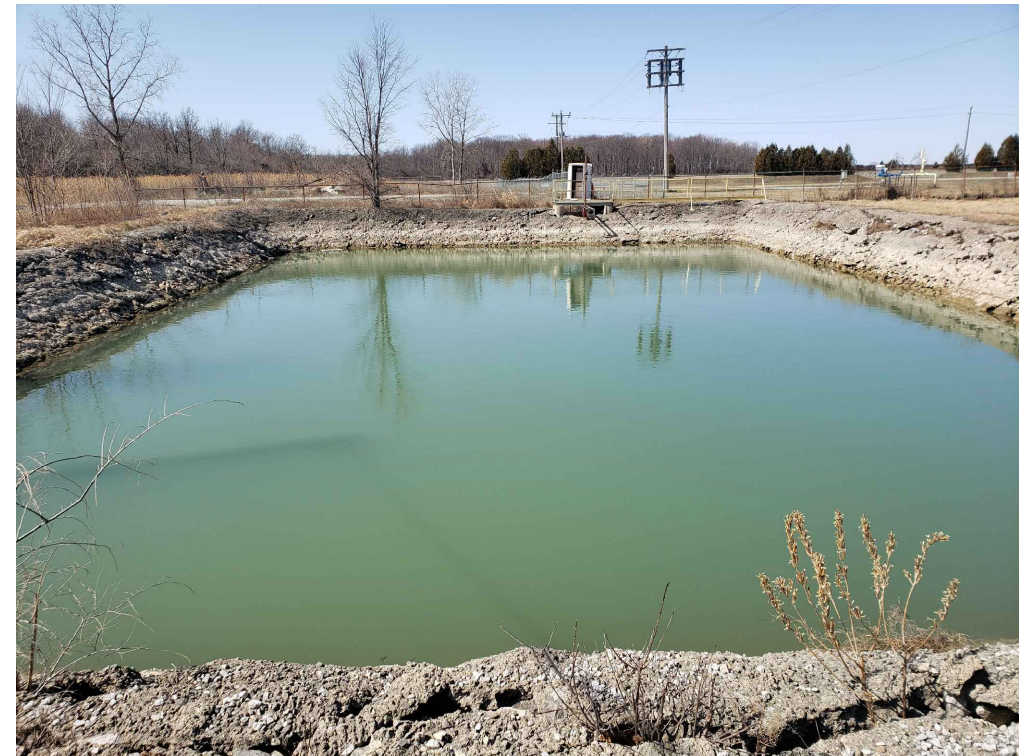
16 EQ POND
Fig 4A

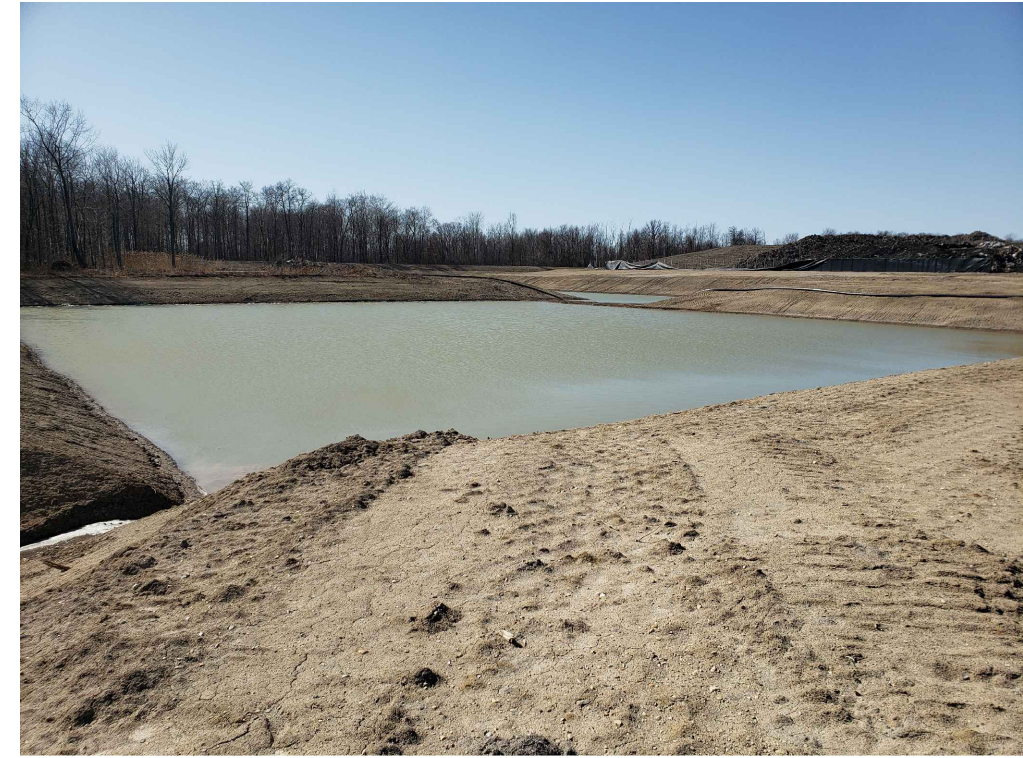
18 SURFACE WATER POND A
Fig 4A

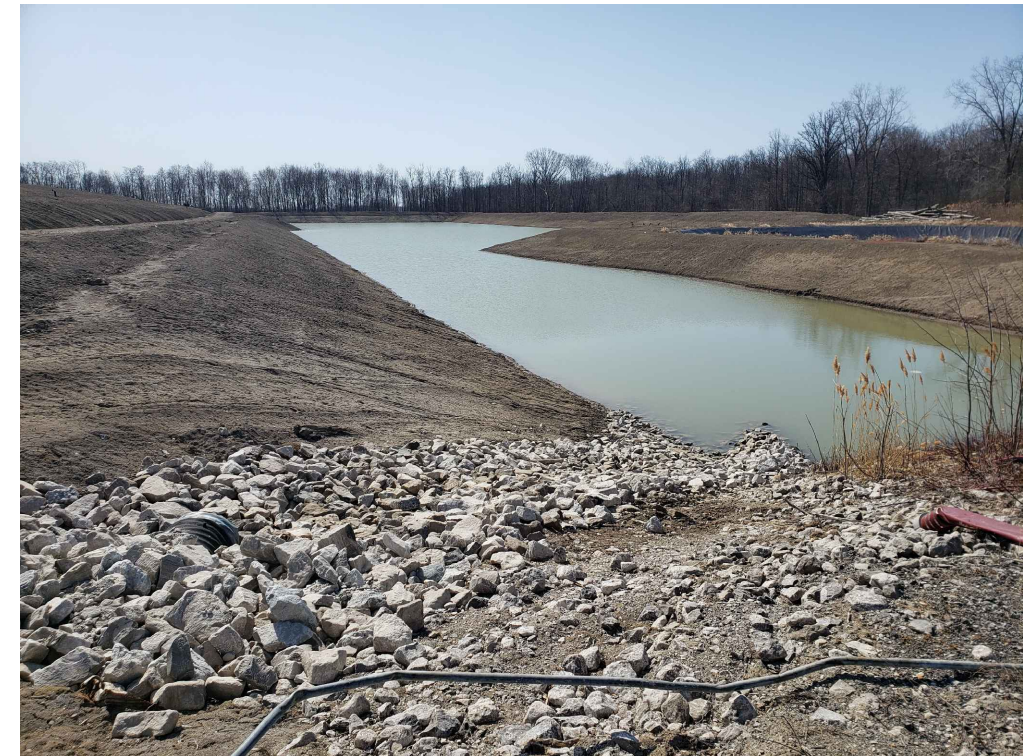
20 SURFACE WATER POND D
Fig 4A

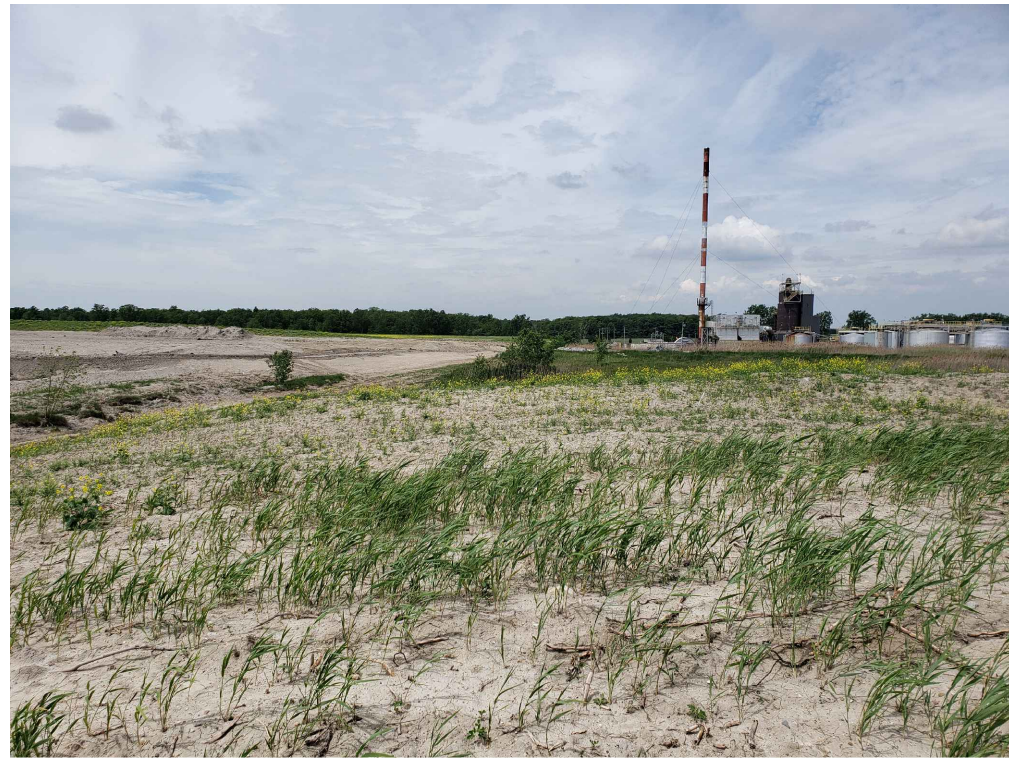
1 CELL 19-3A AND 19-3B
Fig 3A

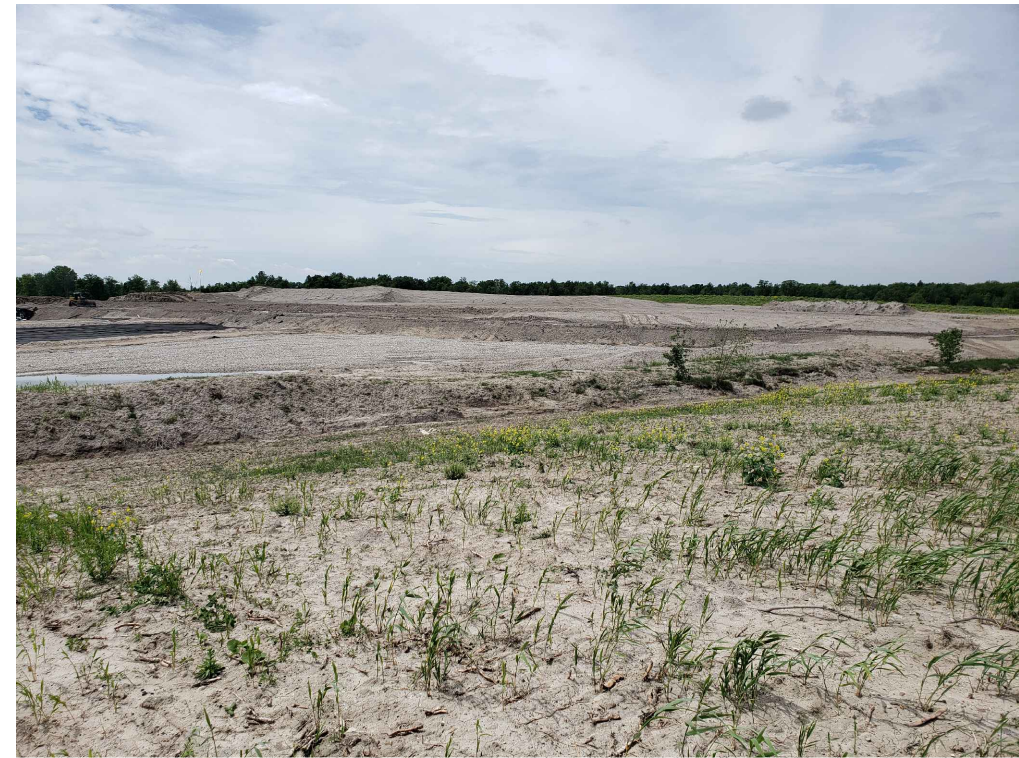
2 CELL 19-3B INTERIM COVER
Fig 3A

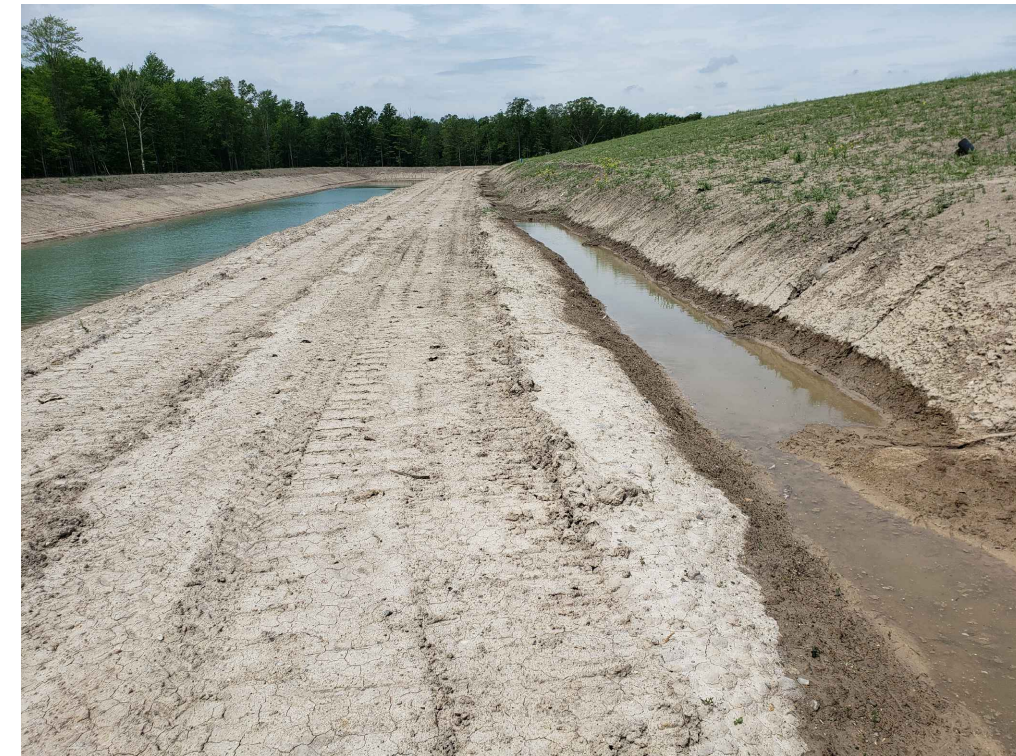
4 SOUTH ACCESS ROAD AND DITCH
Fig 3A

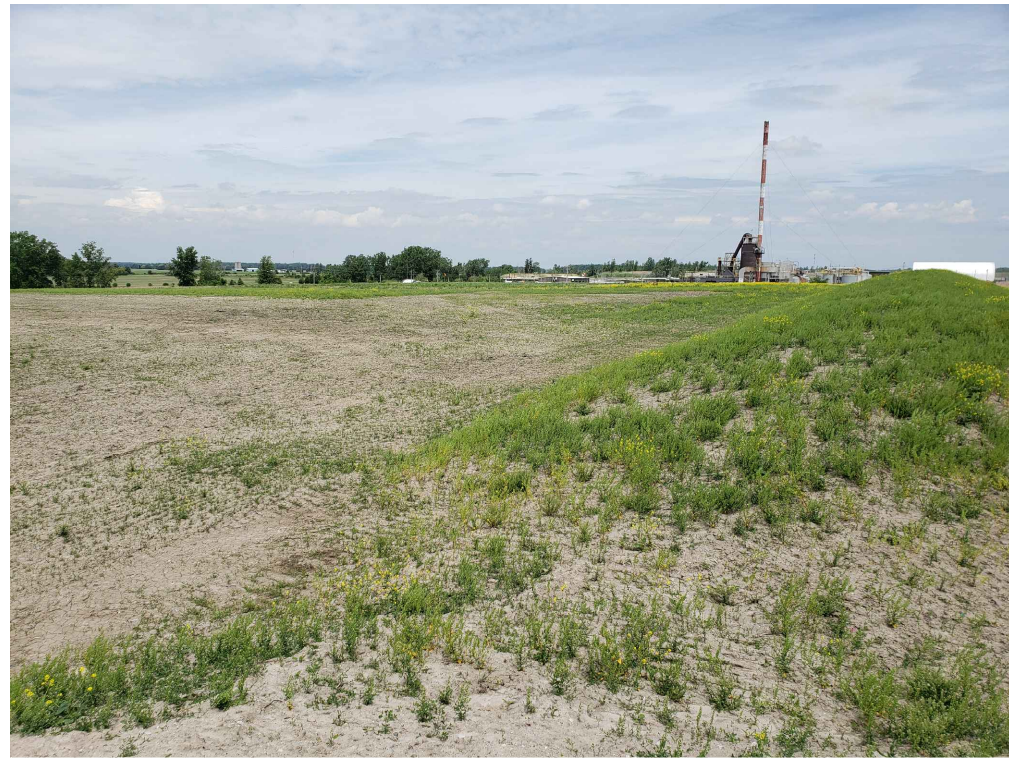
5 FINAL COVER - TOPSOIL PLACEMENT CELL 19-1
Fig 3A

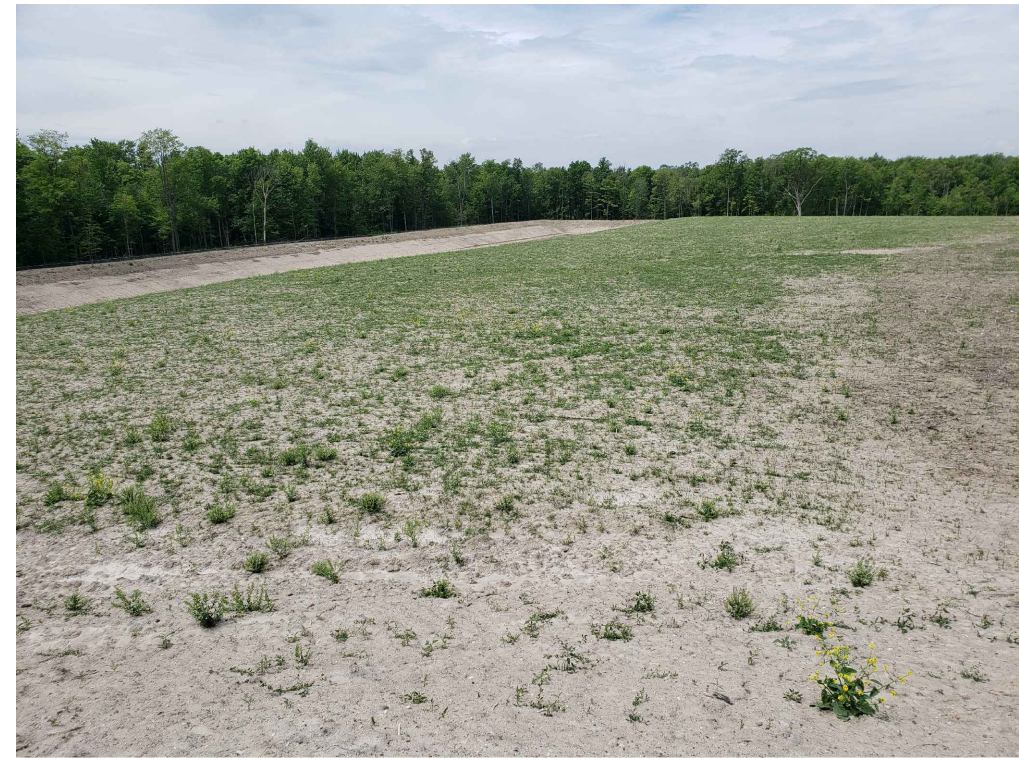
6 FINAL COVER - TOPSOIL PLACEMENT CELL 19-1
Fig 3A

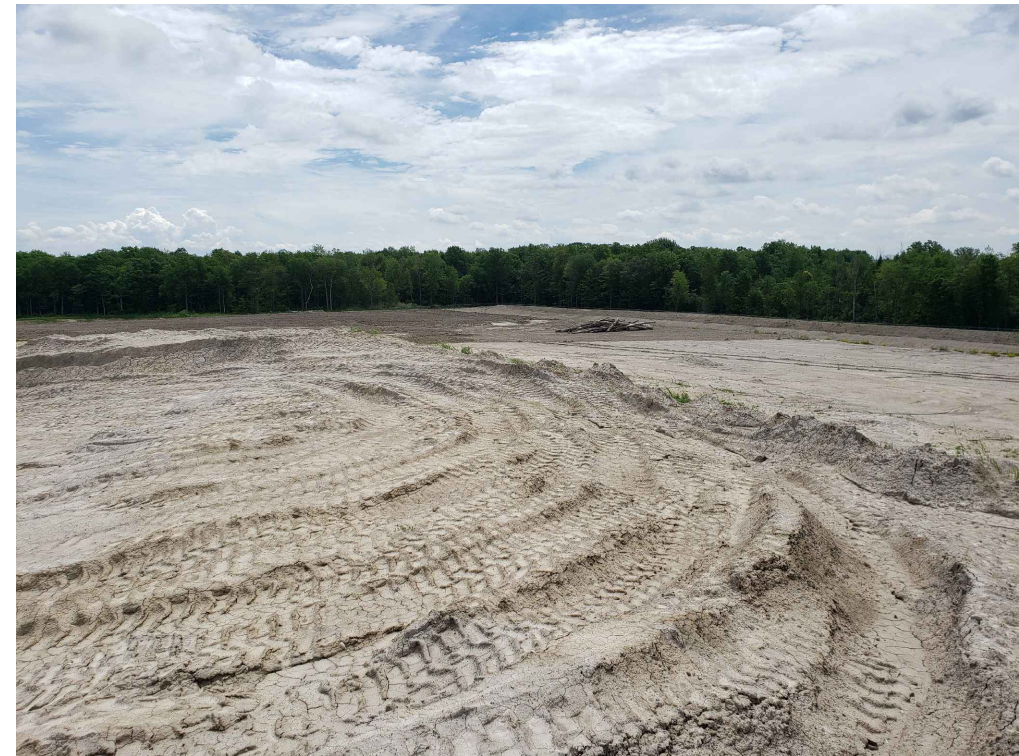
8 CELL 19-2 CLAY STOCKPILE AND INTERIM COVER
Fig 3A

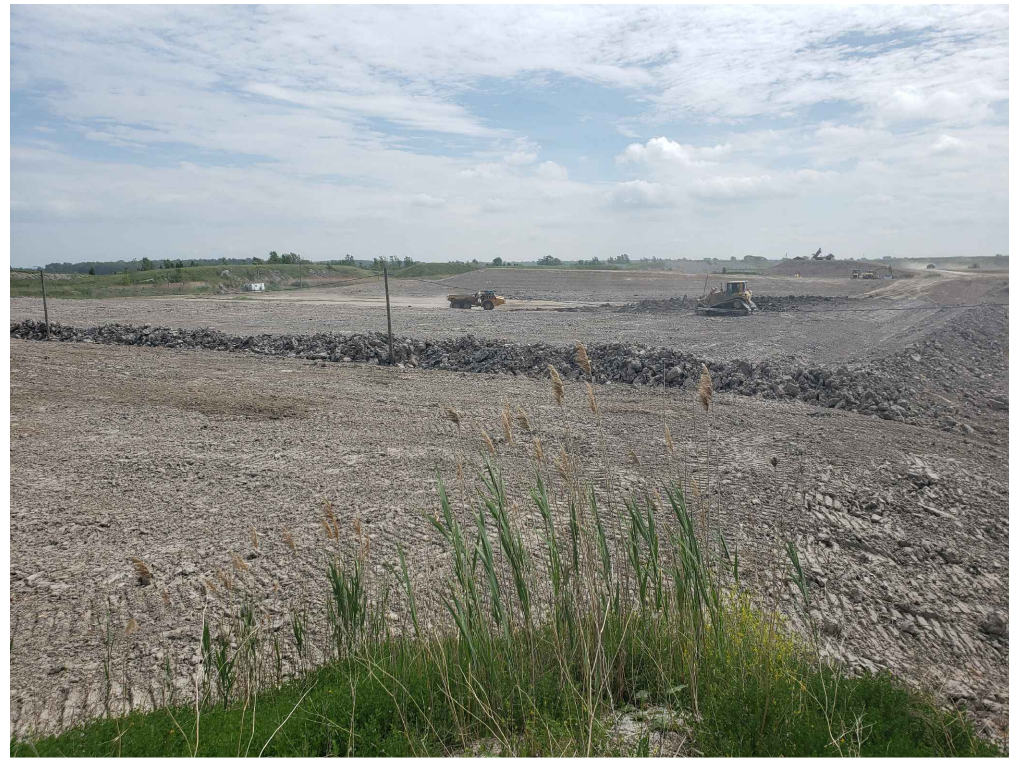
9 NORTH AREA STOCKPILING
Fig 4A

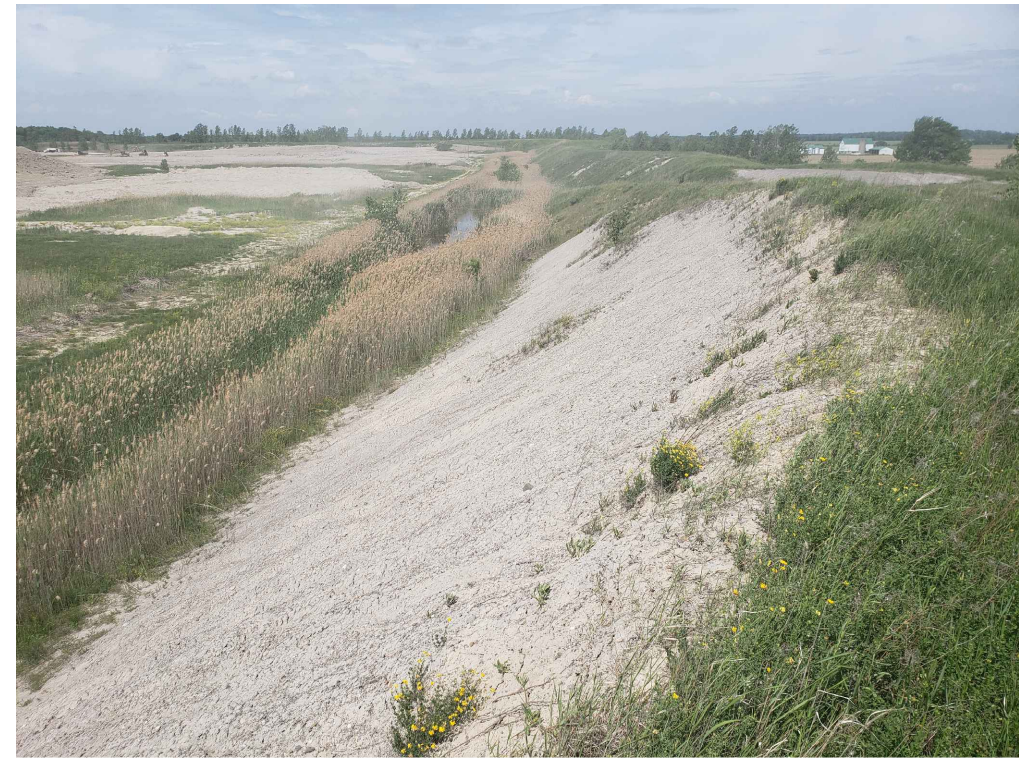
10 EROSION CHANNELS ALONG NORTH PERIMETER BERM
Fig 4A

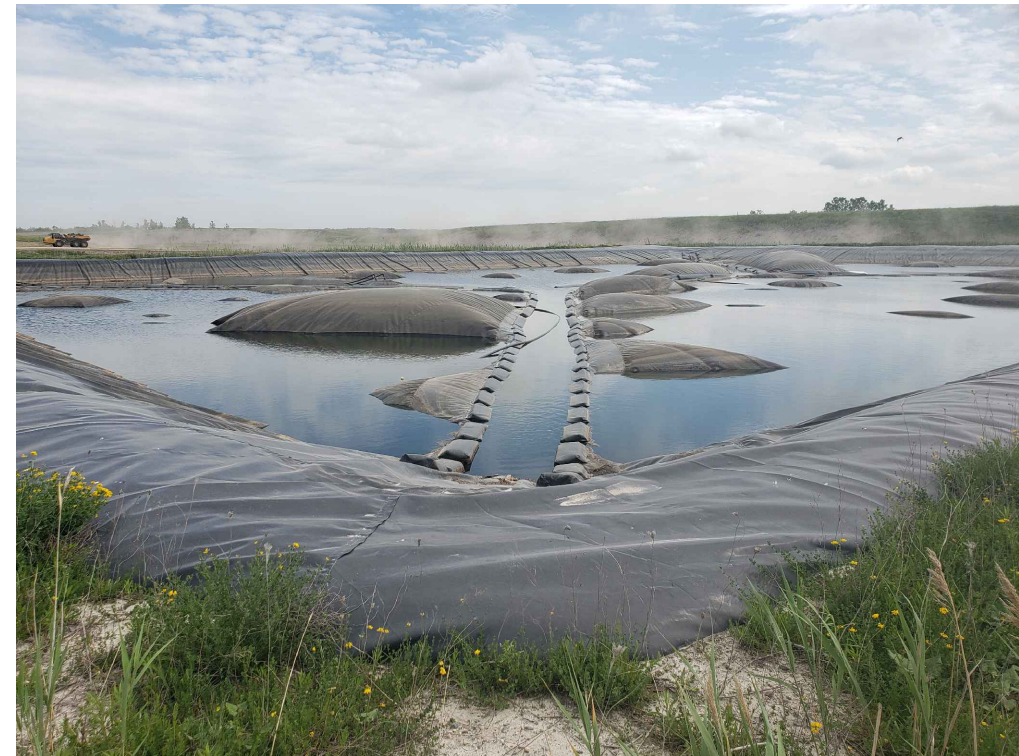
12 PONDED WATER ON EAST LEACHATE POND COVER
Fig 4A

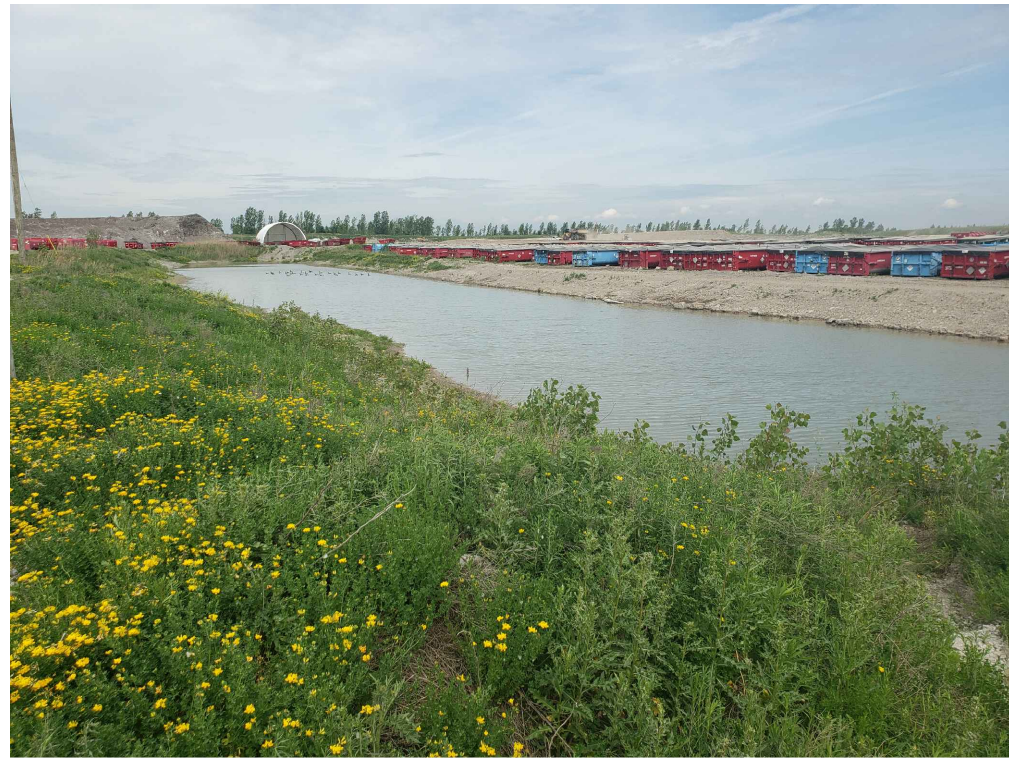
13 EAST PROCESS POND
Fig 4A

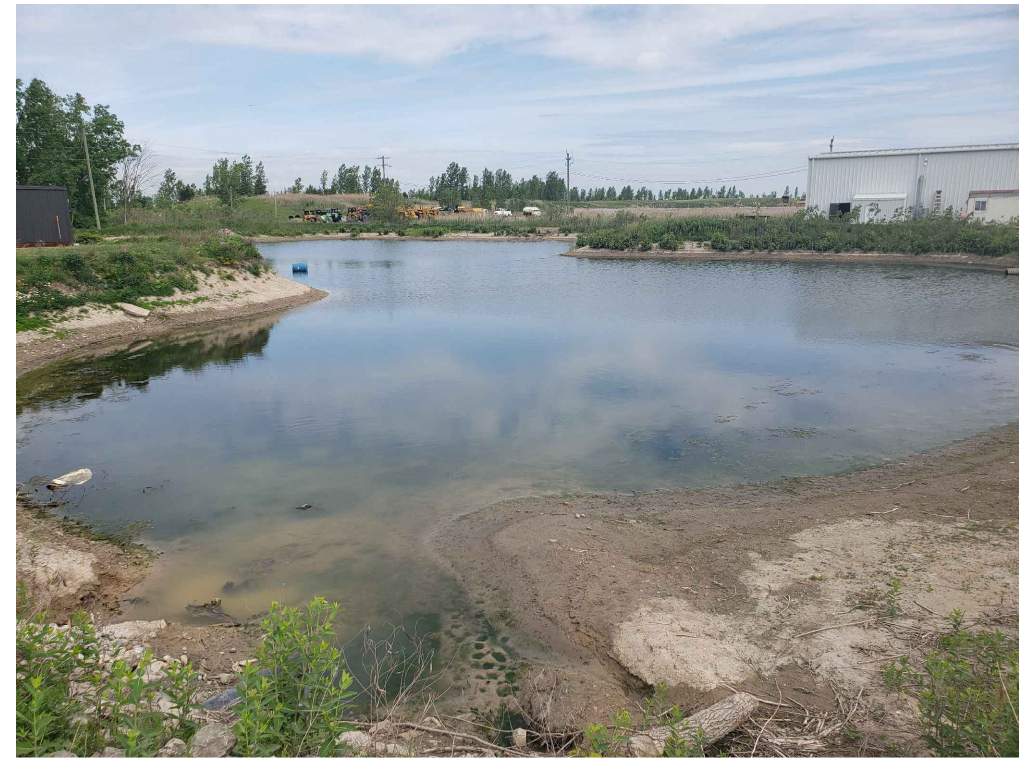
14 NORTH PROCESS POND
Fig 4A

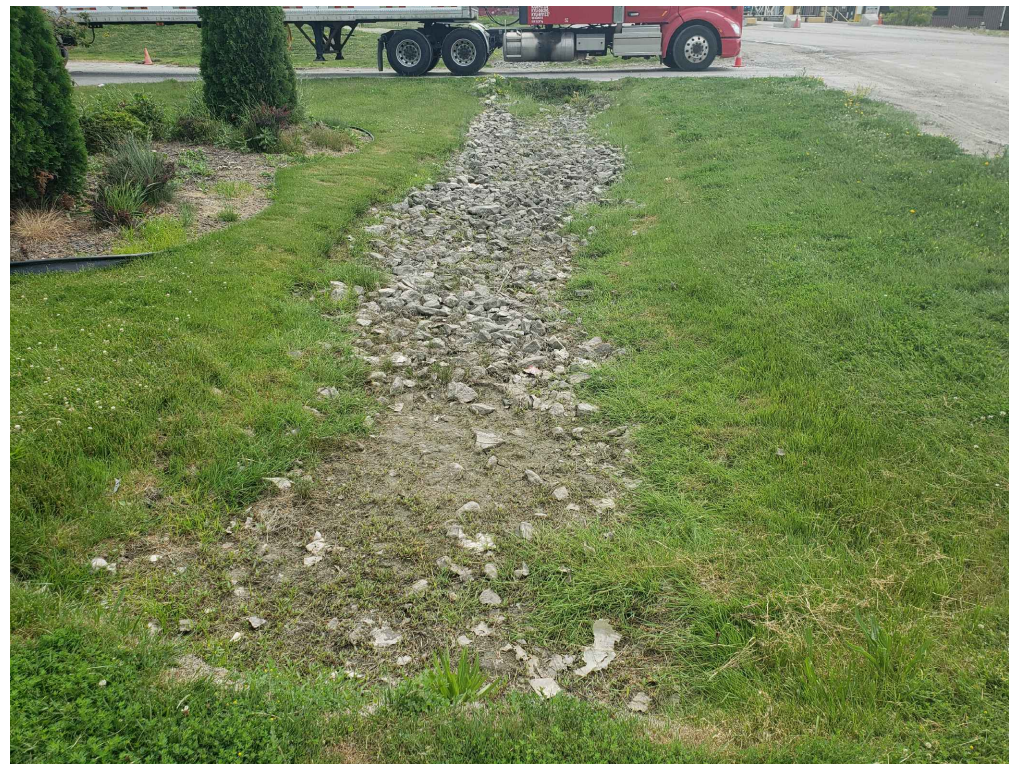
15 PROCESS DITCH
Fig 4A

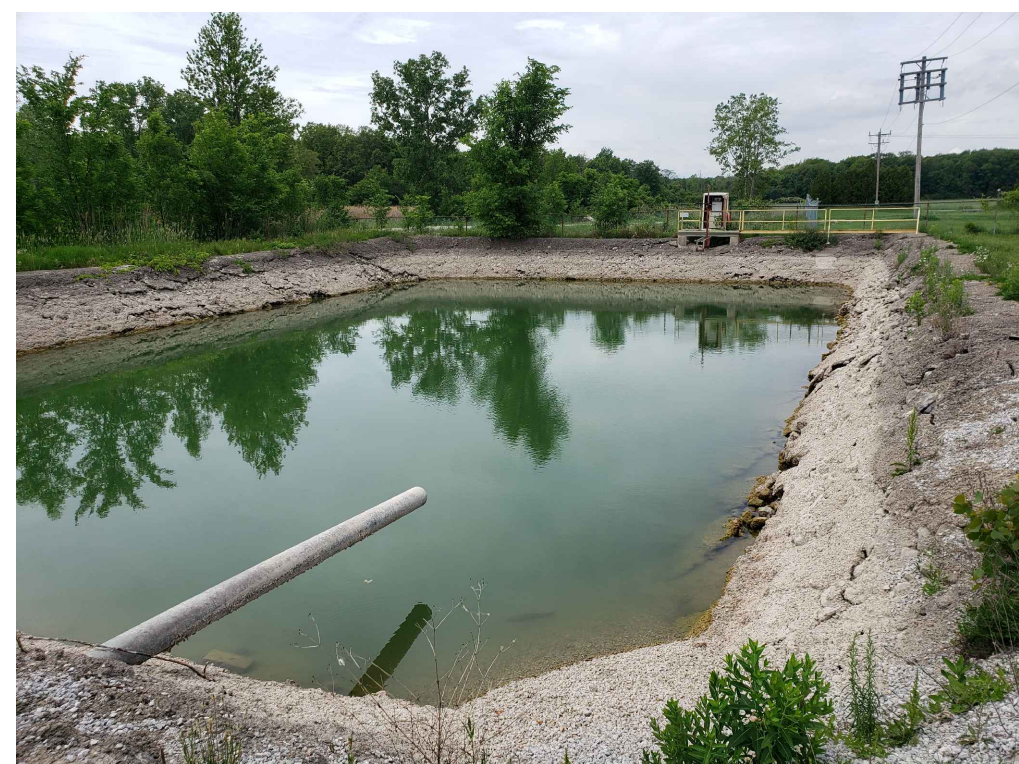
16 EQ POND
Fig 4A

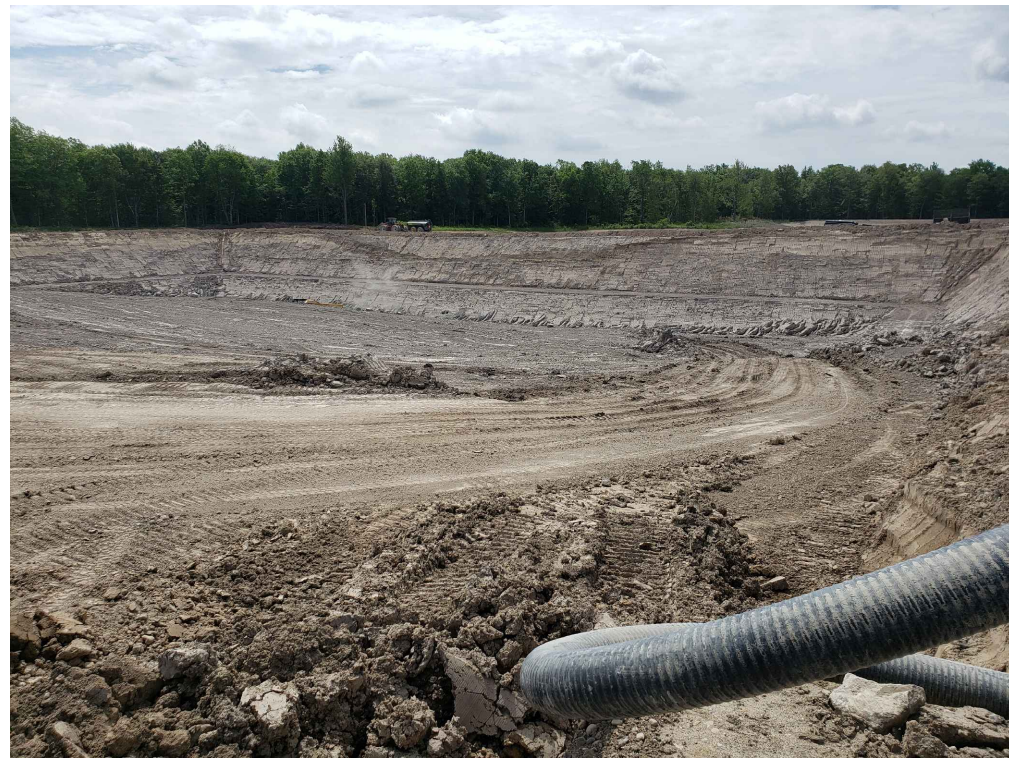
17
Fig 4A **FORMER EAST SURFACE WATER POND - CELL 20-1 EXCAVATION**

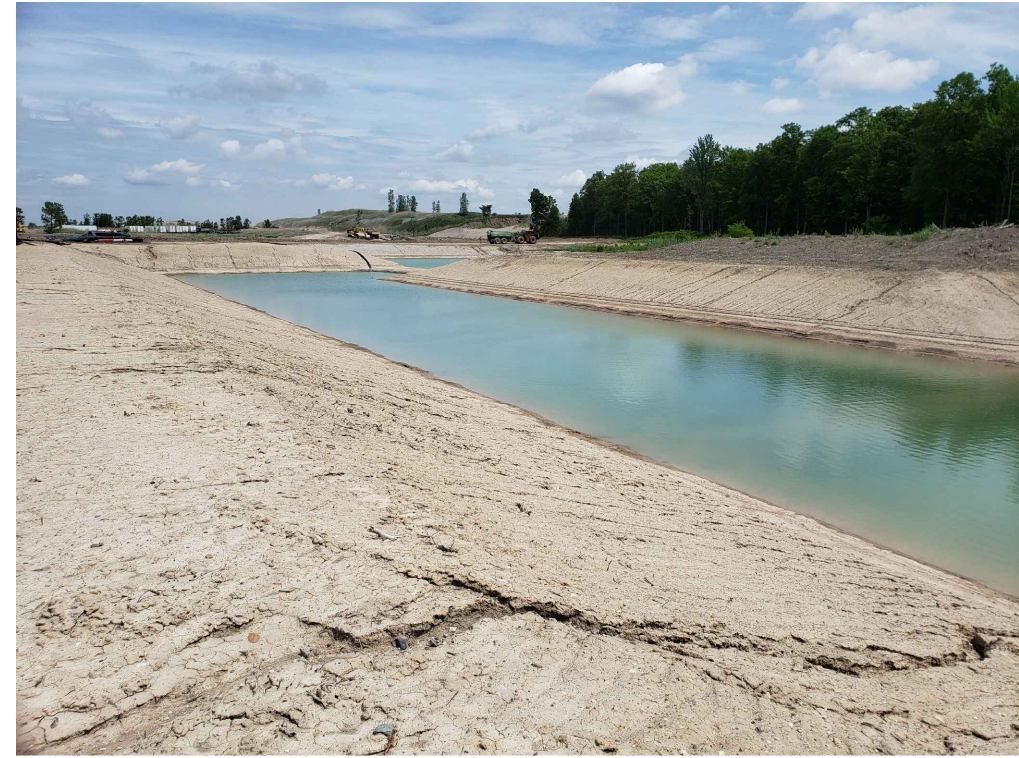
18
Fig 4A **SURFACE WATER POND A**

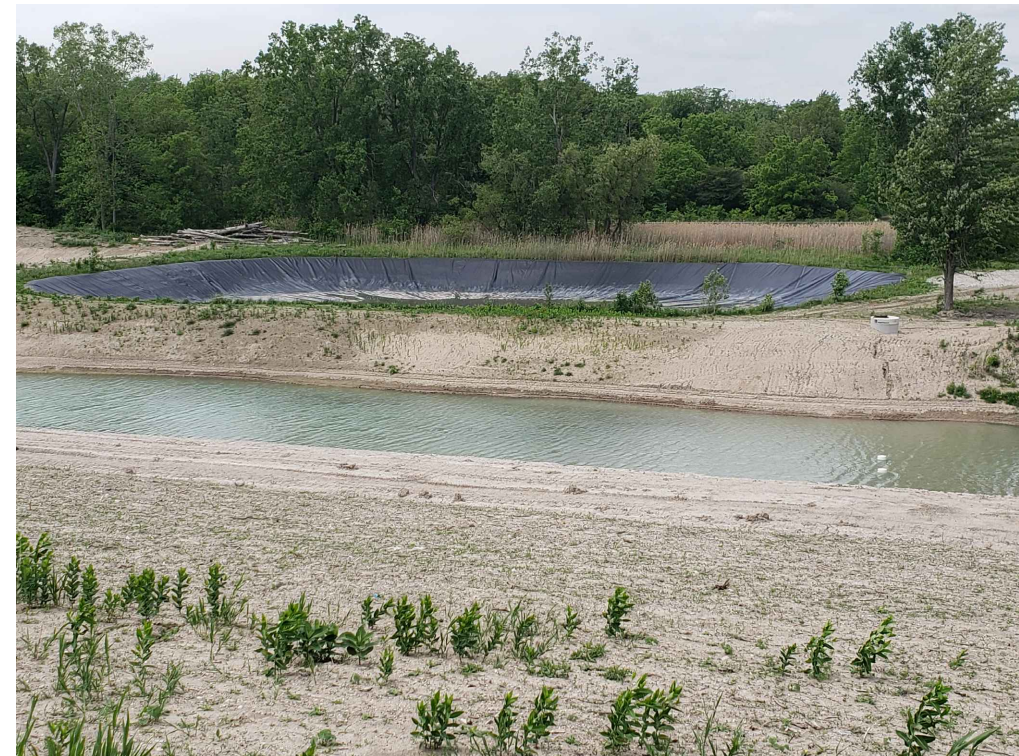
20
Fig 4A **SURFACE WATER POND D**
