2021 Quarterly Site Inspections

Clean Harbors Lambton Facility

Clean Harbors Canada Inc.

February 22, 2022

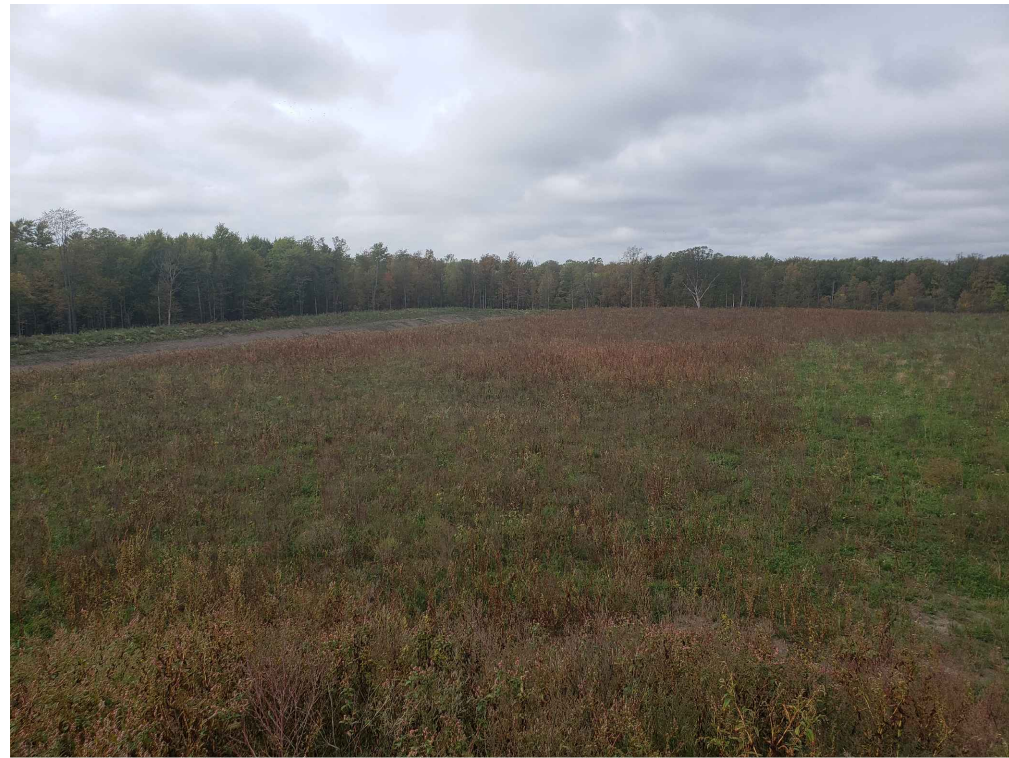
5 FINAL COVER - TOPSOIL PLACEMENT CELL 19-1
Fig 3A

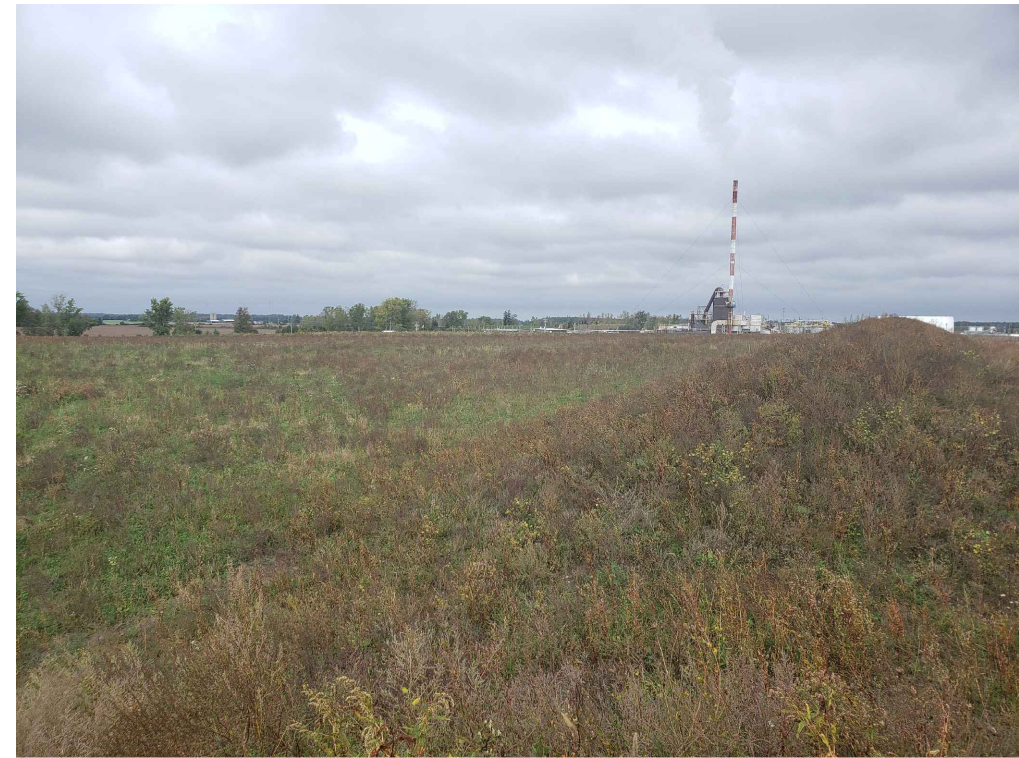
6 FINAL COVER - TOPSOIL PLACEMENT CELL 19-1
Fig 3A

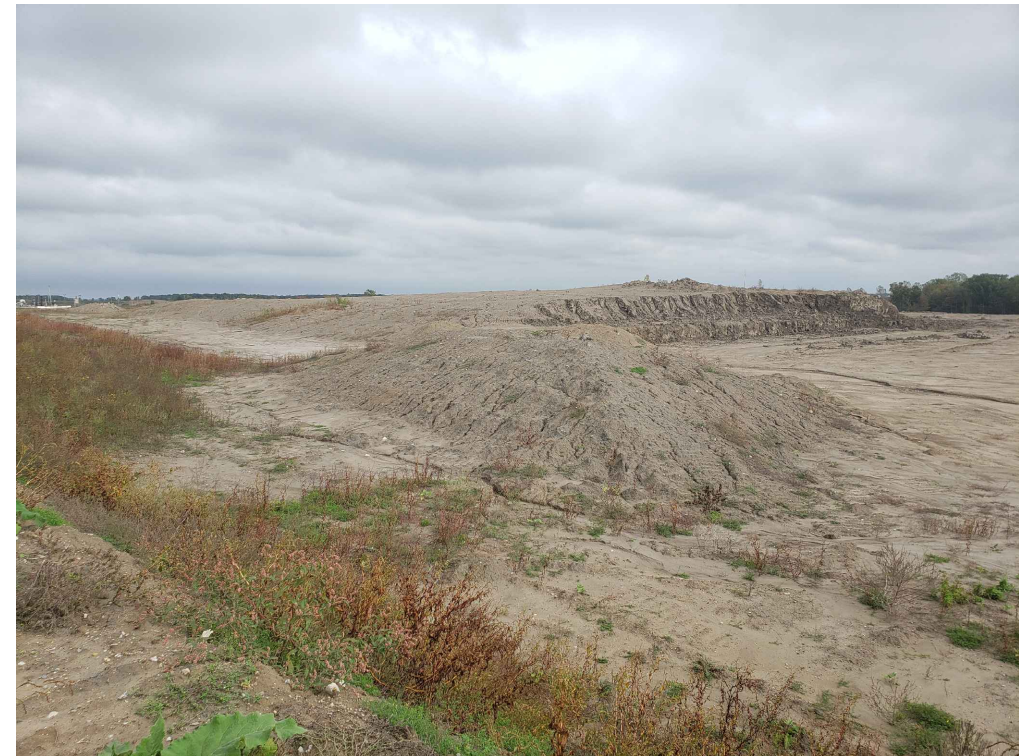
8 CELL 19-2 CLAY STOCKPILE AND INTERIM COVER
Fig 3A

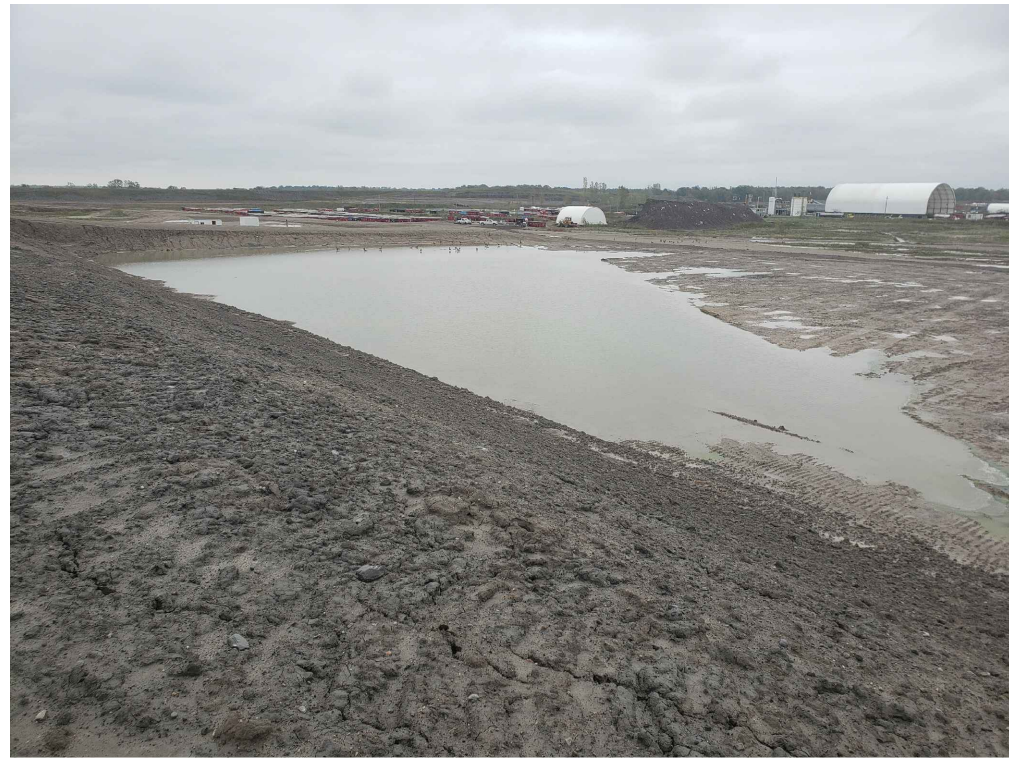
9 NORTH STOCKPILING AREA
Fig 4A

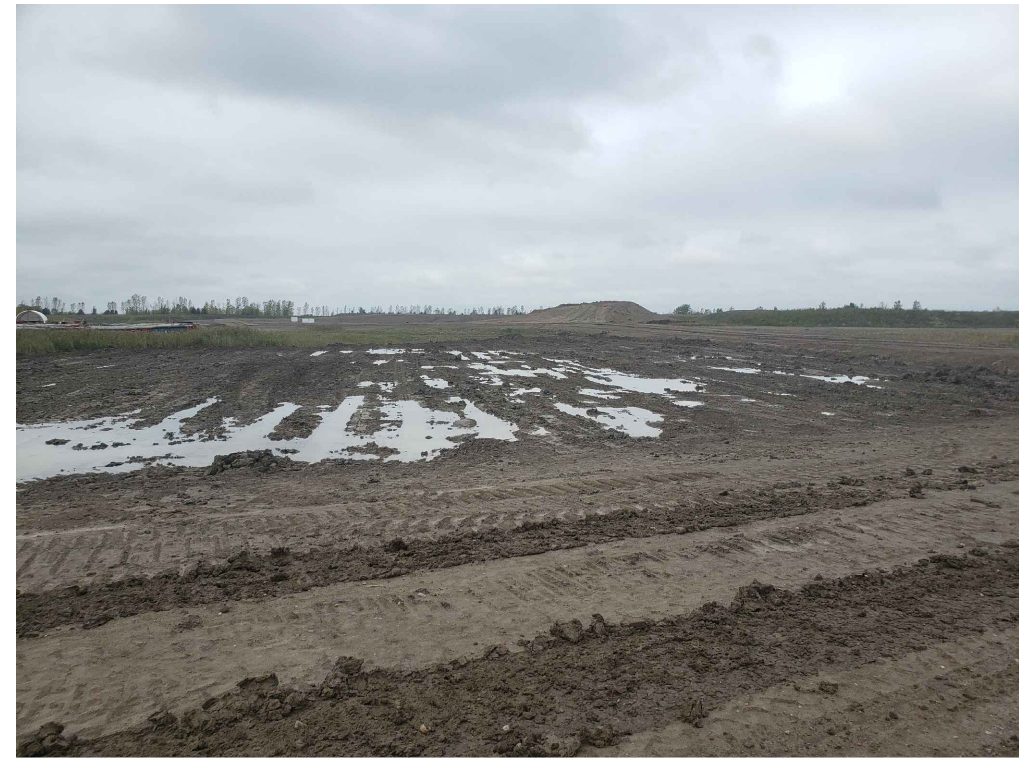
10 NORTHEAST CORNER OF THE SITE LOOKING WEST
Fig 4A

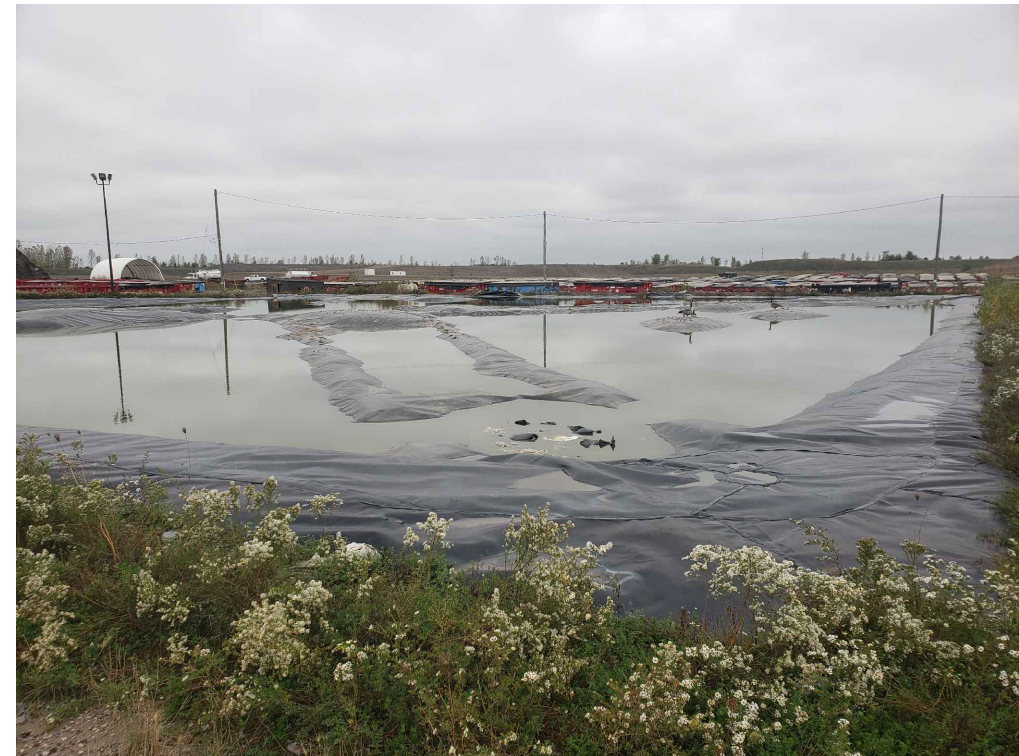
12 PONDED WATER ON WEST LEACHATE POND COVER
Fig 4A

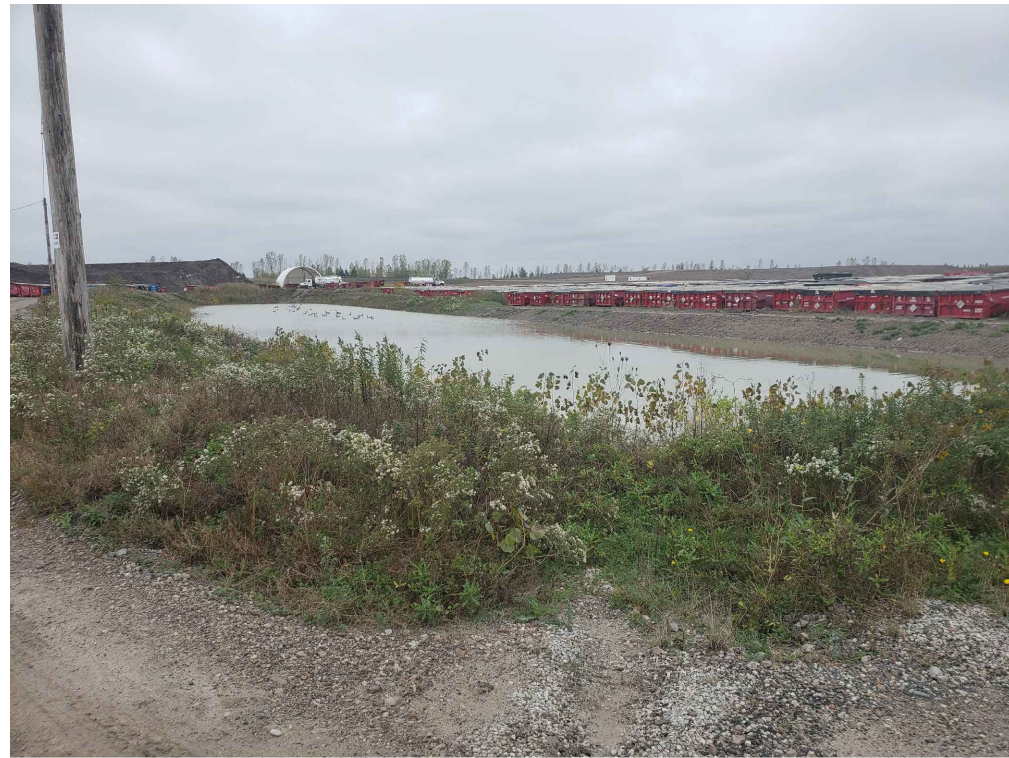
13 EAST PROCESS POND
Fig 4A

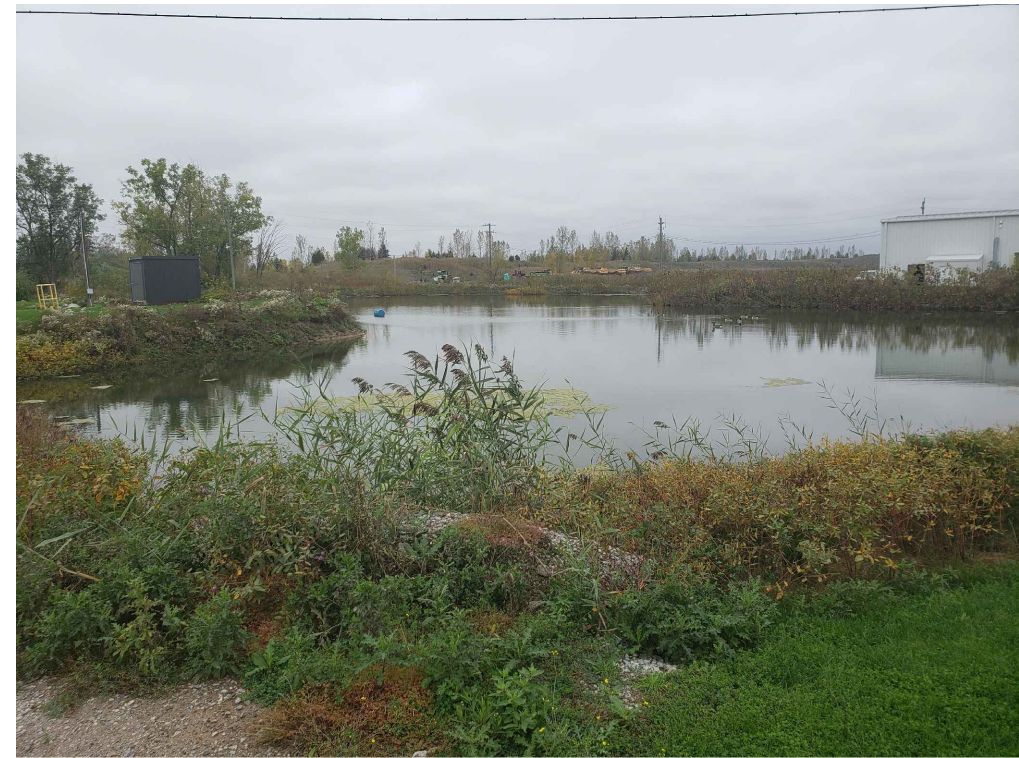
14 NORTH PROCESS POND
Fig 4A

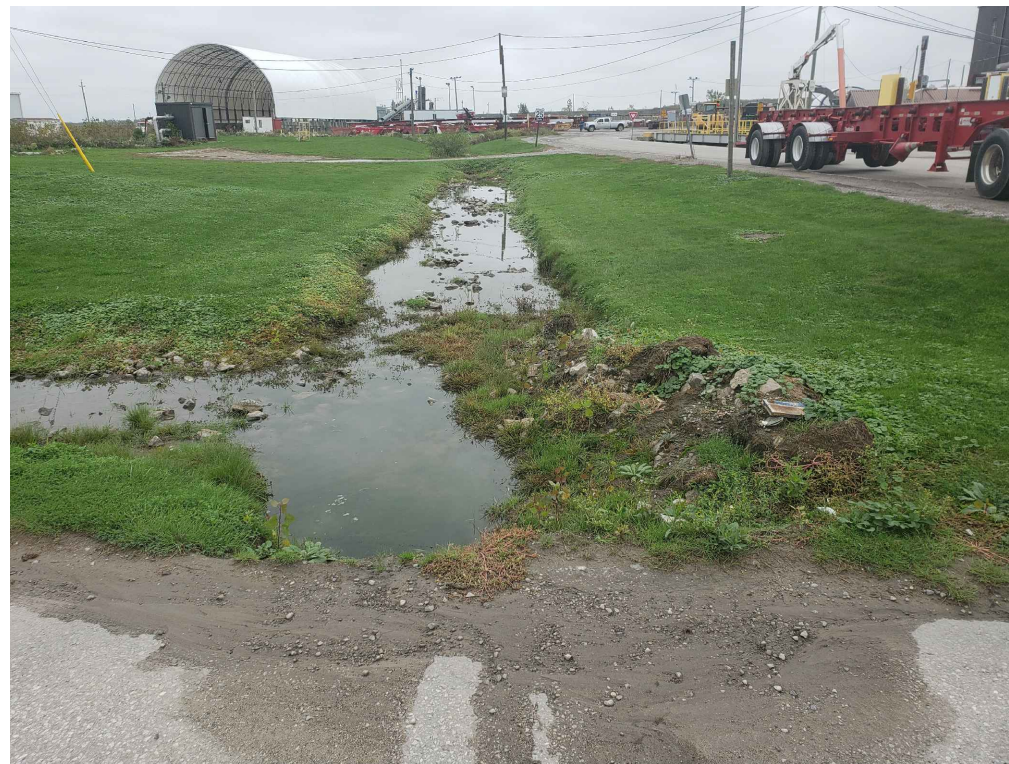
15 PROCESS DITCH
Fig 4A

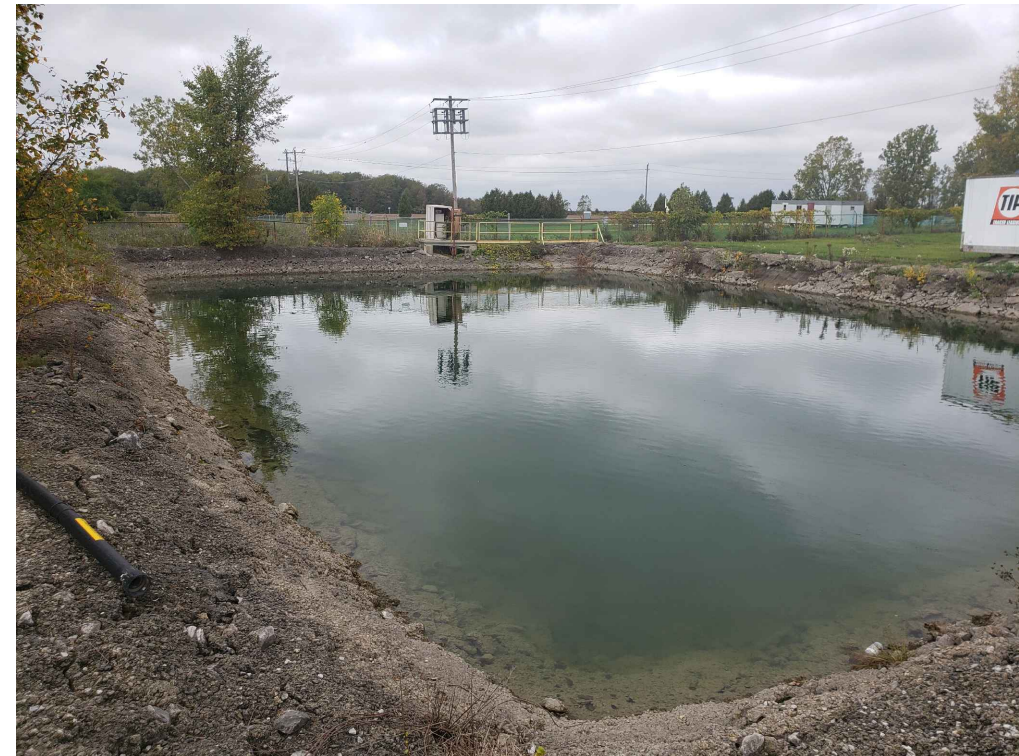
16 EQ POND
Fig 4A

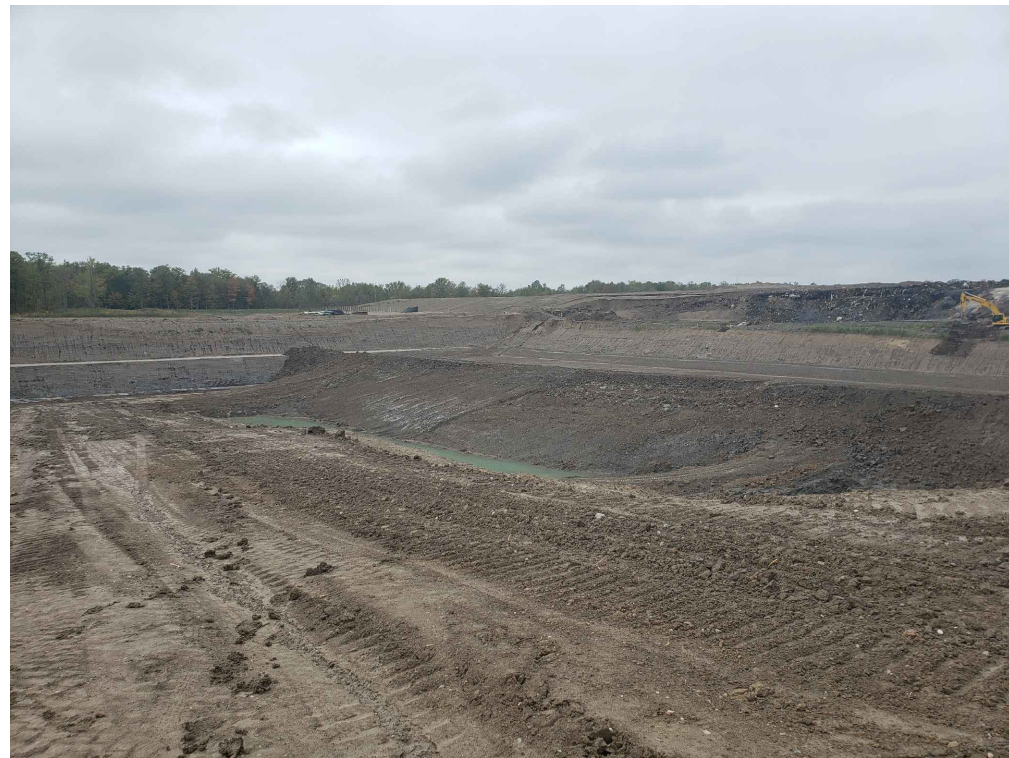
17
Fig 4A **FORMER EAST SURFACE WATER POND - CELL 20-1 EXCAVATION**

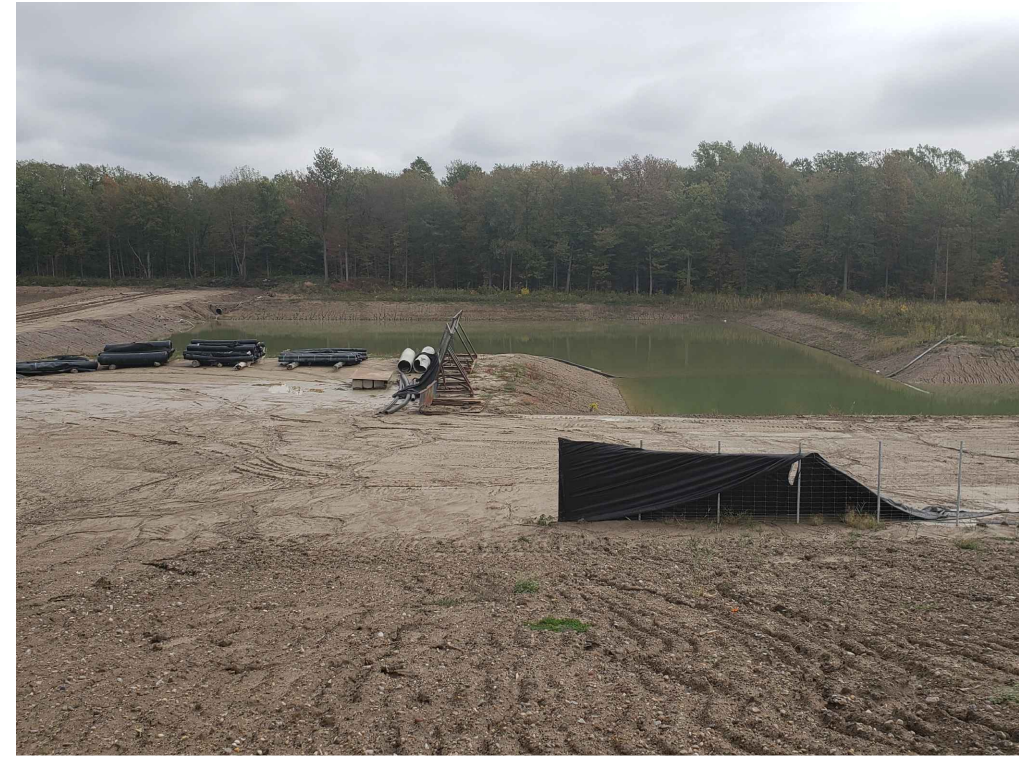
18
Fig 4A **SURFACE WATER POND A**

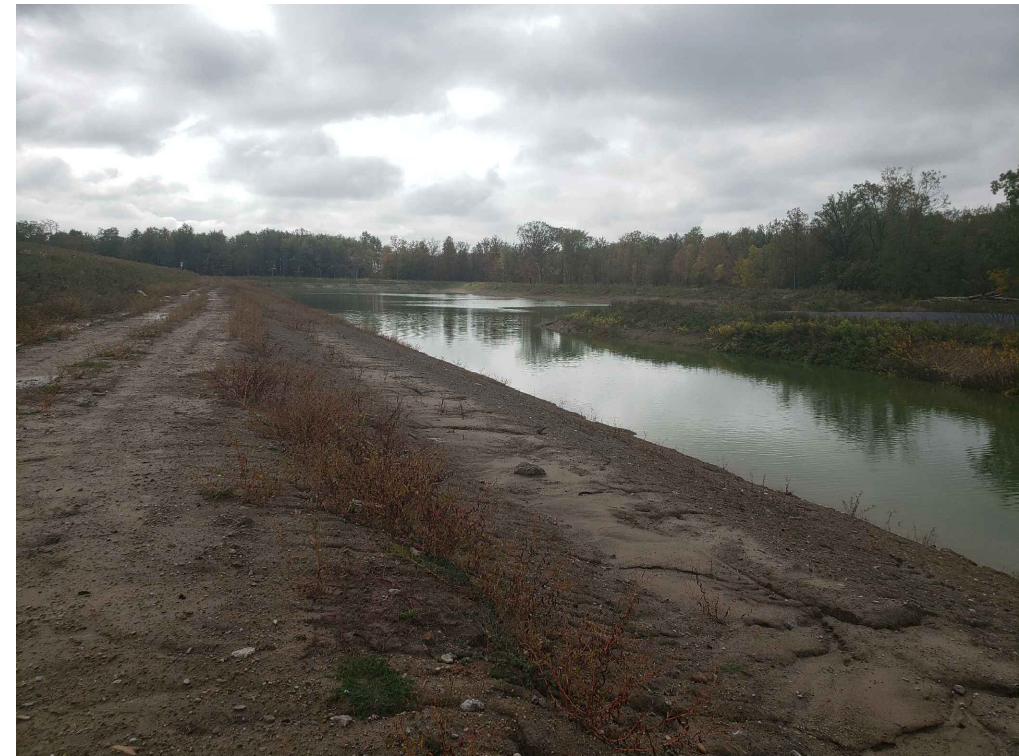
20
Fig 4A **SURFACE WATER POND D**

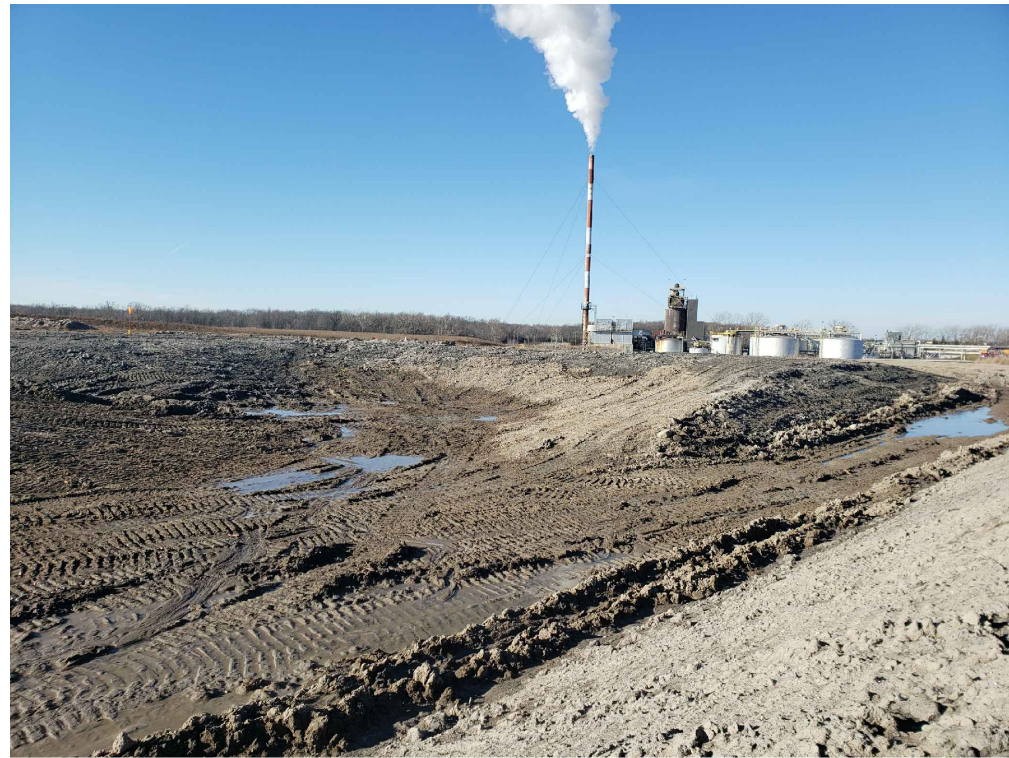
1 CELL 19-3B AND 19-1
Fig 3A

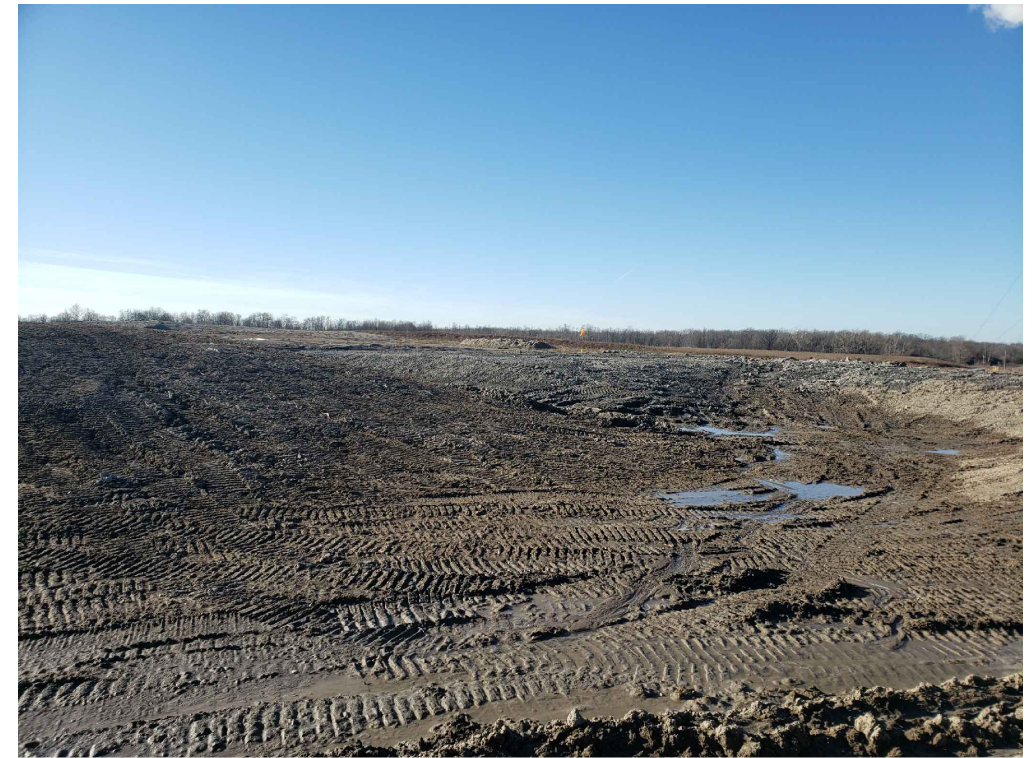
2 CELL 19-3B AND 19-3A INTERIM COVER
Fig 3A

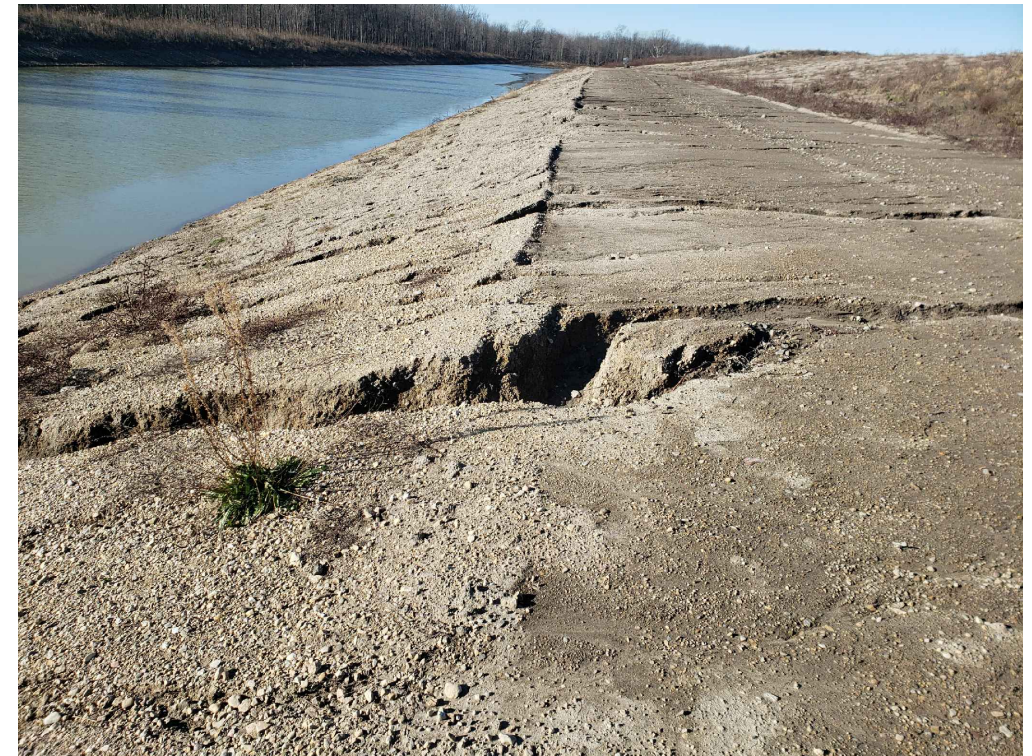
4 SOUTH ACCESS ROAD EROSION CHANNEL
Fig 3A

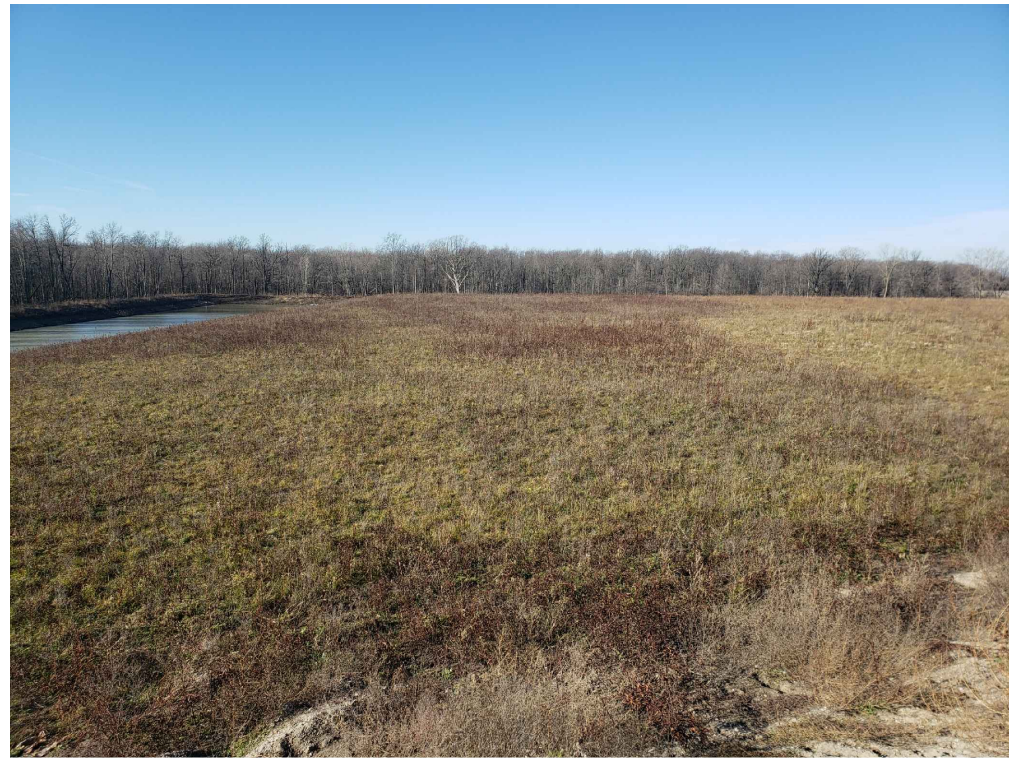
5 FINAL COVER - TOPSOIL PLACEMENT CELL 19-1
Fig 3A

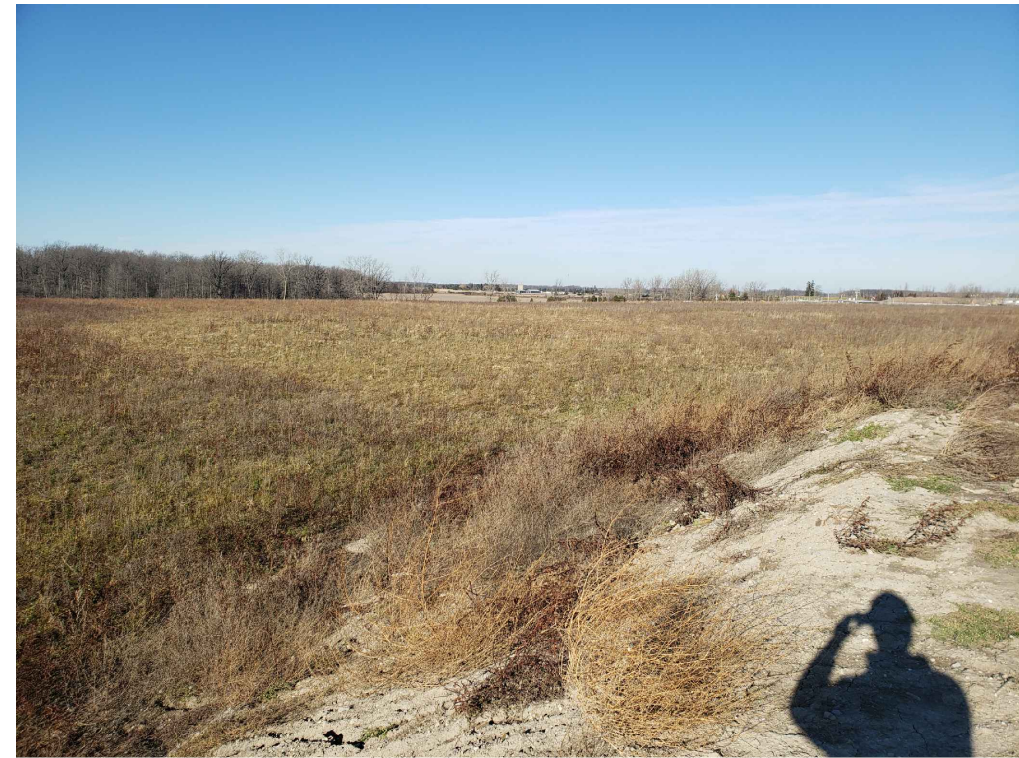
6 FINAL COVER - TOPSOIL PLACEMENT CELL 19-1
Fig 3A

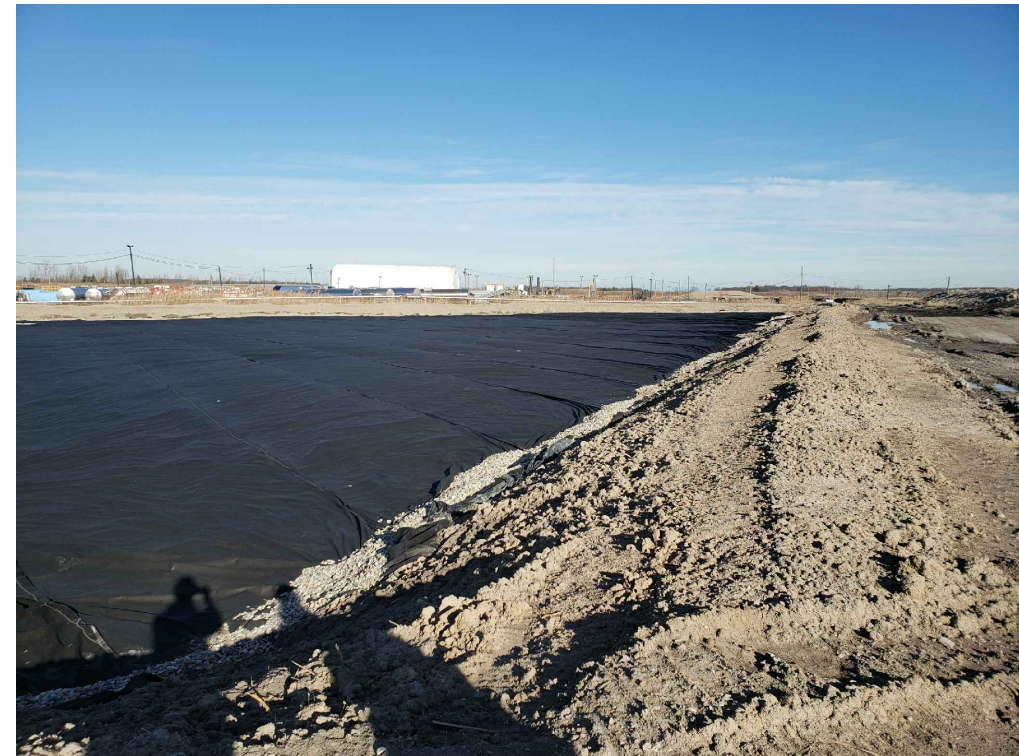
8 CELL 19-4
Fig 3A

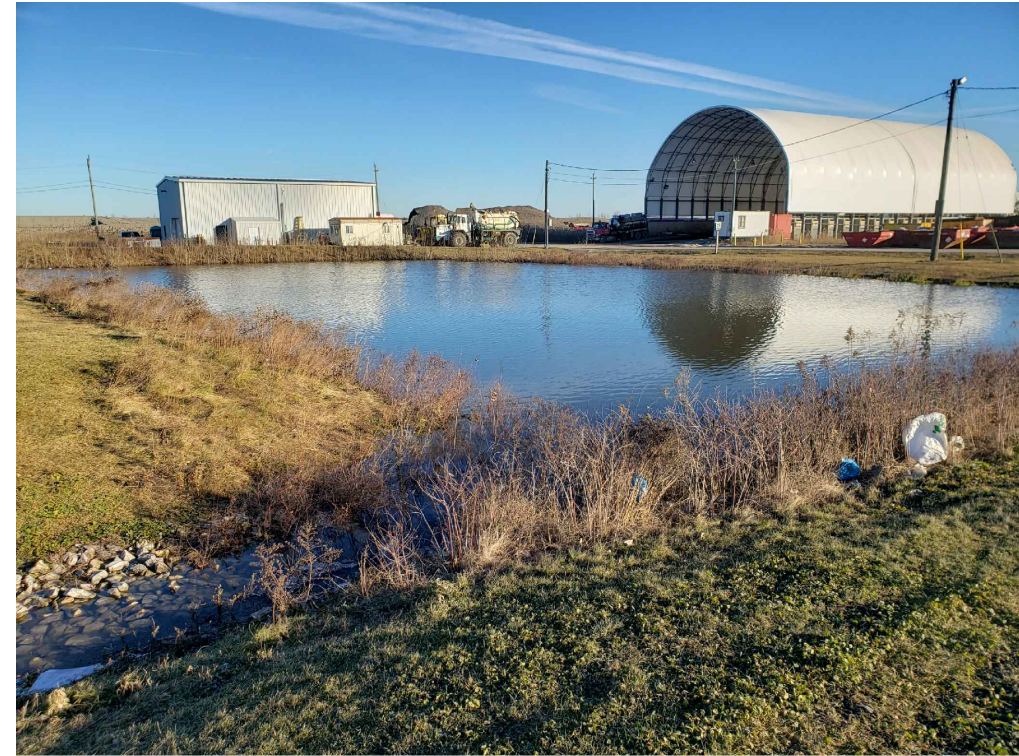
14 NORTH PROCESS POND
Fig 4A

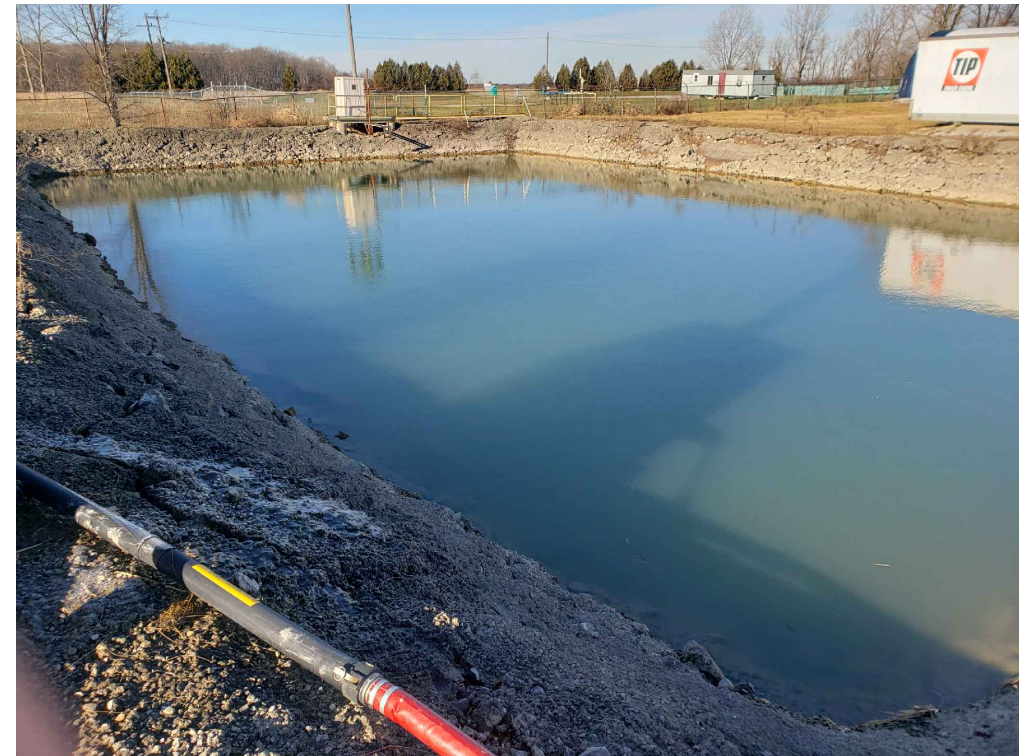
16 EQ POND
Fig 4A

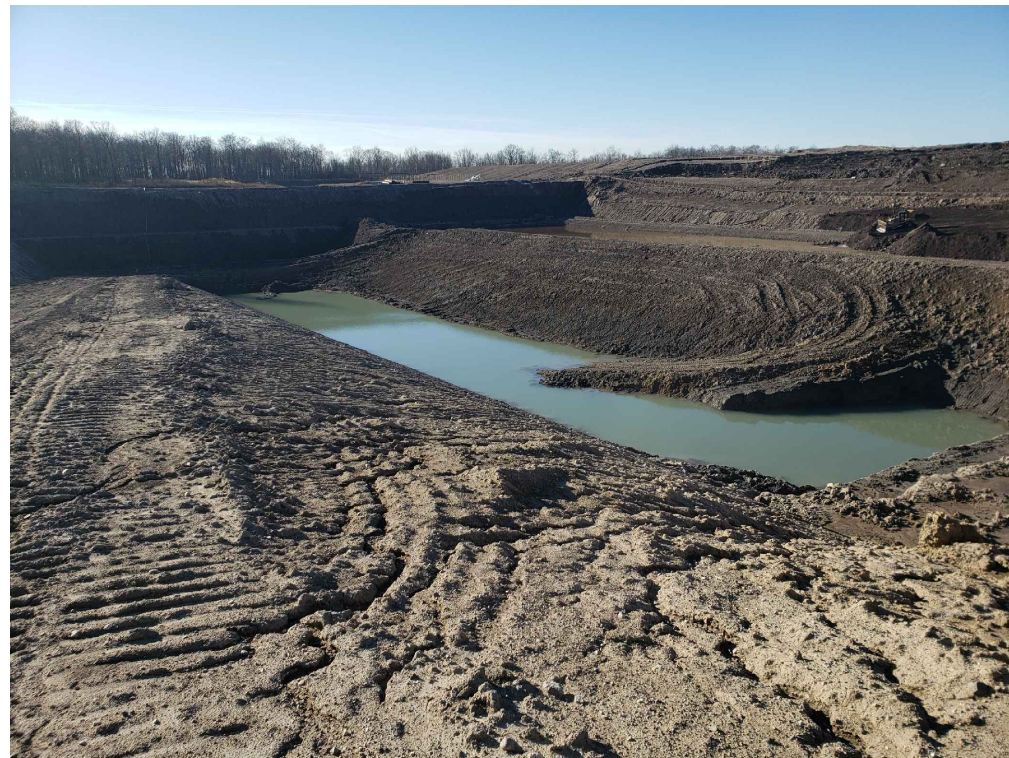
17 FORMER EAST SURFACE WATER POND - CELL 20-1 EXCAVATION
Fig 4A

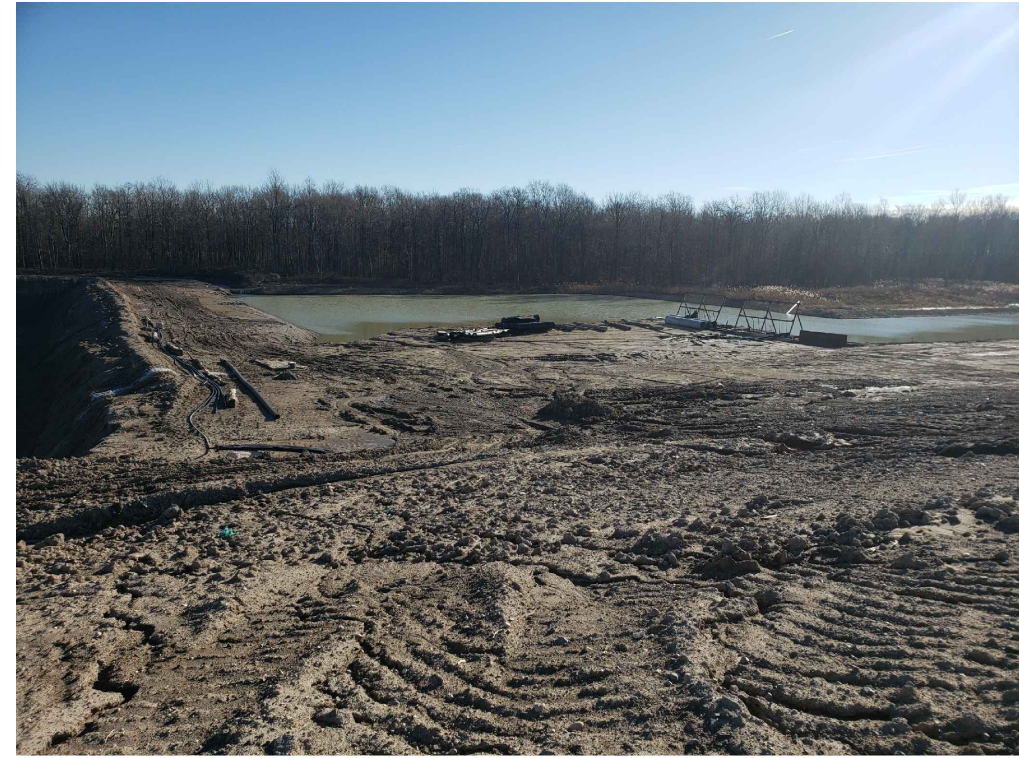
18 SURFACE WATER POND A
Fig 4A

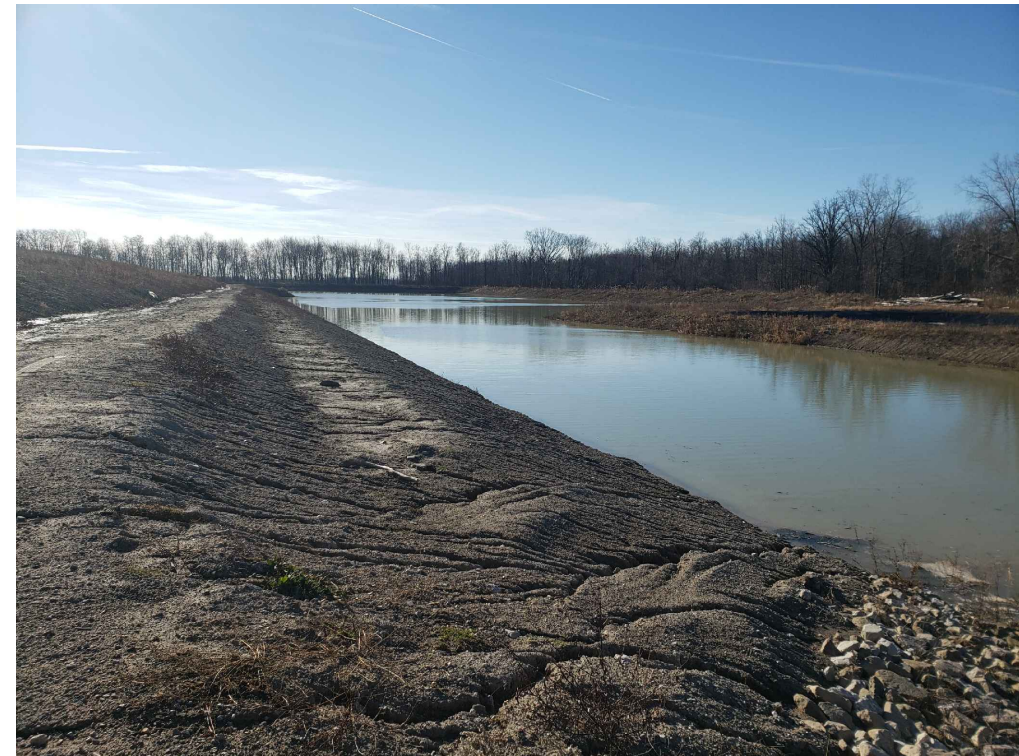
20 SURFACE WATER POND D
Fig 4A
