Clean Harbors Canada, Inc.
Lambton Facility
4090 Telfer Road R.R. #1
Corunna, ON
N0N 1G0

2021 Annual Landfill Report

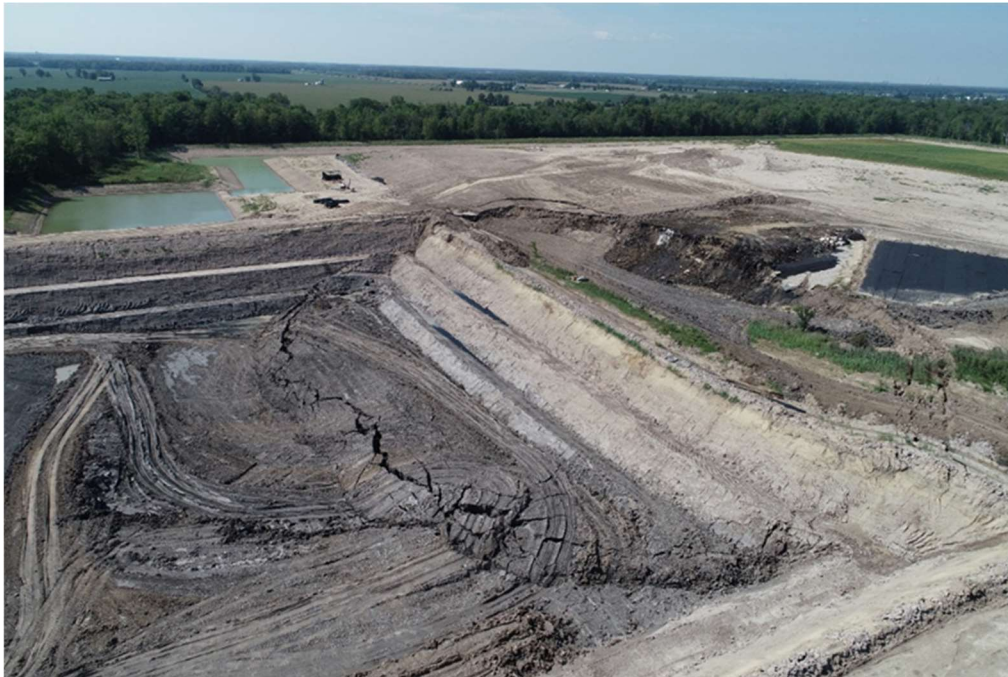
On August 18 2021, during the construction of Cell 20-1, deep surface cracks were noted in the clay material on the upper interior side slope (slope along the Pre-1986/Cell 19-3 area) by on-site contractor staff.

Within a two-hour period, the interior side slope rotated approximately 7-meters. The rotation consisted of approximately a 7-meter drop on the upper portion and a 7-meter rise in part of the base. The rotation event impacted Cell 20-1 and a small portion on the eastern side of the active landfill area of Cell 19-3. All staff had vacated the area

prior to the rotation event and no waste or leachate was discharged to the natural environment.
