Clean Harbors Canada, Inc.  
Lambton Facility  
4090 Telfer Road, R.R. #1  
Corunna, Ontario  
N0N 1G0

# **2016 Annual Landfill Report**

## Executive Summary

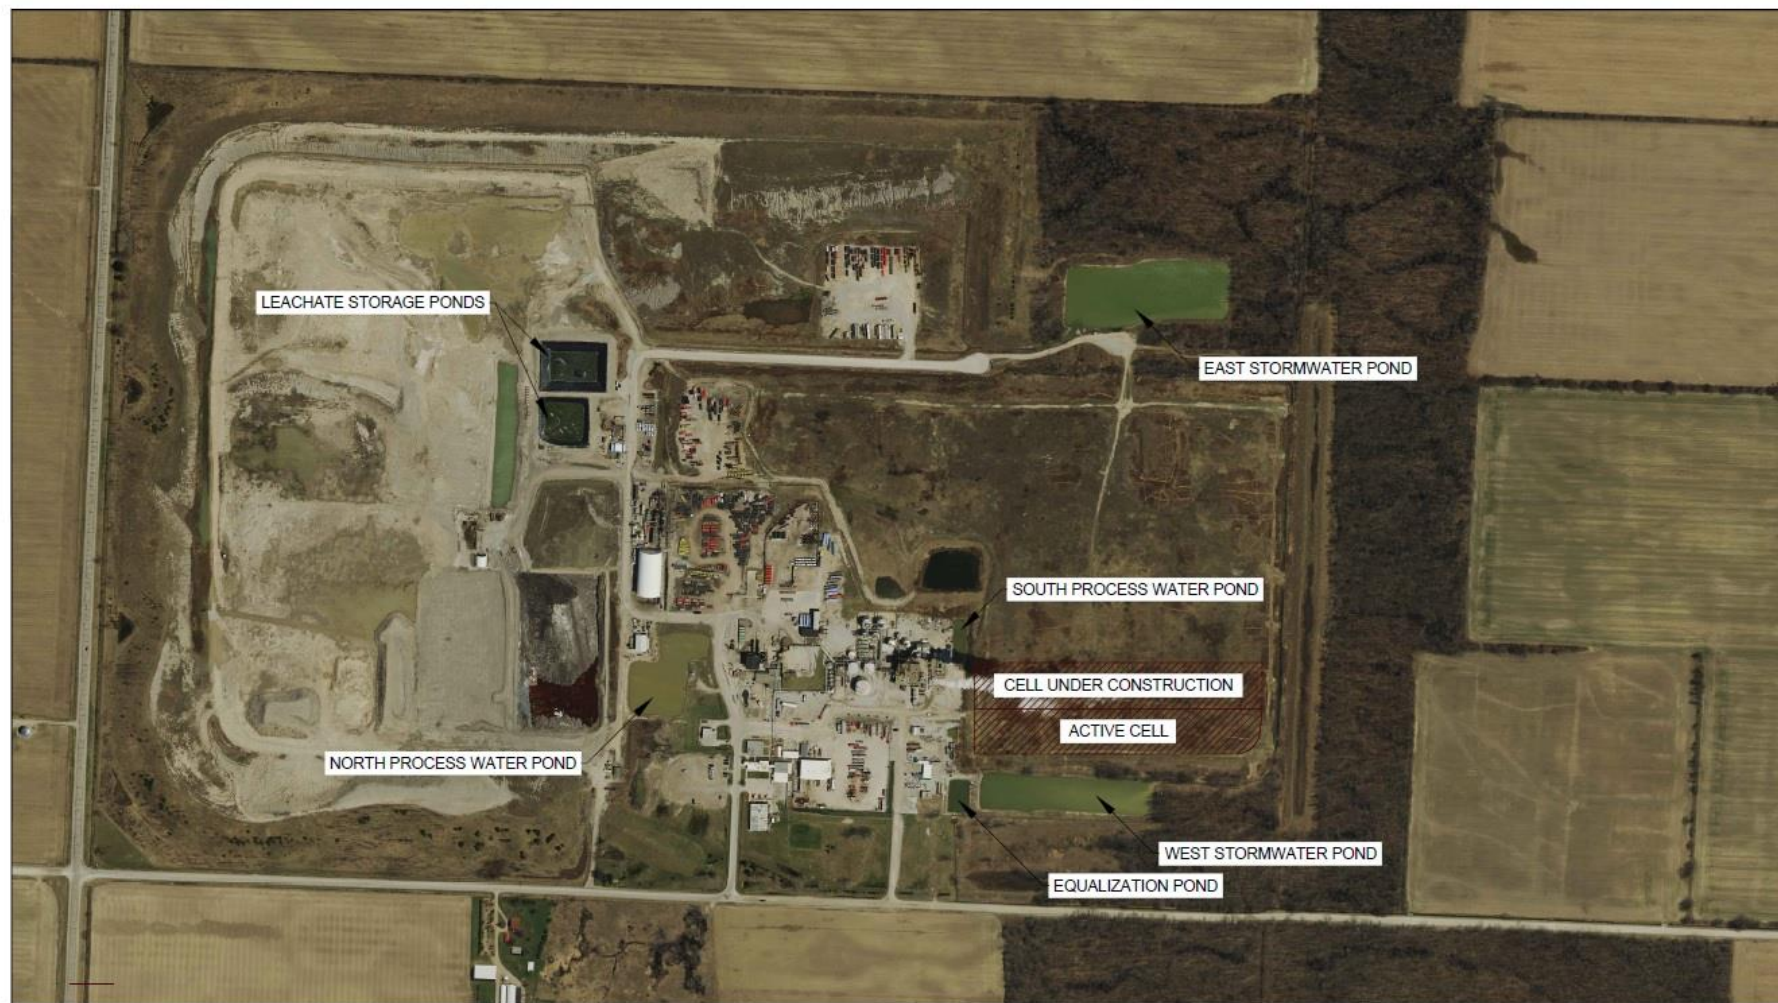
Figure 2. Site Works and Development Plan

Clean Harbors Canada, Inc. operates a hazardous waste management complex on a 140 hectare parcel of land in St. Clair Township, Lambton County, called the Lambton Facility. The location of the Lambton Facility and major site features are shown in **Figure 1** and **Figure 2**, respectively.

- Installation of the perimeter leachate collection trench, leachate pumping wells (1 to 6), and leachate pumping station to support development of Cells 19-1 and 19-2
- Installation of the hydraulic control layer in Cell 19-1
- Construction of the waste receiving area
- Construction of the haul route from the Waste Receiving Area to Cell 19-1
- Construction of the new leachate reservoir
- Interim cap placement in the northern portion of the site

Major features of the site are shown in **Figure 2**.

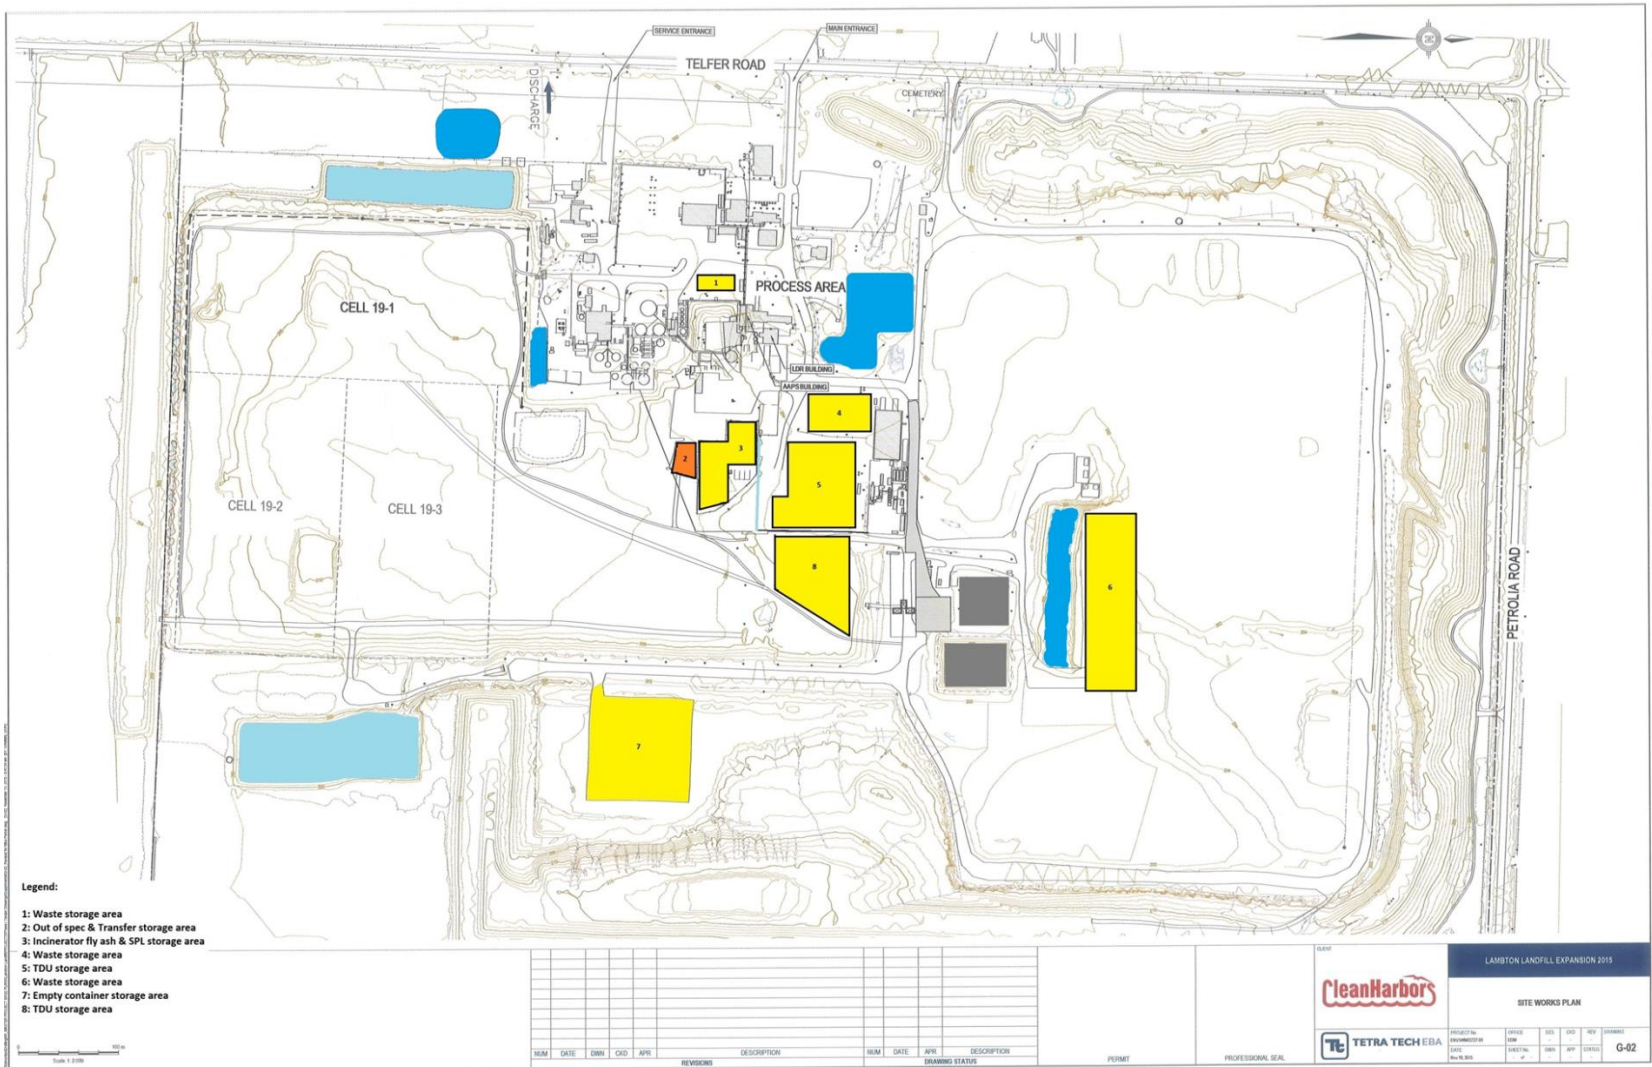
**Figure 3. On-Site Waste Storage Areas**

A summary of all waste loads rejected and related reasoning is presented in **Appendix D**. Rejected loads are contained within the Out of Spec and Transfer Storage Area. No processing or co-mingling with other waste will take place – containers will stay in this storage area untouched until it is determined that they will be shipped to another disposal location or returned to the customer. Containers will be shipped out of the site as they have been received. Once moved to the Out of Spec and Transfer Storage Area the container will be marked up in such a way as to make it discernible from the Transfer containers stored within the same area. This will be achieved by the use of marking items such as caution tape. Transfer containers will not have any such markings, which will differentiate them from the Out of Spec containers. **Figure 3** provides a site plan showing the various storage areas on site and location of out-of-spec material.
