Addendum to the Geotechnical Evaluation and Remedial Plan

**Cell 20-1, Slope Issues - Clean Harbors
Lambton Facility Landfill Corunna, Ontario**

Clean Harbors Canada, Inc.

December 17, 2021

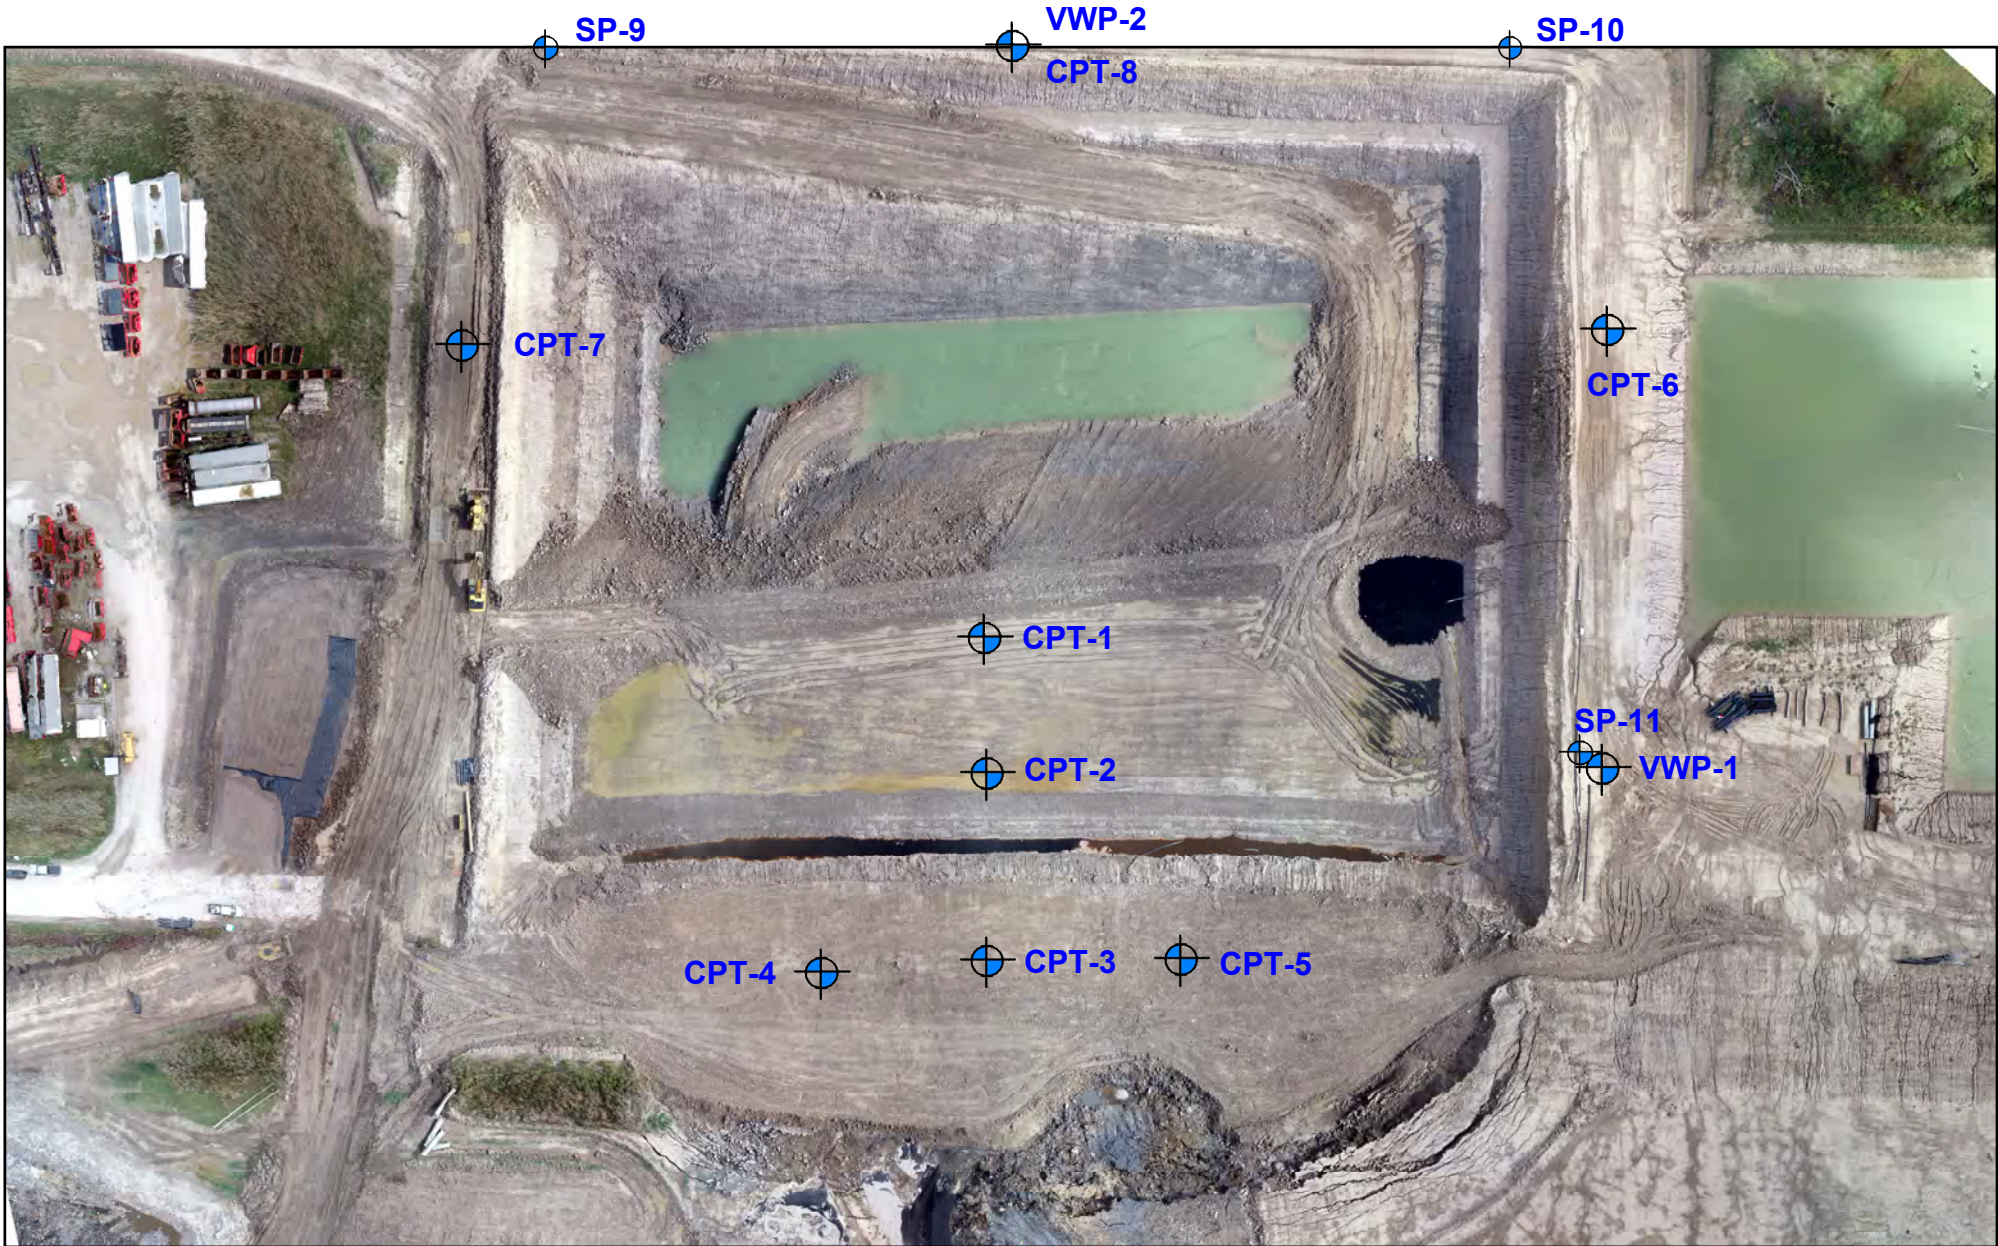
FIGURE 1

Figure 1 shows the locations of the CPT and VWP investigations that were completed in December 2021. The aerial photograph shown on Figure 1 was obtained from the drone camera on October 13, 2021. Ground surface contours generated from the drone flight are shown on Figure 2.

The investigative depths for the CPTs and VWP boreholes is summarized in Table 2.1. The boreholes were located in the field by GHD staff. Murphy Contracting provided the coordinates and ground surface elevations of the staked CPT and VWP locations. Ground surface elevations at the staked locations are provided in Table 2.1. At each CPT and VWP location, an additional wood stake was driven as a future reference point for ground surface movement, referred to as survey points (SPs). Three additional SPs (SP-9, SP-10, and SP-11) were also installed at the northeast, southeast and southwest corners of Cell 20-1, as shown on Figure 1.

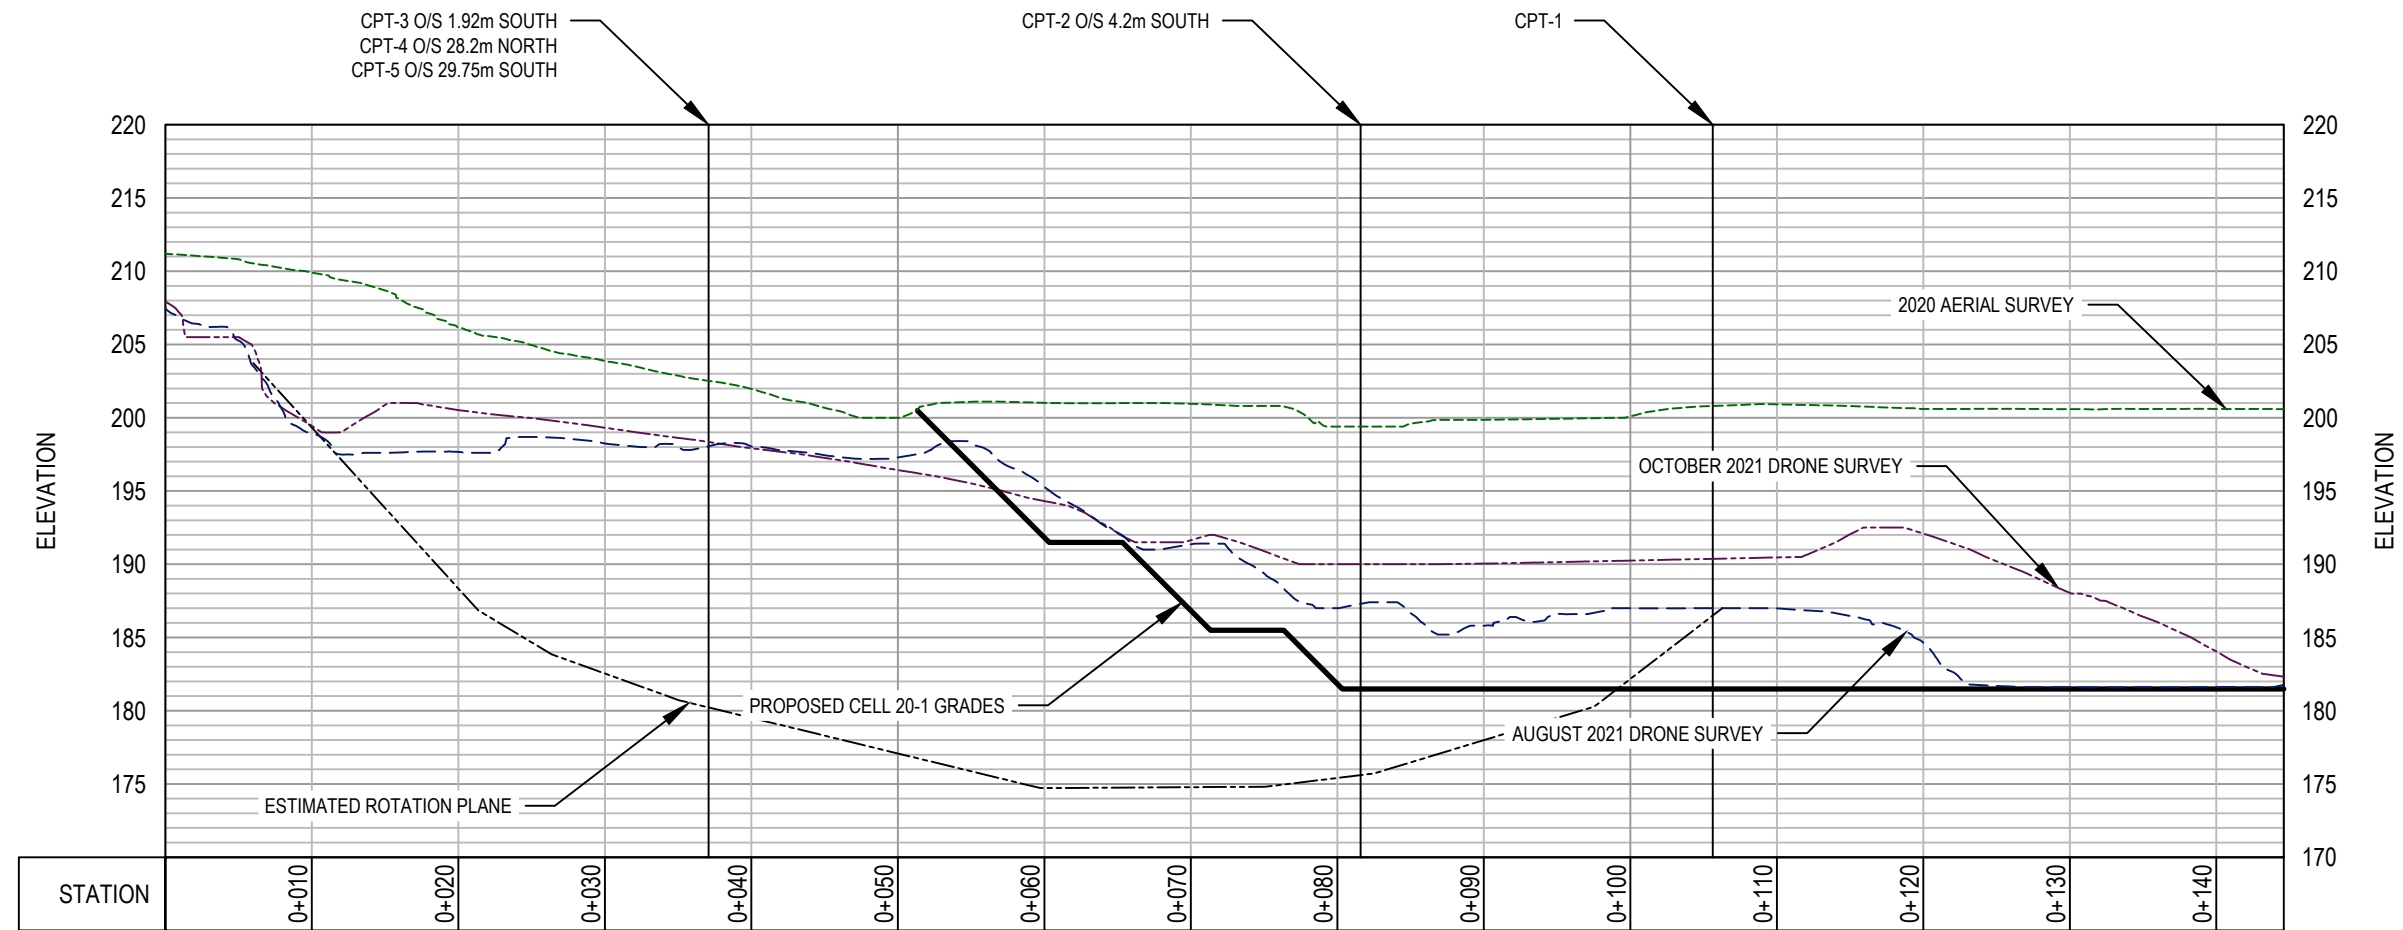
Figure 3A

CROSS-SECTION 1
WEST SLOPE

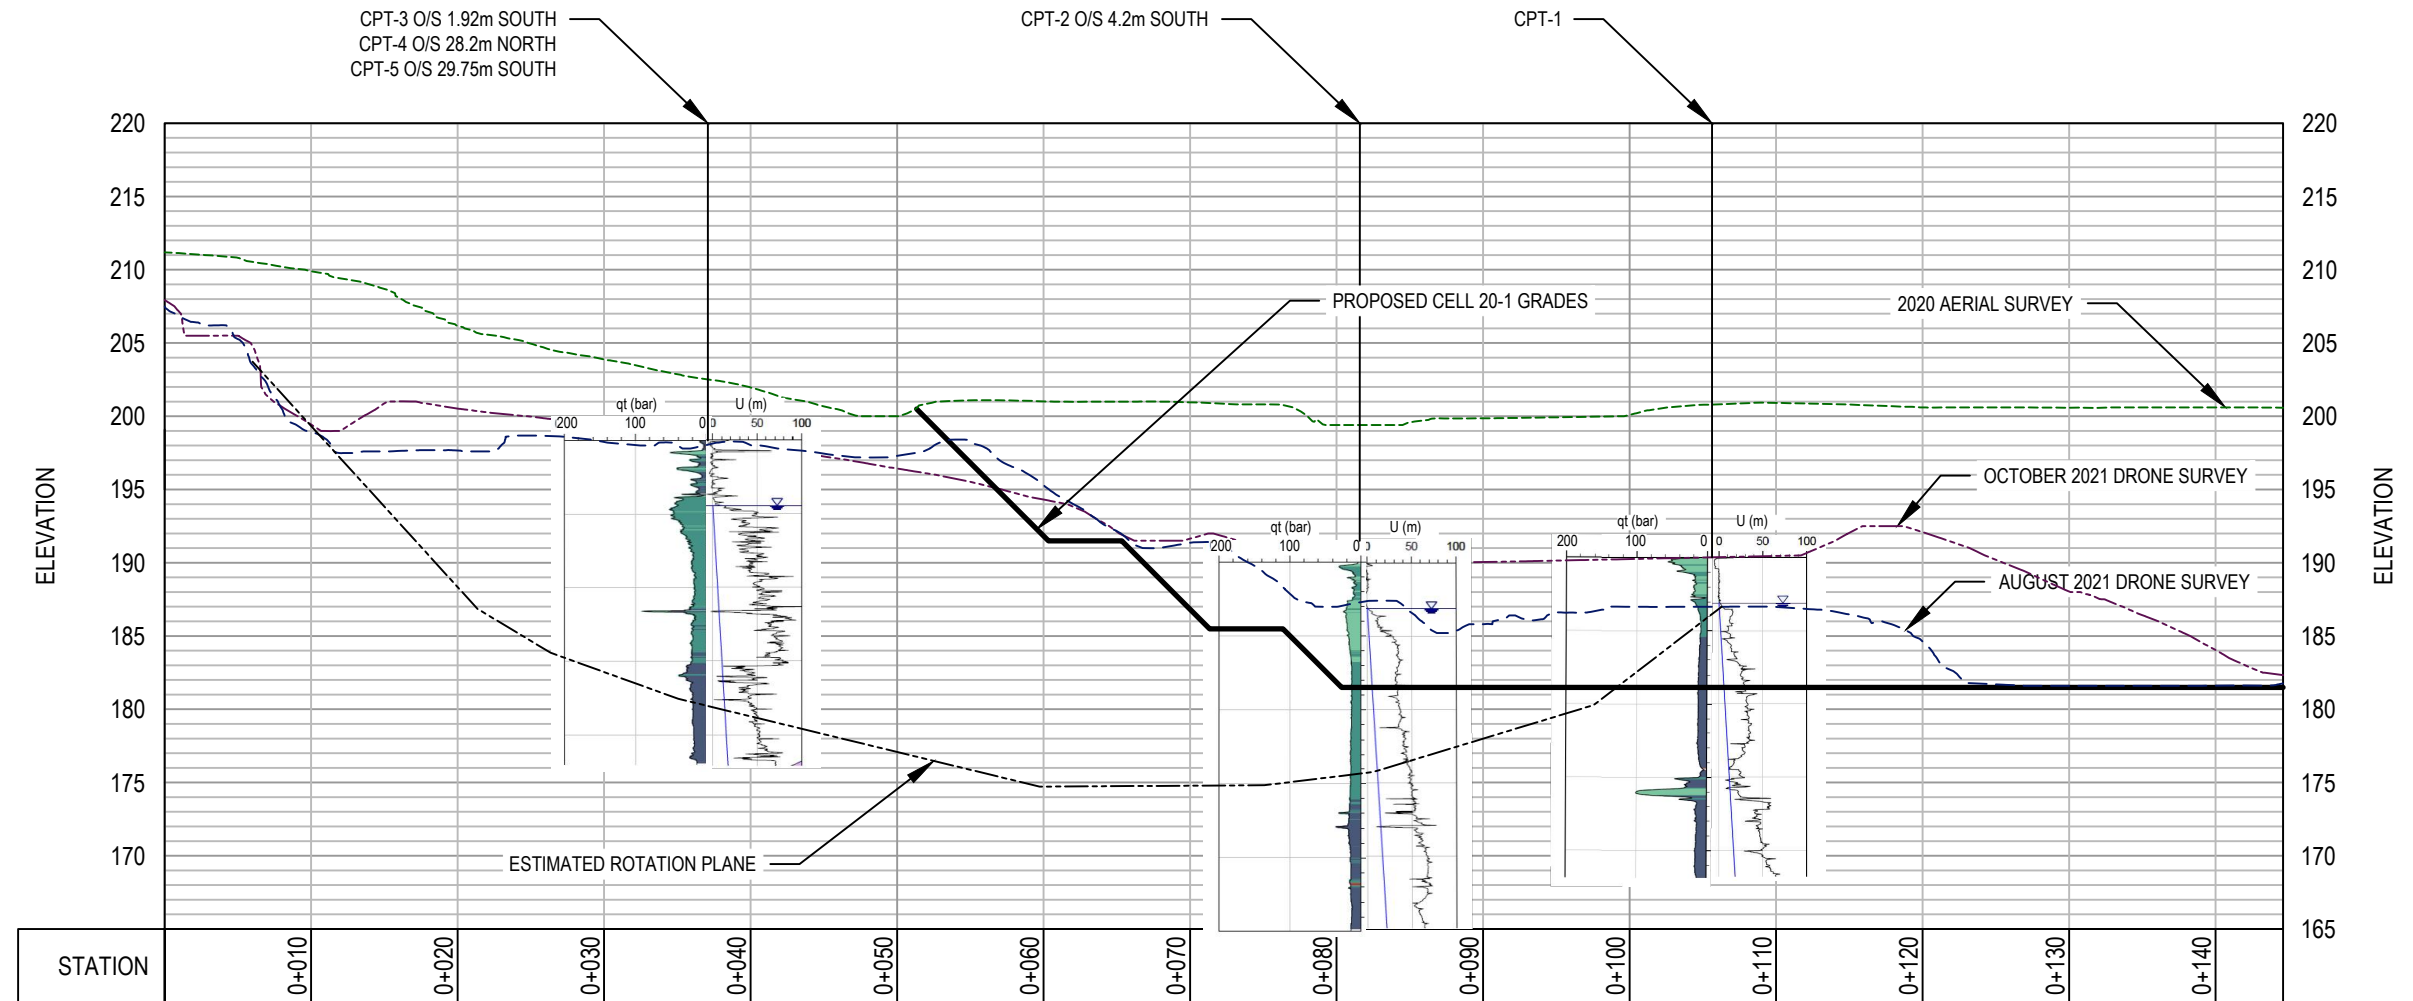
Figure 3B

CROSS-SECTION 1
WEST SLOPE

CPT 1 and 2 were advanced in the west portion of the floor of Cell 20-1, and CPT 3, 4, and 5, were advanced through the rotated bench on the upper portion of the west slope. Plots of the tip resistance (qt), and pore water pressure (u) are provided for reference on a cross-section through the west slope (see Figures 3A and 3B). The CPT 3 plot shows some evidence of disturbed soil (erratic and elevated pore water pressures) to a depth of about elevation 182 m AMSL. This corresponds to the approximate depth of the estimated rotational plane, as shown on Figure 3B. Evidence of a remoulded zone in CPT 1 and CPT 2 was not obvious.

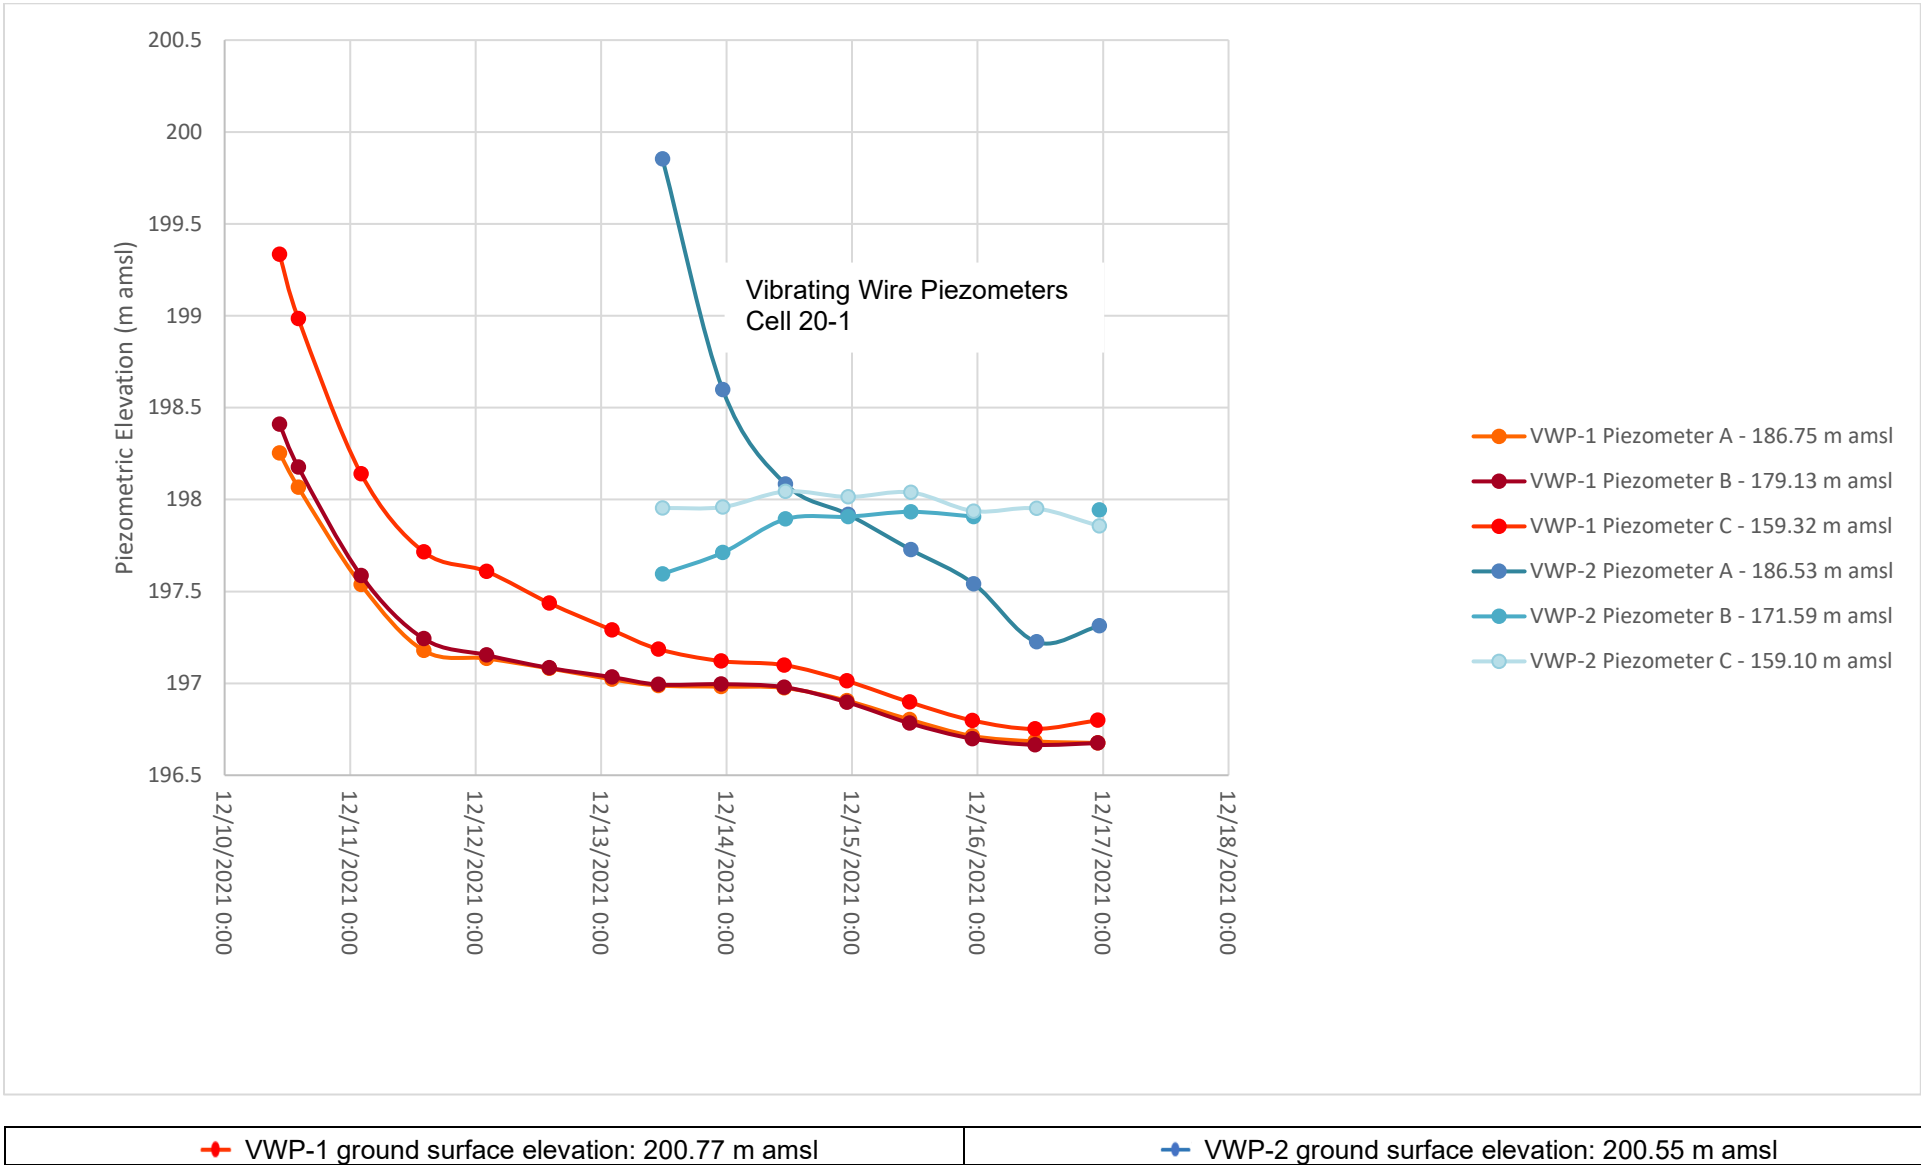
Figure 4
Vibrating Wire Piezometric Elevations- Cell 20-1

Data plots of the piezometric surface collected as of the time of issuing this report are shown on Figure 4. The piezometric surface for the piezometers is showing stabilized conditions at between elevation 196.7 and 196.8 m AMSL for VWP-1-21. VWP-2 piezometric readings are in the range of 197.3 to 197.9 m AMSL, but may not be in a stabilized state at the time of issuance of this report.

VWP boreholes VWP-1-21 and VWP-2-21 were instrumented with vibrating wire style pneumatic pore water pressure transducers. These piezometers were installed to targeted depths based on the results of the CPT probes and expected subsurface conditions, and then the boreholes were fully grouted using a cement bentonite slurry. Each piezometer has a thin wire cable that extends from the piezometer tip up to the ground surface, and each cable is connected to a data logger. The piezometers record the piezometric head at the piezometer tip depth. Data is recorded on a daily basis. After initial stabilization of pressures due to installation, the piezometric data will provide long-term readings of the stabilized piezometric pressure at the installed depths. The piezometers were installed at the following depths:

- VWP-1-21: 14.0 m, 21.6 m, and 41.5 m bgs; and
- VWP-2-21: 14.0 m, 29.0 m, and 41.5 m bgs.

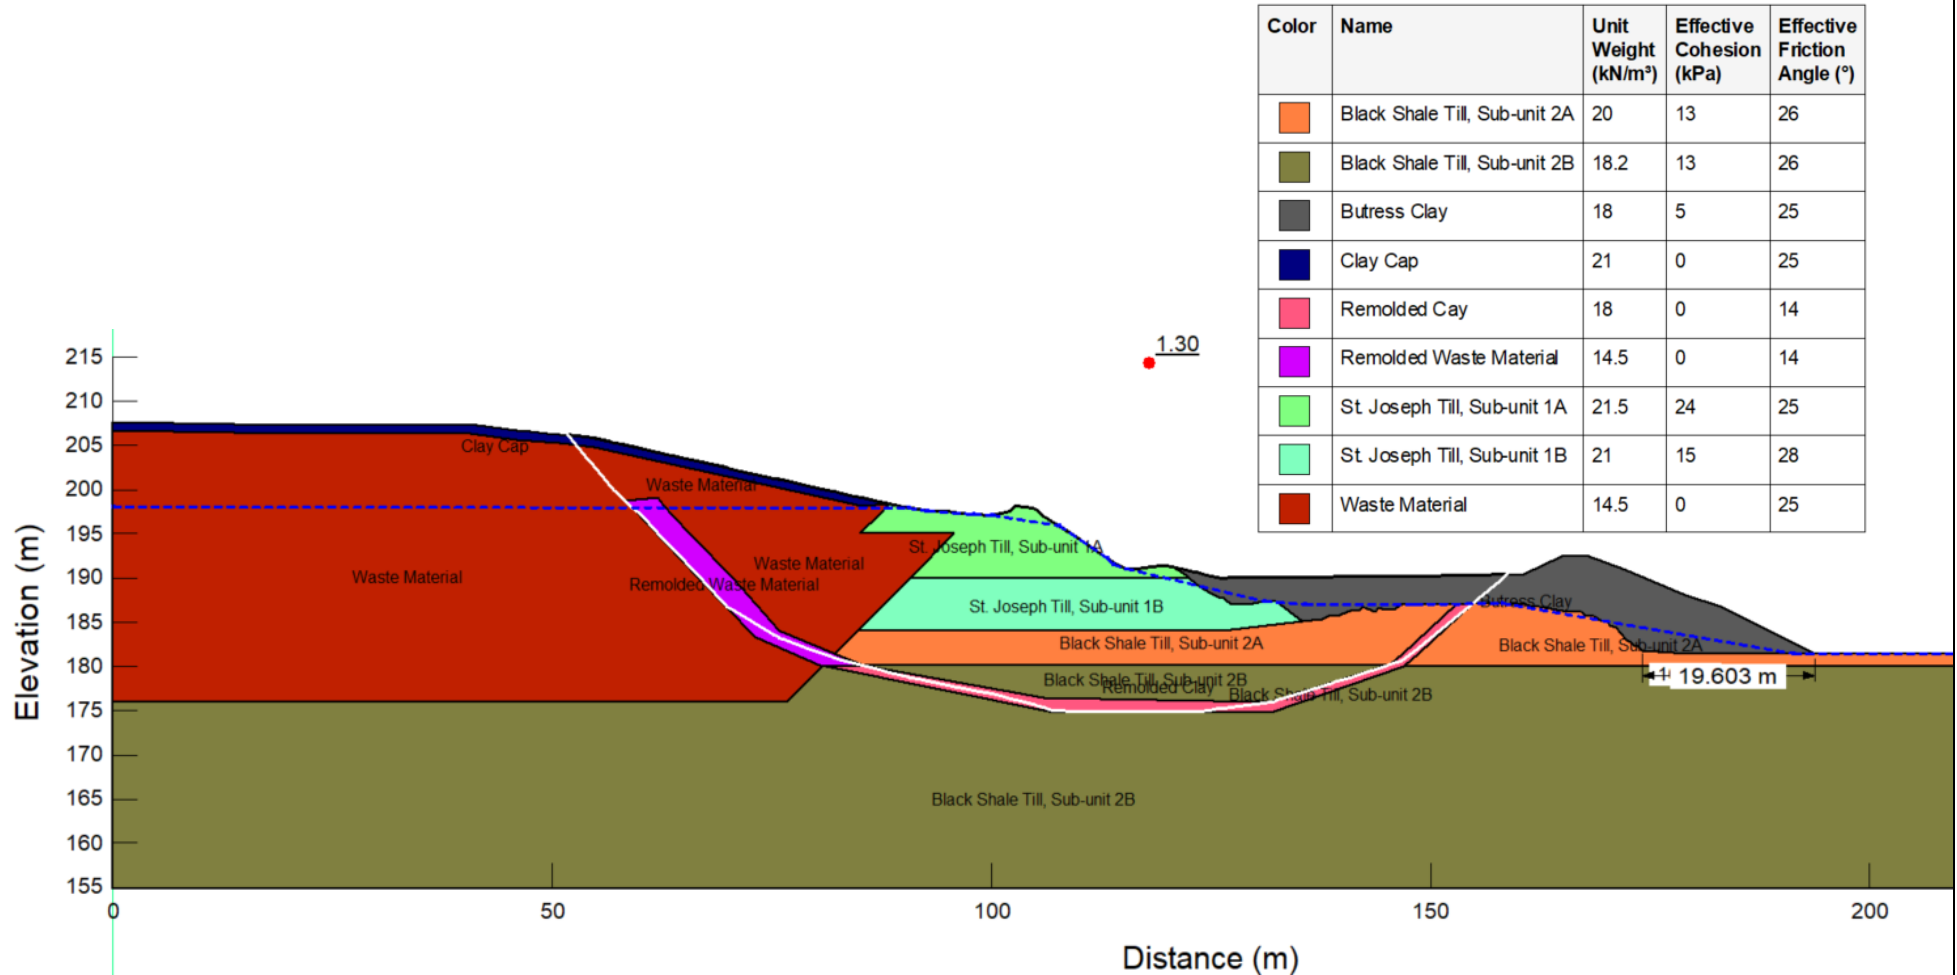
West Slope- As-Constructed Butress Stabilization and Pre-1986 Waste Cell Graded and Capped

Client :	Clean Harbors Canada Inc.	
Projet :	Cell 20 Slope Issues	
Reference :	044985	
Location :	West Slope	
Analysis :	Static Drained	F.S : 1.30

October 13, 2021, and the results of the field investigations, to update the slope stability model for the west slope in this current report. Based on the findings of the CPTs within the west slope, no changes in the geotechnical parameters presented in the previous model of this area are necessary. The CPT results at CPT 3 suggest that the rotational plane is materially consistent with the assumed depth presented in the Slope Issues Report. The model included on Figure 5 does show a revised surface topography of the completed buttress, based on the cross-section of the area shown on Figure 3A. The calculated factor of safety (FS) is similar to that presented in the Slope Issues Report, and is 1.30 in the revised model, as shown on Figure 5.

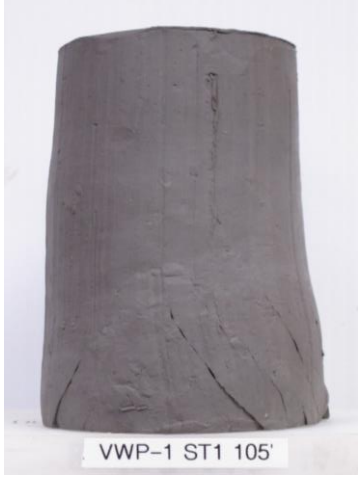
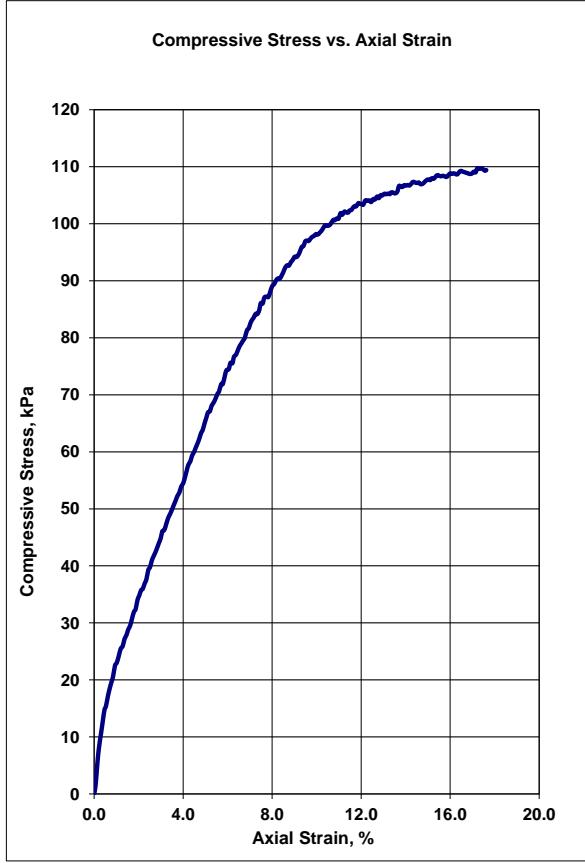
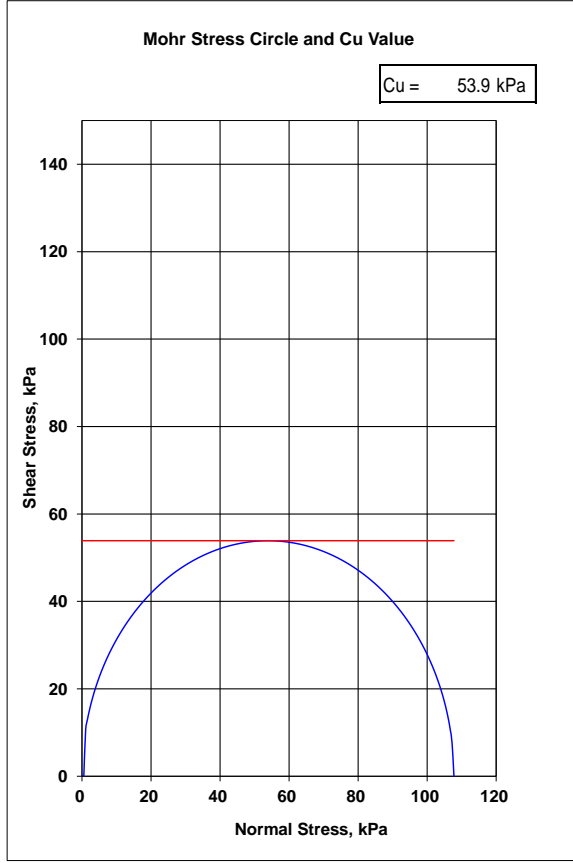
Unconfined Compressive Strength	kPa	107.8
Shear Strength	kPa	53.9
Rate of Strain	%/min	1.0
Strain at Failure	%	15.0
Maximum strain reached	%	17.6

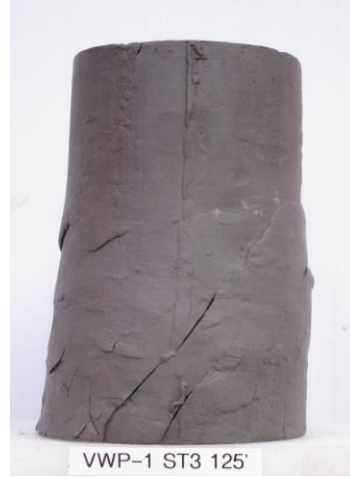
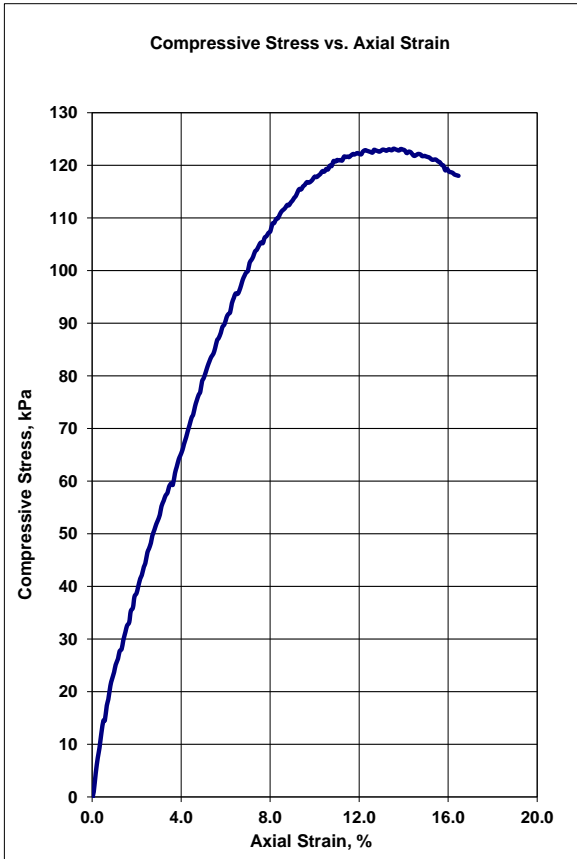
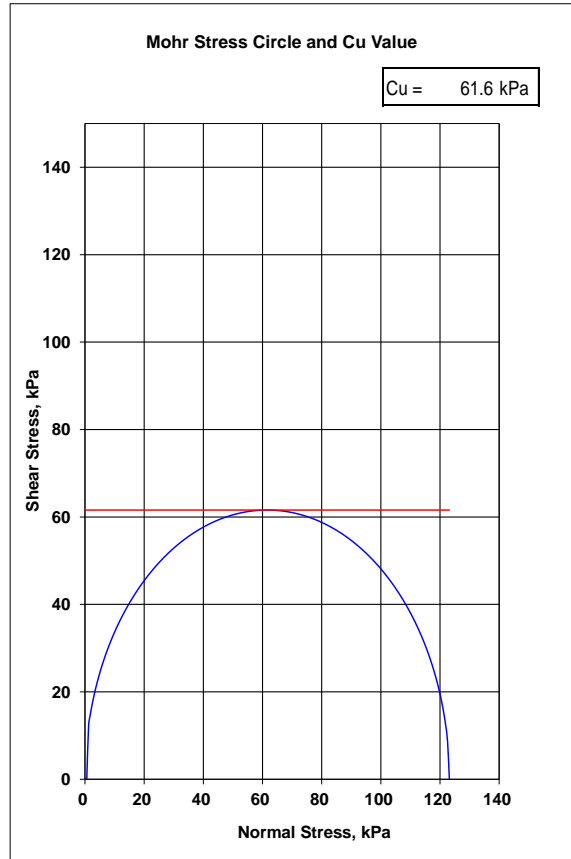
Unconfined Compressive Strength	kPa	123.2
Shear Strength	kPa	61.6
Rate of Strain	%/min	1.0
Strain at Failure	%	13.5
Maximum strain reached	%	16.5

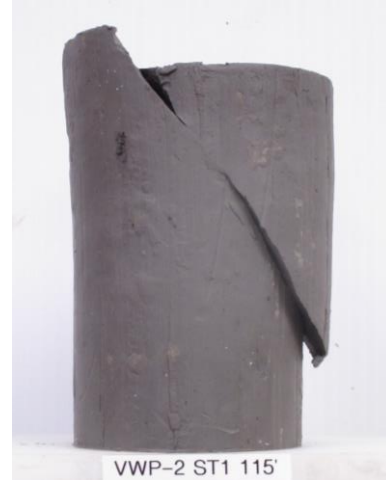
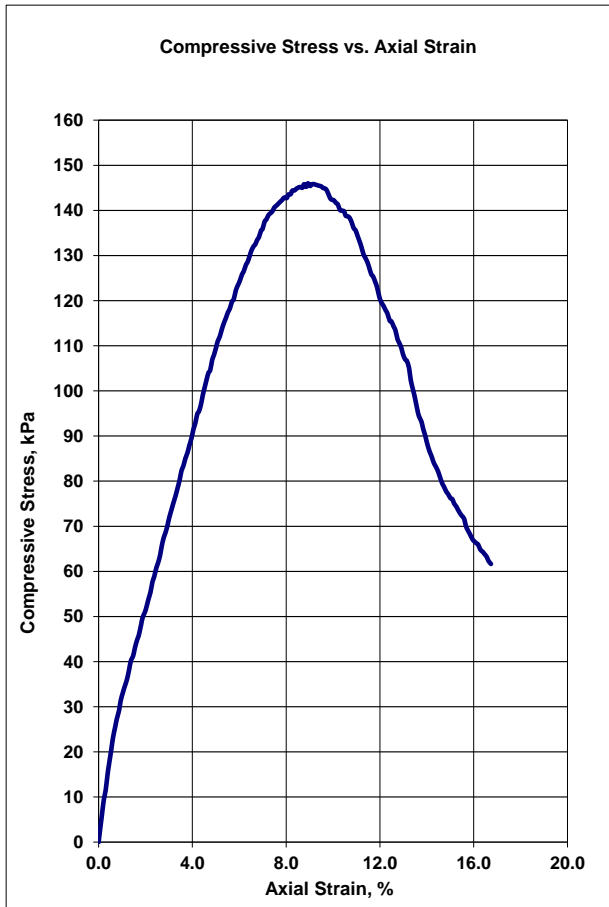
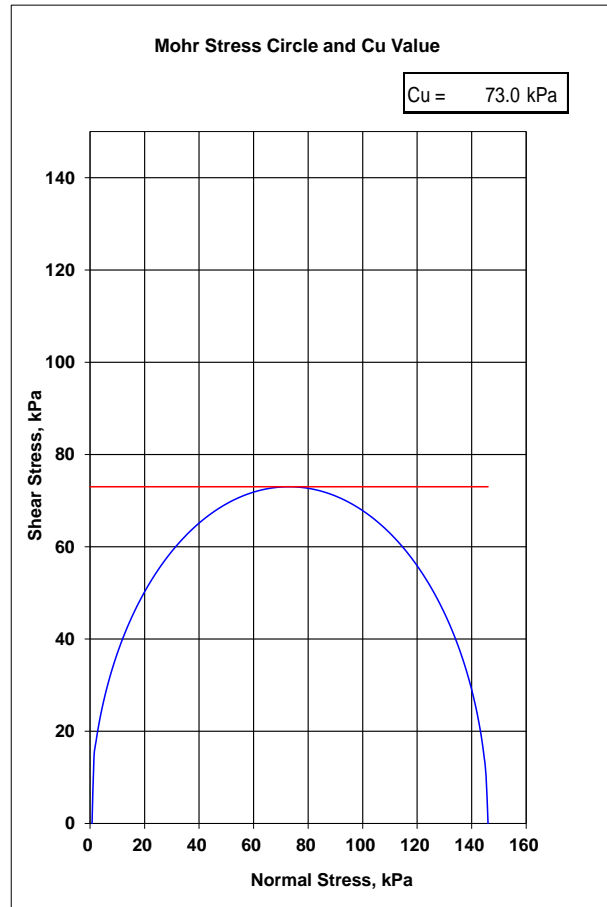
Unconfined Compressive Strength	kPa	146.0
Shear Strength	kPa	73.0
Rate of Strain	%/min	1.0
Strain at Failure	%	8.9
Maximum strain reached	%	16.7

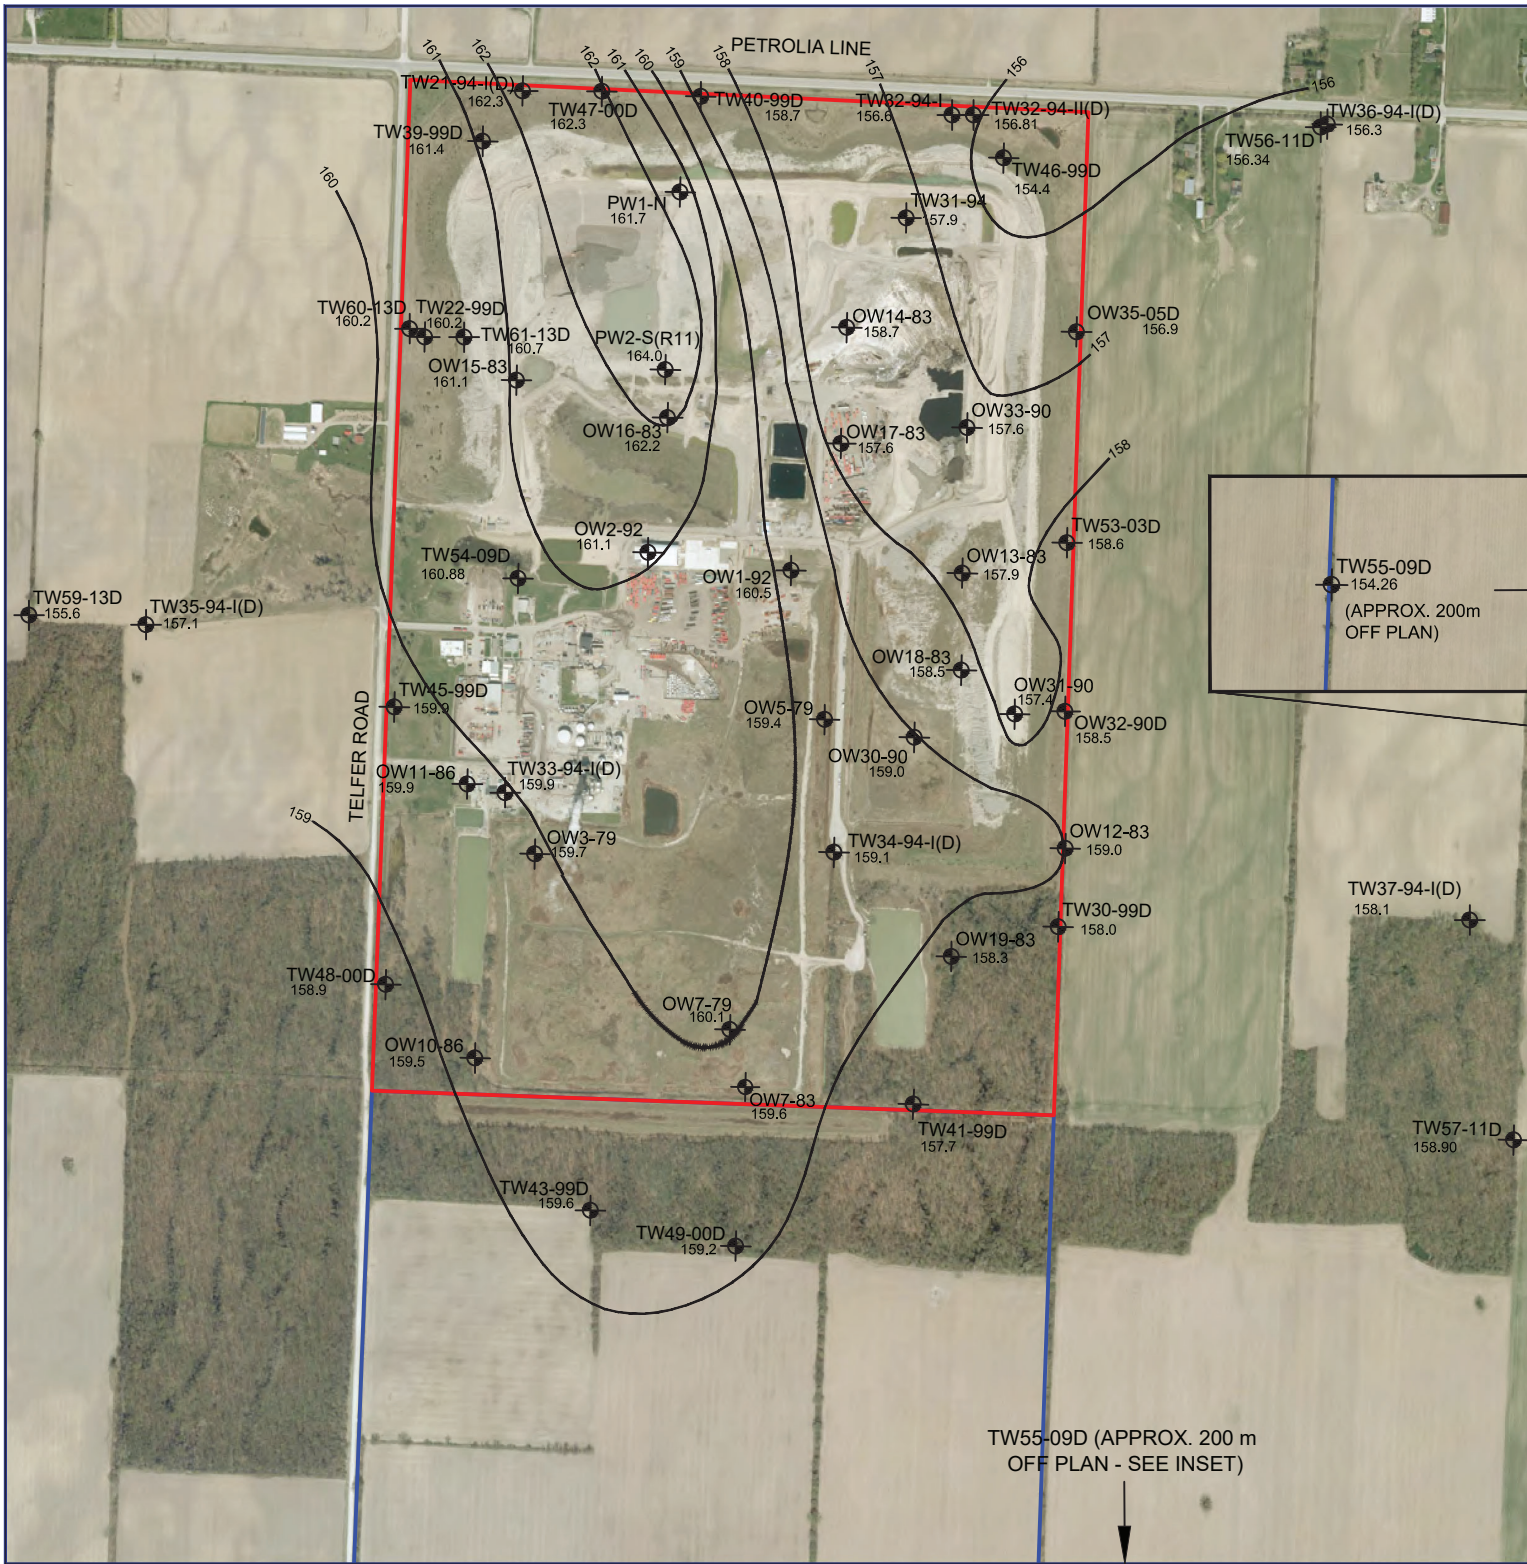
**Bedrock Surface Topography- Lambton
Facility (RWDI, 2013), and Bedrock Log
TW-34-94-I**

The purpose of the VWP boreholes was to obtain deep subsurface information, and to confirm the depth and elevation of the bedrock deposit (Kettle Point Shale Formation). Subsurface conditions in VWP-1-21 and VWP-2-21 were consistent with our 2020 boreholes, and encountered clayey silt deposits to the base of the boreholes. Both boreholes were terminated at refusal to split spoon penetration on inferred shale bedrock, which was encountered at a depth of 42.7 and 42.4 m bgs respectively, corresponding to elevations 158.07 and 158.15 m AMSL. These bedrock depths are consistent with the expected bedrock elevations in this area, based on the 2013 bedrock surface topography map, prepared by RWDI Air Inc. (included in Appendix D). Bedrock monitoring well TW-34-94-I, installed in 1994, to the northwest of Cell 20-1, is included in Appendix D for reference. Similar geologic conditions were noted in TW-34-94-I, to those that were observed in our two VWP boreholes and 2020 boreholes.
