APPENDIX F

Quarterly Site Inspection Reports

2017 Annual Landfill Report

Subject: 2017 First Quarter Site Inspection

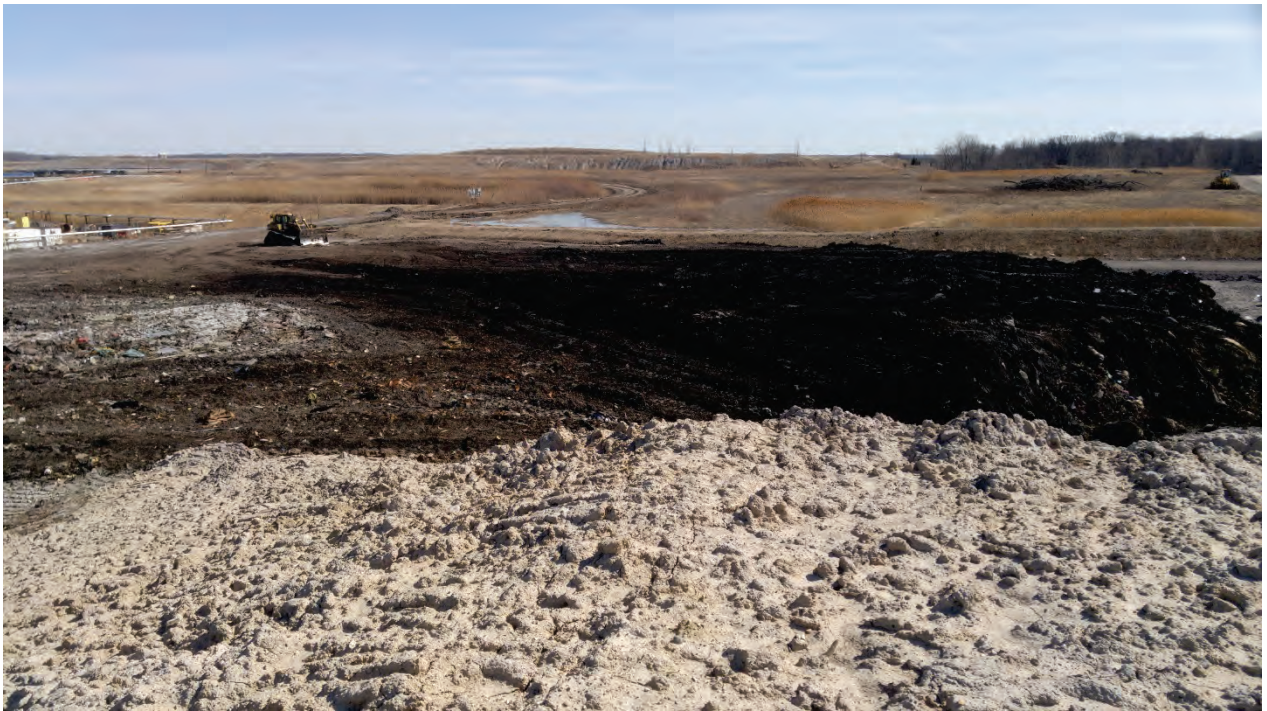
Photo 1 - Active landfilling cell (northern portion of Cell 19-1-2)

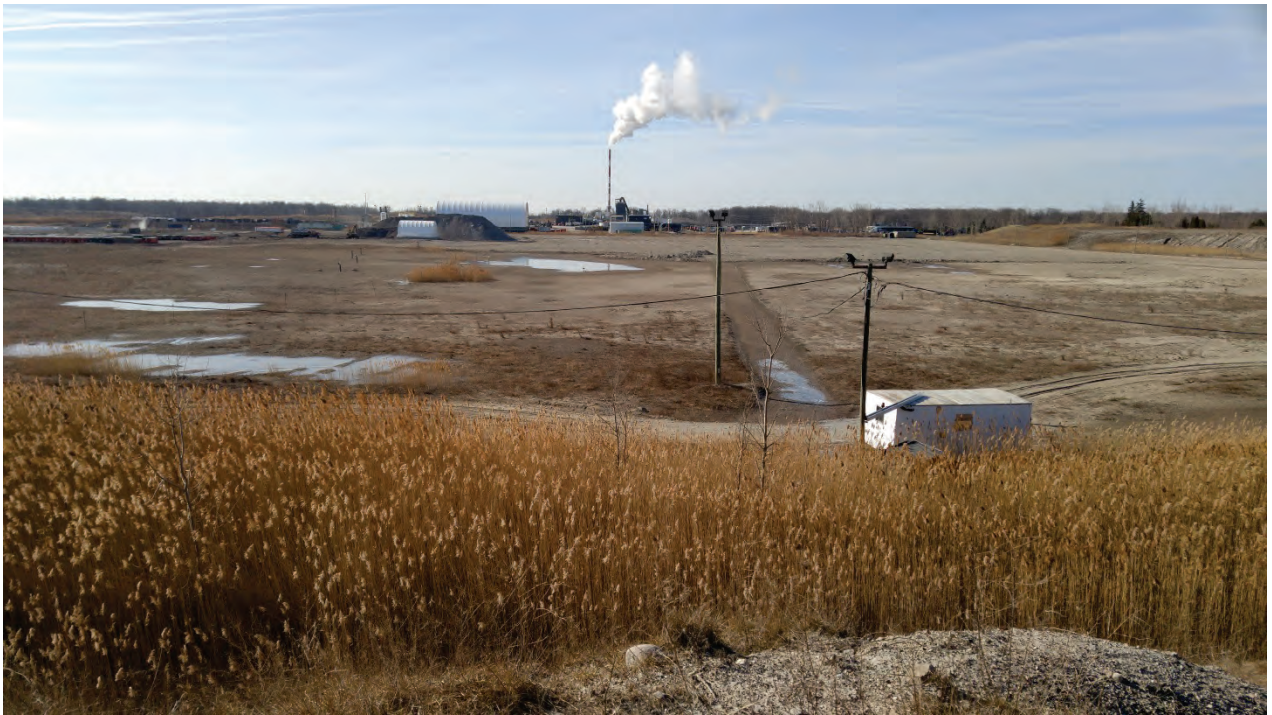
Photo 3 - Ponding within northwest corner of Site

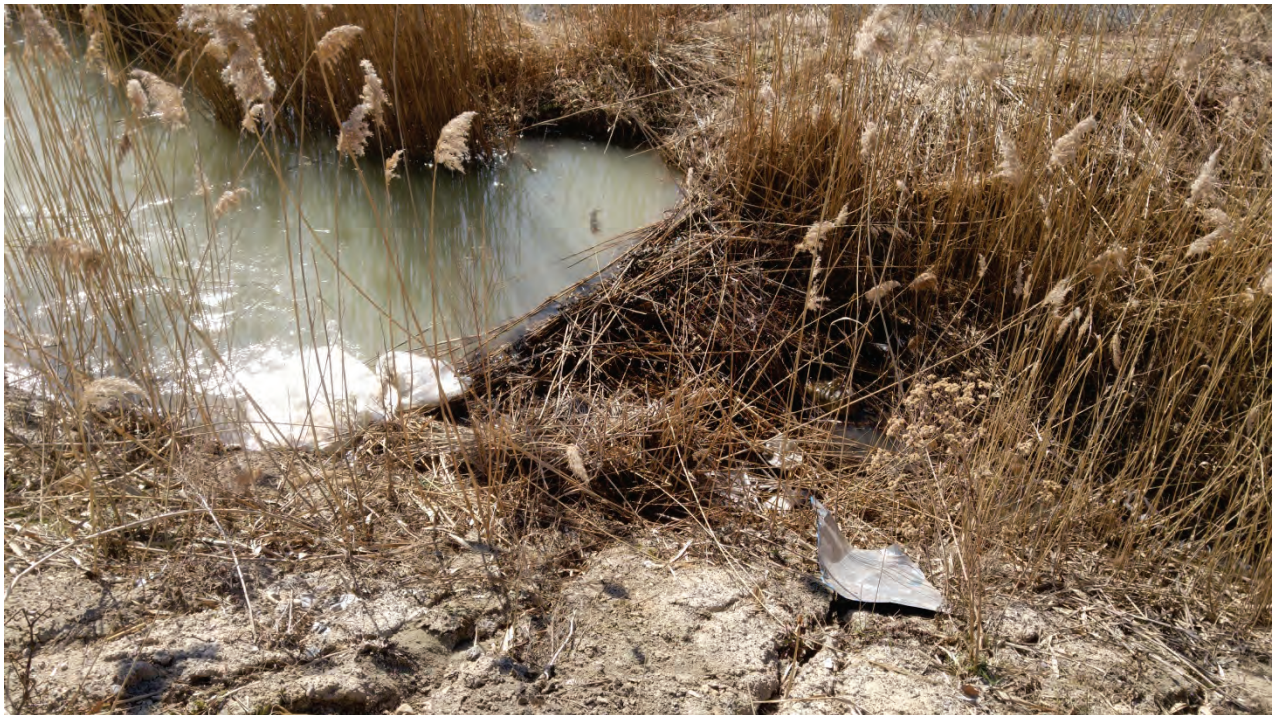
Photo 8 - Southwest ditch, surface water blockage

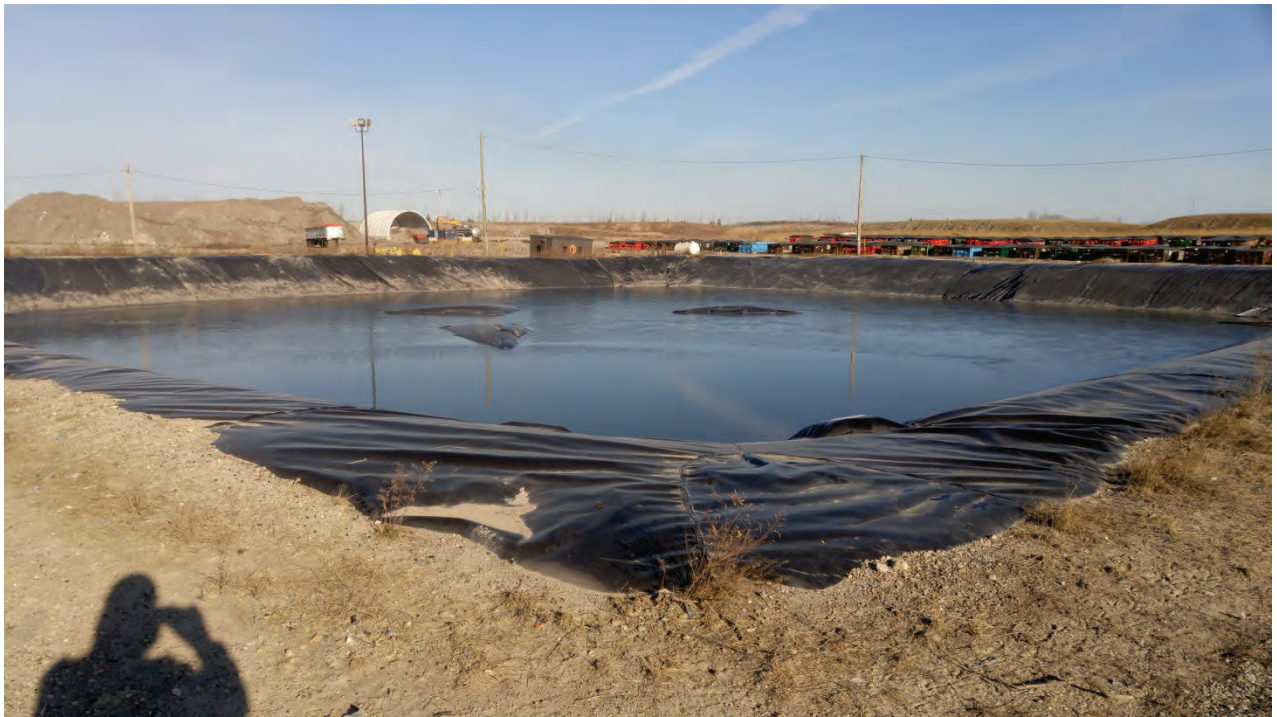
Photo 15 - South Leachate Reservoir

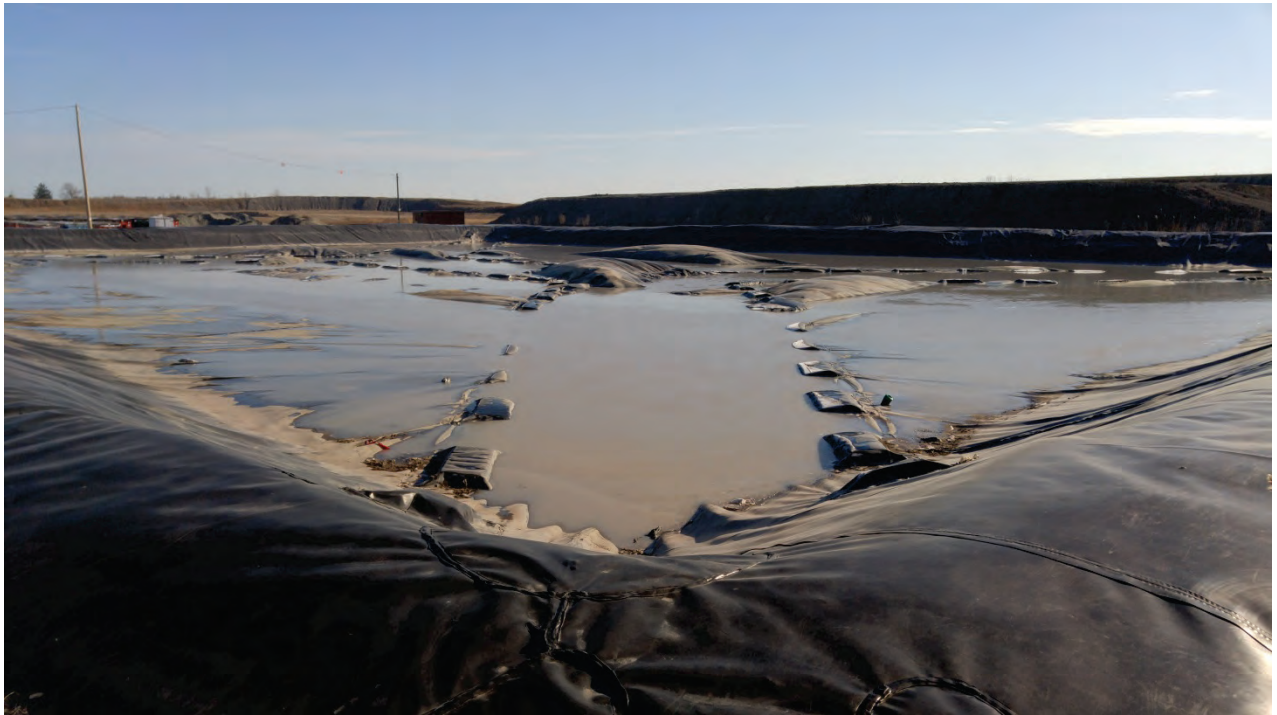
Photo 16 - East Leachate Reservoir

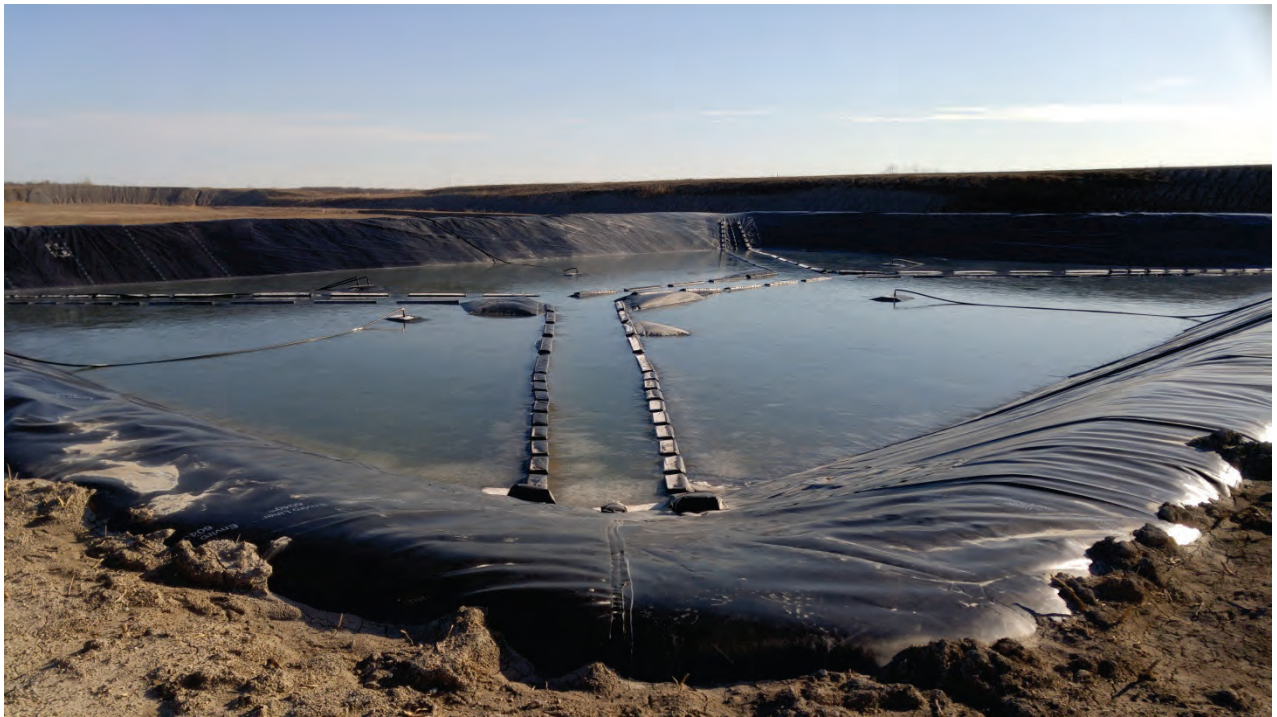
Photo 17 - Newly Constructed Leachate Reservoir

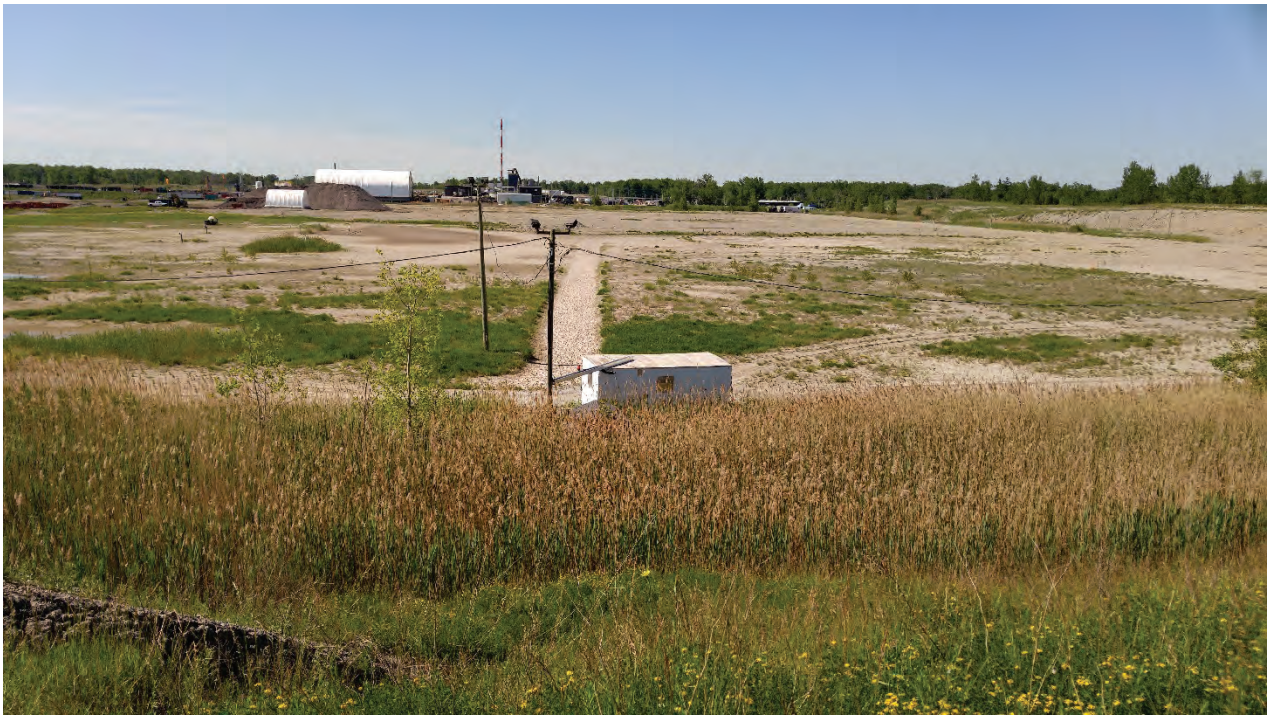
Photo 3 - Ponding within northwest corner of Site

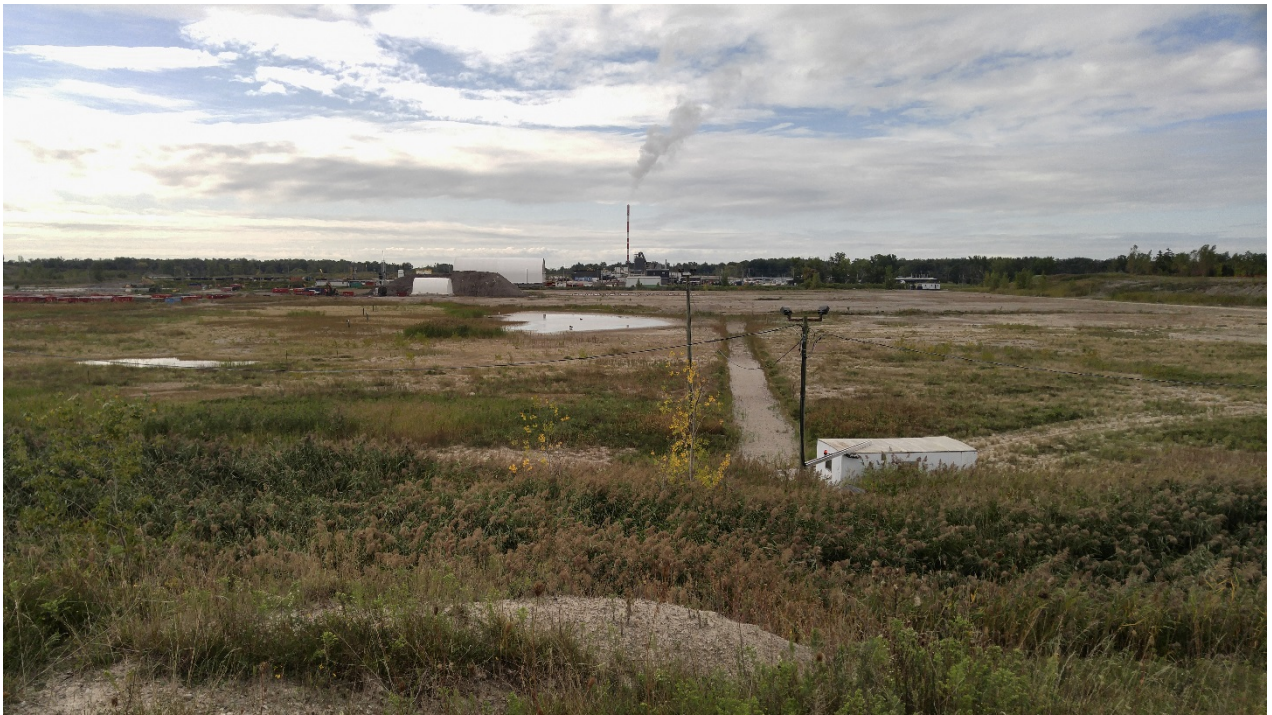
Photo 3 - Ponding within northwest corner of Site

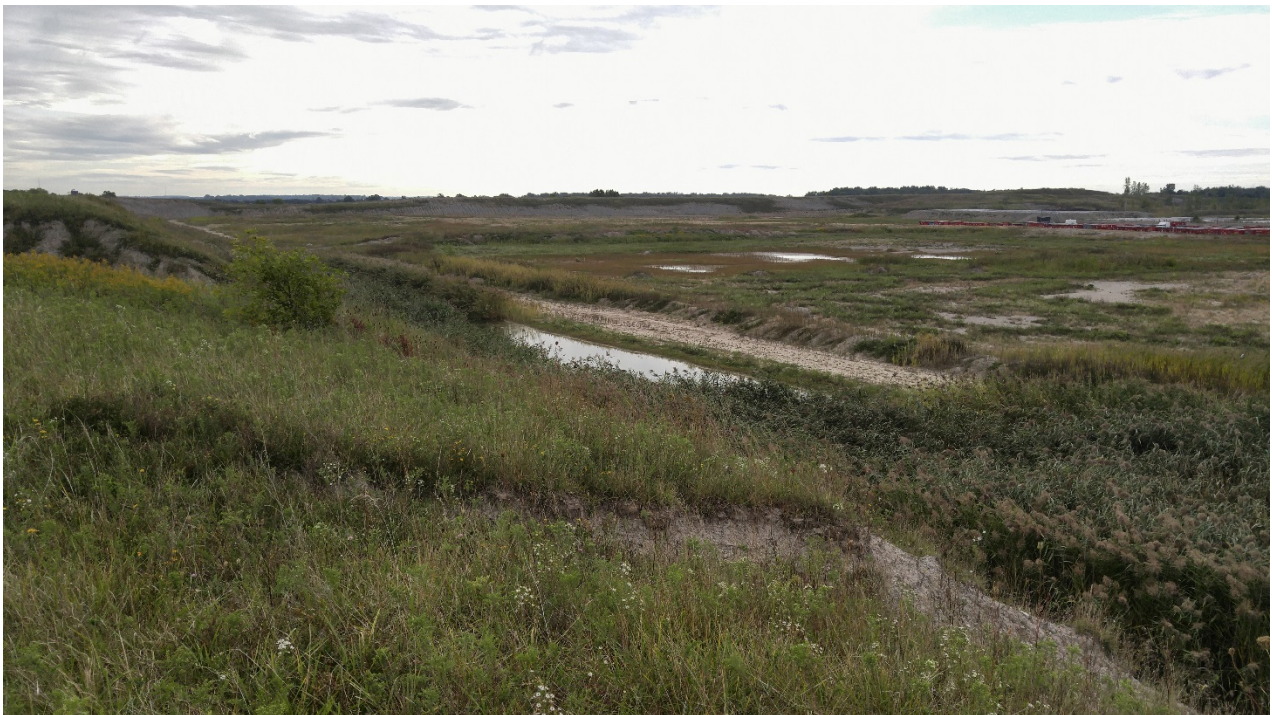
Photo 4 - Ponding in northern, central portion of Site

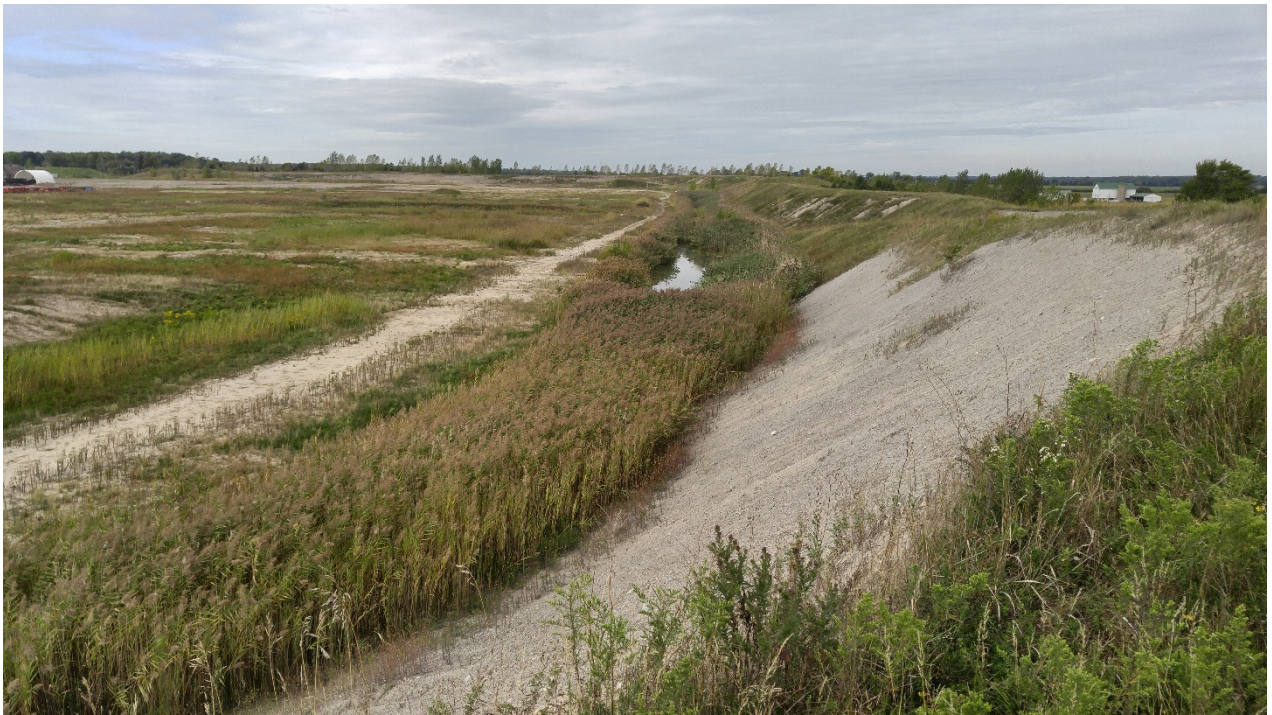
Photo 5 - North ditch, surface water blockage

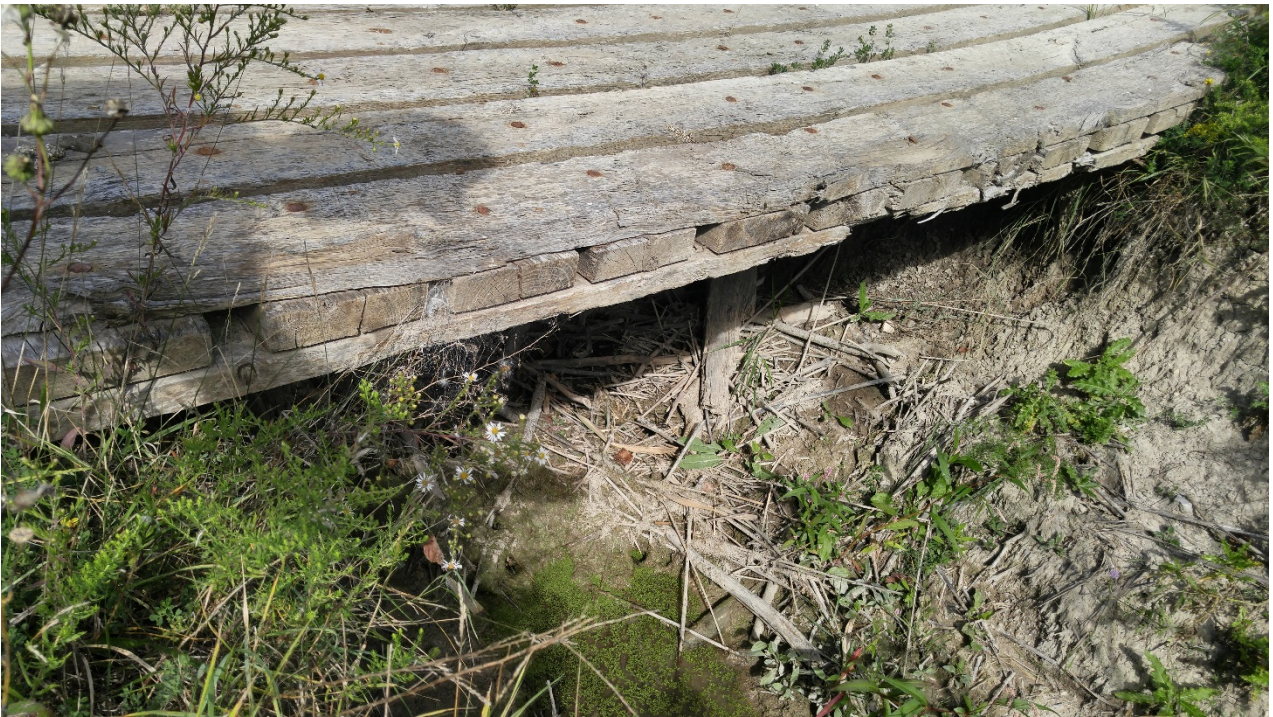
Photo 7 - South ditch, surface water blockage west of access bridge

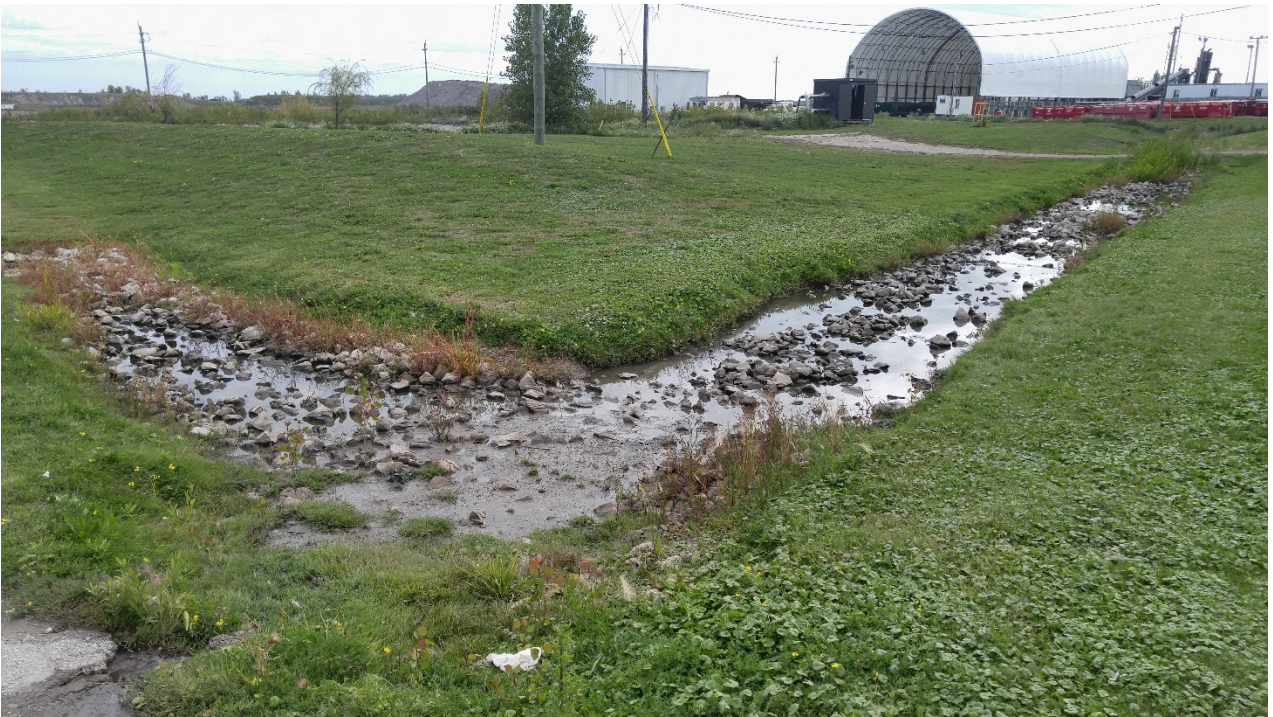
Photo 11 - North Process Water Pond ditch

- The ditches feeding the North Process Water Pond had minimal standing water at the time of the Inspection. As shown in Photo 11, these ditches have significant sediment buildup in the rip rap and culverts, with little to no flow toward the pond. It is recommended that sediment be removed from the ditch, including the ditch in front of the HHW Depot.

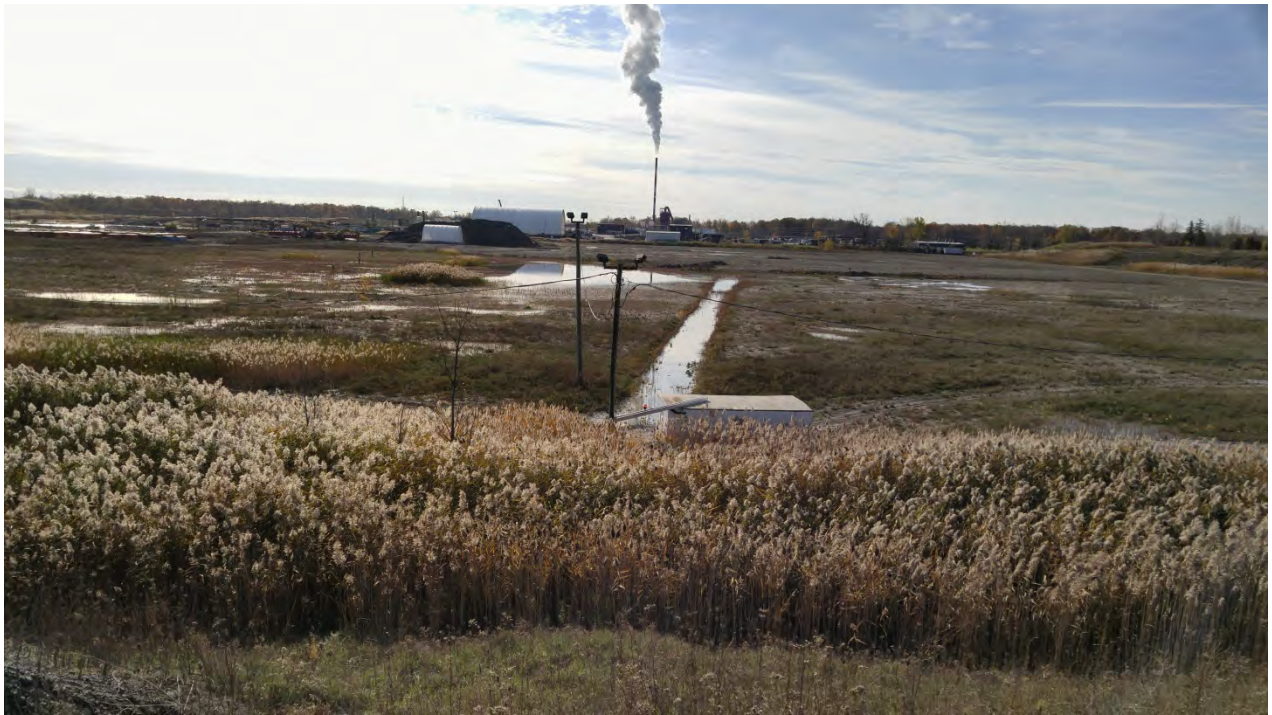
Photo 3 - Ponding within northwest corner of Site

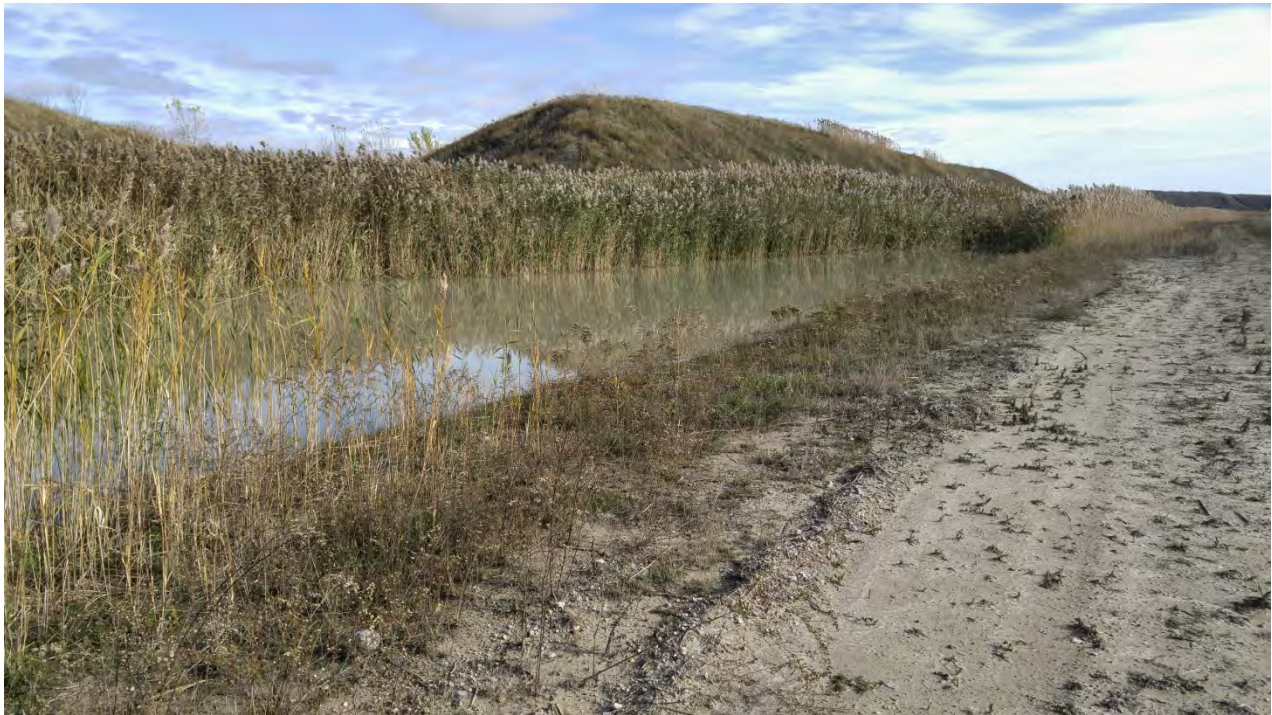
Photo 4 - High water levels in central portion of north perimeter ditch

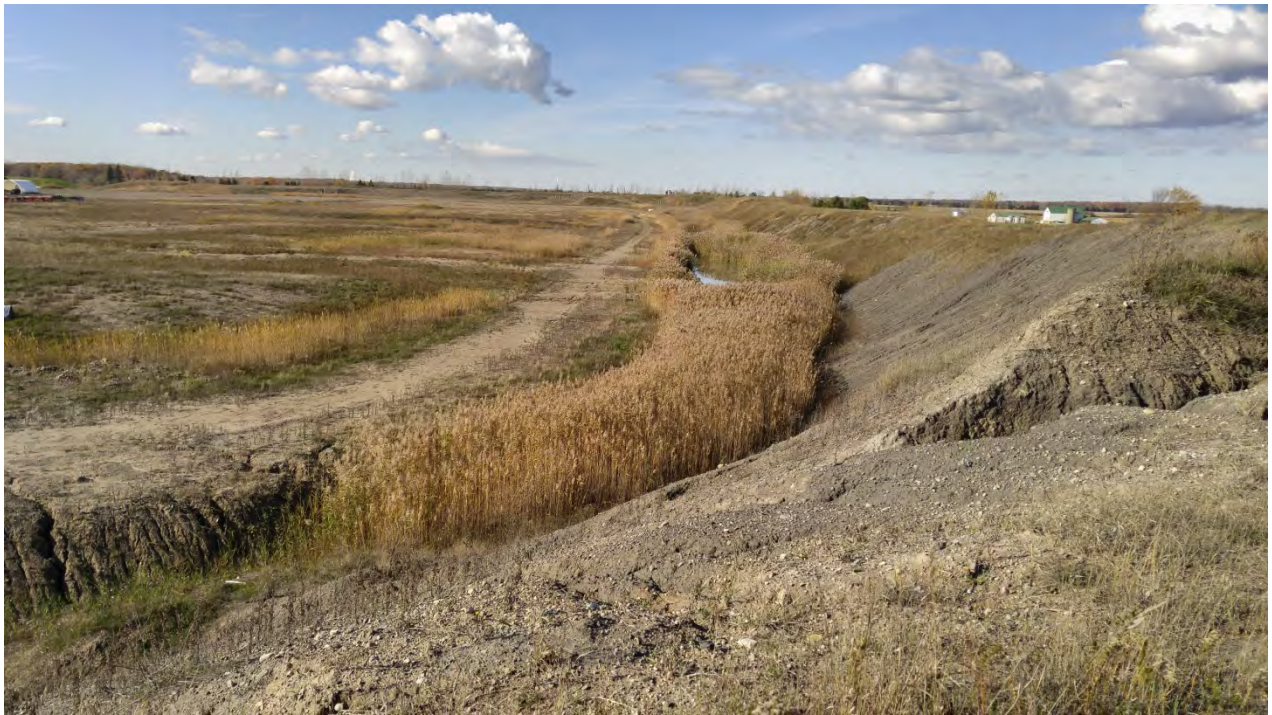
Photo 5 - North ditch, surface water blockage

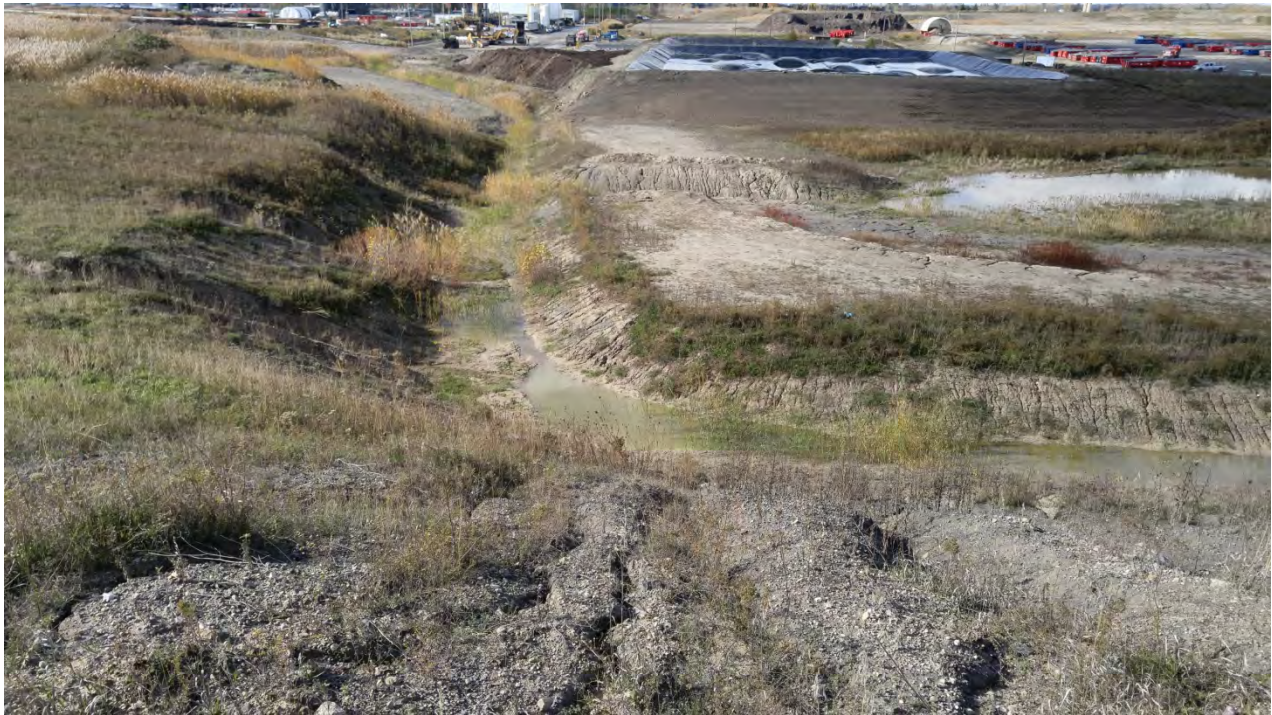
Photo 6 - North landfill area, southeast ditch, partial surface water blockage

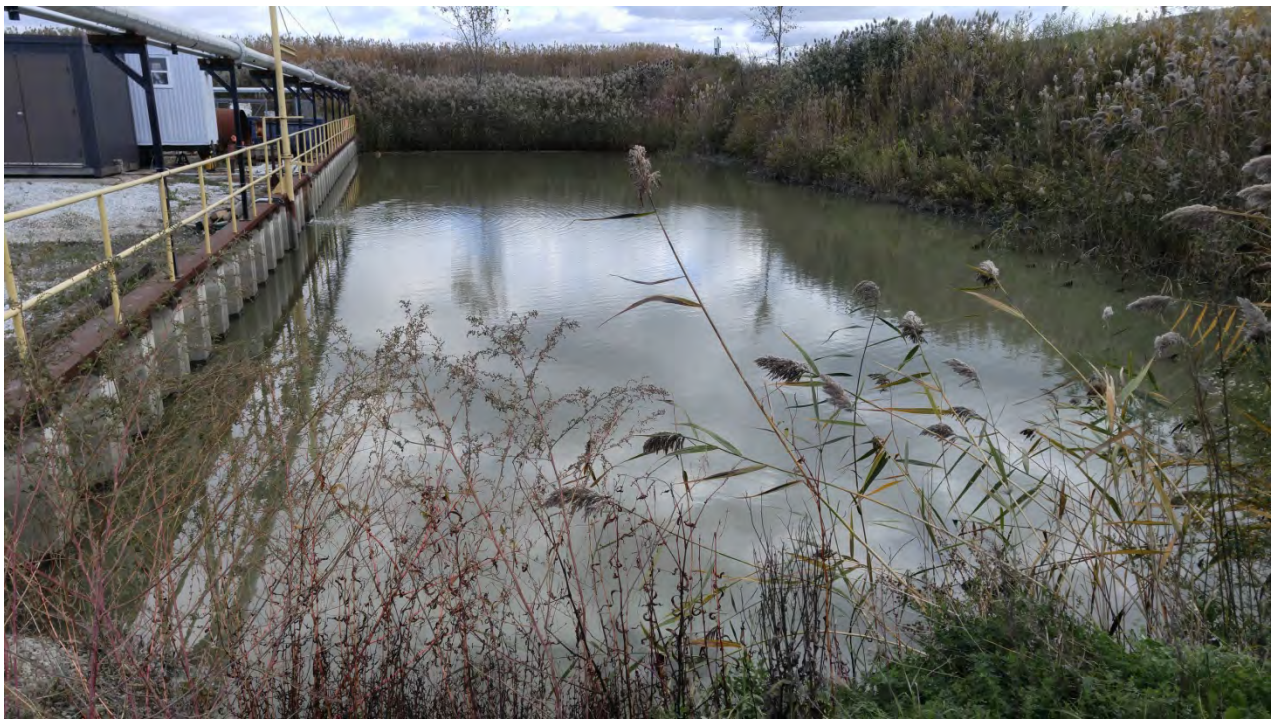
The following provides a description of the status of the North Process Water Pond (Photo 12):

Photo 12 - North Process Water Pond

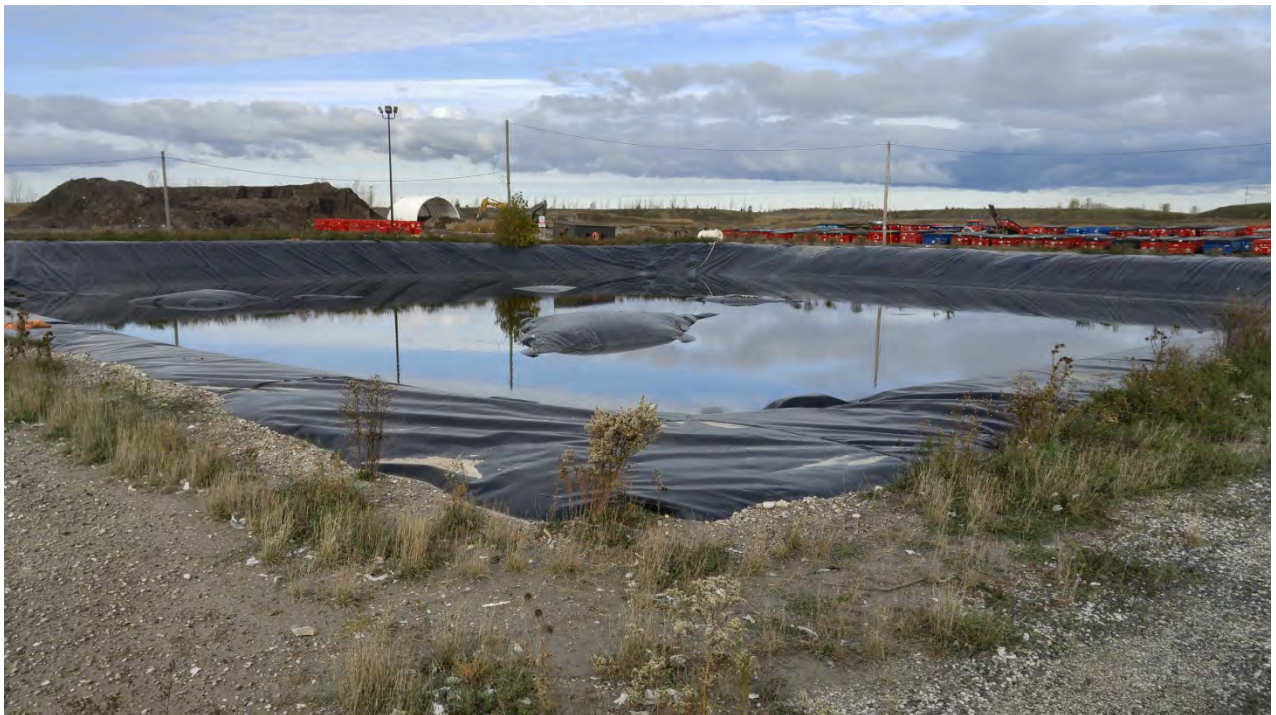
The following provides a description of the status of the South Process Water Pond (Photo 13):

Photo 13 - South Process Water Pond

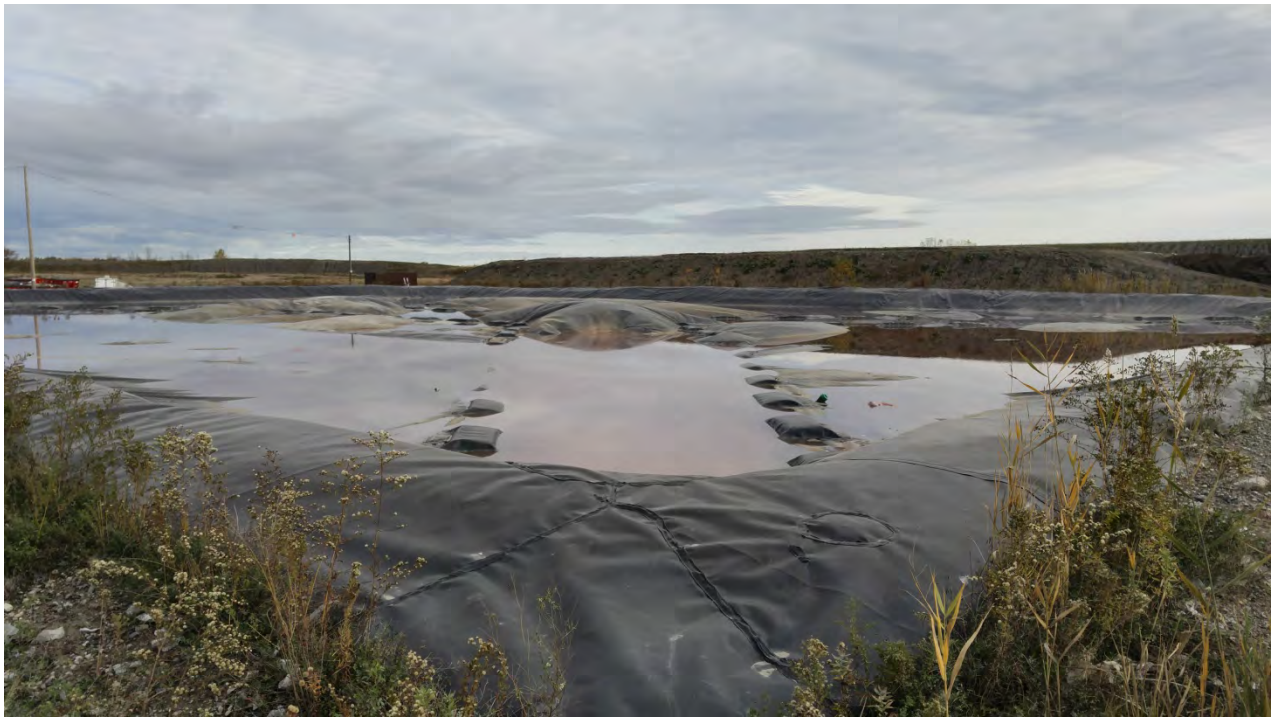
The following provides a description of the status of the South Leachate Reservoir (Photo 14):

Photo 14 - South Leachate Reservoir

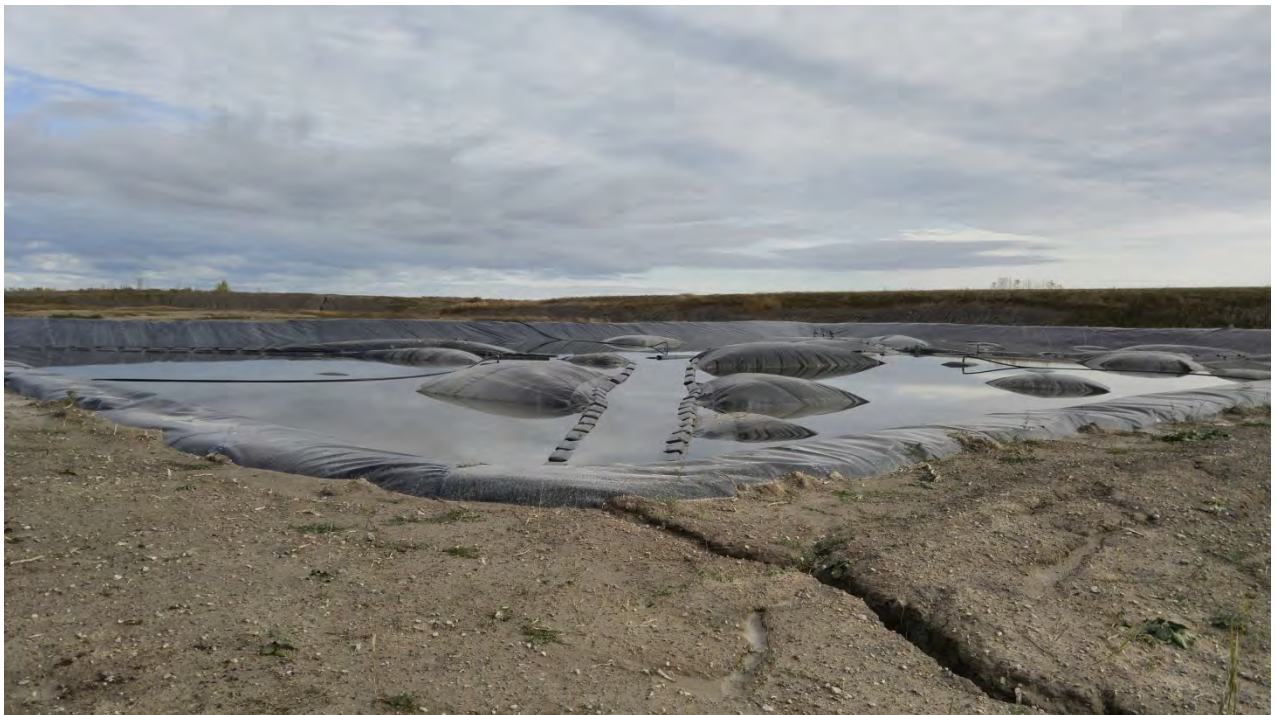
The following provides a description of the status of the East Leachate Reservoir (Photo 15):

Photo 15 - East Leachate Reservoir
