2018 Quarterly Site Inspections

Clean Harbors Lambton Facility
4090 Telfer Road, Corunna, Ontario

Clean Harbors Canada, Inc.

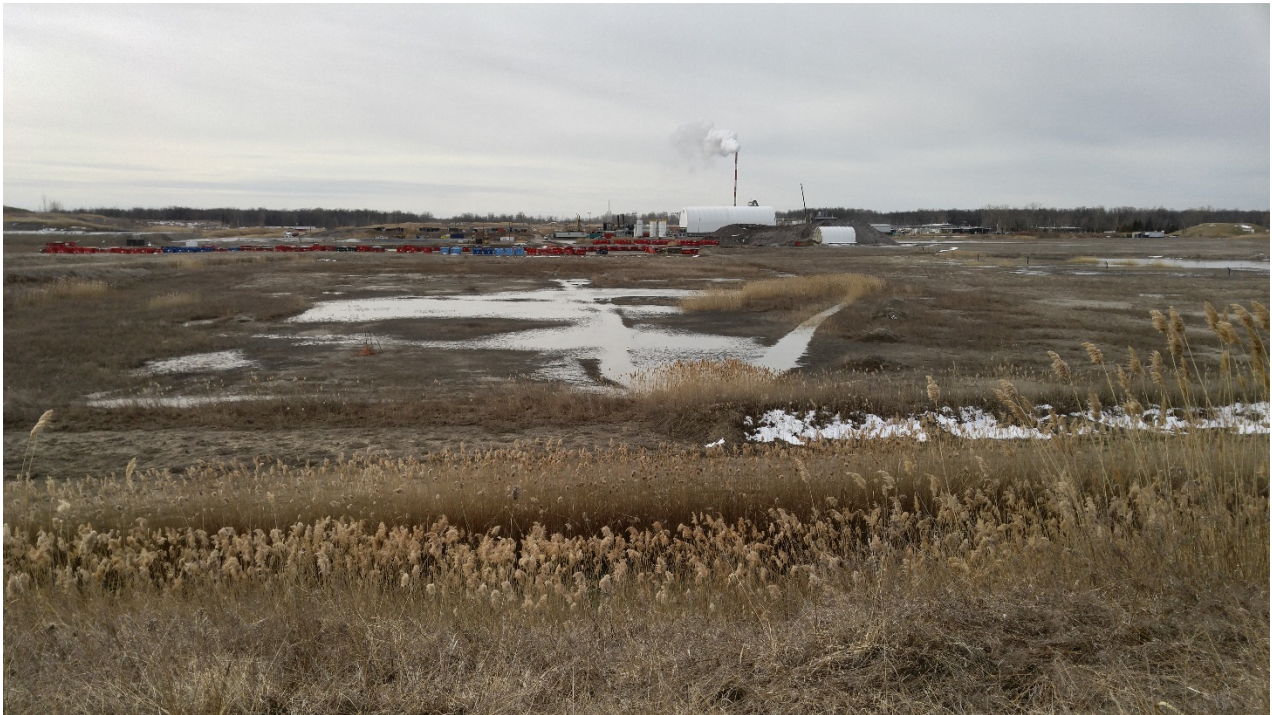
- Shallow ponding was identified within the southwest corner of the Original Landfill Area (OLA).
- Water levels were very high within the southern perimeter ditch of the OLA, nearly overtopping in areas. Pumping was not active during the Inspection.
- Shallow ponding was identified within the northwest corner of the OLA (location as shown on Figure 1 and Photo 3). The area has been graded to drain to the north ditch with an internal swale. The internal swale was partially full during the Inspection, with no observed flow.
- Minor ponding was noted in the northwest portion of proposed Cell 21-3 (i.e., located centrally in the northern portion of the Site), as shown in Photo 4. Two drainage paths were identified, both of which were full. No flow was observed.

Photo 4 - Ponding in northern, central portion of Site

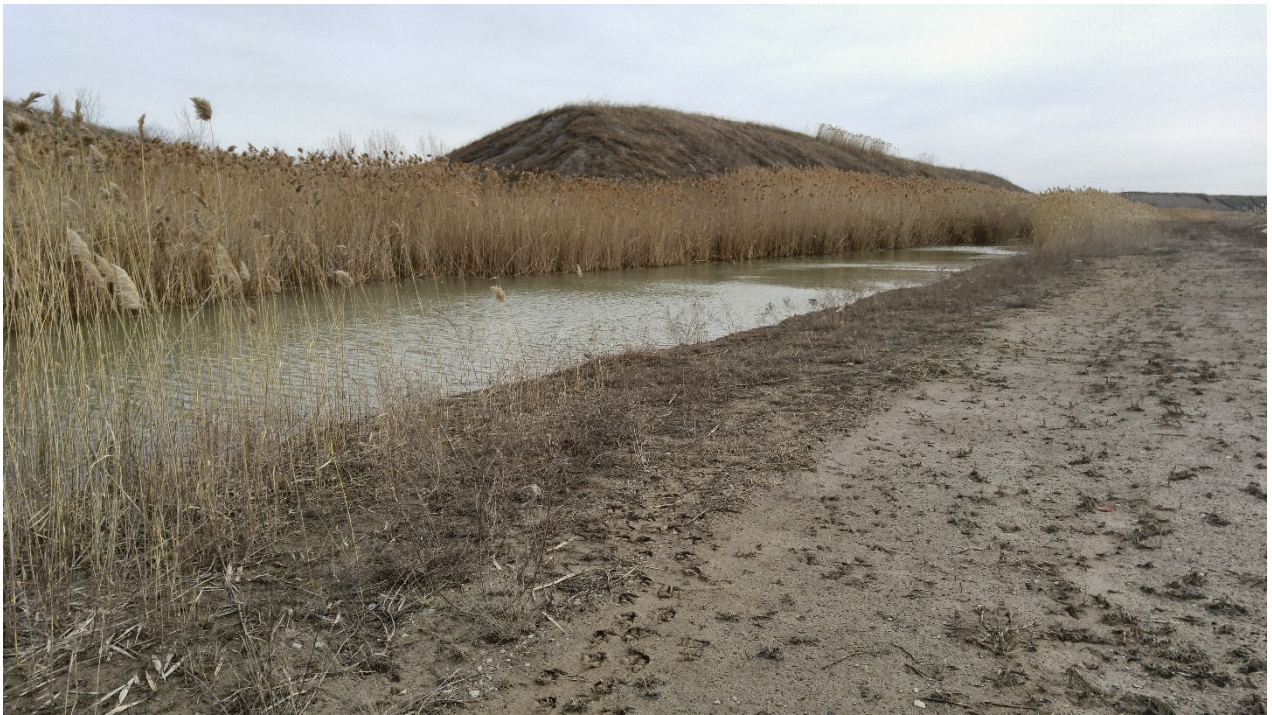
- Water levels continue to be high in the central portion of the north ditch, as shown in Photo 5. High water levels in the north ditch have the potential to prohibit the above-noted ponded areas from draining during wetter periods.

Photo 5 - High water levels in central portion of north perimeter ditch

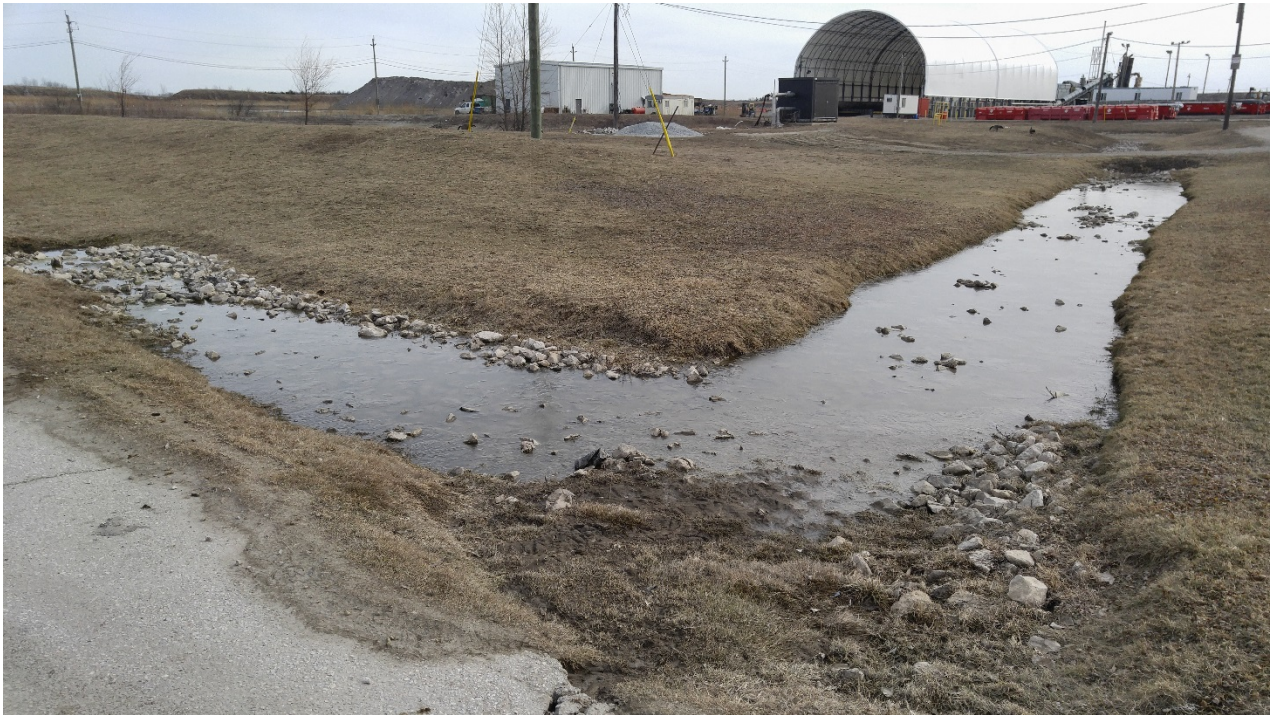
- The process water ditch adjacent to the TDU area exhibited a moderate water level at the time of Inspection. This ditch was not being pumped at the time of Inspection. Significant erosion channels immediately to the west, along the Landfill Container Compound access road, have been repaired, though channels remain on the road shoulder.
- The ditches feeding the North Process Water Pond had moderate to high levels of standing water at the time of Inspection. As shown in Photo 12, these ditches have significant sediment buildup in the rip rap and culverts, with little to no potential for flow toward the pond. The ditches were also partially covered with ice. It is recommended that sediment be removed from the ditches, including the ditch in front of the HHW Depot.

Photo 12 - North Process Water Pond ditch

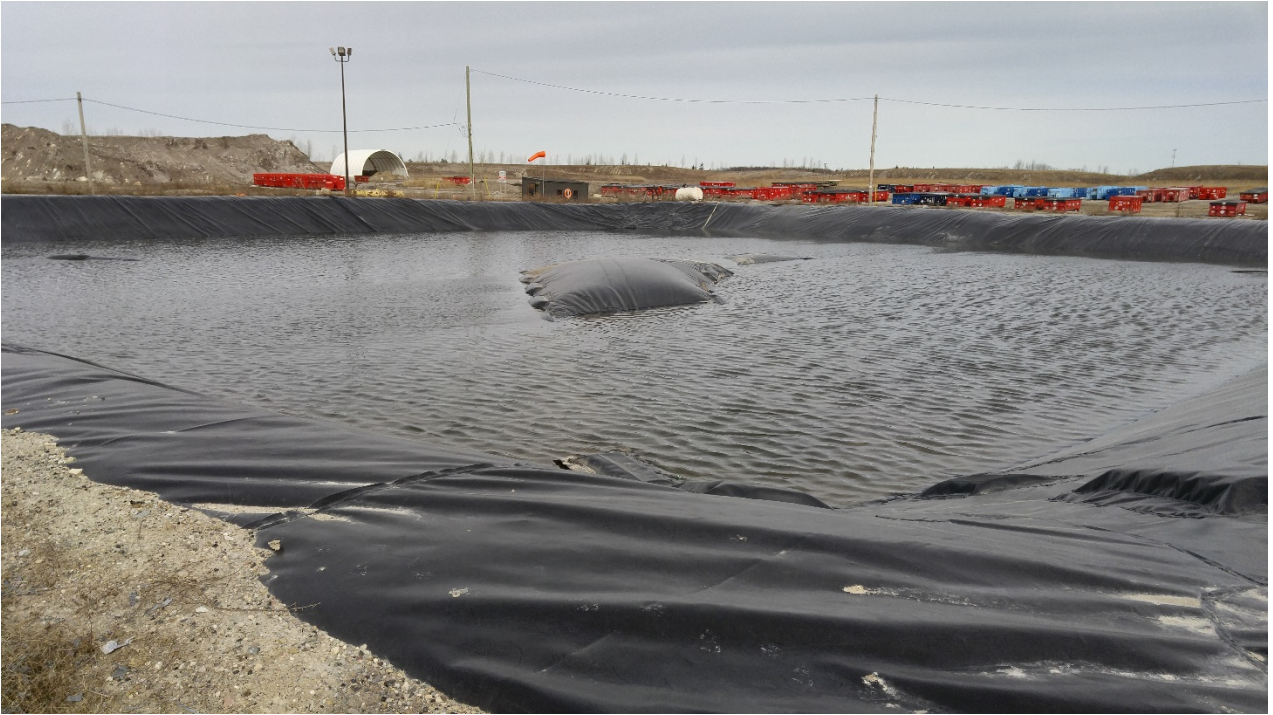
Photo 14 - South Leachate Reservoir

The following provides a description of the status of the South Leachate Reservoir (Photo 14):

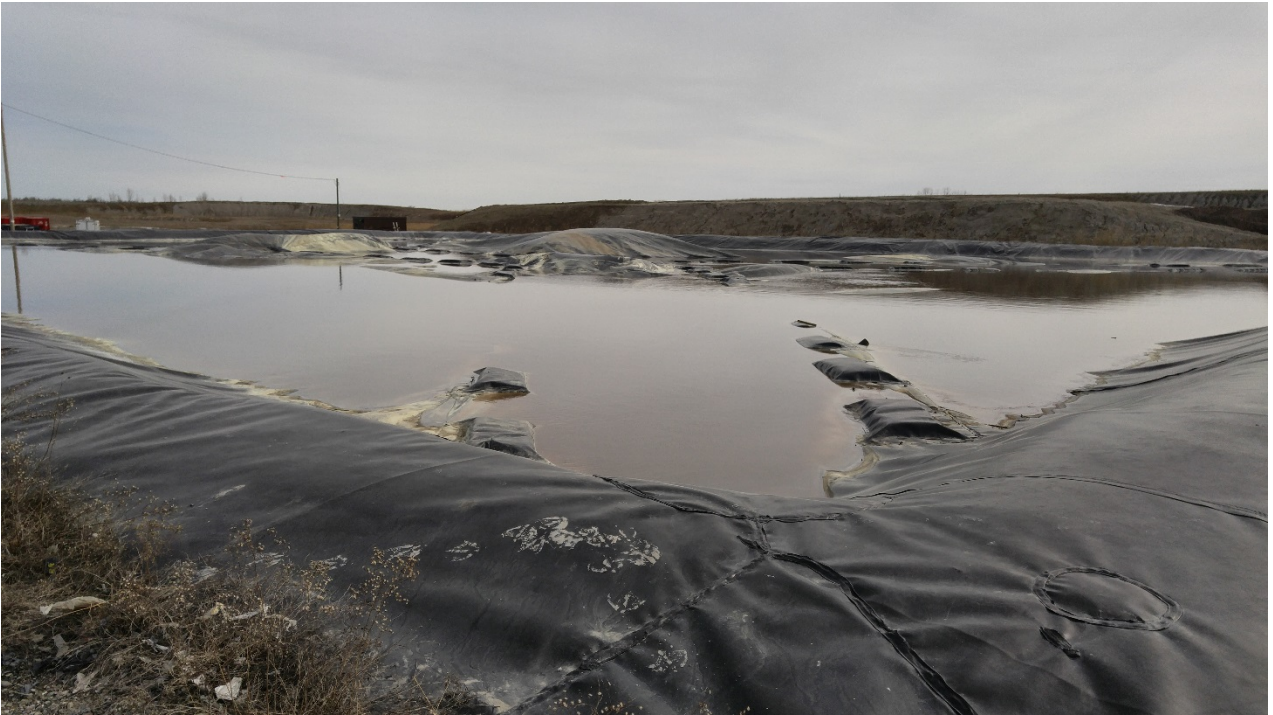
Photo 15 - East Leachate Reservoir

The following provides a description of the status of the East Leachate Reservoir (Photo 15):

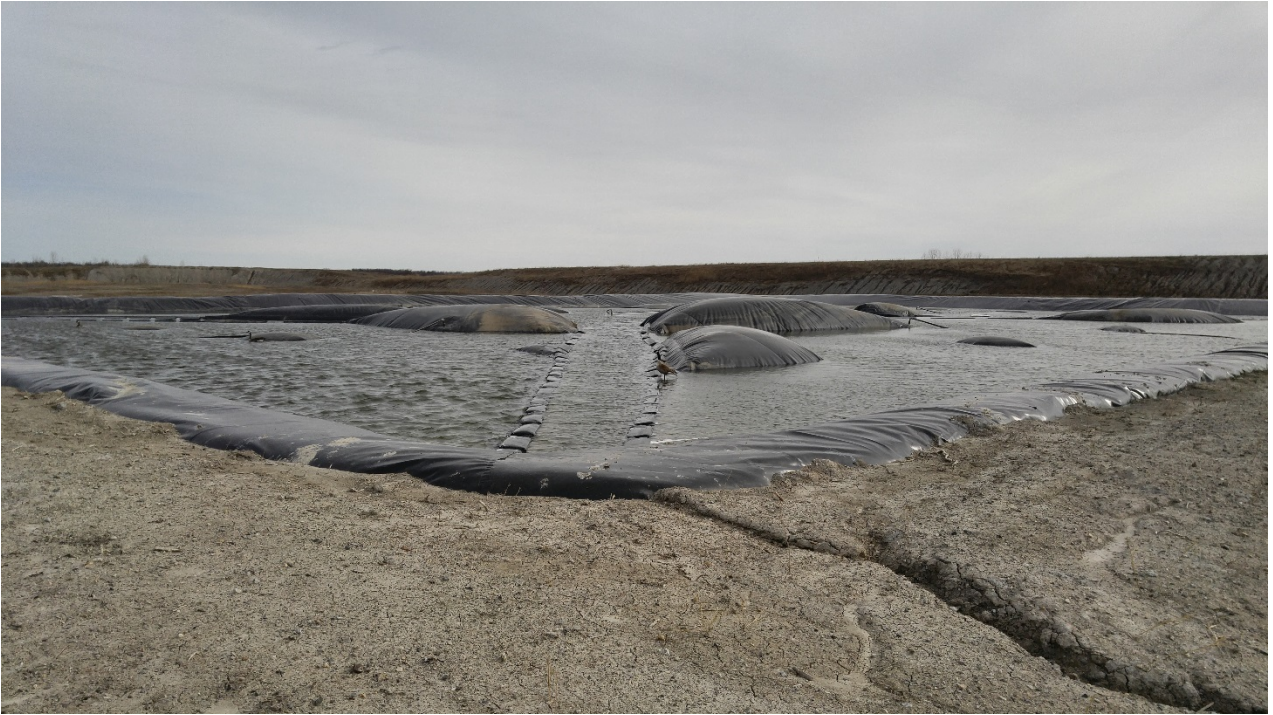
Photo 16 - New Leachate Reservoir

The following provides a description of the status of the New Leachate Reservoir (Photo 16):

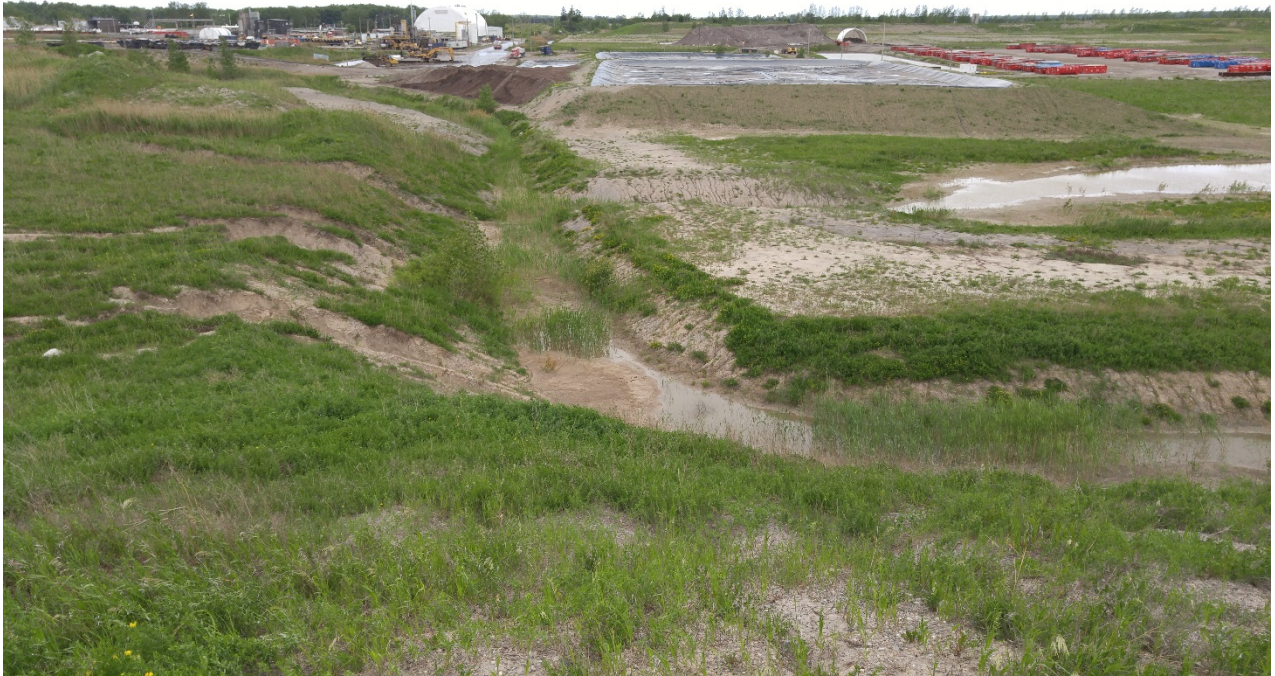
- Significant erosion was identified in the southeast corner of the OLA, resulting in sedimentation of the perimeter ditch and limited water flow, as shown in Photo 7 and Figure 1. Minimal standing water was observed in the southeast ditch and the internal swale to the north.

Photo 7 - North landfill area, southeast ditch, partial surface water blockage

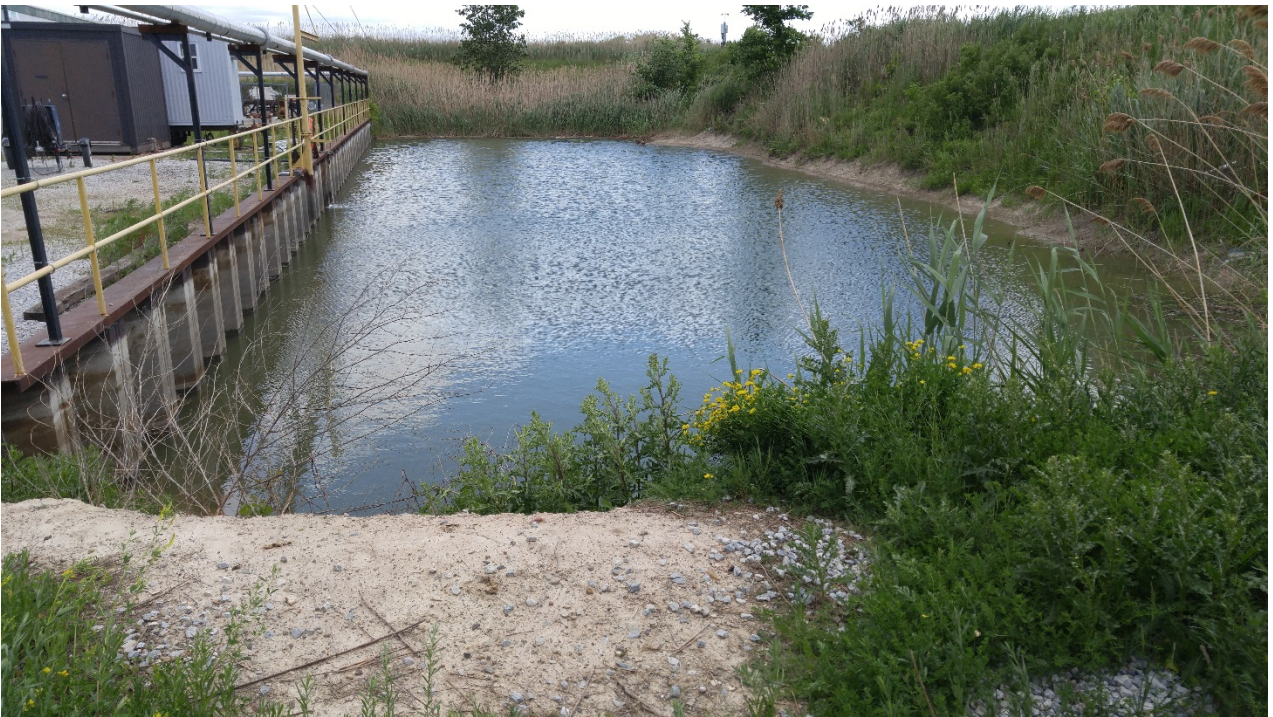
Photo 14 - South Process Water Pond

The following provides a description of the status of the South Process Water Pond (Photo 14):

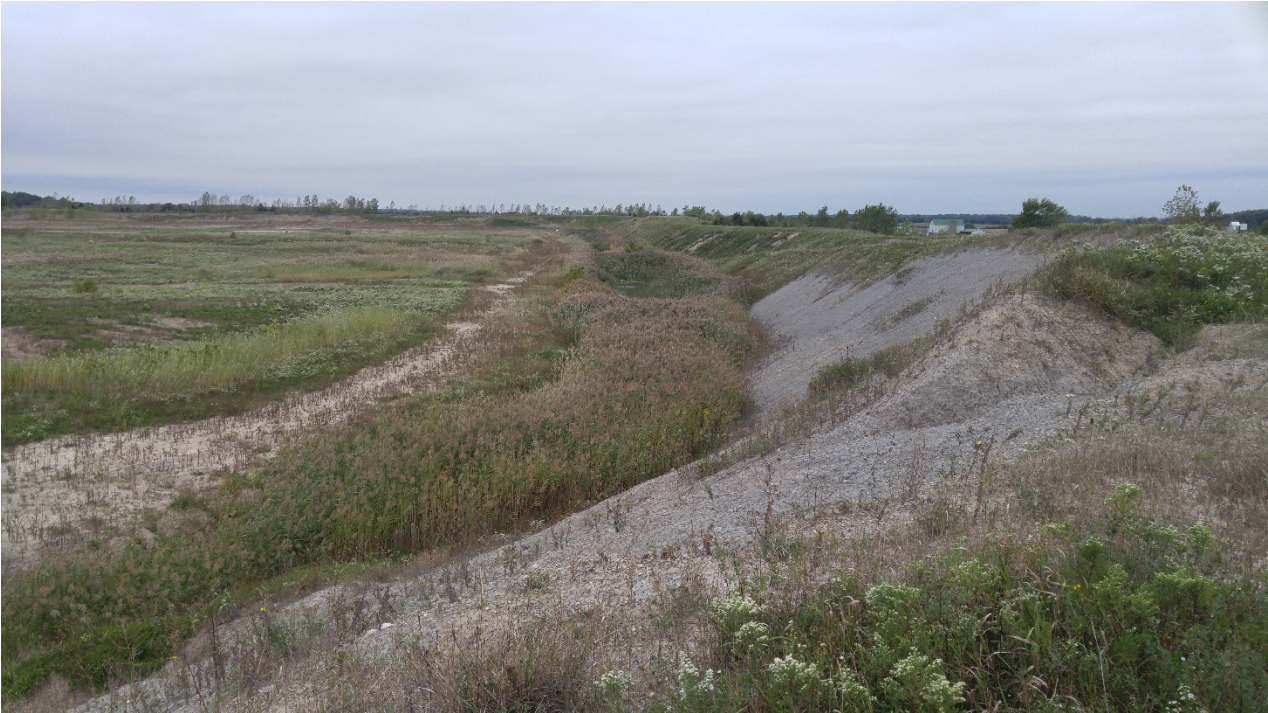
Photo 6 - North ditch, surface water blockage

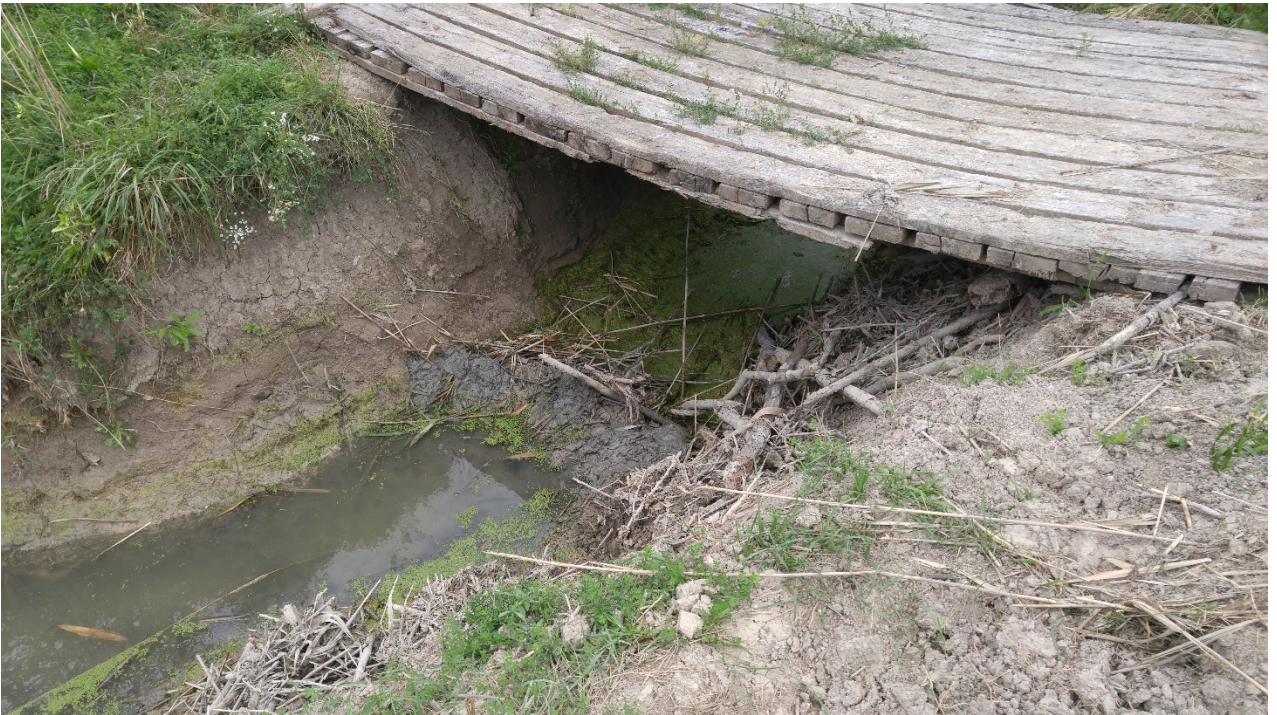
Photo 8 - South ditch, surface water blockage east of access bridge

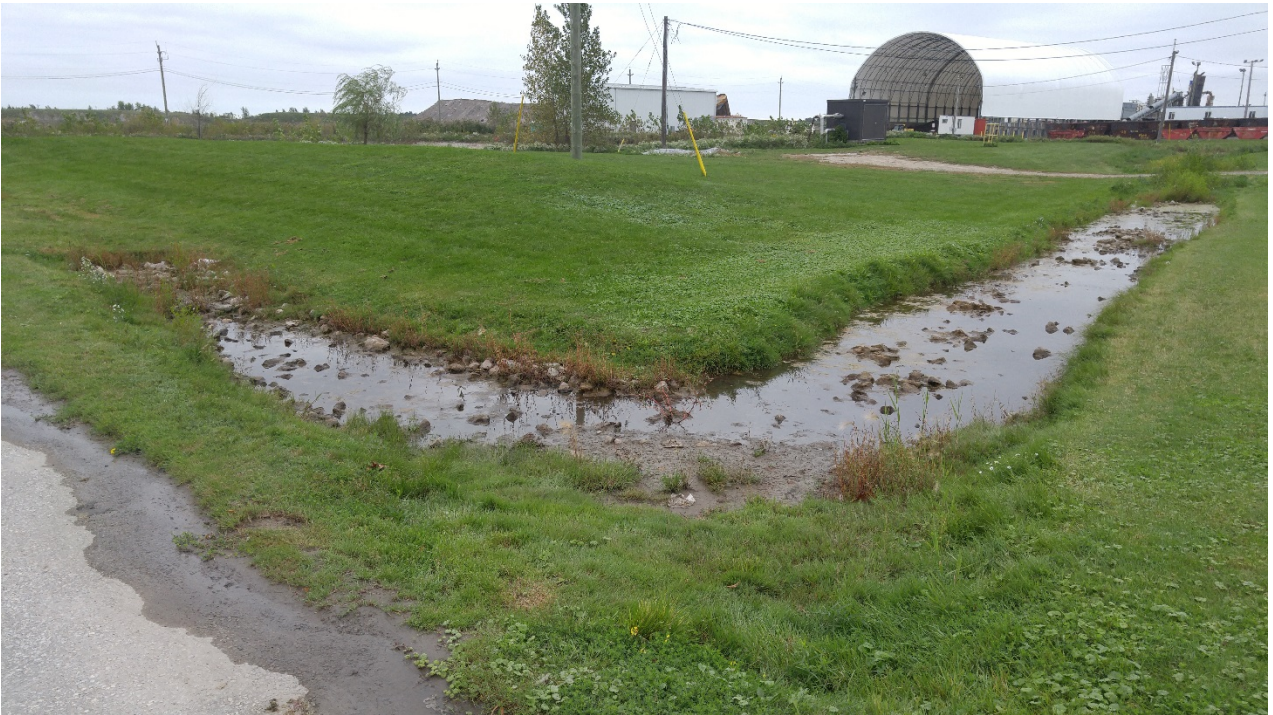
Photo 12 - North Process Water Pond ditch

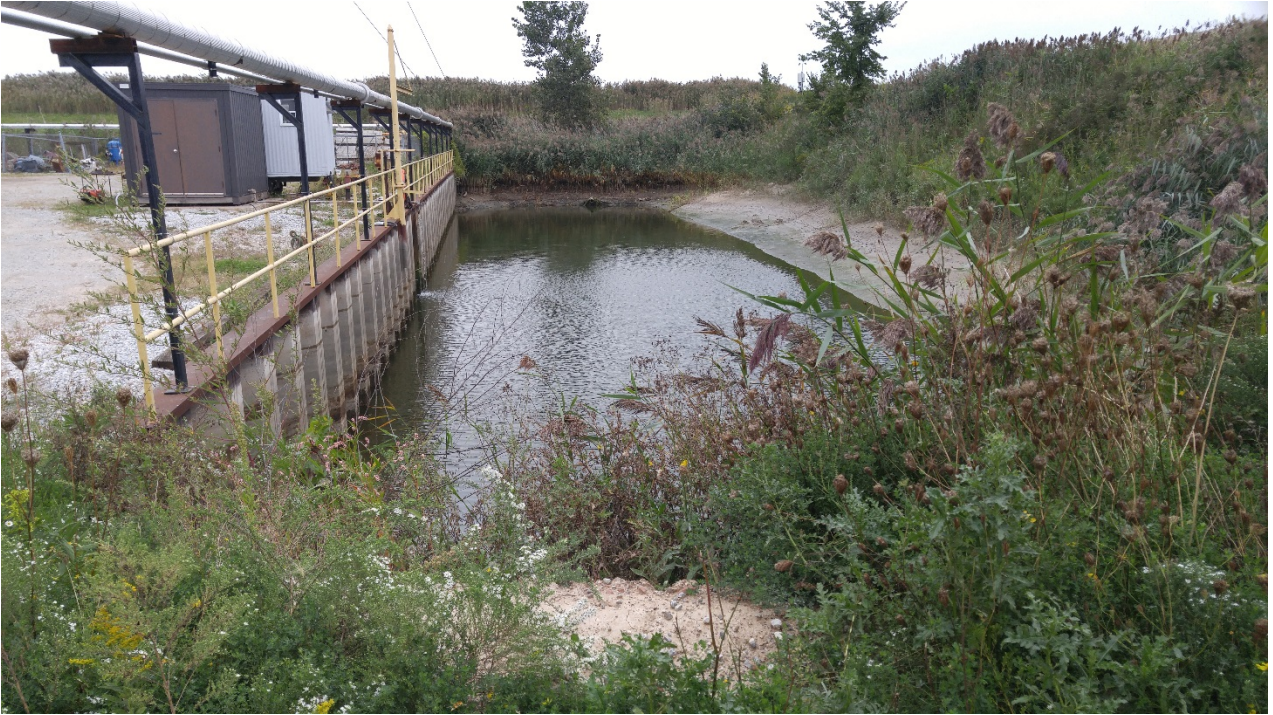
Photo 14 - South Process Water Pond

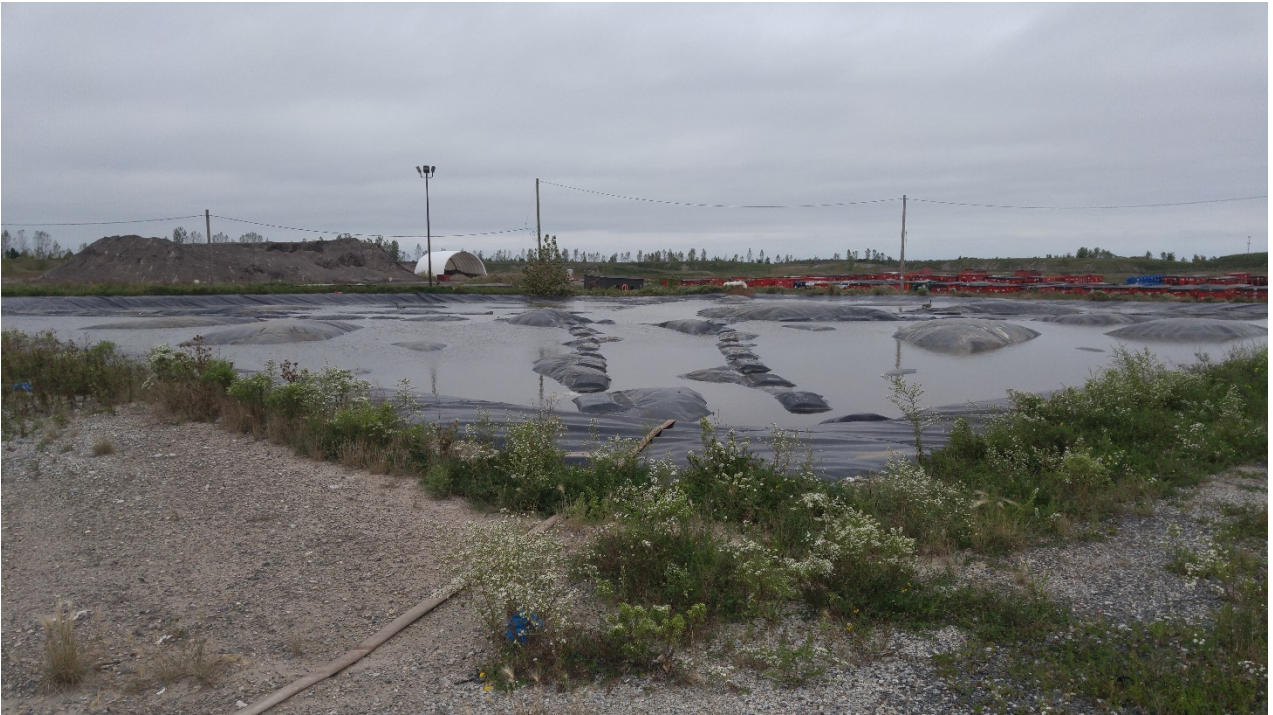
Photo 15 - South Leachate Reservoir

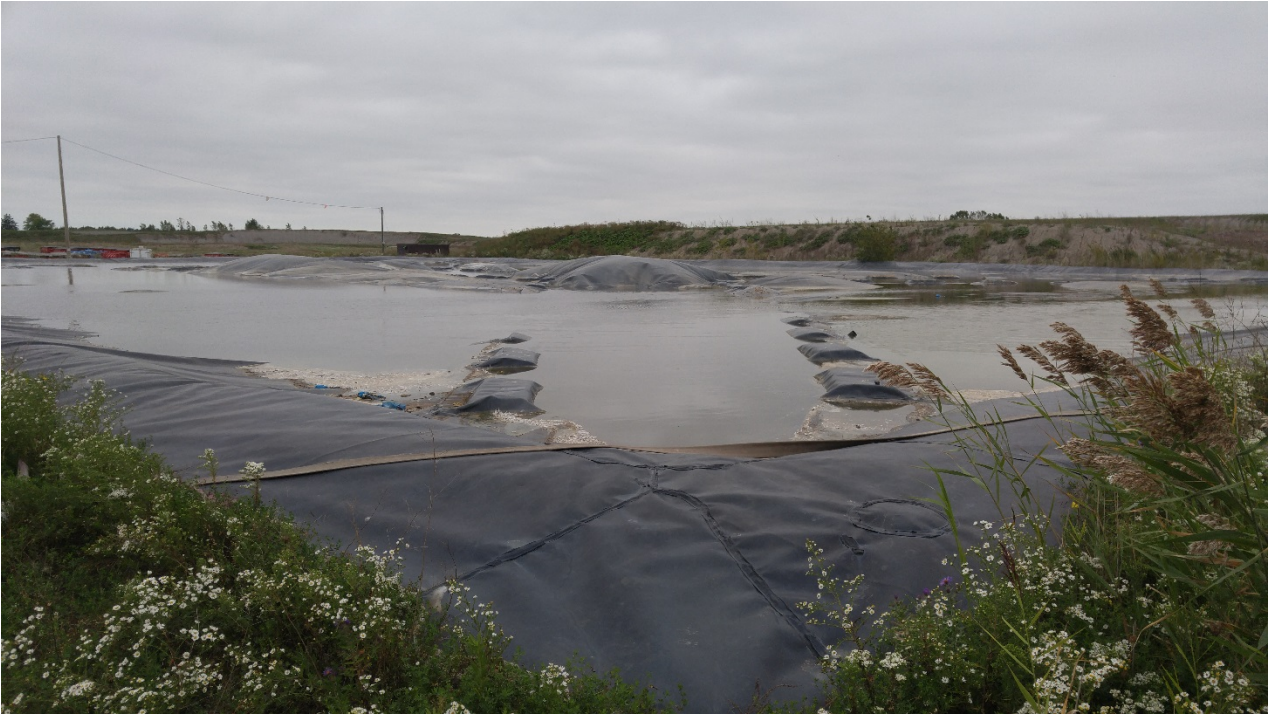
Photo 16 - East Leachate Reservoir

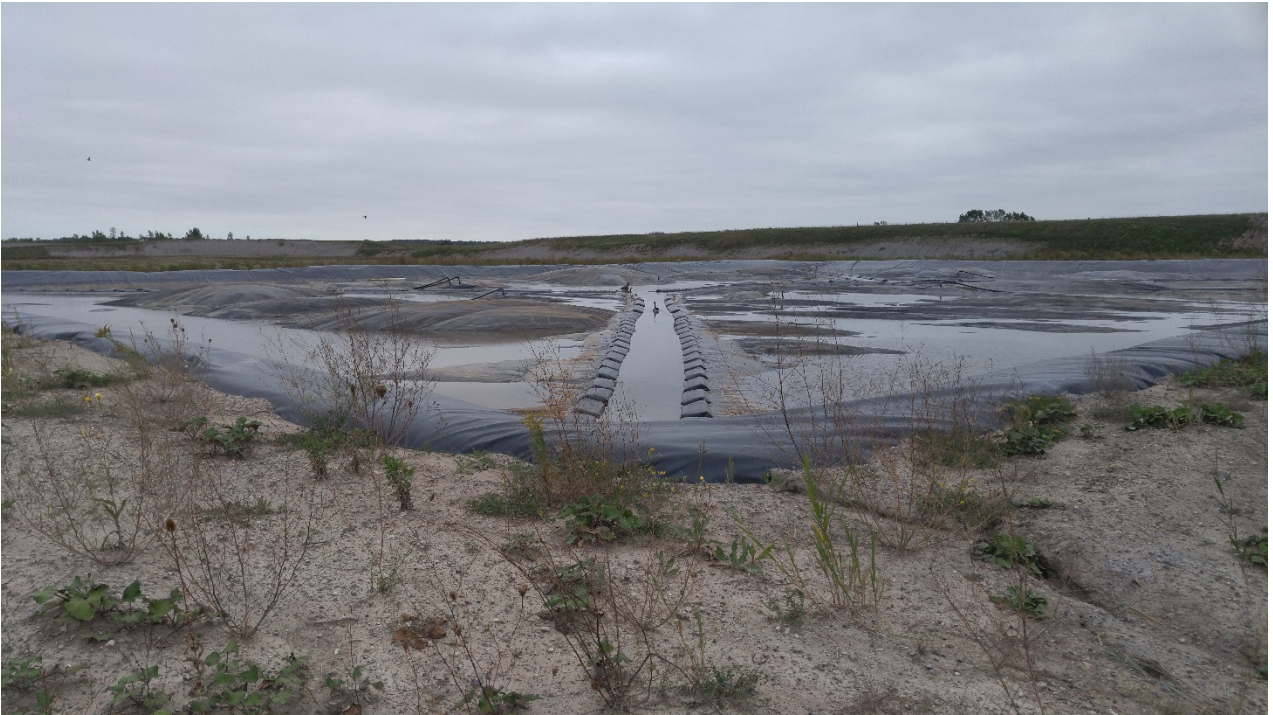
Photo 17 - New Leachate Reservoir

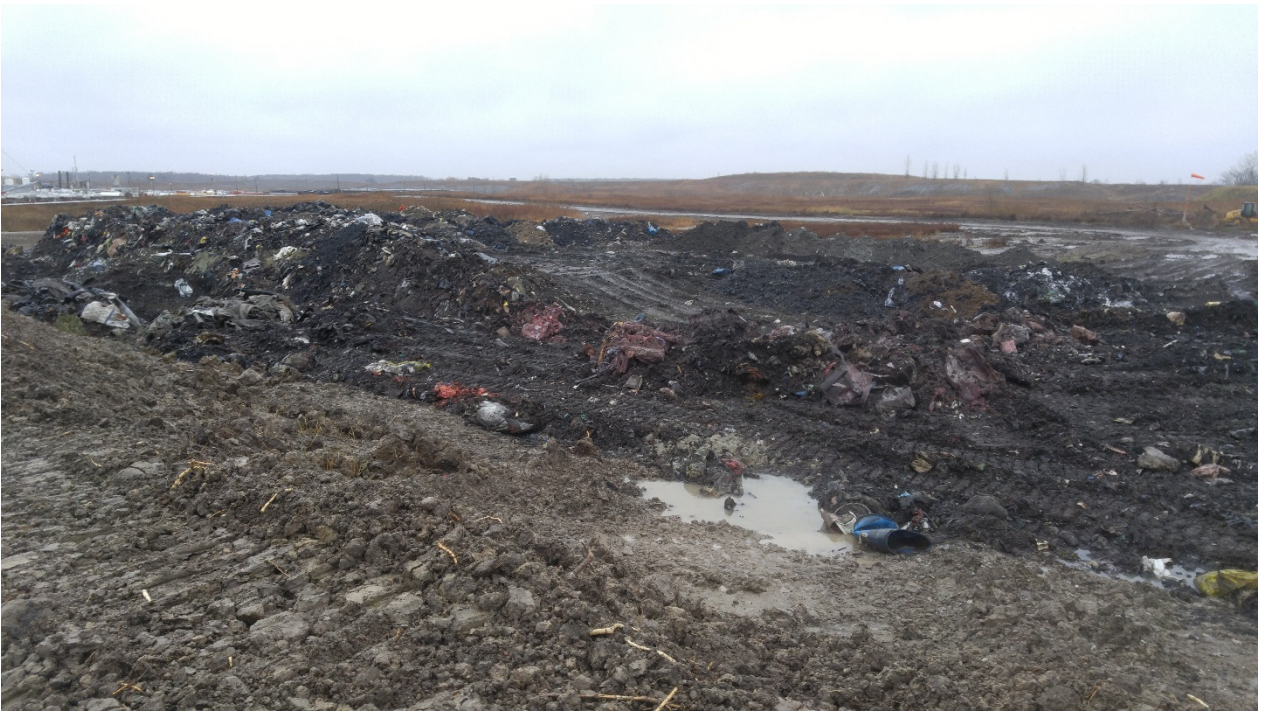
Photo 1 - Active landfilling cell (northern portion of Cell 19-1-3)

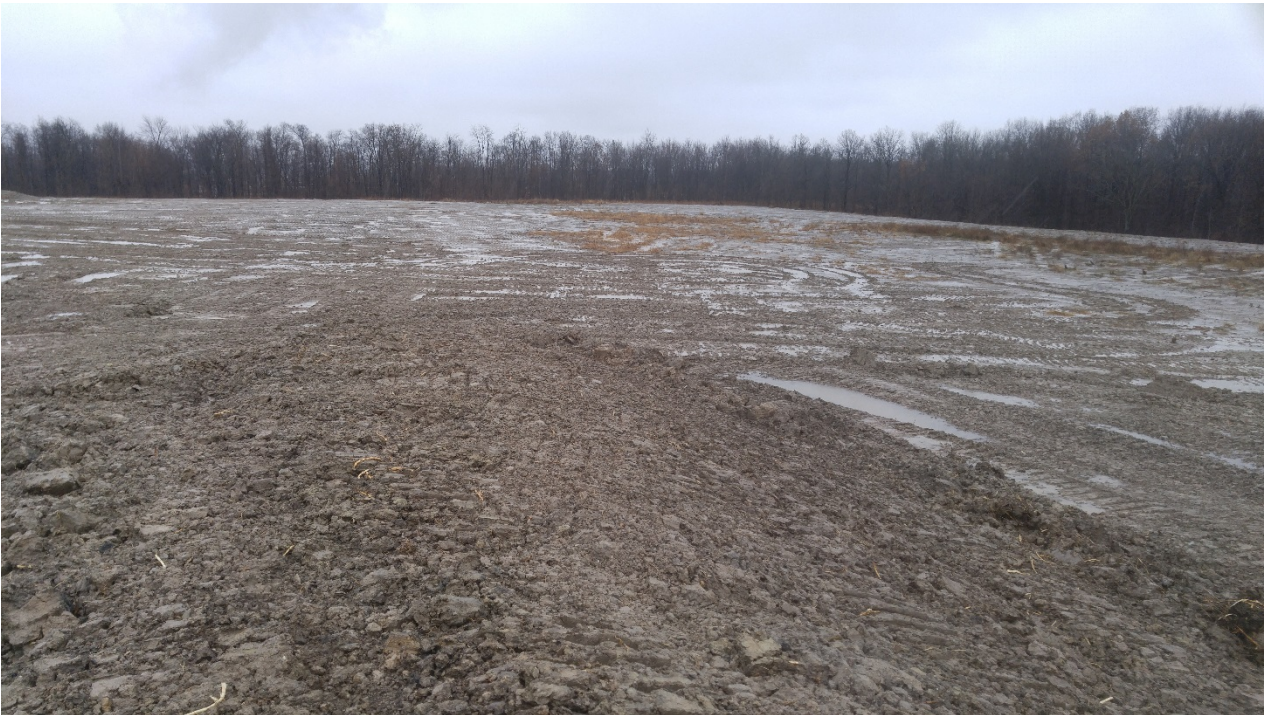
Photo 2 - Interim cap placement, Cells 19-1-1 and 19-1-2

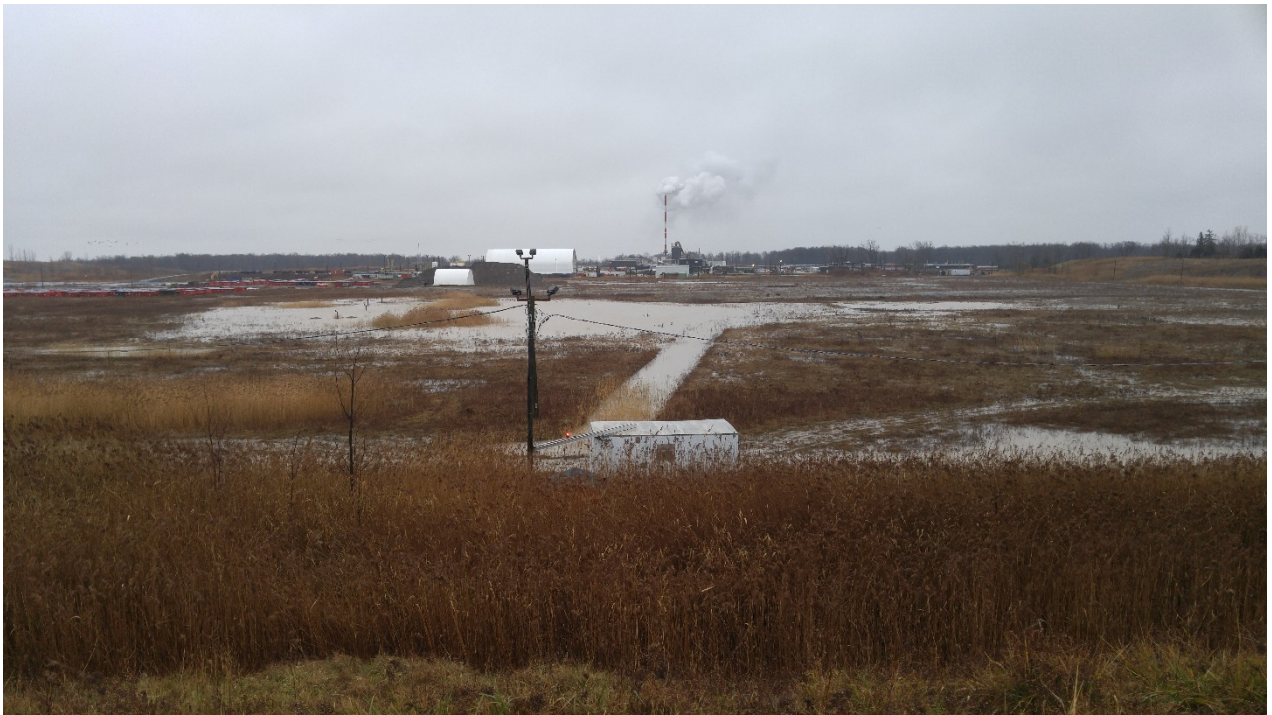
- Standing water was identified within the northwest corner of the OLA, as shown on Figure 1 and Photo 3. The area has been graded to drain to the north ditch with an internal swale. The internal swale was full, with no observed flow during the Inspection.

Photo 3 - Standing water in northwest corner of Site

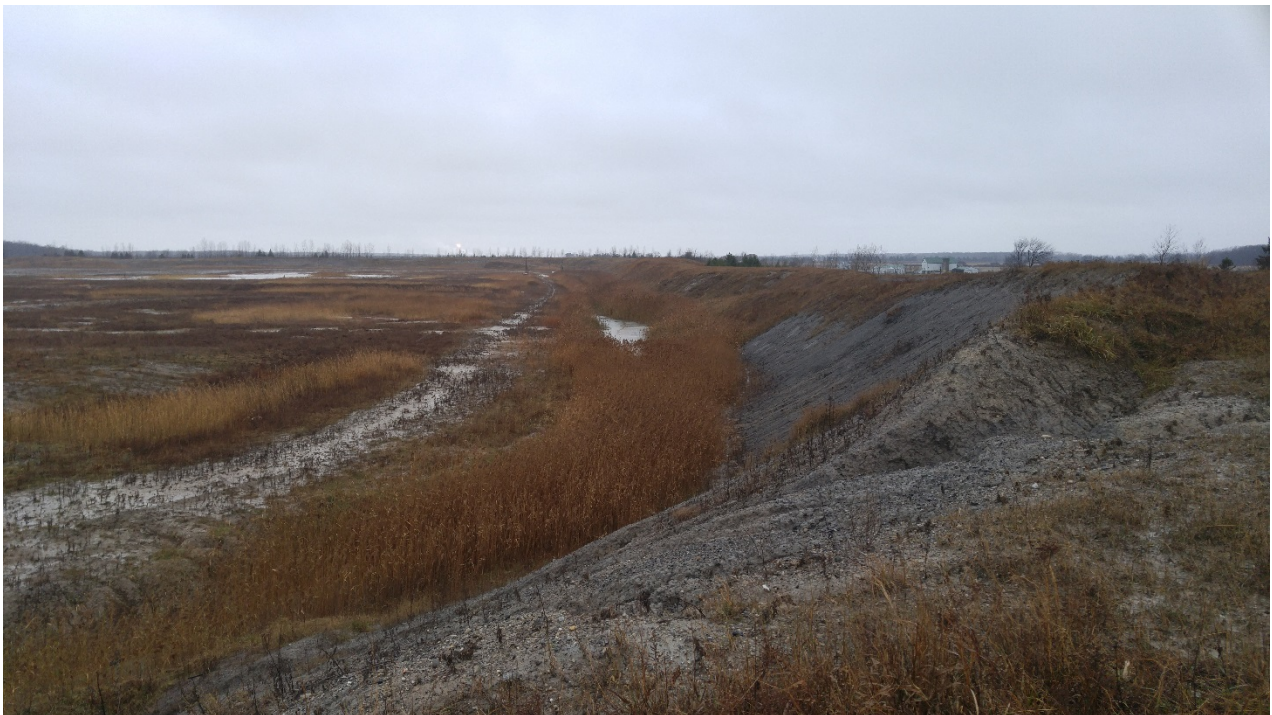
- Flow from the north ditch to the eastern ditch is impeded by sedimentation in the northeast corner of the Site, likely brought on by dense wetland vegetation within the ditch and sedimentation, as shown in Photo 6 and Figure 1.

Photo 6 - North ditch, surface water blockage

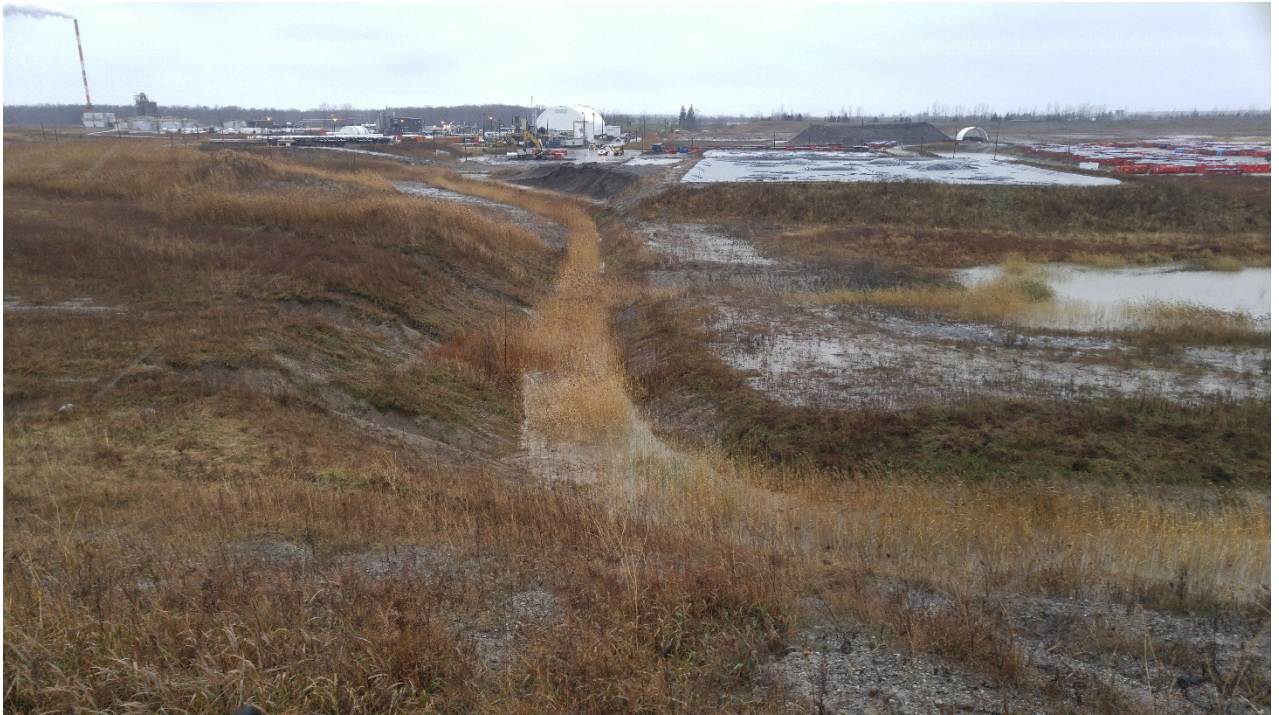
- Significant erosion was identified in the southeast corner of the OLA, resulting in sedimentation of the perimeter ditch and limited water flow, as shown in Photo 7 and Figure 1. Water levels were sufficient to overtop the sedimentation, resulting in limited flow. Standing water was observed in the internal swale and low-lying area to the north, as shown in Photo 8 and Figure 1.

Photo 7 - North landfill area, southeast ditch, partial surface water blockage

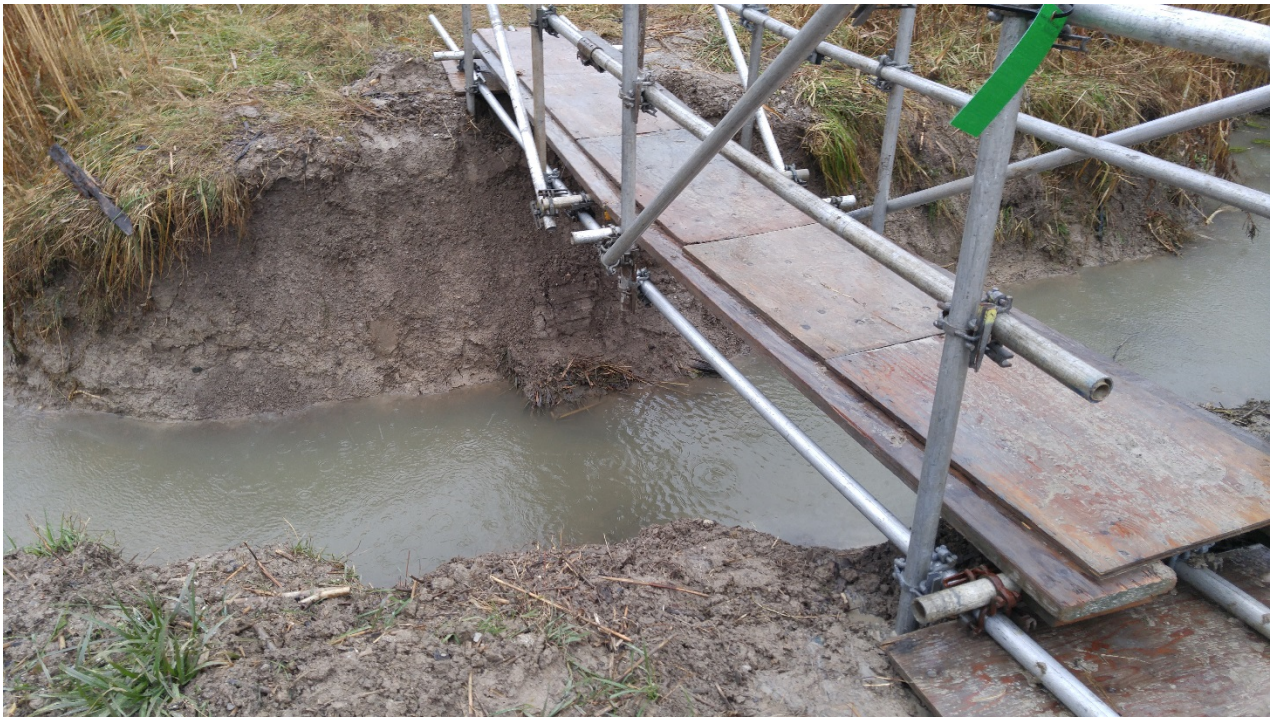
- The previously noted flow break in the south ditch (the result of wildlife activity - specifically beavers), located at the Gate 6 access bridge, has been removed. As shown in Photo 9, water levels were moderate to high, with limited observed flow.

Photo 9 - South ditch, surface water blockage removed

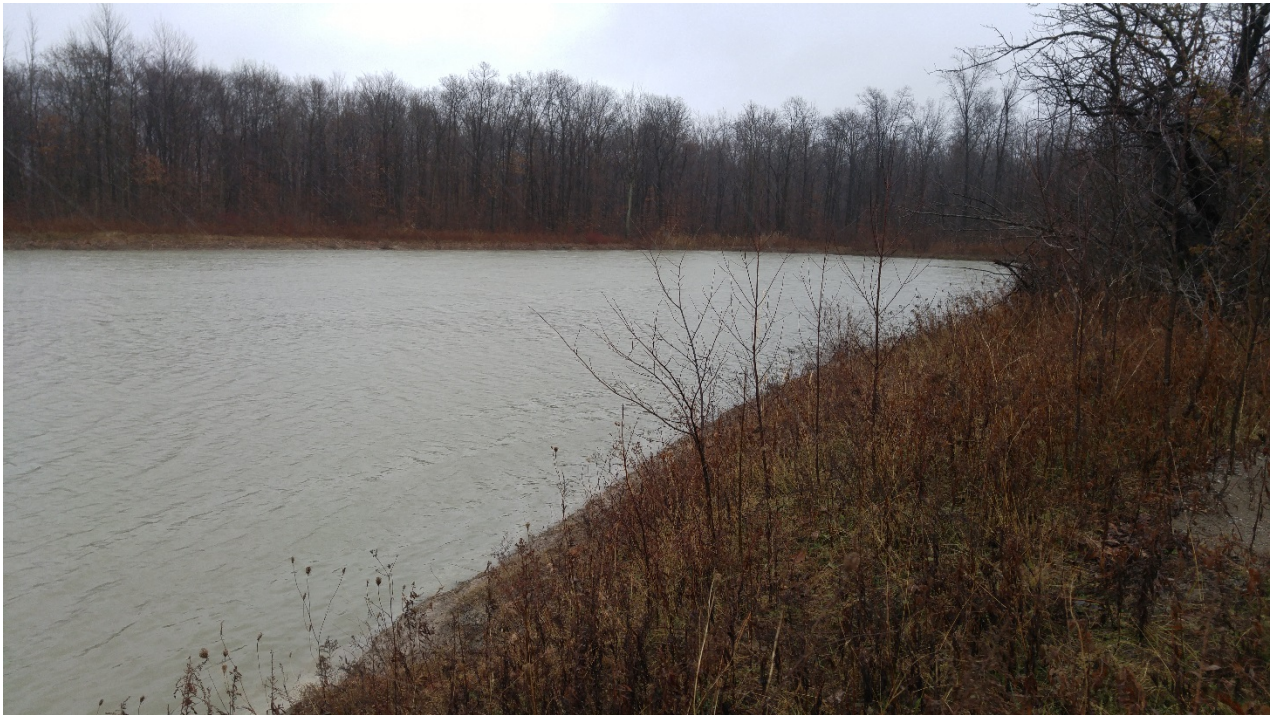
Photo 10 - East Surface Water Pond

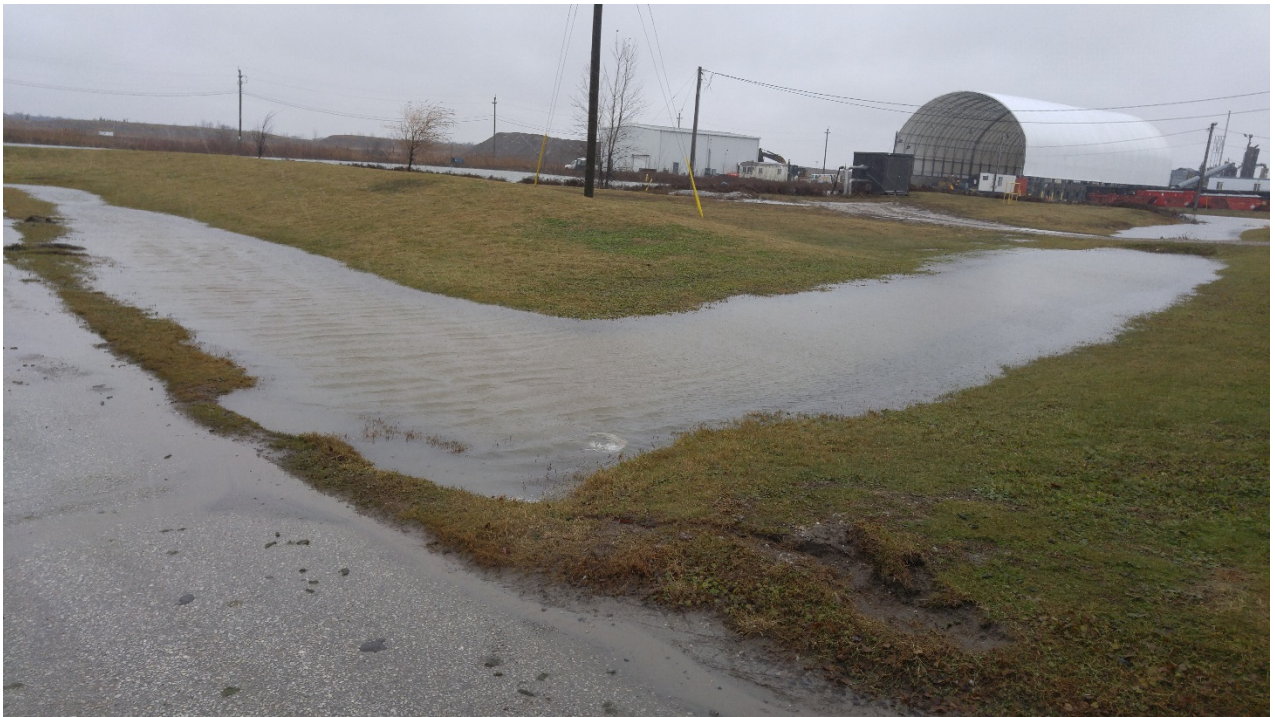
- The process water ditch adjacent to the TDU area exhibited a high water level at the time of Inspection. This ditch was not being pumped at the time of Inspection. Erosion channels were observed immediately to the west, along the shoulder of the Landfill Container Compound access road.
- The ditches feeding the North Process Water Pond exhibited very high water levels, matching the level of the North Process Water Pond, as shown in Photo 13. Prior inspections identified sedimentation and culvert damage in these ditches, impeding flow and resulting in standing water within the ditches. It is recommended that sediment be removed and culvert(s) be repaired as necessary to promote drainage.
- Moderate to high water levels were observed in the small ditches near the South Process Water Pond at the time of the Inspection.

Photo 13 - North Process Water Pond ditch
