2018 Quarterly Site Inspections

Clean Harbors Lambton Facility
4090 Telfer Road, Corunna, Ontario

Clean Harbors Canada, Inc.

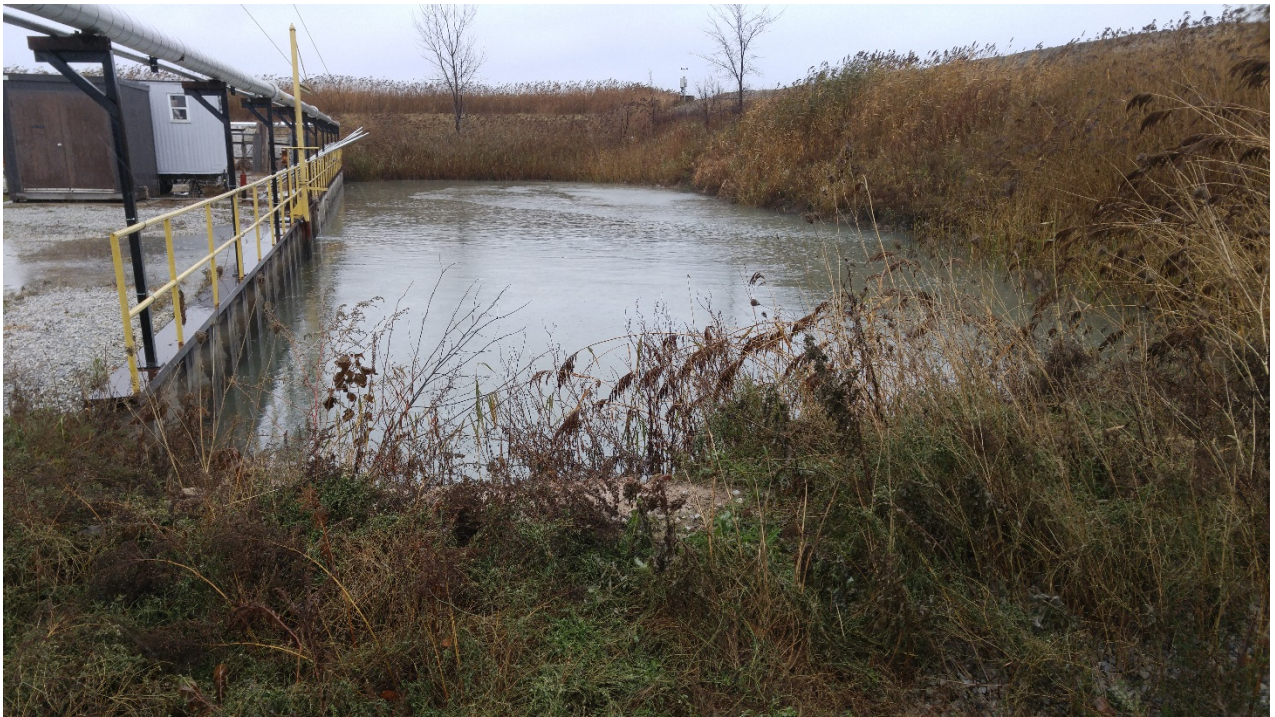
Photo 15 - South Process Water Pond

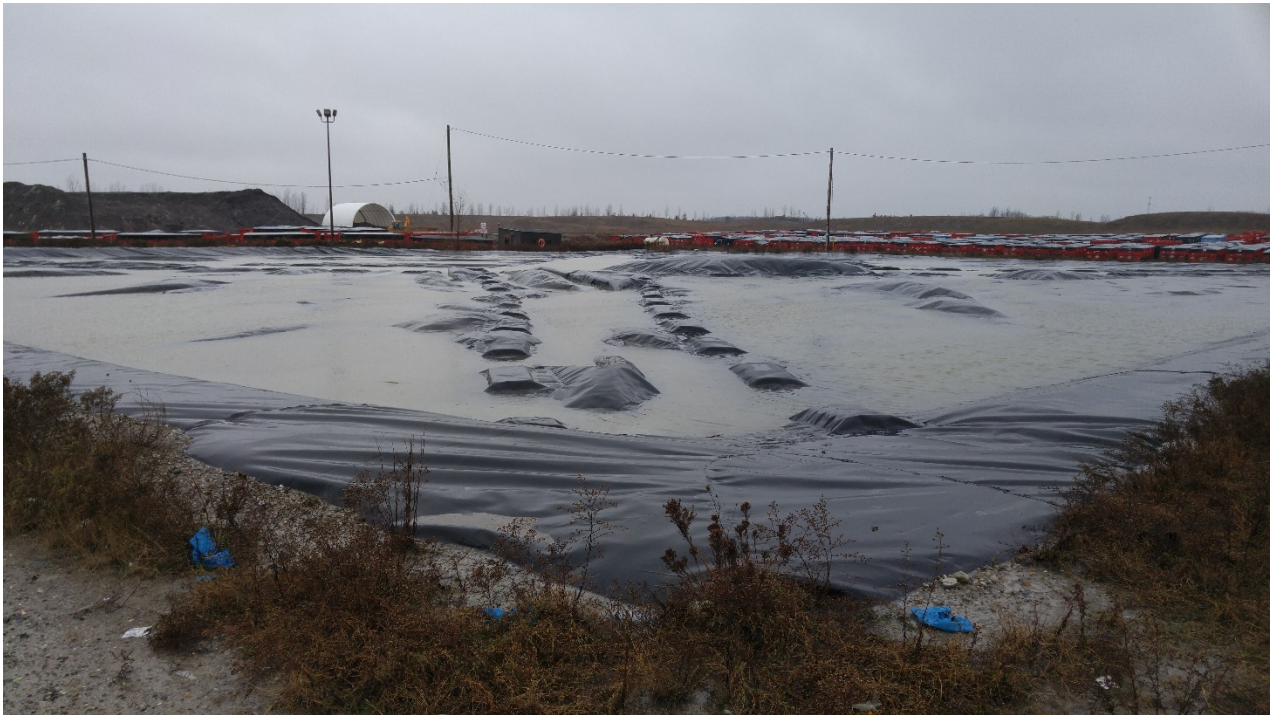
Photo 16 - South Leachate Reservoir

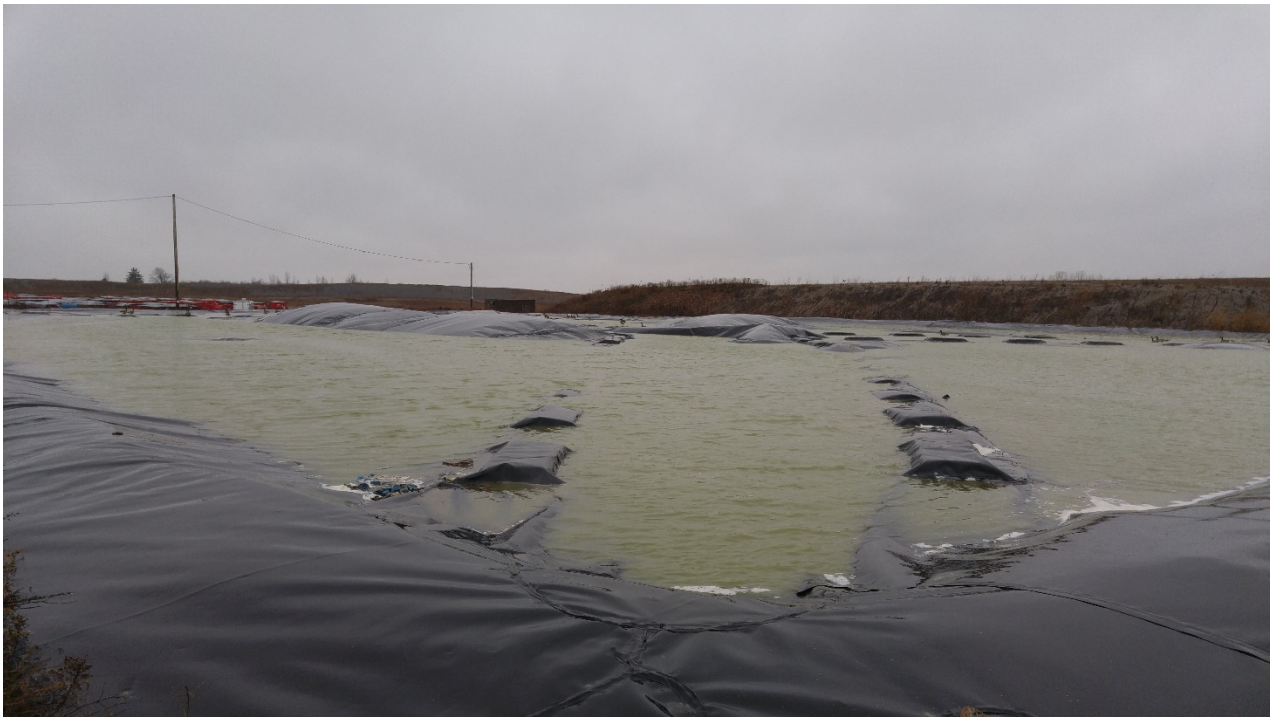
Photo 17 - East Leachate Reservoir

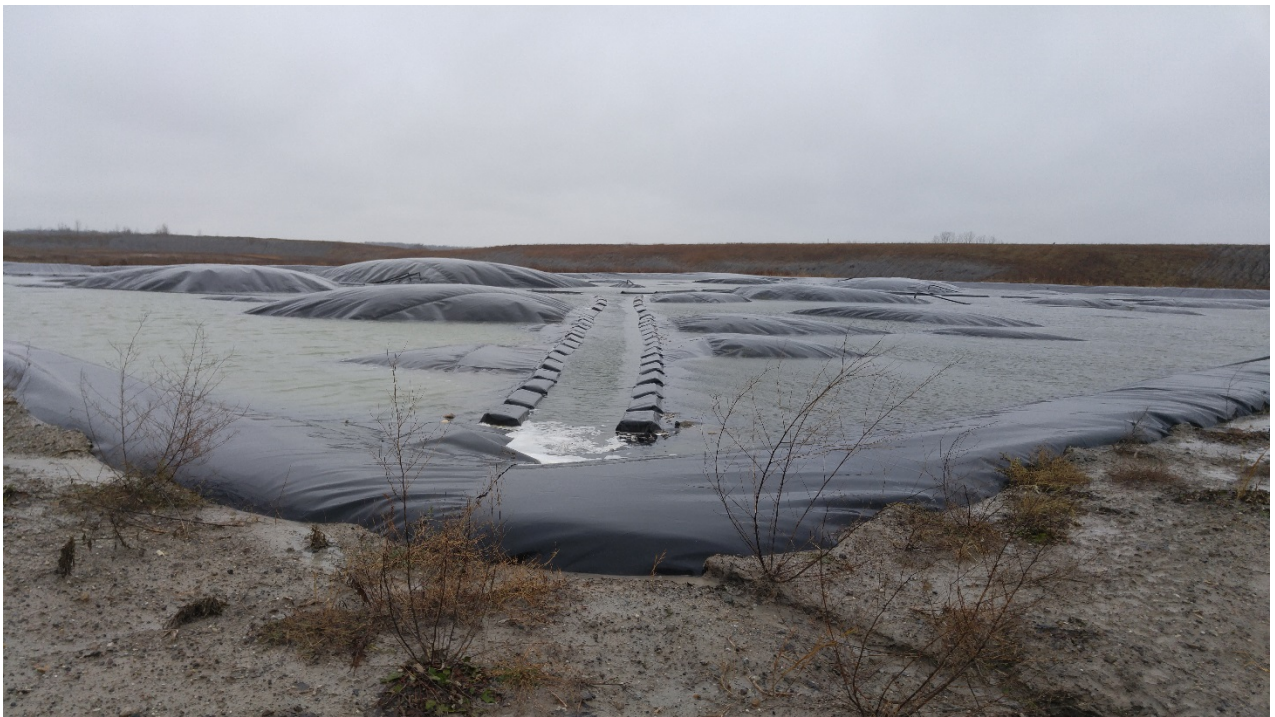
Photo 18 - New Leachate Reservoir
