2019 Quarterly Site Inspections

Clean Harbors Lambton Facility
4090 Telfer Road, Corunna, Ontario

Clean Harbors Canada, Inc.

Subject: 2019 First Quarter Site Inspection

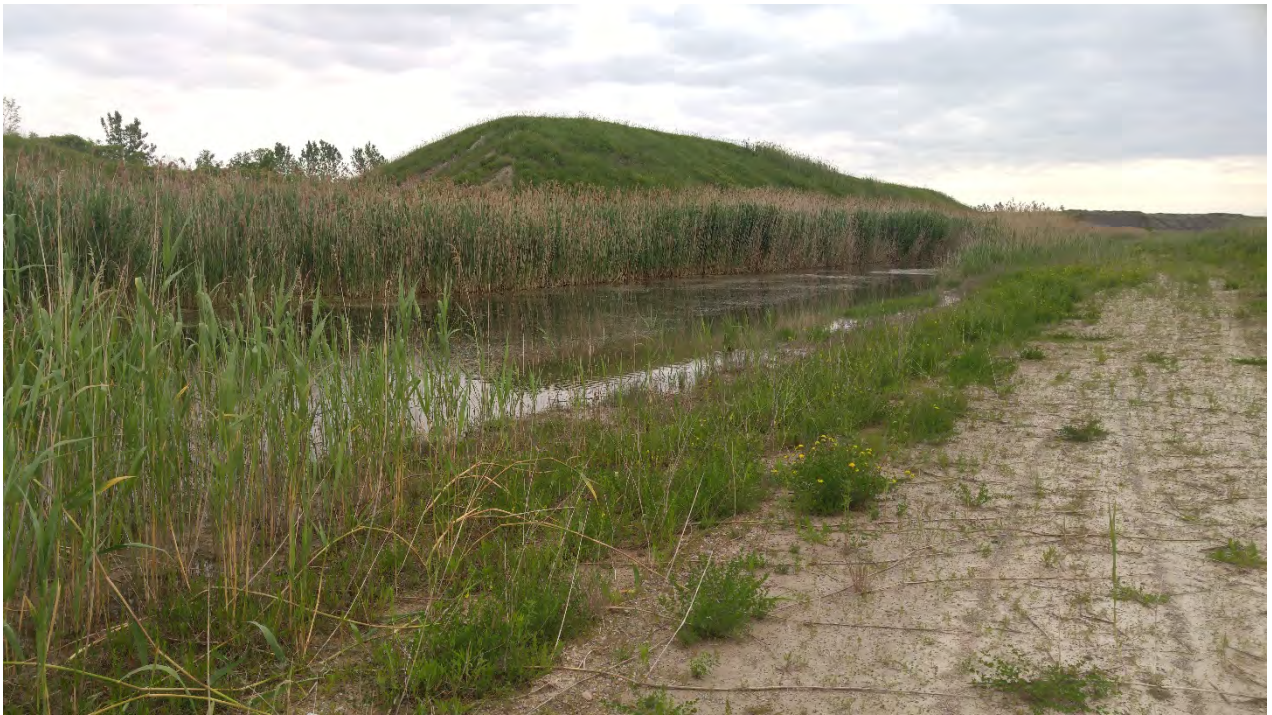
Photo 5 - High water levels in central portion of north perimeter ditch

- Water levels continue to be high in the central portion of the north ditch, nearly full and covered with ice, as shown in Photo 5. High water levels in the north ditch have the potential to prohibit surface drainage from the OLA during wetter periods.

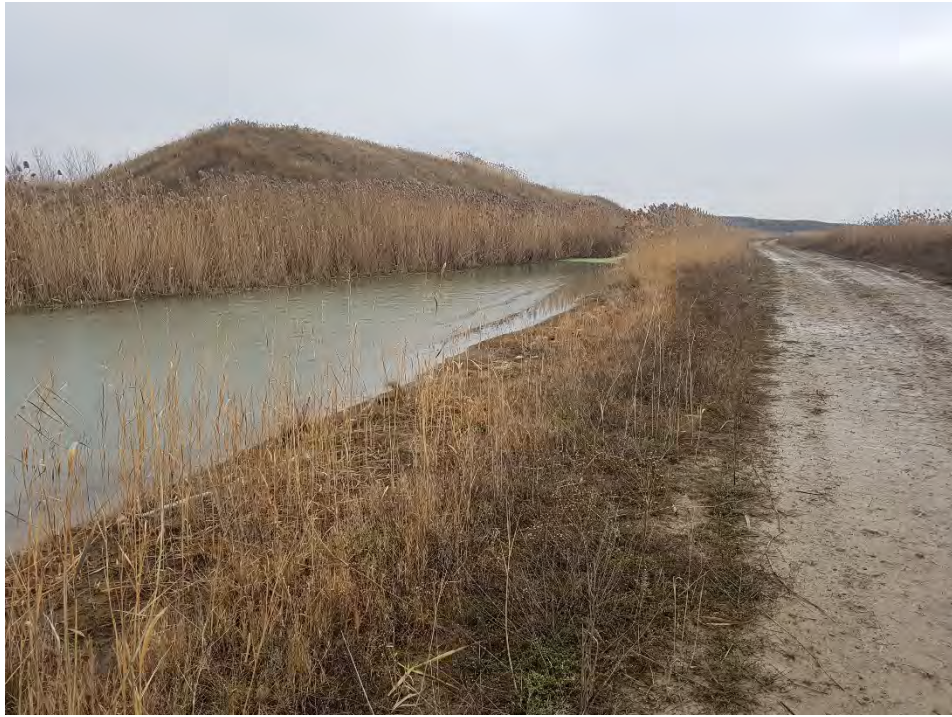
Photo 9 - High water levels in central portion of north perimeter ditch

- Water levels continue to be high in the central portion of the north ditch, as shown in Photo 9. High water levels in the north ditch have the potential to prohibit surface drainage from the OLA during wetter periods.

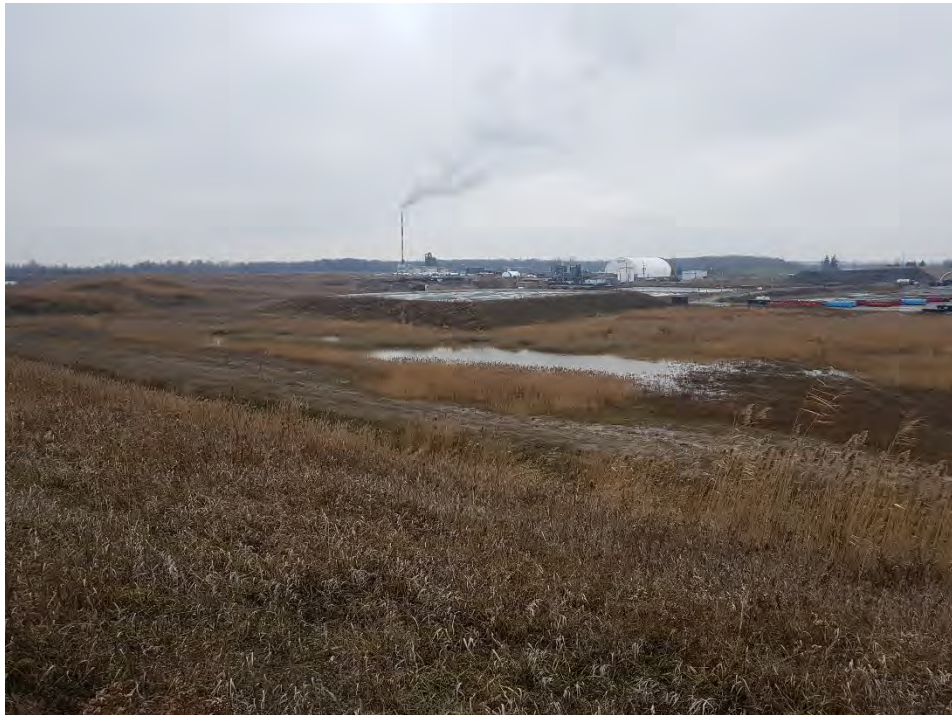
Photo 12 - Standing water in southeast corner of Original Landfill Area

- Significant erosion was identified in the southeast corner of the OLA, resulting in sedimentation of the perimeter ditch and limited water flow, as shown in Photo 11 and Figure 1. This portion of ditch was wet, with standing water noted and dense wetland vegetation. Standing water was observed in the internal swale and low-lying area to the north, as shown in Photo 12 and Figure 1.

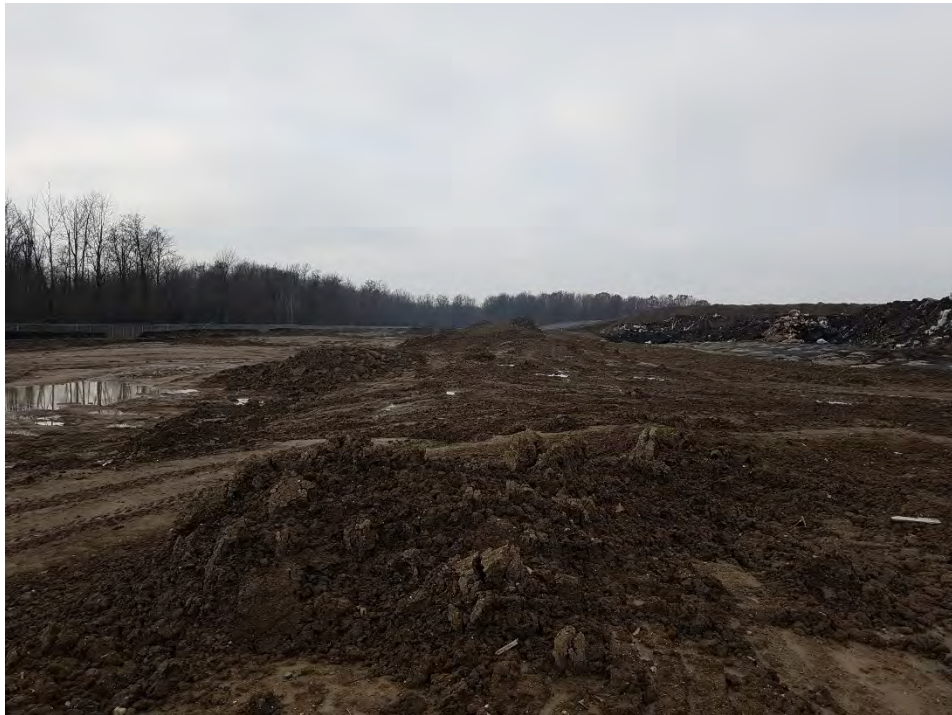
- Damp conditions were observed in the east perimeter ditch between the OLA and the East Surface Water Pond.
- Remediation of the south ditch has been completed as per Provincial Officer's Order No. 2681-BCPKUJ, as shown in Photo 13 and Figure 1, standing water was noted south of cell 19-1 and cell 19-2 as shown in Photo 14 and Figure 1.

Photo 13 – Completed south ditch remediation

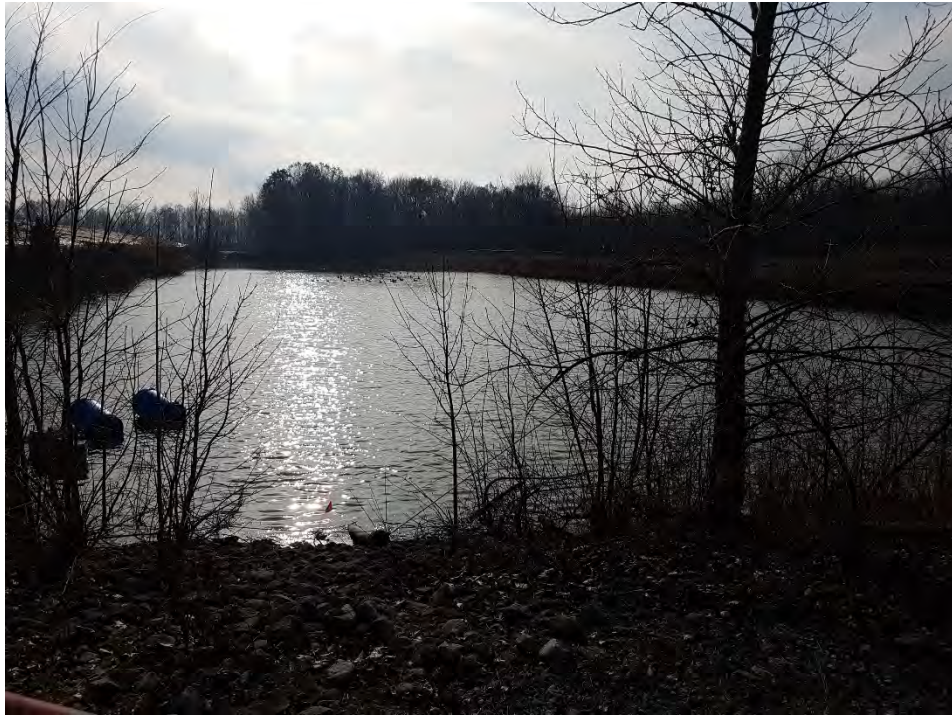
Photo 16 - East Surface Water Pond

The following provides a description of the status of the East Surface Water Pond (Photo 16):

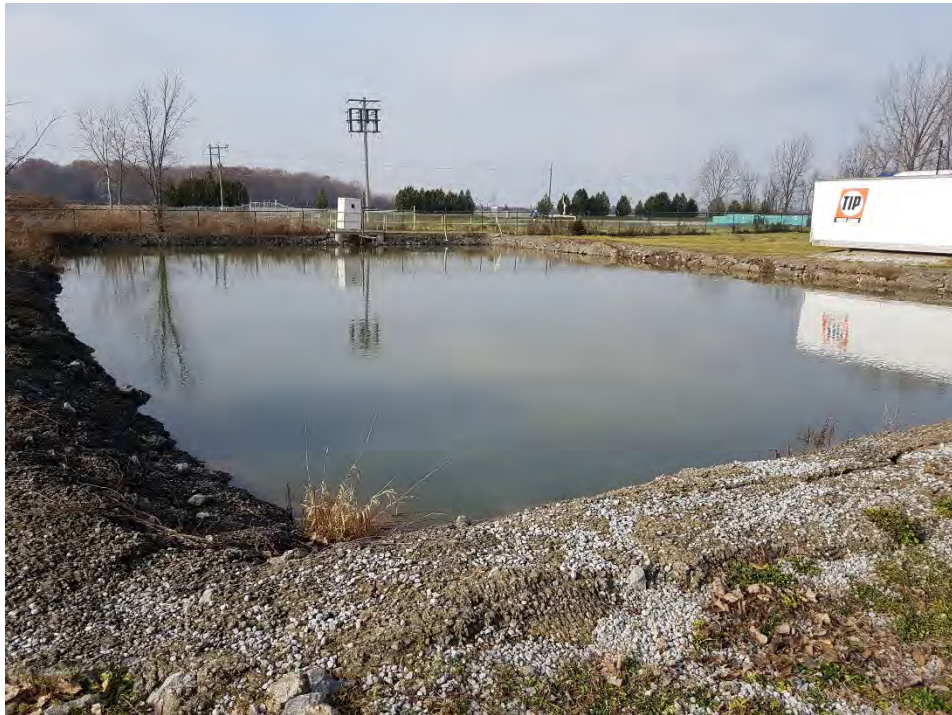
Photo 17 - West Surface Water Pond

The following provides a description of the status of the West Surface Water Pond (Photo 17):

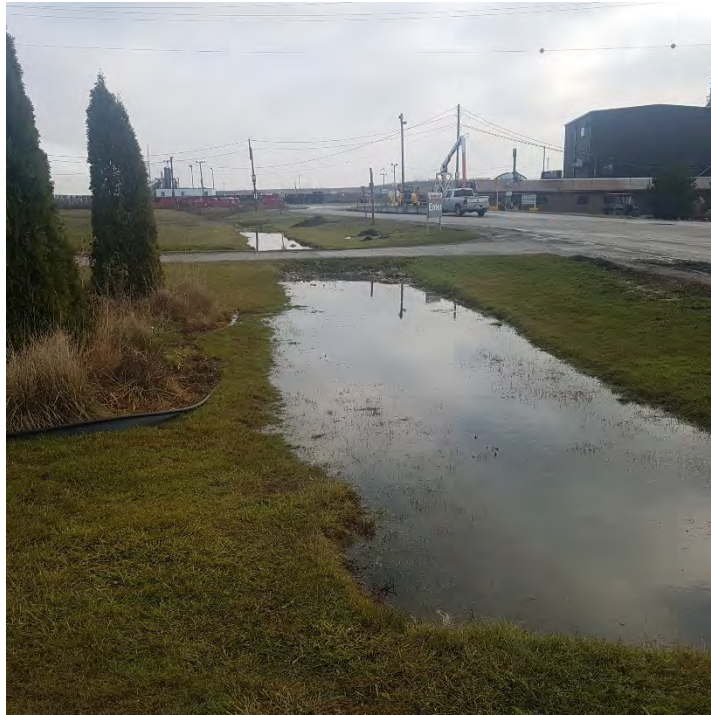
Photo 18 - Equalization Pond

The following provides a description of the status of the Equalization Pond (Photo 18):

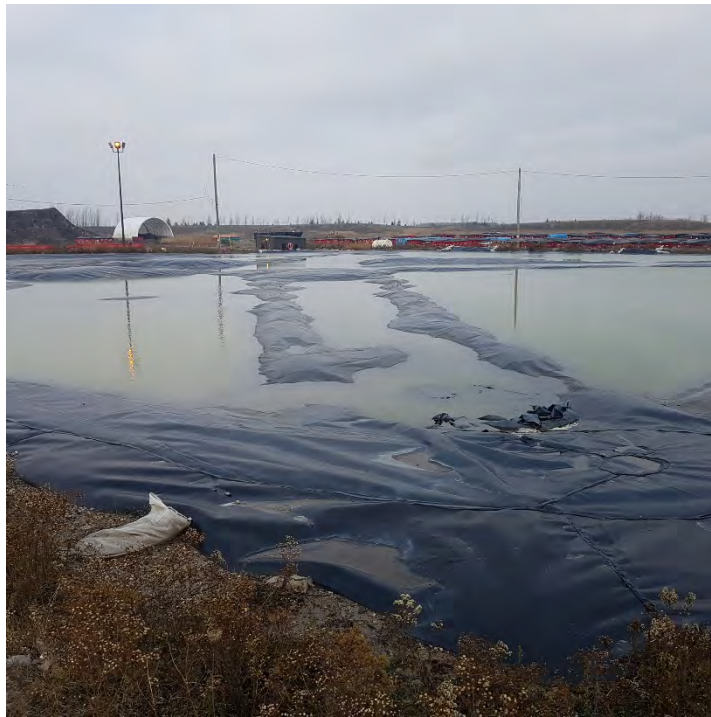
Photo 20 - North Process Water Pond

The following provides a description of the status of the North Process Water Pond (Photo 20):

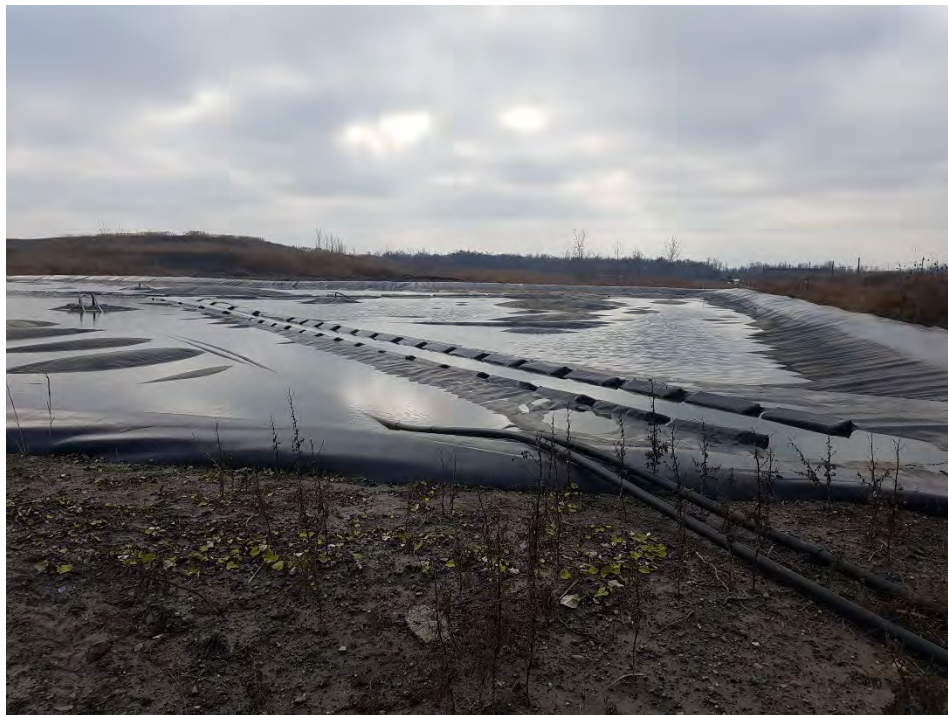
Photo 21 - South Leachate Reservoir

The following provides a description of the status of the South Leachate Reservoir (Photo 21):

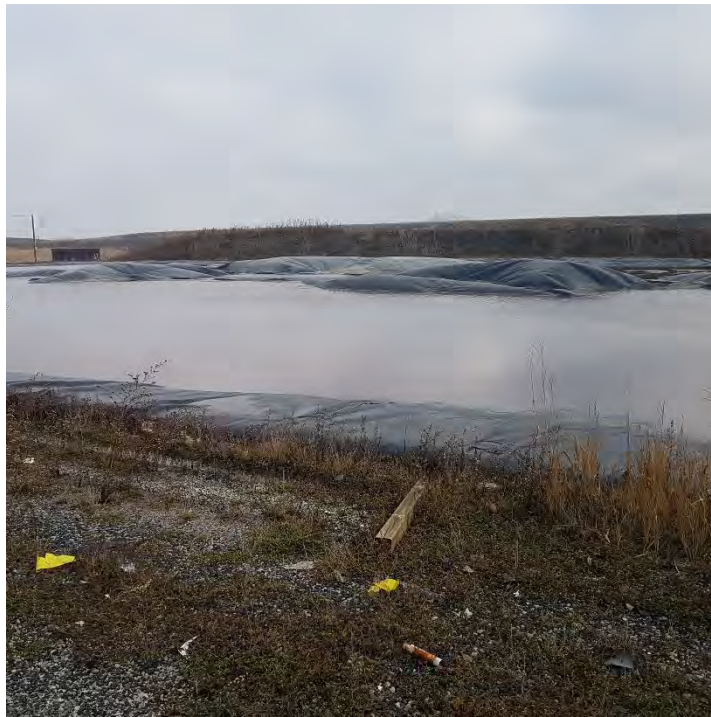
Photo 22 - East Leachate Reservoir

The following provides a description of the status of the East Leachate Reservoir (Photo 22):
