2021 Quarterly Site Inspections

Clean Harbors Lambton Facility

Clean Harbors Canada Inc.

February 22, 2022

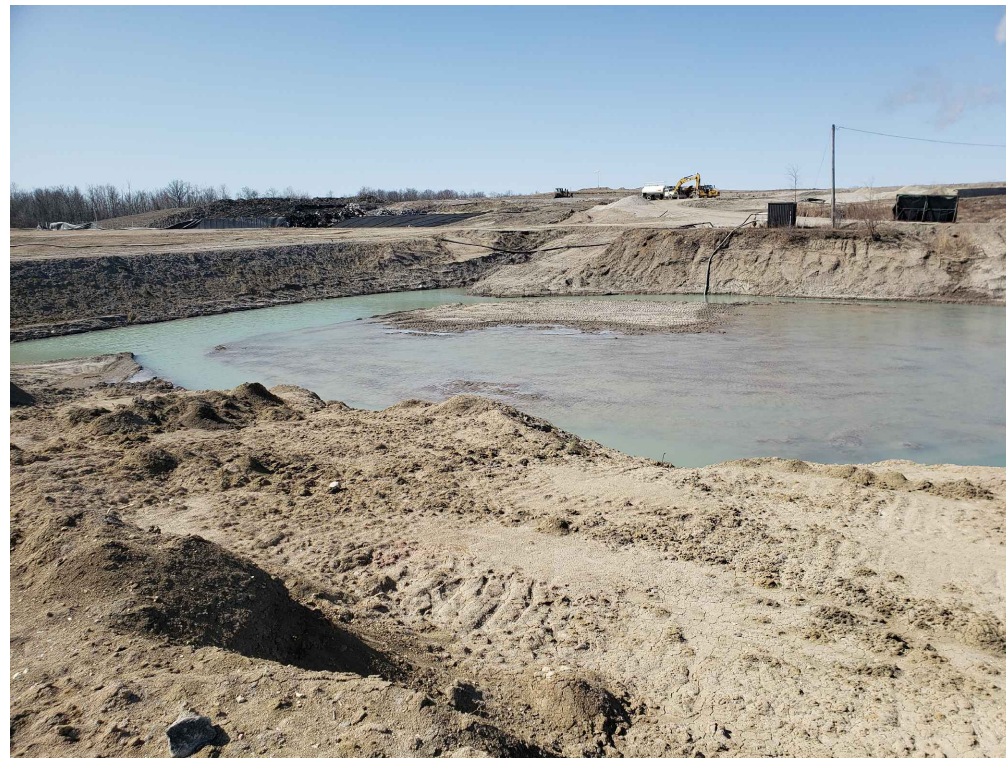
17 FORMER EAST SURFACE WATER POND - ACTIVE DEWATERING FOR CELL 20-1
Fig 4A

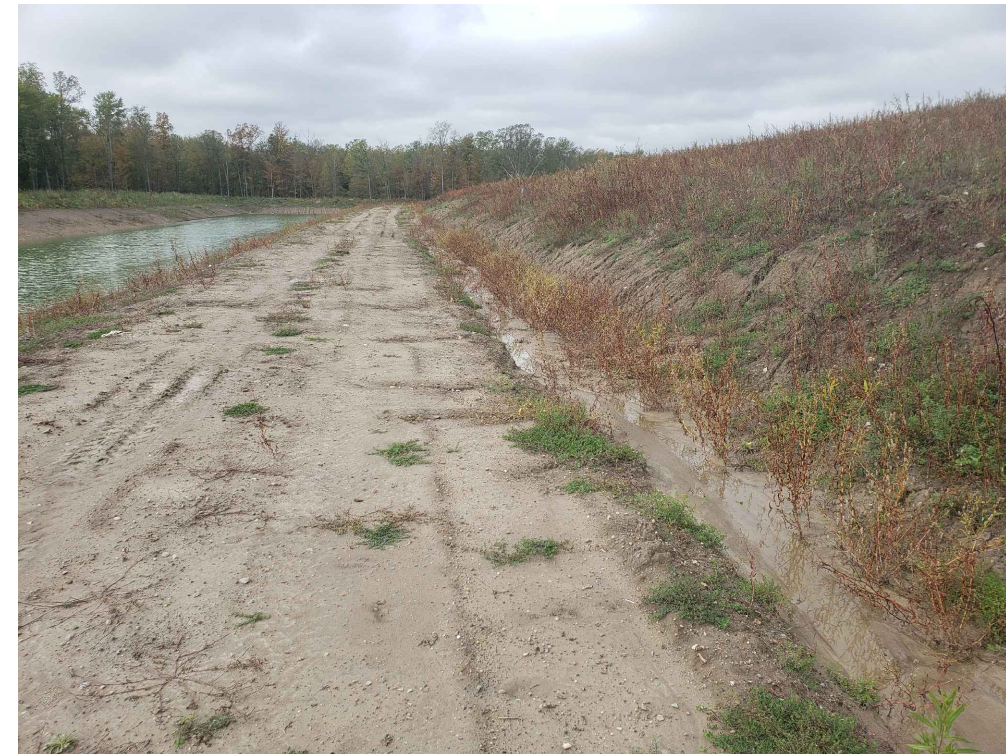
4 SOUTH ACCESS ROAD AND DITCH
Fig 3A

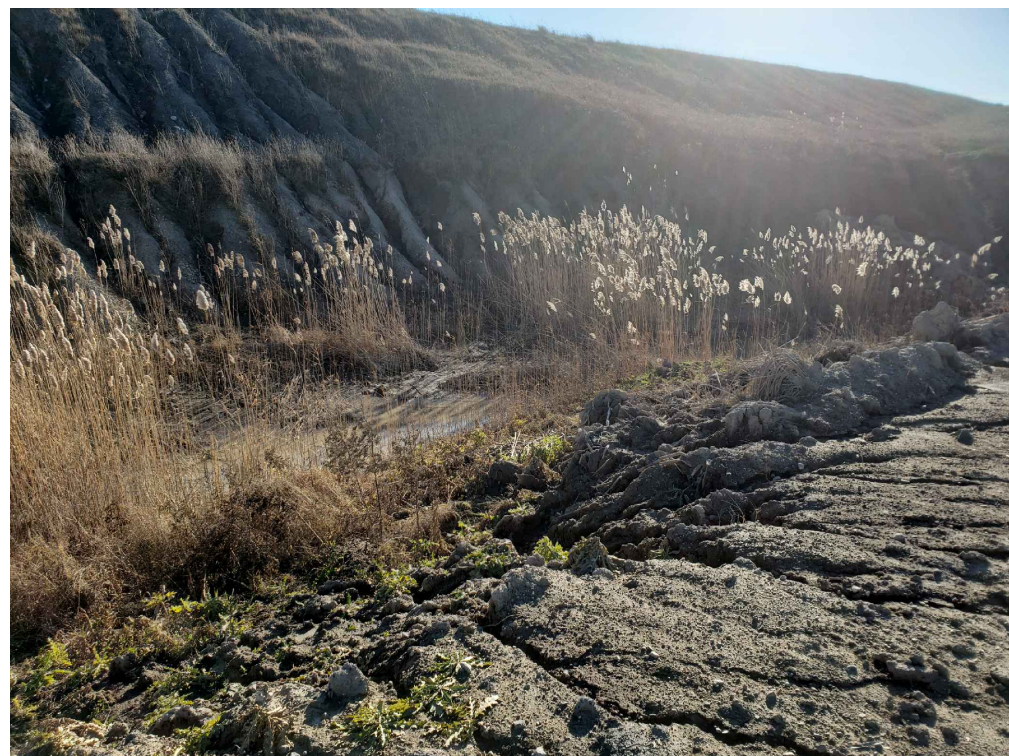
11 EROSION CHANNELS AND SEDIMENTATION ALONG EAST PERIMETER DITCH
Fig 4A
