MEMORANDUM:

RE: Regional surface water review. Clean Harbors Canada. 2019 Annual Landfill Report Executive Summary Executive Report Prepared by Clean Harbors Canada Inc. – undated.

2019 Annual Surface Water Quality Monitoring Report (Appendix H). Clean Harbors Lambton Facility. 4090 Telfer Road Corunna. Report Prepared by GHD Consulting - undated

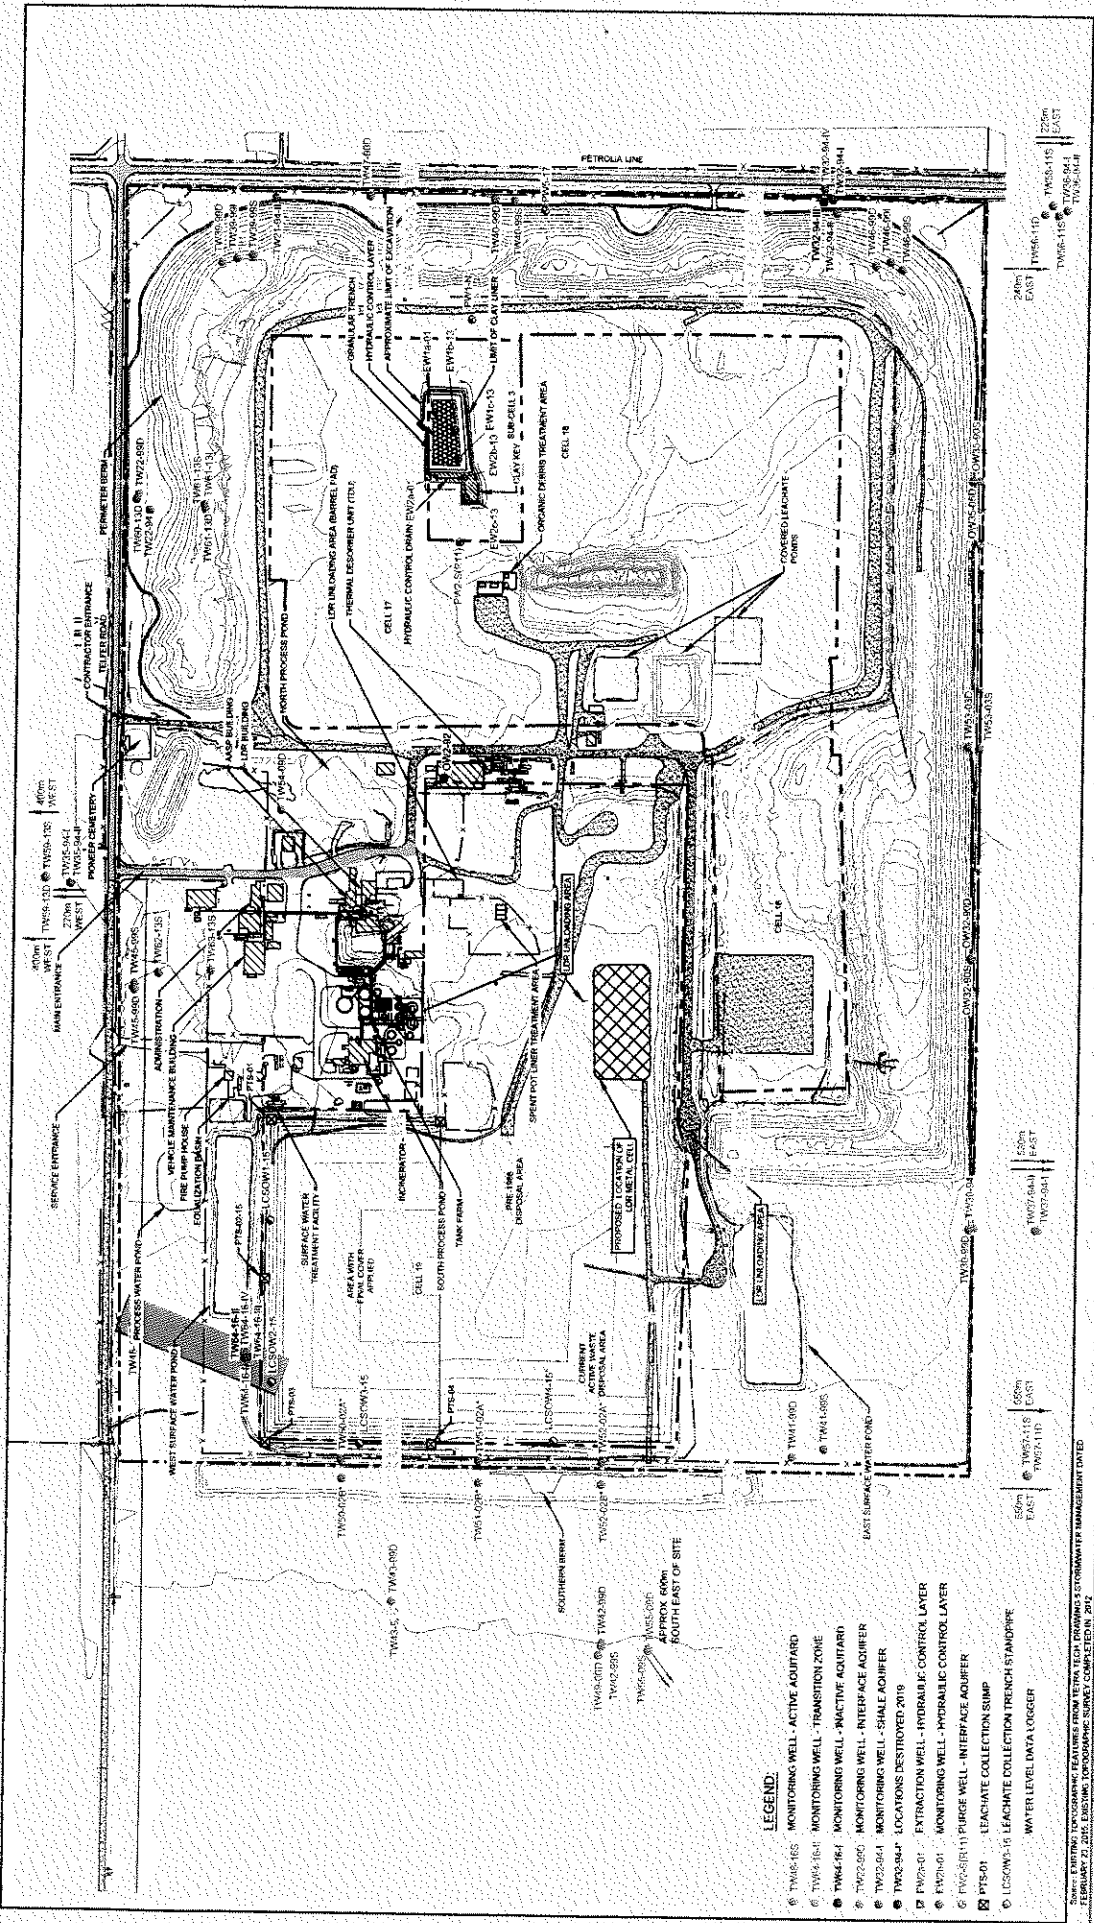
FIGURE 3

MONITORING WELL NETWORK
