APPENDIX F

Quarterly Site Inspection Reports

2017 Annual Landfill Report

Subject: 2017 First Quarter Site Inspection

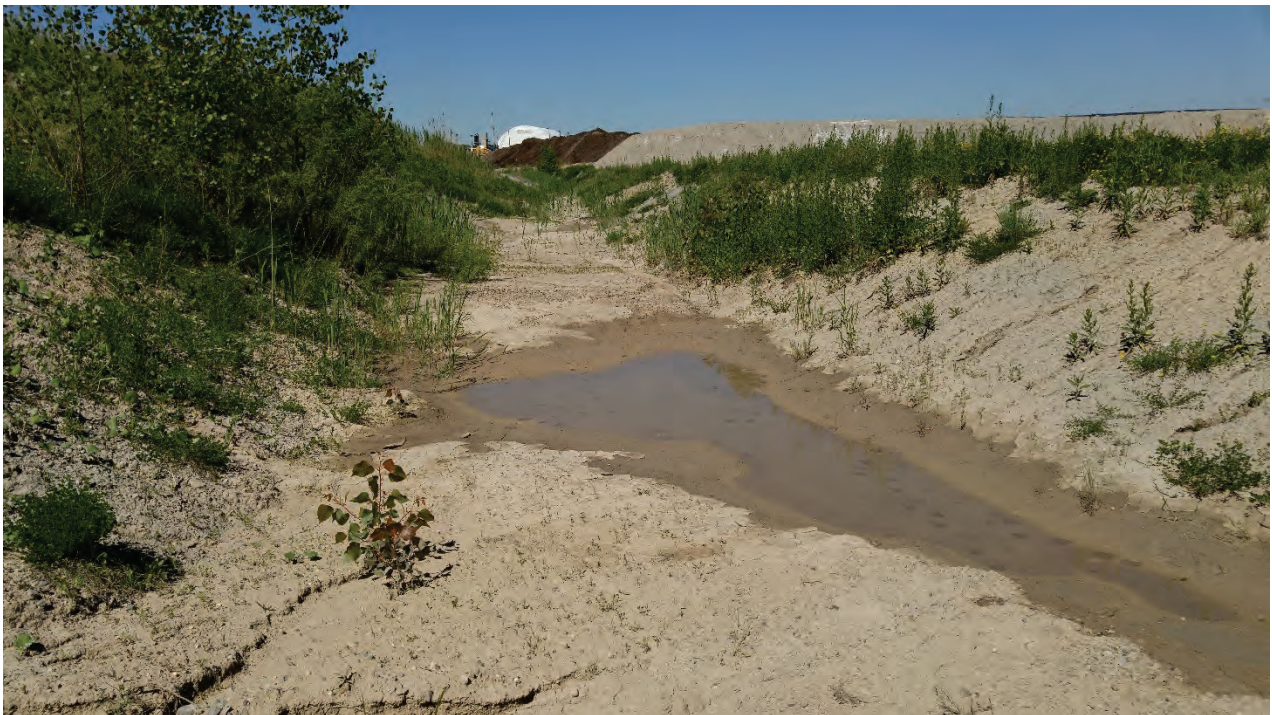
Photo 6 - North landfill area, southeast ditch, partial surface water blockage

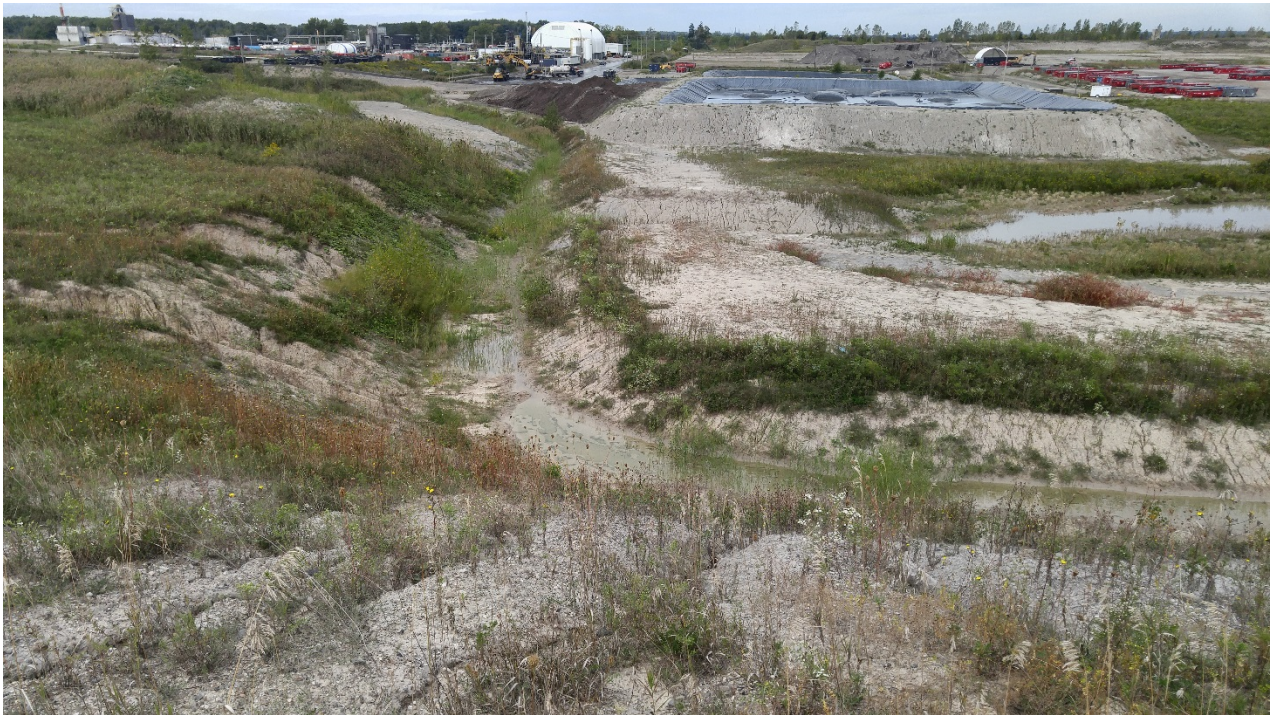
Photo 6 - North landfill area, southeast ditch, partial surface water blockage

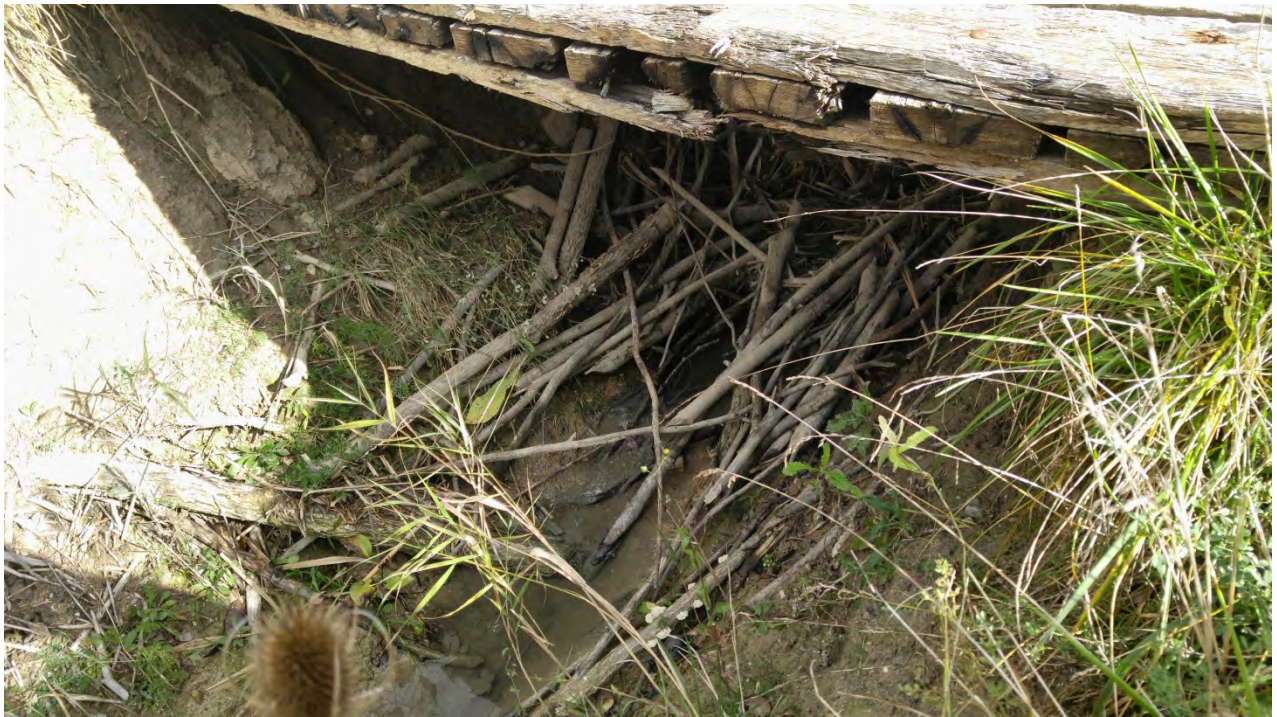
Photo 7 - South ditch, surface water blockage west of access bridge
