2018 Quarterly Site Inspections

Clean Harbors Lambton Facility
4090 Telfer Road, Corunna, Ontario

Clean Harbors Canada, Inc.

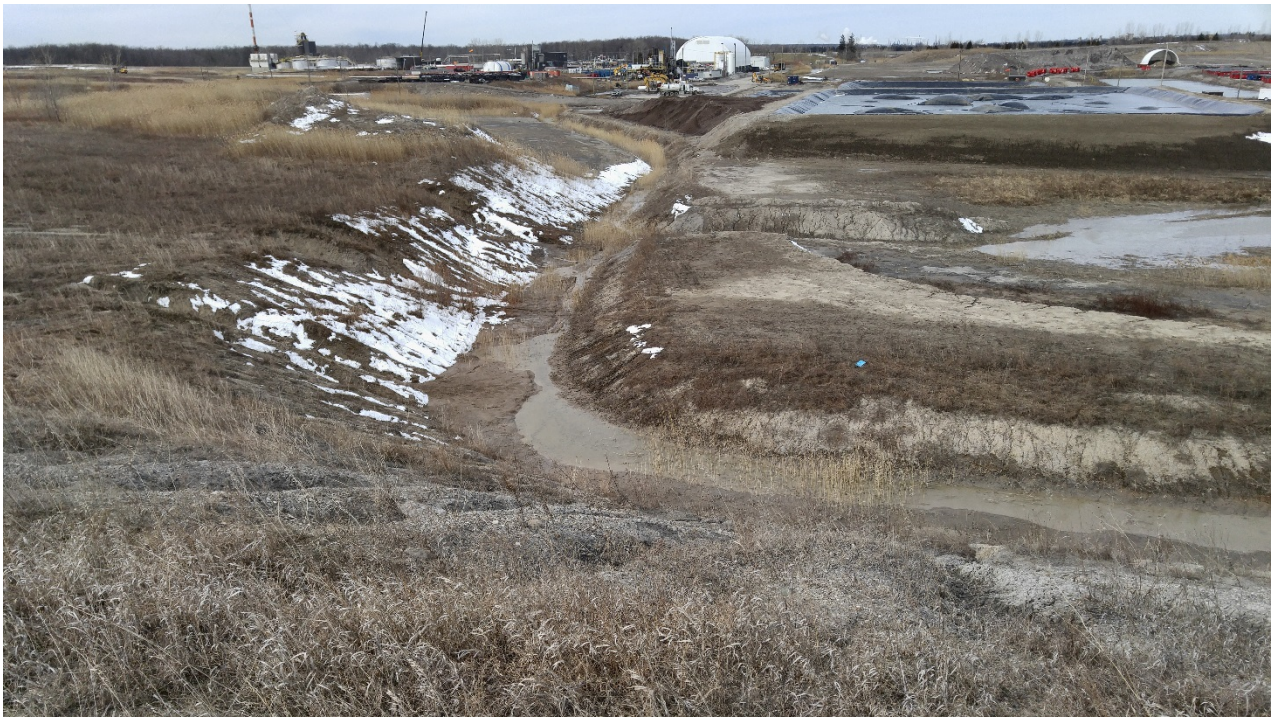
- Significant erosion was identified in the southeast corner of the OLA, resulting in sedimentation of the perimeter ditch and limited water flow, as shown in Photo 7 and Figure 1. Low levels of standing water were observed in the southeast ditch and the internal swale to the north.

Photo 7 - North landfill area, southeast ditch, partial surface water blockage

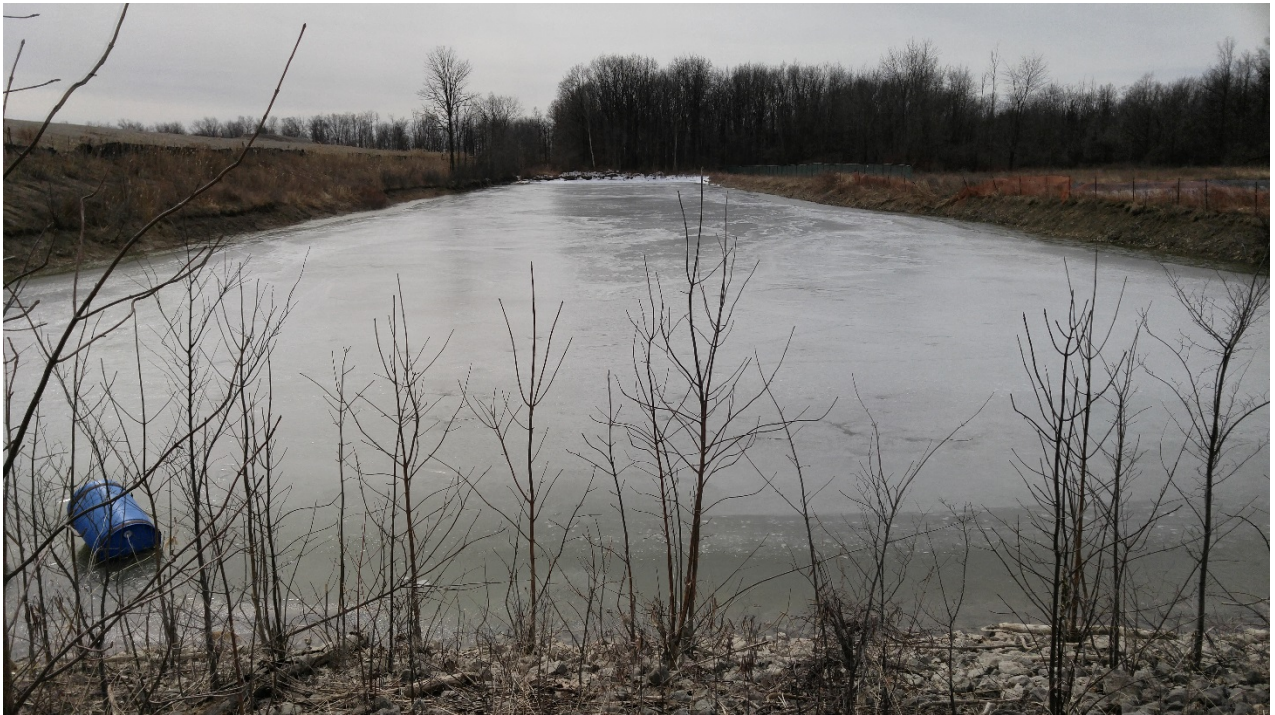
Photo 10 - West Surface Water Pond

The following provides a description of the status of the West Surface Water Pond (Photo 10):

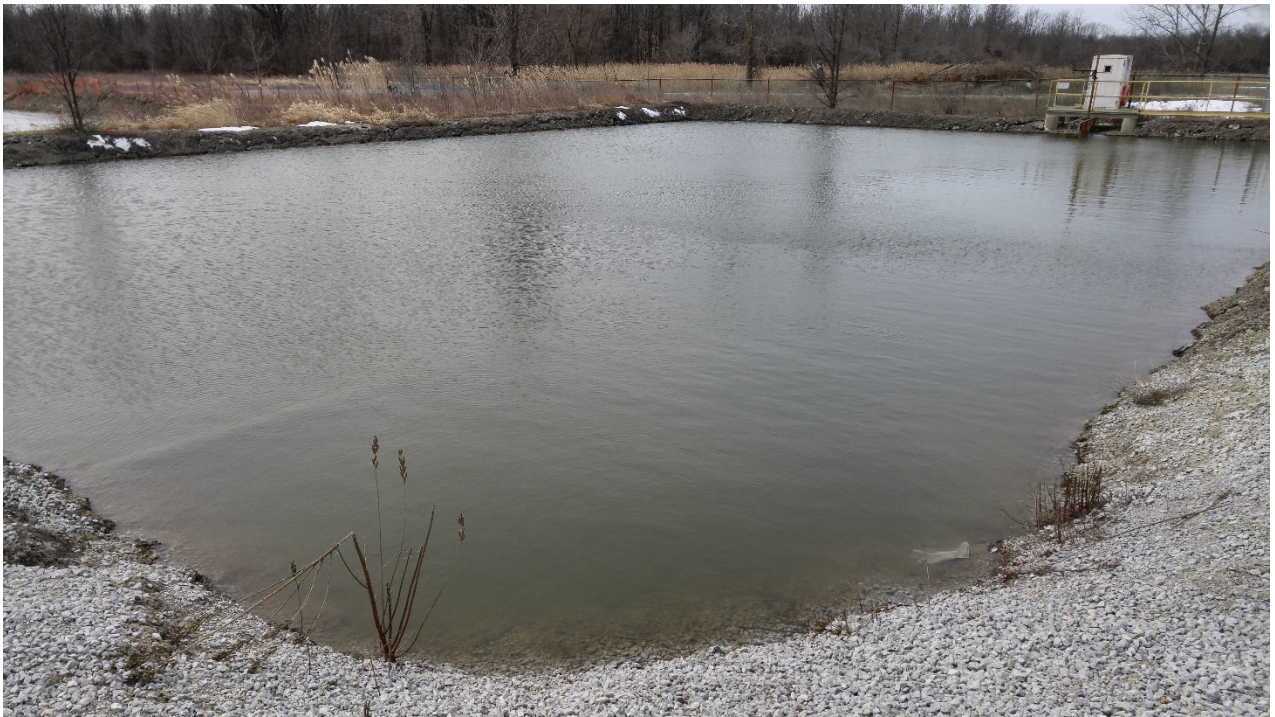
Photo 11 - Equalization Pond

The following provides a description of the status of the Equalization Pond (Photo 11):

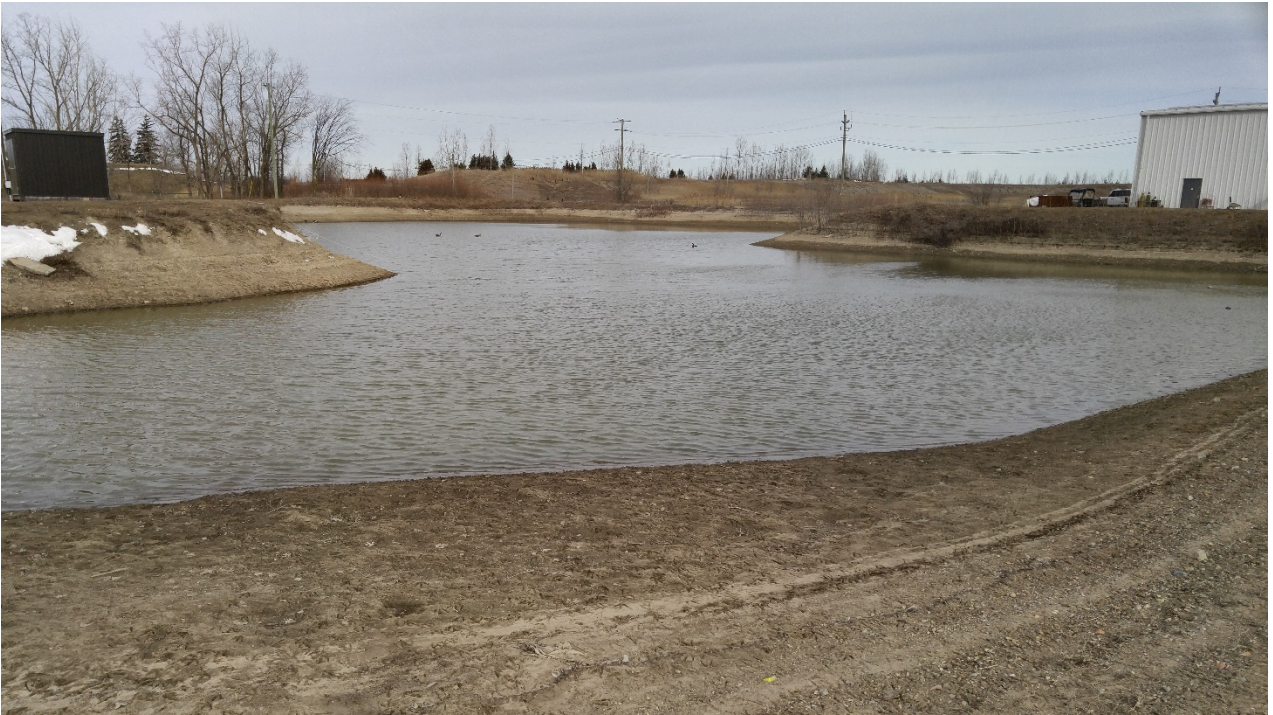
Photo 13 - North Process Water Pond

The following provides a description of the status of the North Process Water Pond (Photo 13):

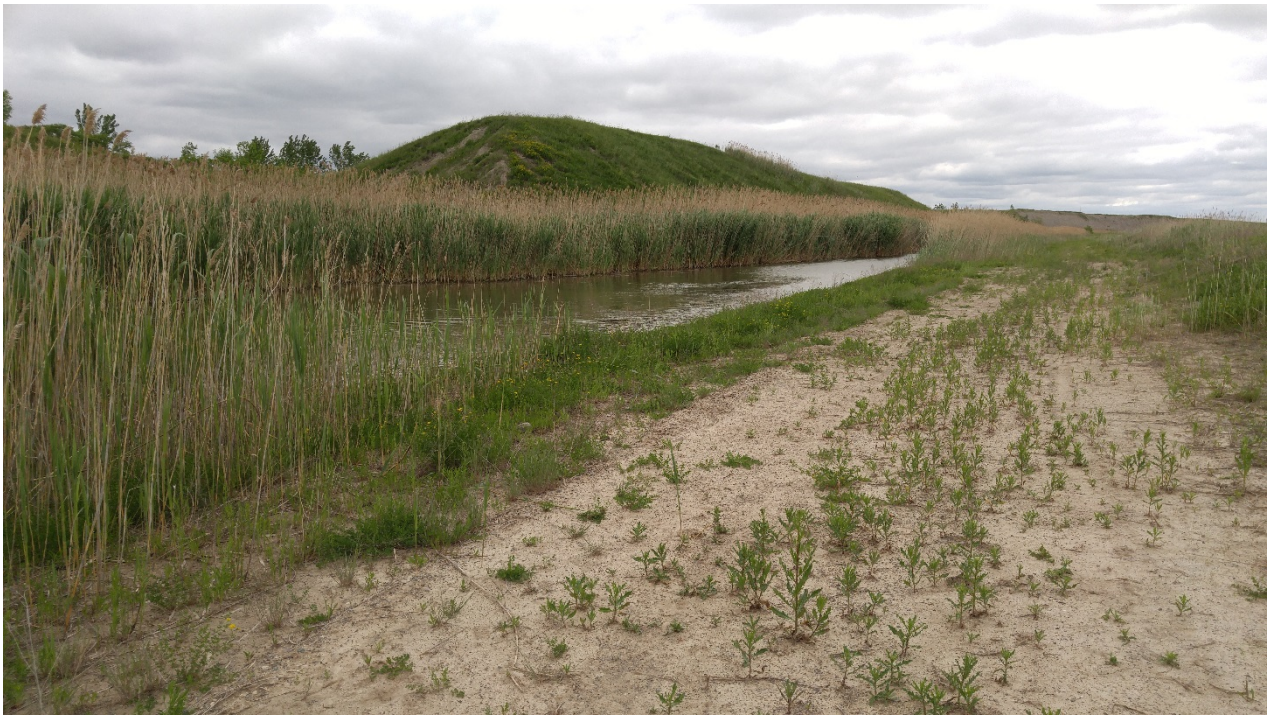
- Shallow ponding was identified within the southwest corner of the Original Landfill Area (OLA).
- Water levels were low within the southern perimeter ditch of the OLA. Pumping was not active during the Inspection.
- No standing water was identified within the northwest corner of the OLA, rather the area was damp as shown in Photo 3. The area has been graded to drain to the north ditch with an internal swale. The internal swale was dry during the Inspection.
- Minimal standing water was noted in the northwest portion of proposed Cell 21-3 (i.e., located centrally in the northern portion of the Site), as shown in Photo 4. The two drainage paths had minimal standing water.
- Water levels continue to be high in the central portion of the north ditch, as shown in Photo 5. High water levels in the north ditch have the potential to prohibit surface drainage from the OLA during wetter periods.

Photo 5 - High water levels in central portion of north perimeter ditch

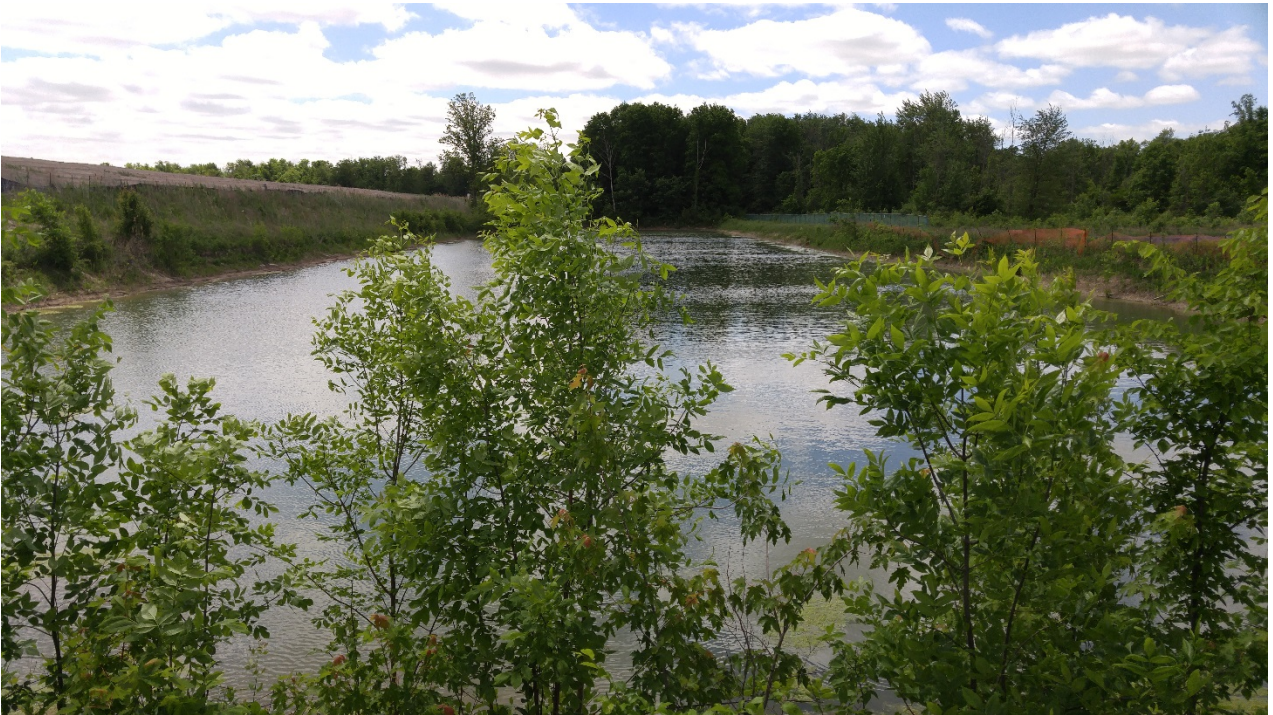
Photo 10 - West Surface Water Pond

The following provides a description of the status of the West Surface Water Pond (Photo 10):

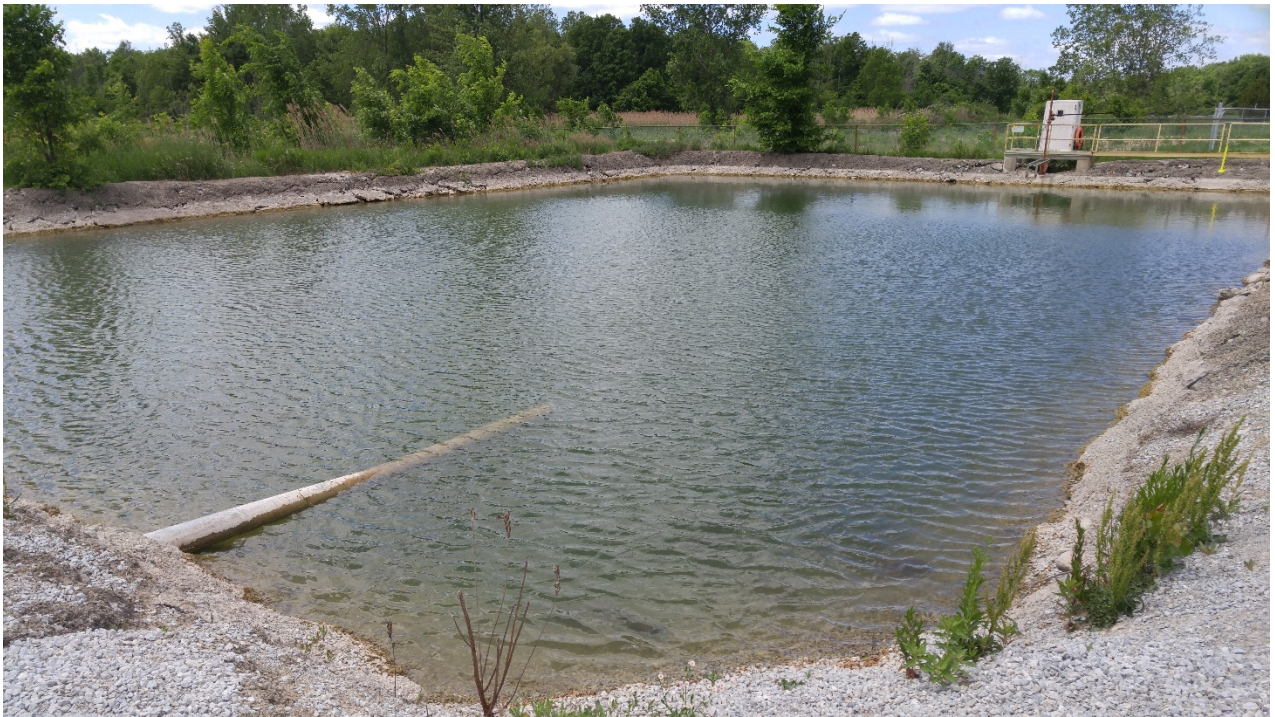
Photo 11 - Equalization Pond

The following provides a description of the status of the Equalization Pond (Photo 11):

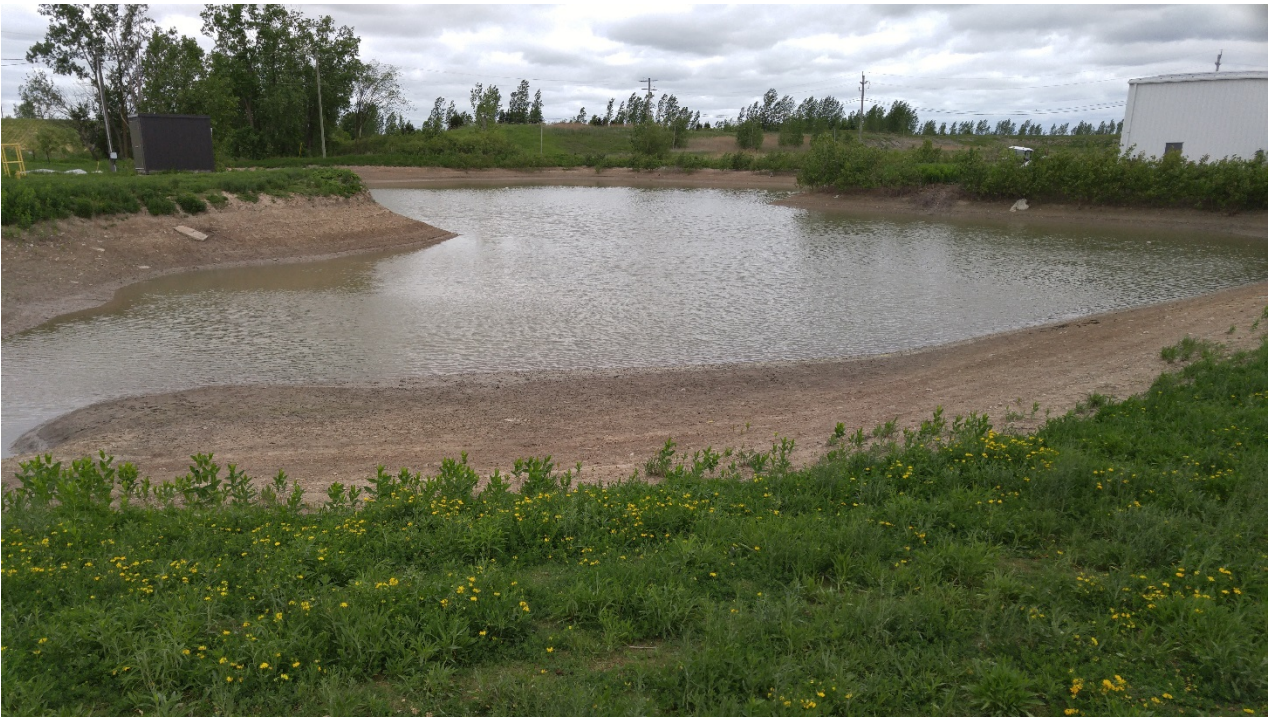
Photo 13 - North Process Water Pond

The following provides a description of the status of the North Process Water Pond (Photo 13):

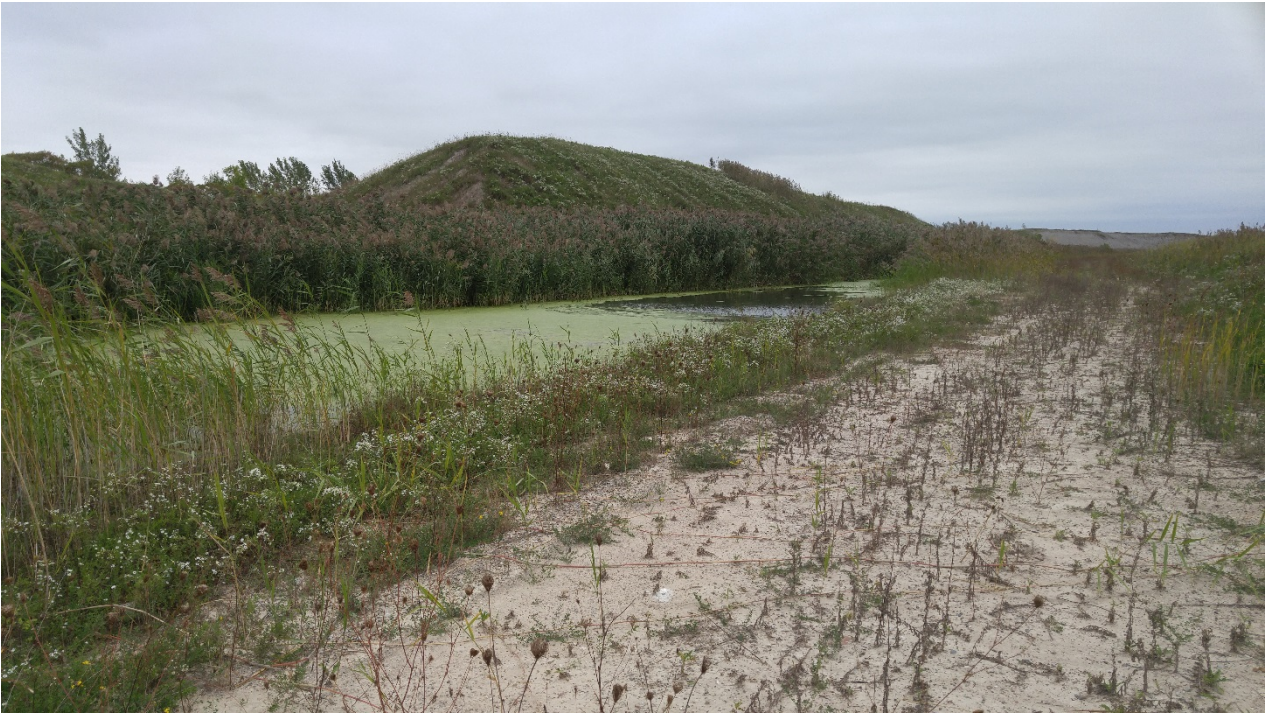
Photo 5 - High water levels in central portion of north perimeter ditch

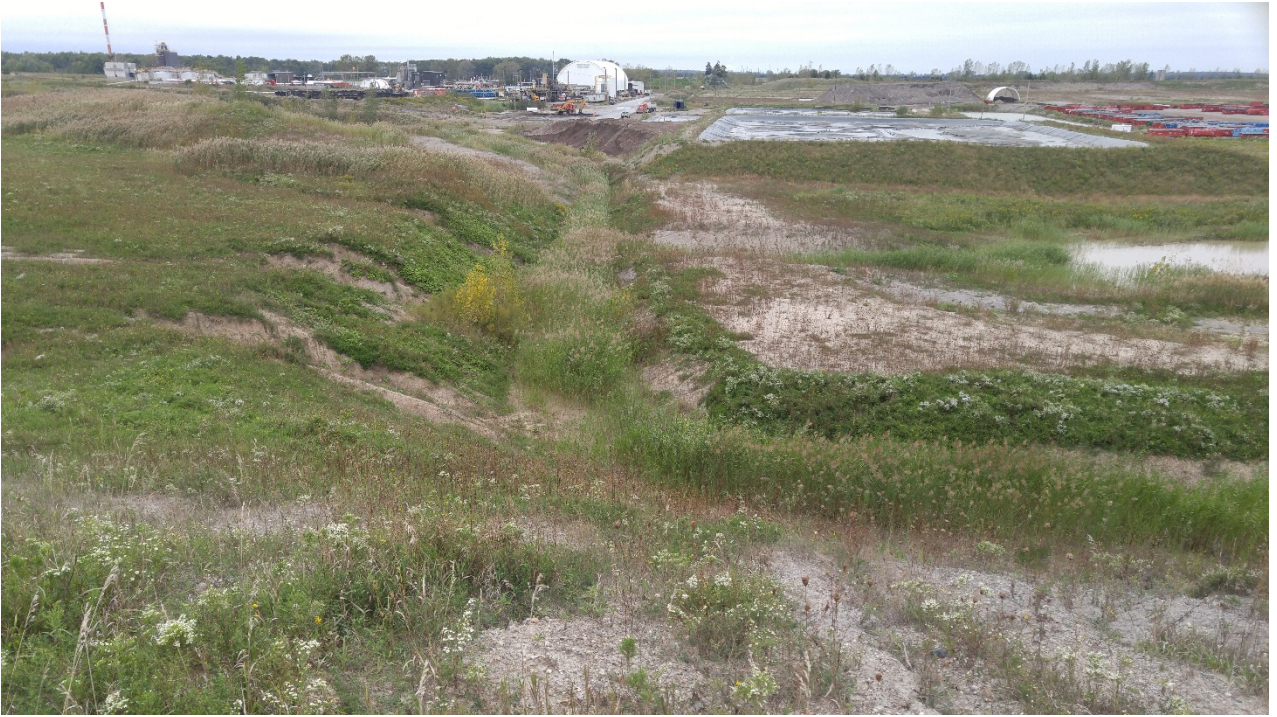
Photo 7 - North landfill area, southeast ditch, partial surface water blockage

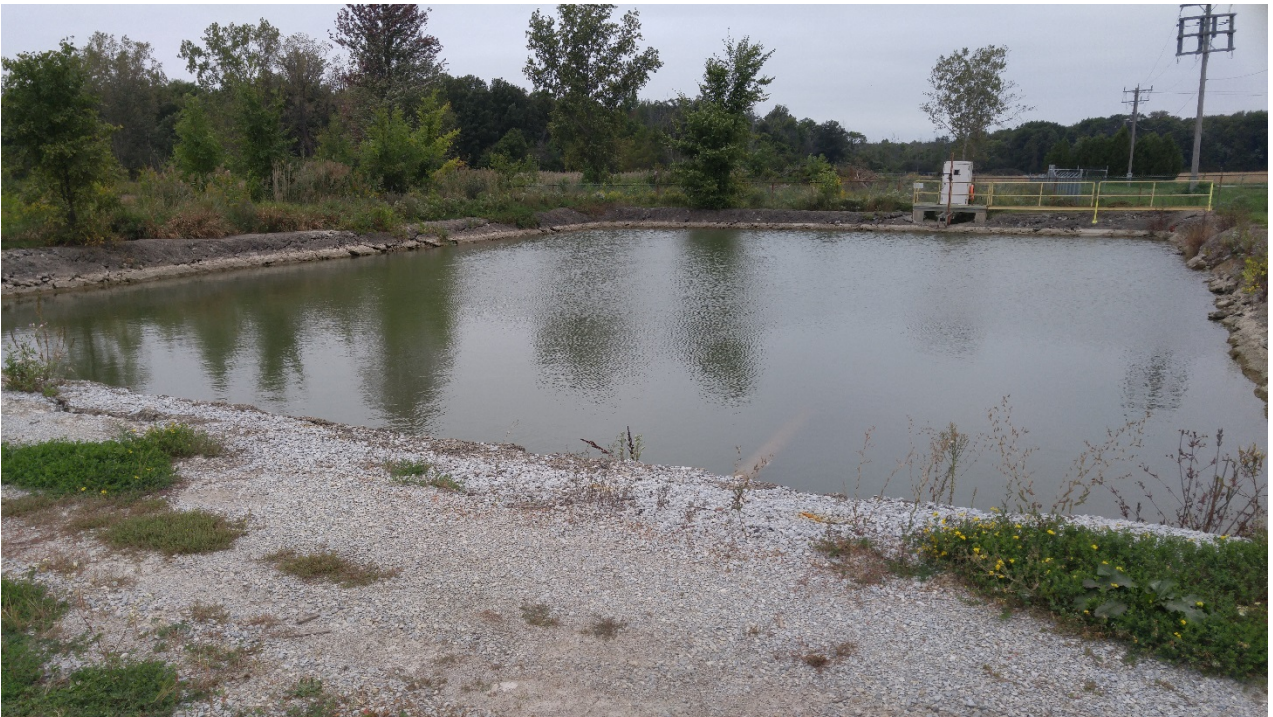
Photo 11 - Equalization Pond

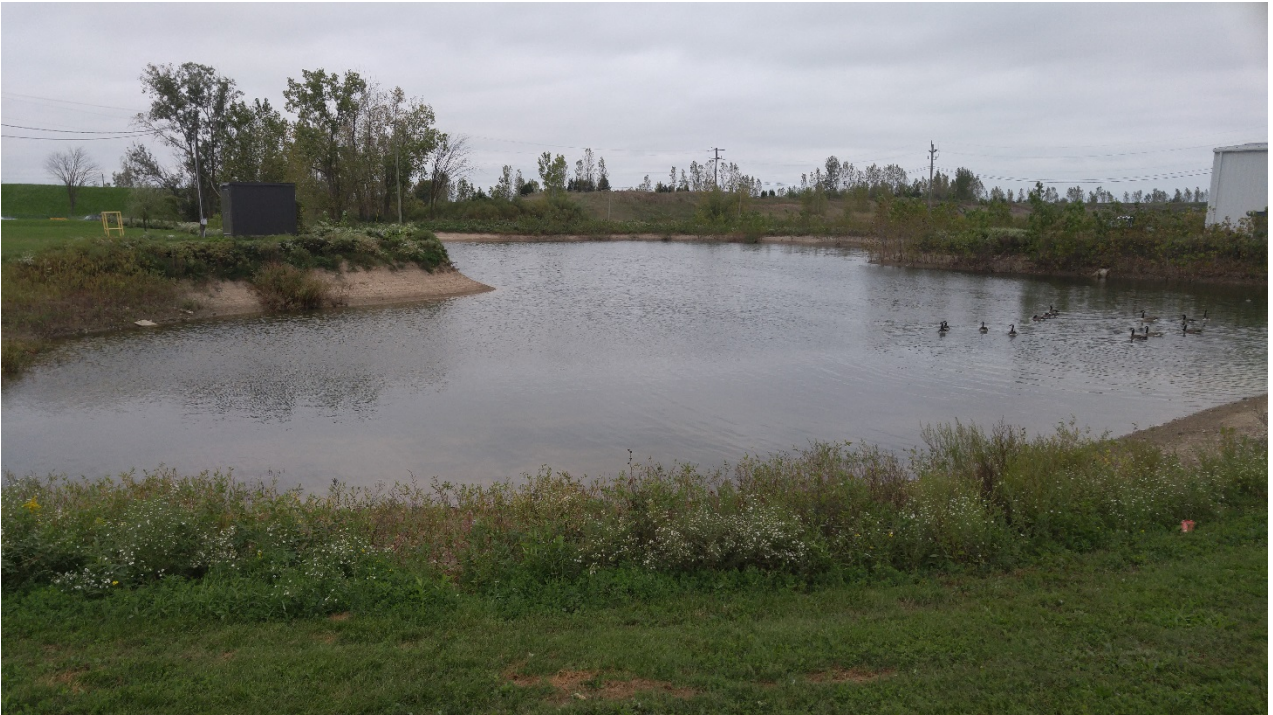
Photo 13 - North Process Water Pond

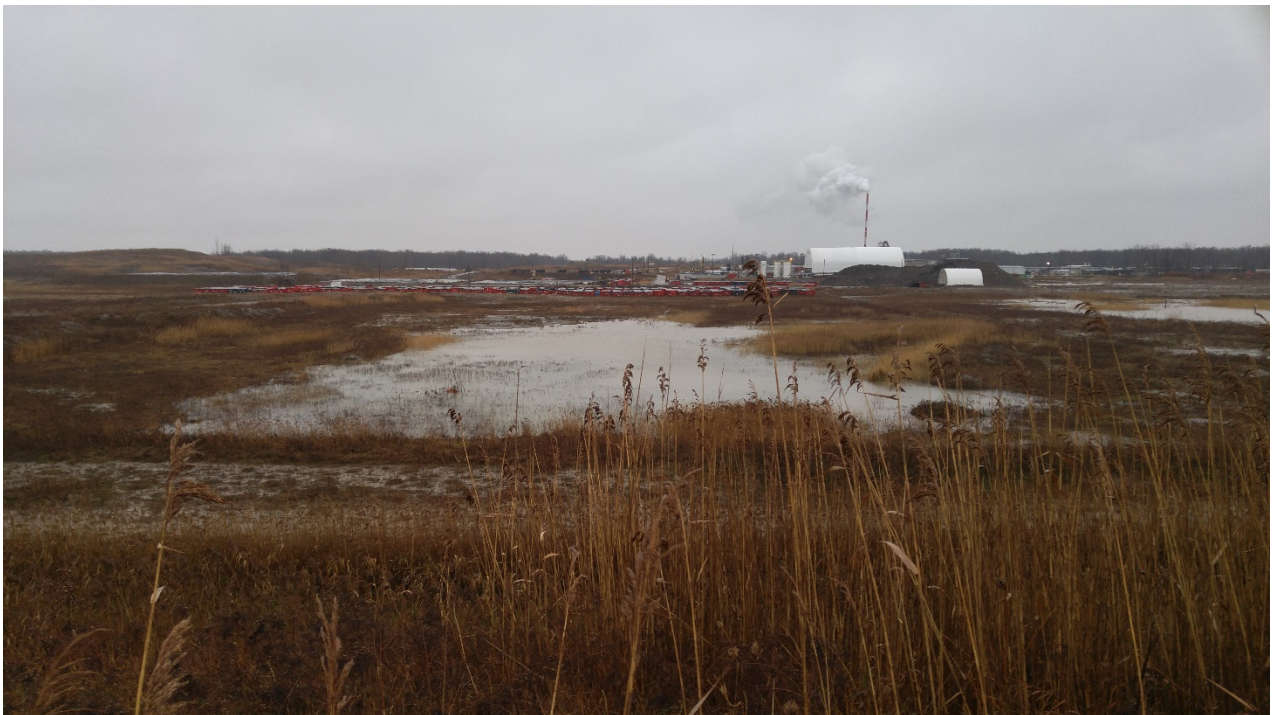
- Standing water was noted in the northwest portion of proposed Cell 21-3 (i.e., located centrally in the northern portion of the Site), as shown in Photo 4. The two drainage paths were under water during the Inspection, with no observed flow.

Photo 4 - Standing water in northern, central portion of Site

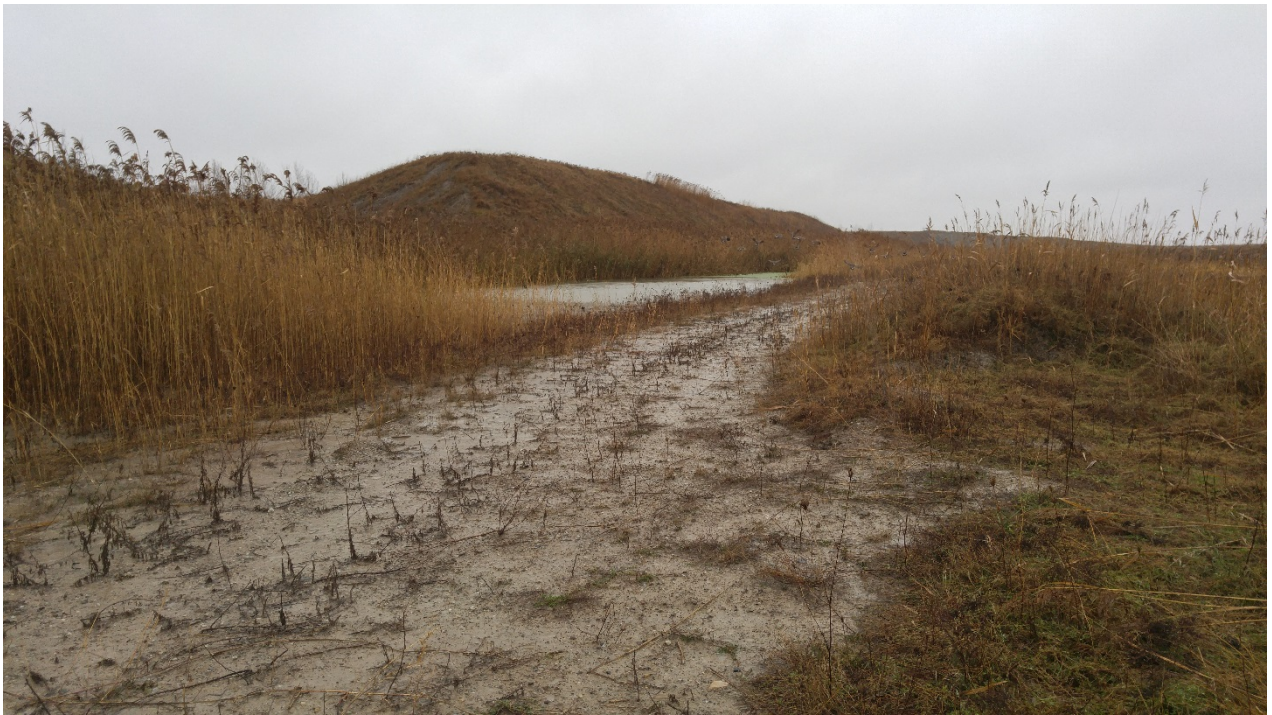
- Water levels continue to be high in the central portion of the north ditch, as shown in Photo 5. High water levels in the north ditch have the potential to prohibit surface drainage from the OLA during wetter periods. Significant algal growth was evident during the Inspection, visible at the far end of Photo 5.

Photo 5 - High water levels in central portion of north perimeter ditch

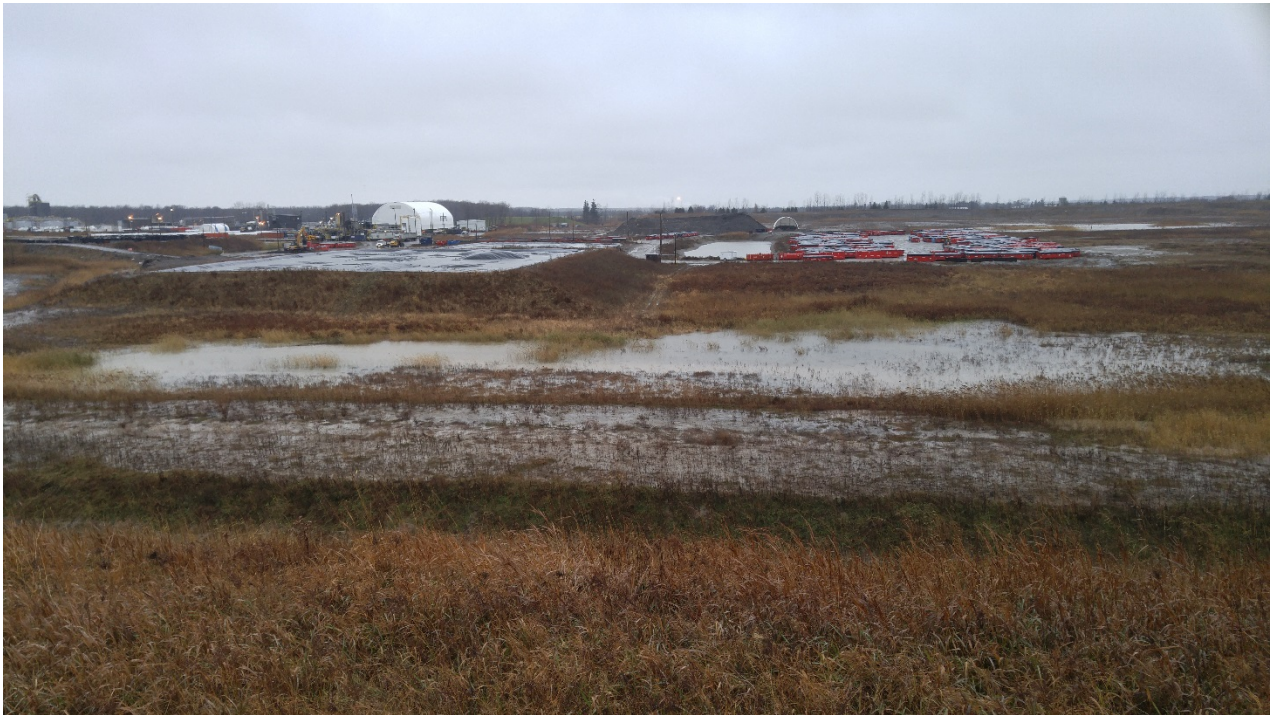
Photo 8 - Standing water in southeast corner of north landfill area

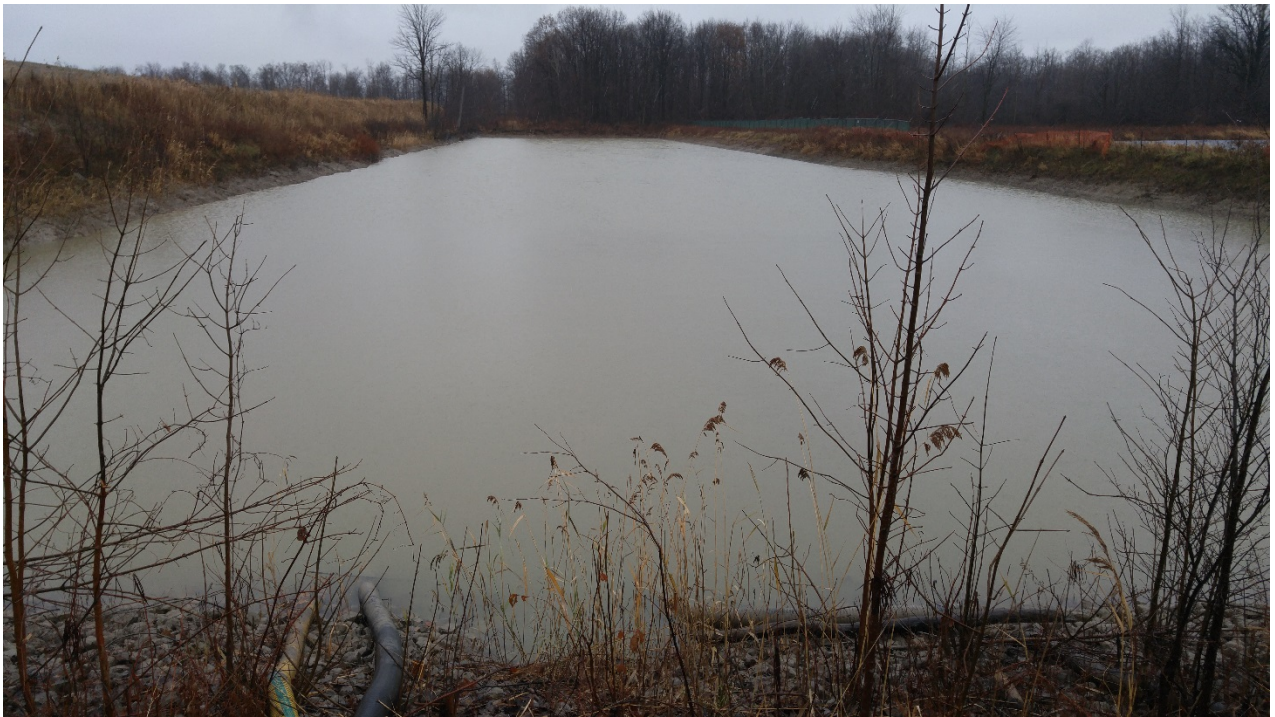
Photo 11 - West Surface Water Pond

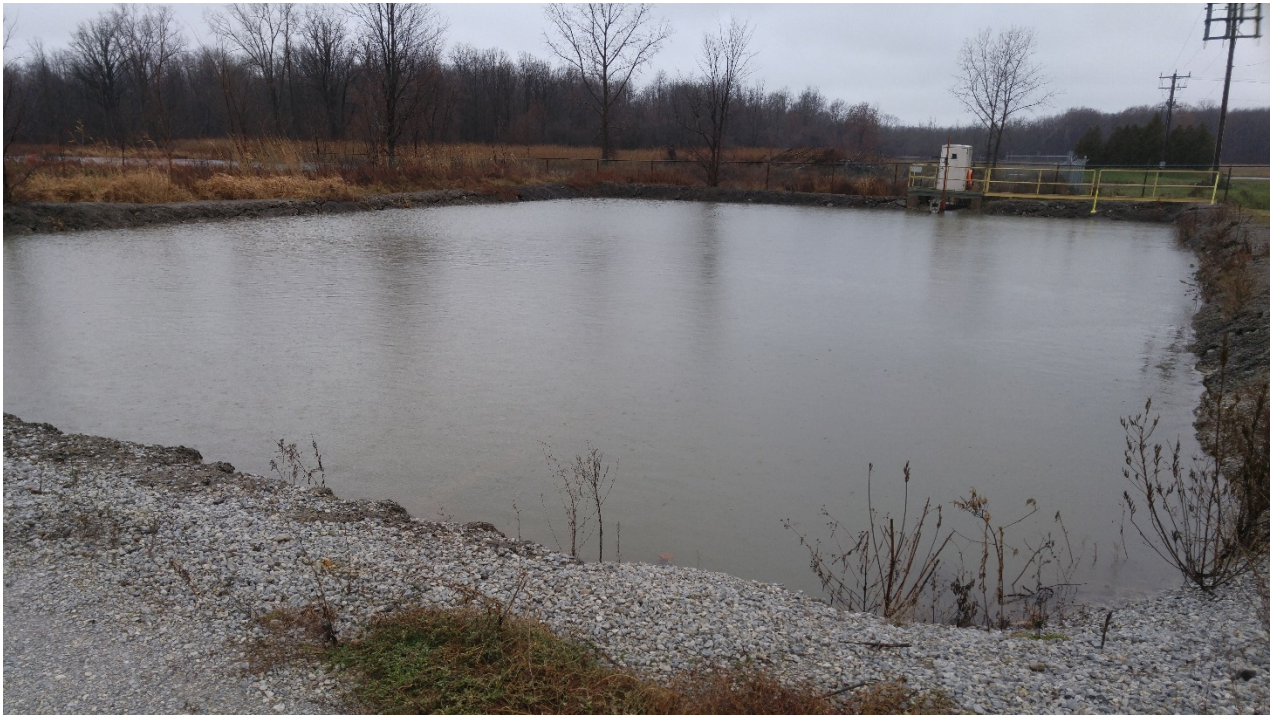
Photo 12 - Equalization Pond

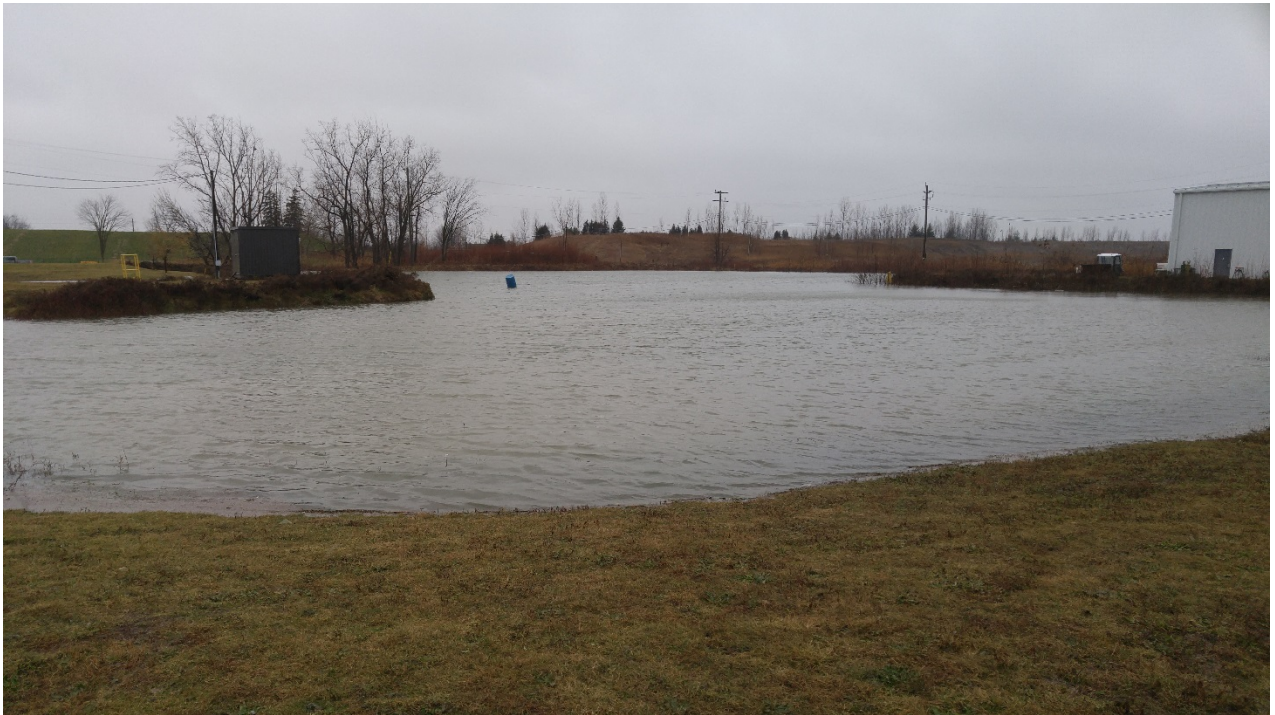
Photo 14 - North Process Water Pond
