2021 Quarterly Site Inspections

Clean Harbors Lambton Facility

Clean Harbors Canada Inc.

February 22, 2022

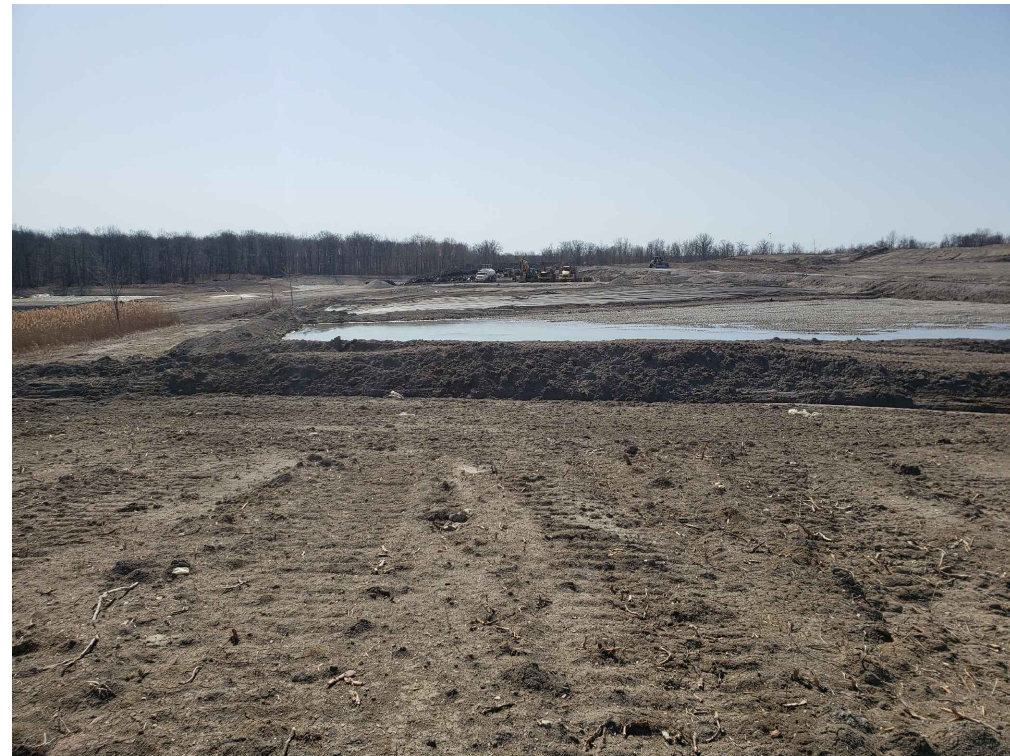
3 CELL 19-3A
Fig 3A

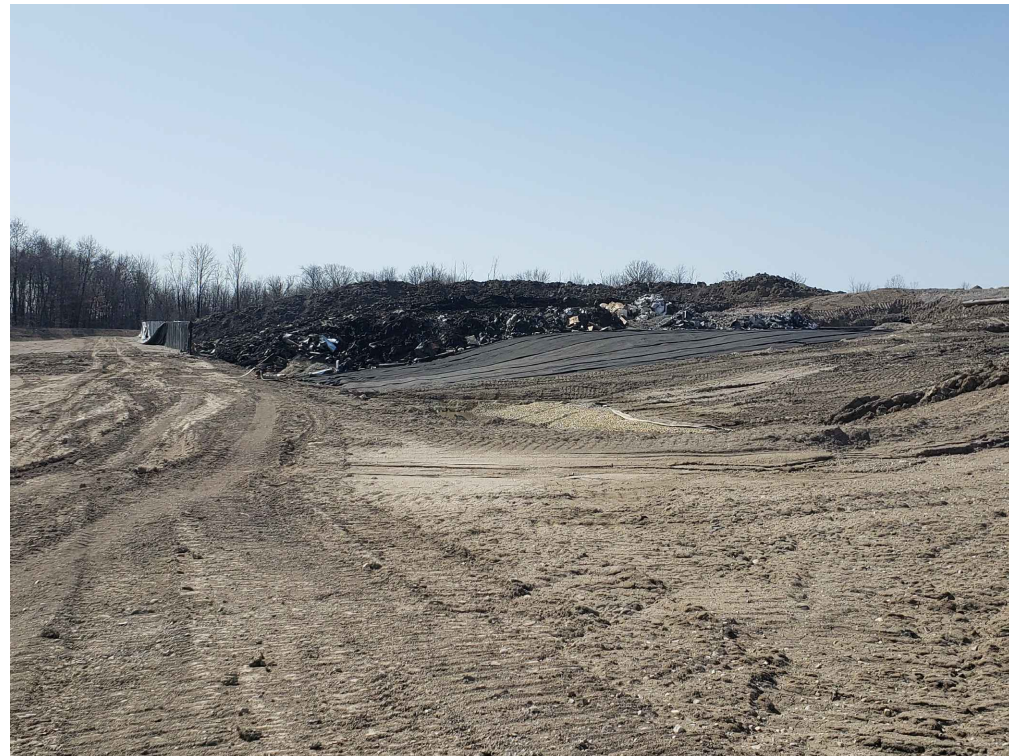
7 CELL 19-2D WASTE FACE
Fig 3A

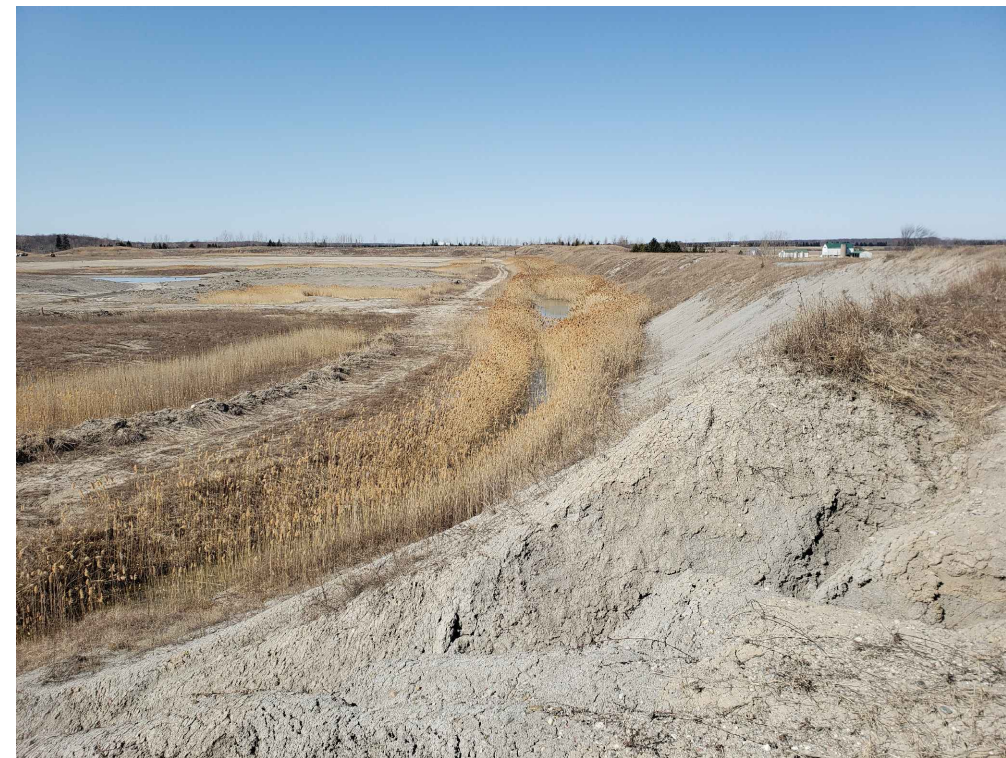
10 EROSION CHANNELS ALONG NORTH PERIMETER BERM
Fig 4A

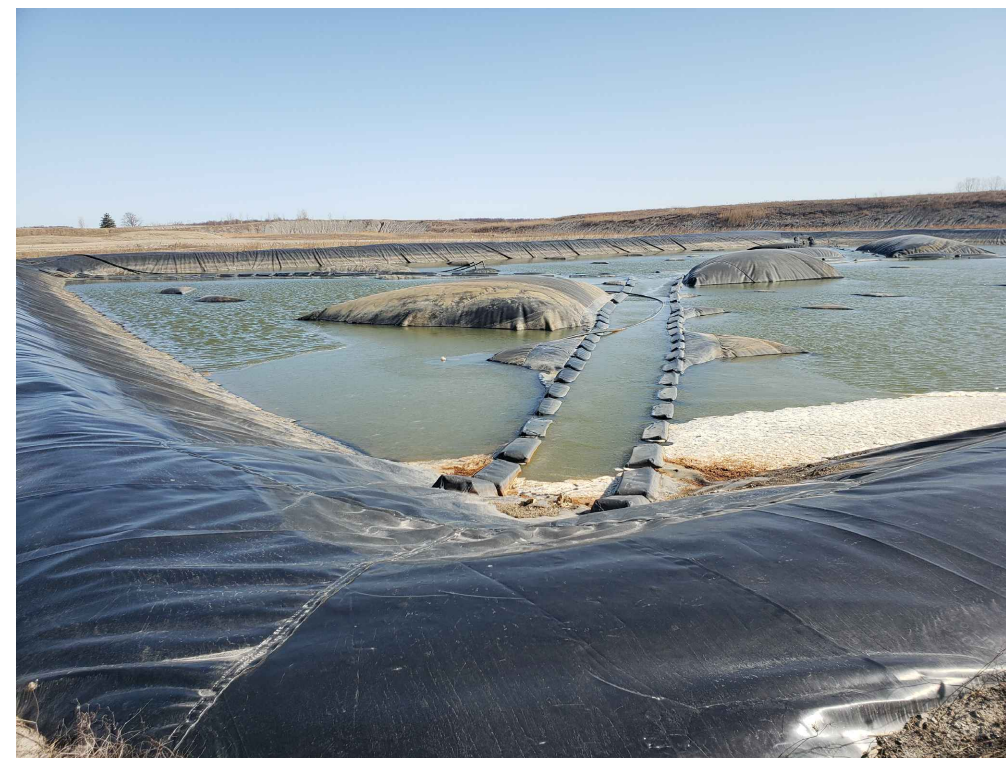
12 PONDED WATER ON EAST LEACHATE POND COVER
Fig 4A

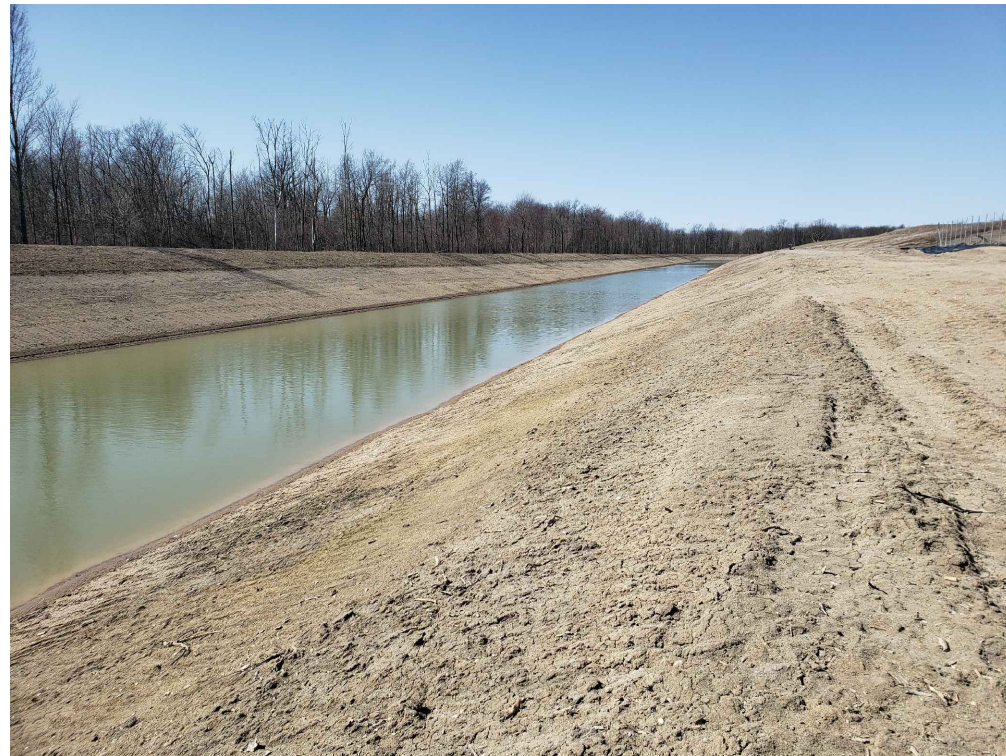
19 SURFACE WATER POND B
Fig 4A

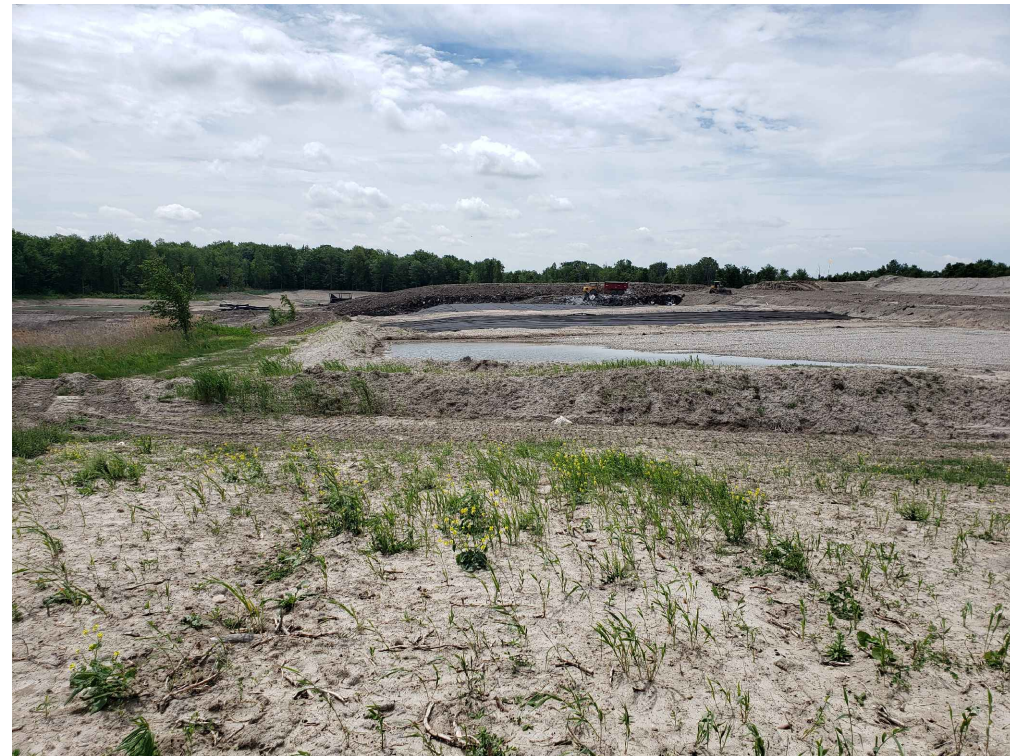
3 CELL 19-3A, 19-2G AND WASTE FACE
Fig 3A

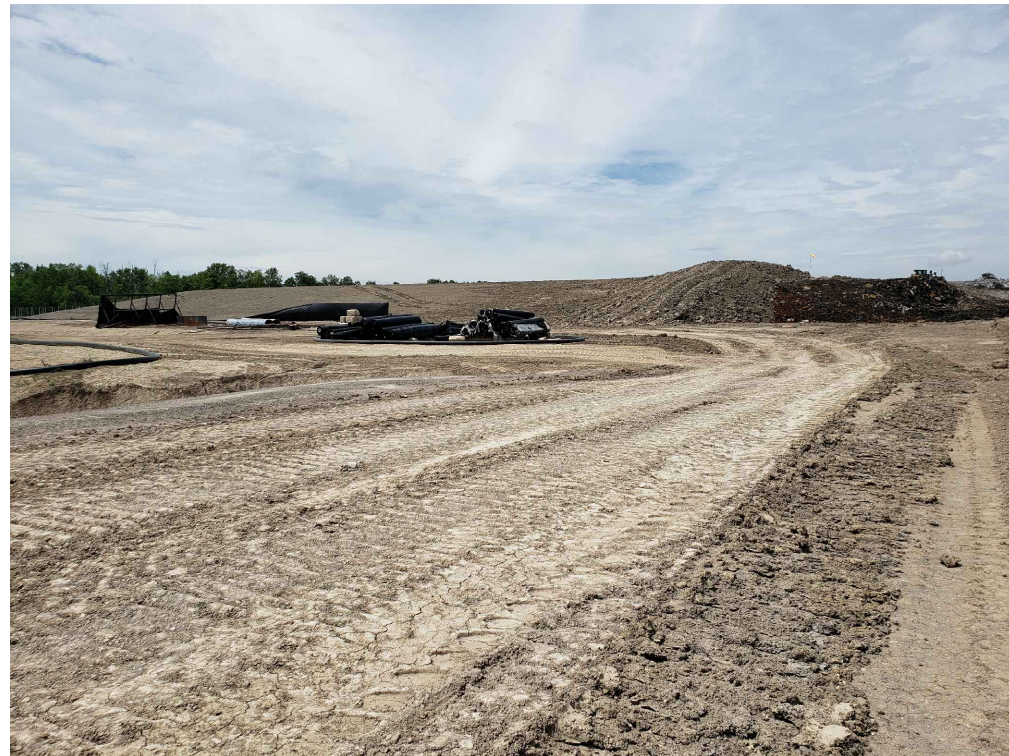
7 CELL 19-2D WASTE FACE
Fig 3A

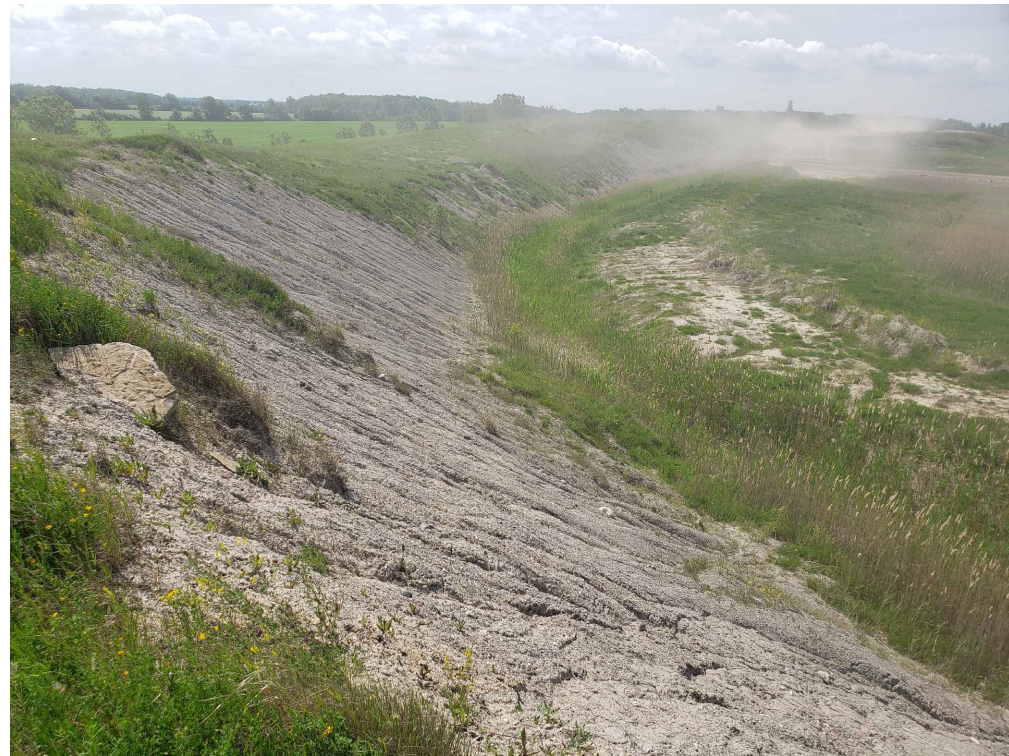
11 EROSION CHANNELS ALONG EAST PERIMETER BERM
Fig 4A

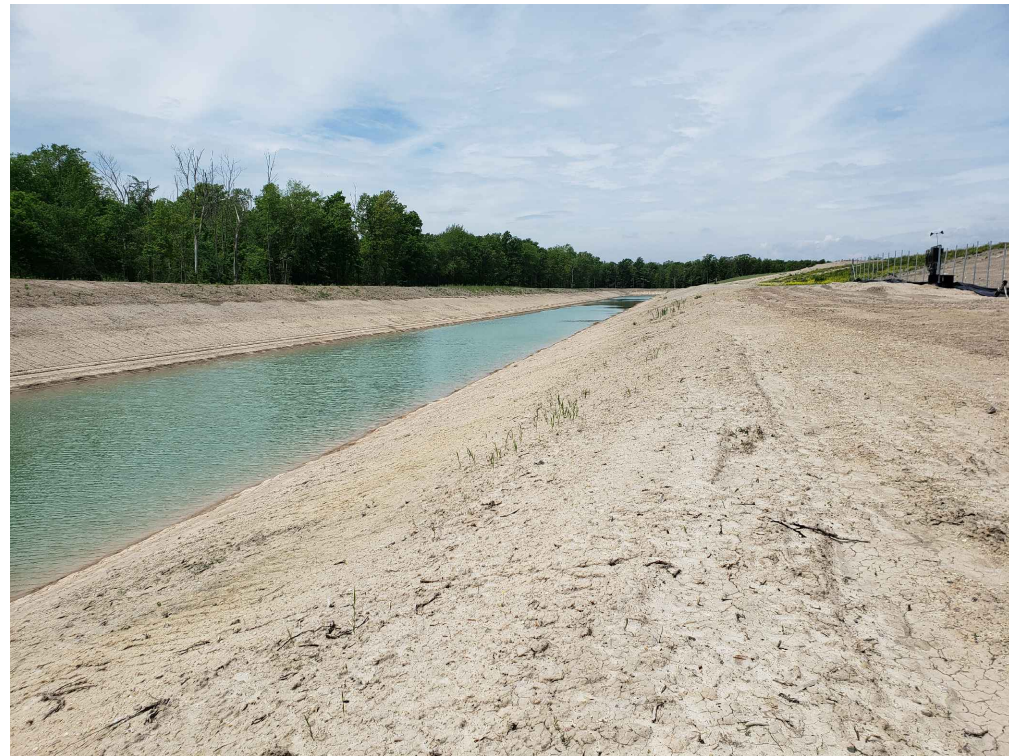
19
Fig 4A **SURFACE WATER POND B**

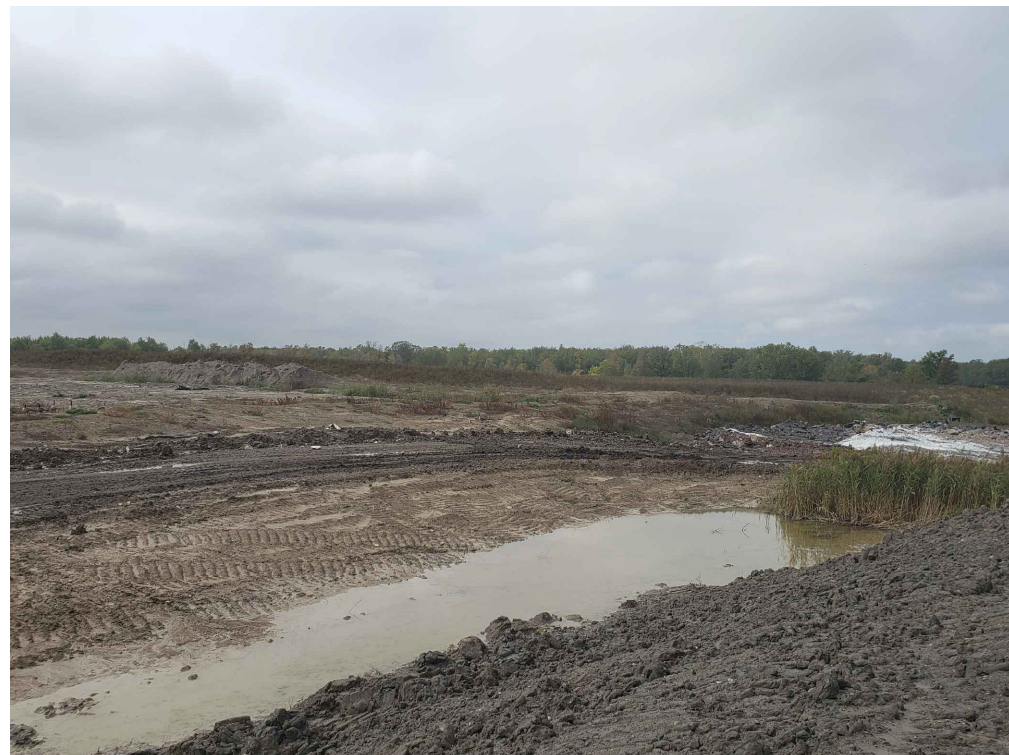
1 CELL 19-3B AND 19-1
Fig 3A

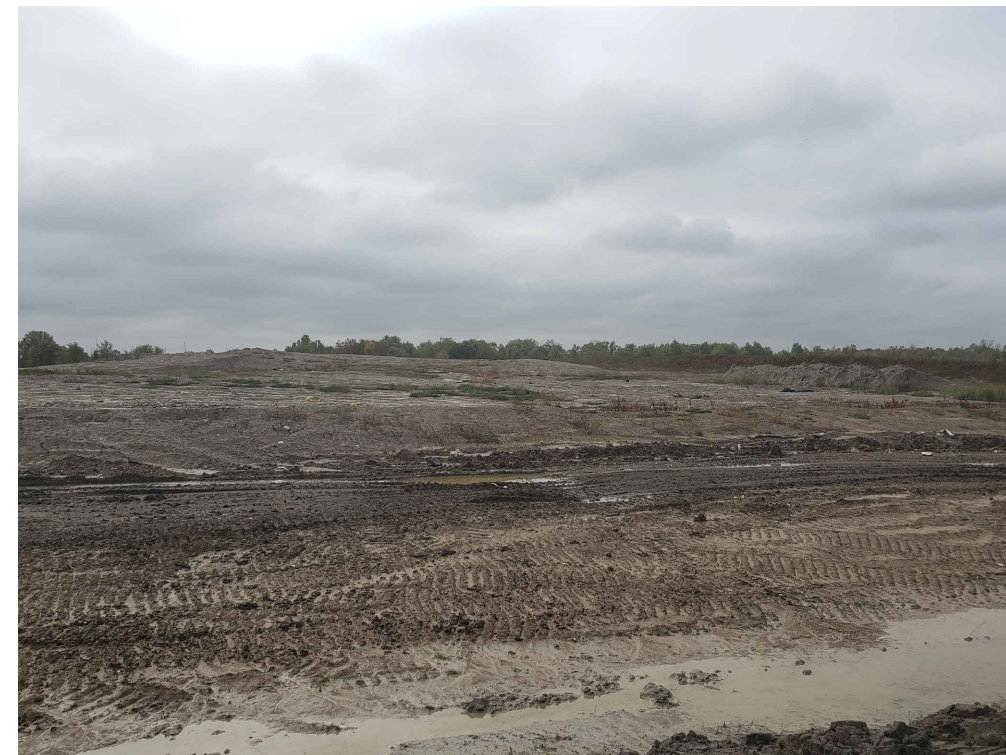
2 CELL 19-3B AND 19-3A INTERIM COVER
Fig 3A

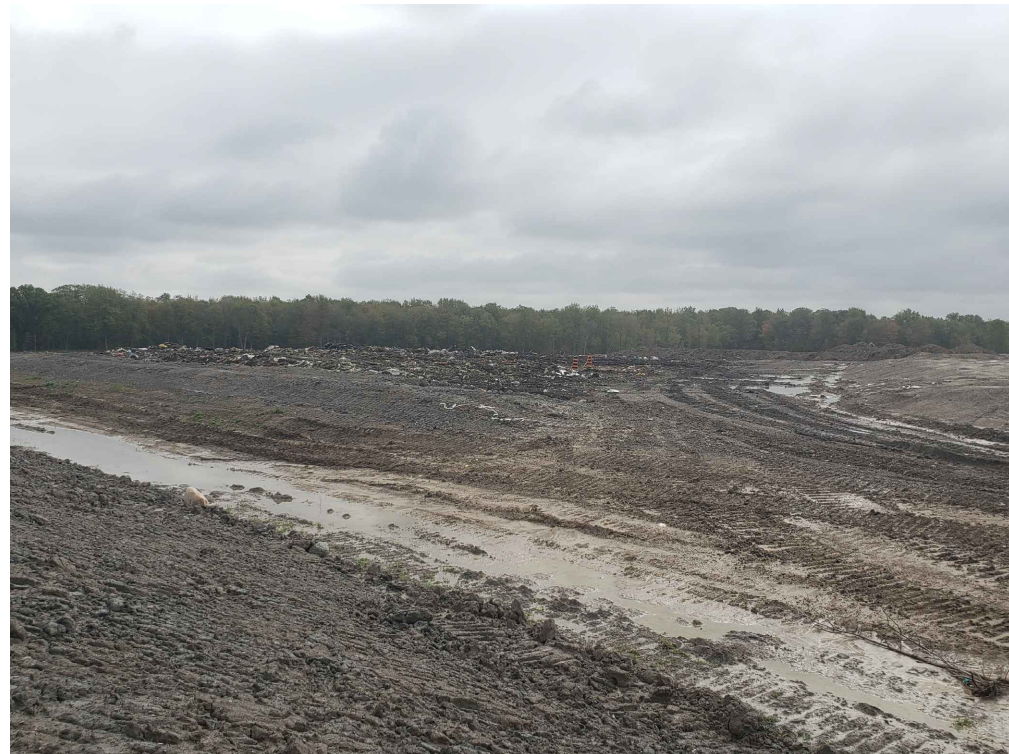
3 CELL 19-3A AREA WITHOUT COVER
Fig 3A

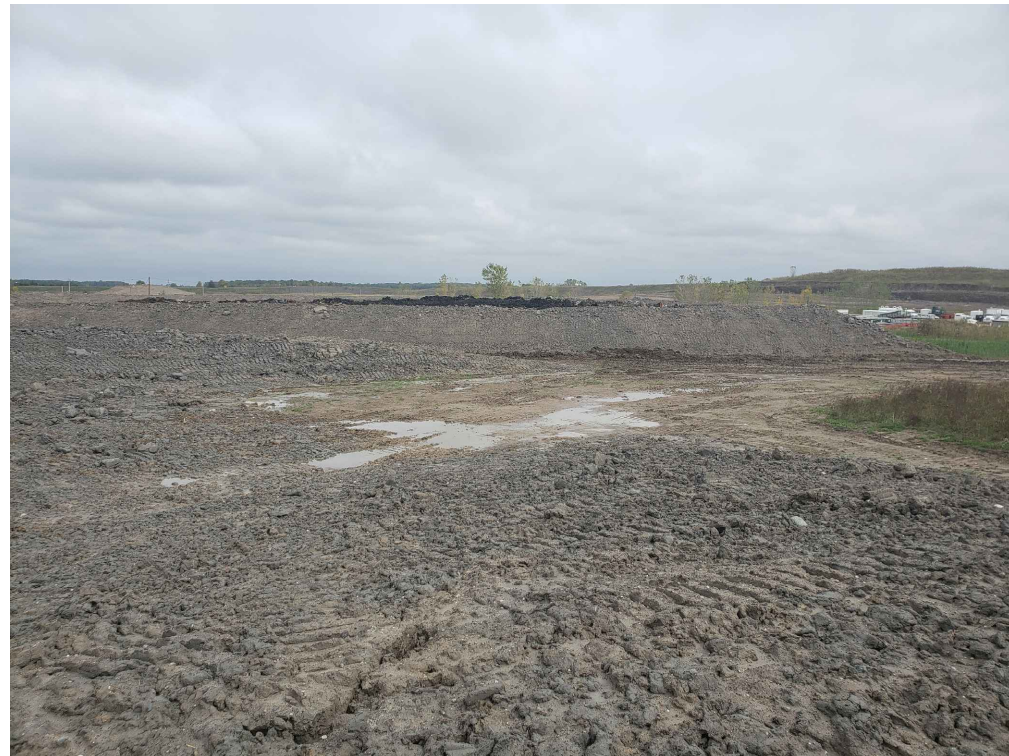
7 ACTIVE WASTE FACE
Fig 3A

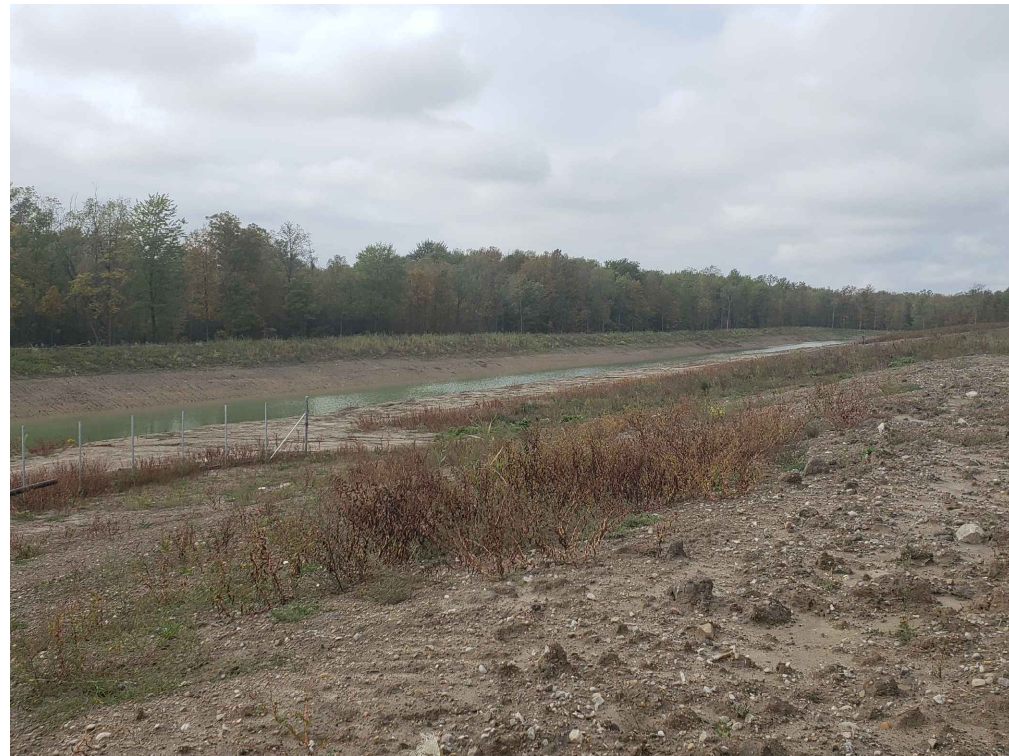
19
Fig 4A **SURFACE WATER POND B**

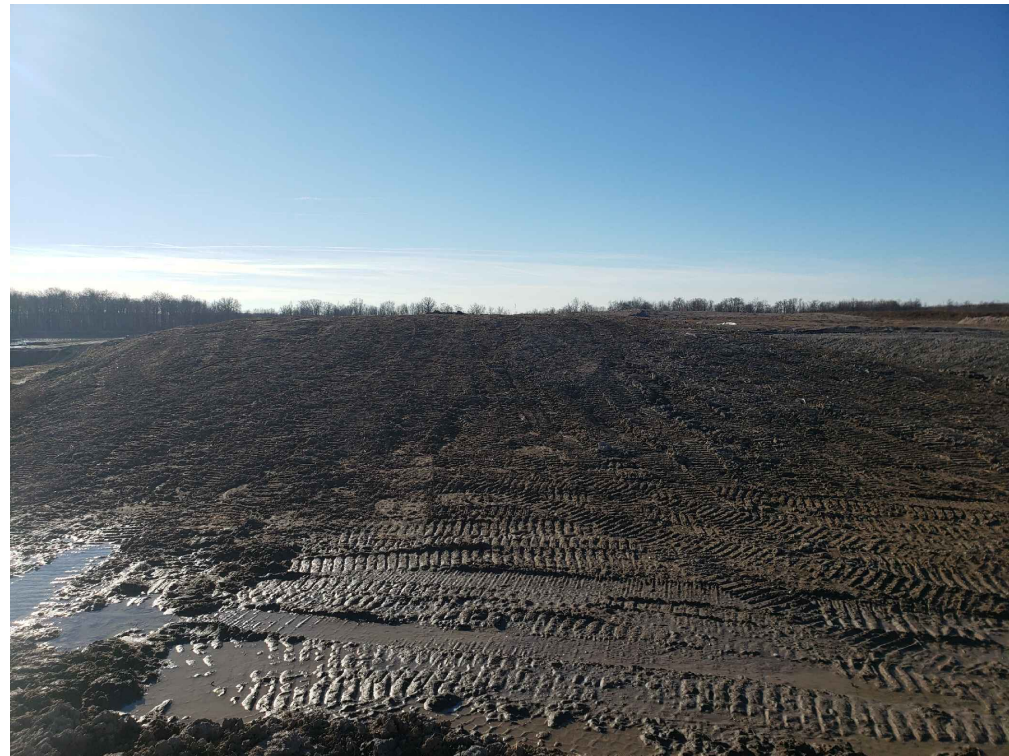
3 CELL 19-3A AREA INTERIM COVER
Fig 3A

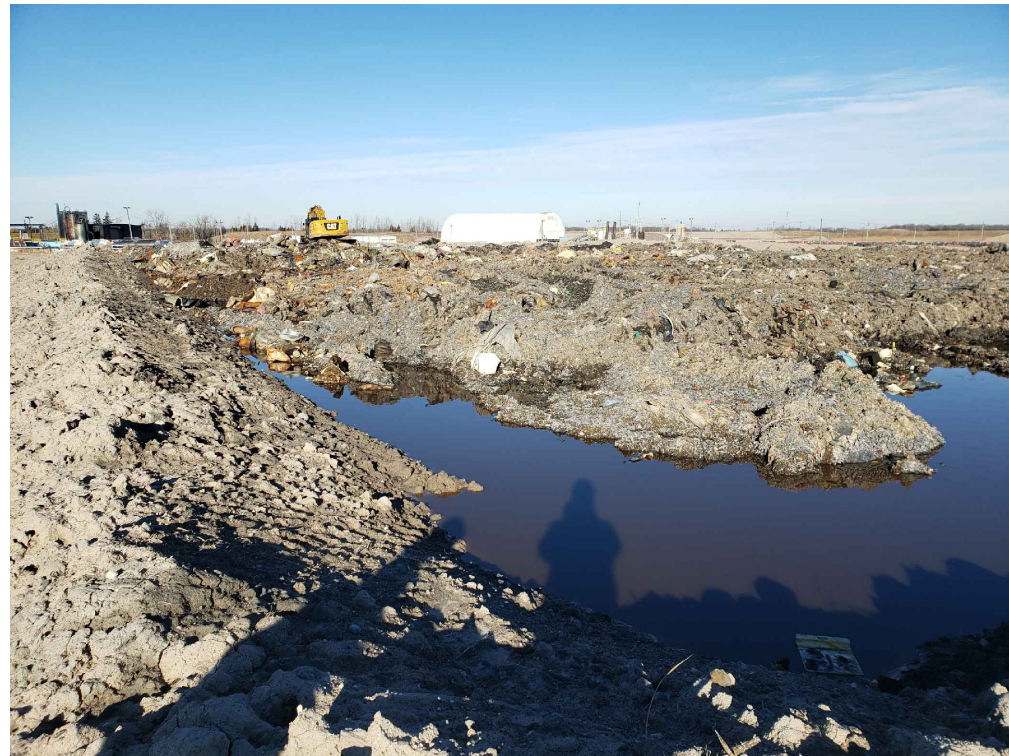
7 ACTIVE WASTE FACE
Fig 3A

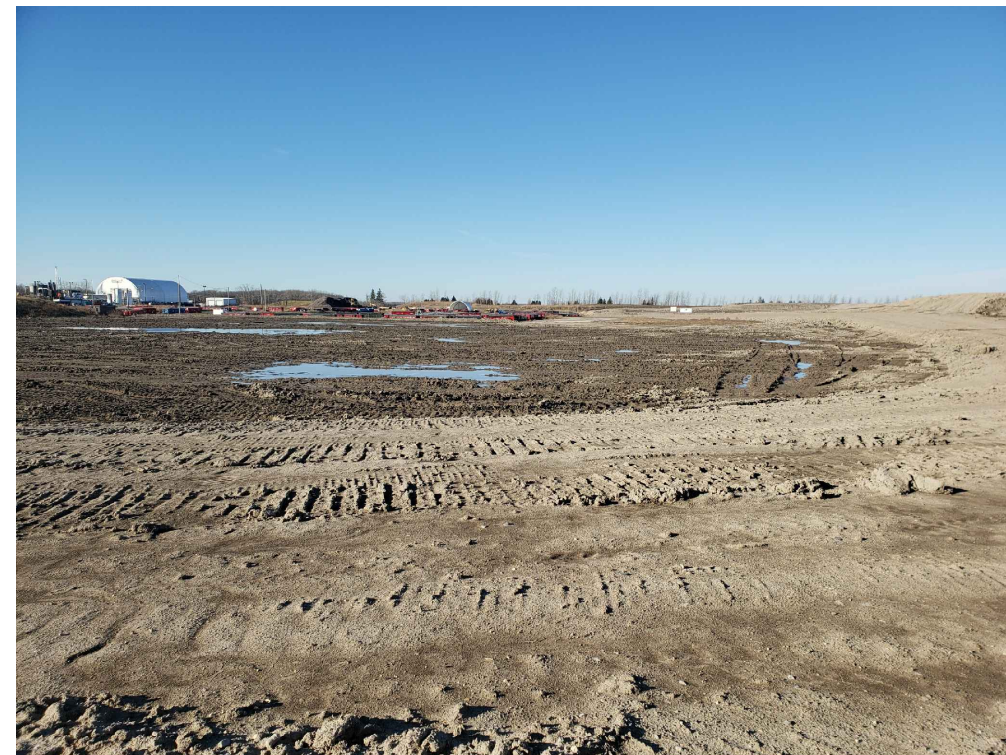
10 NORTHEAST CORNER OF THE SITE LOOKING WEST
Fig 4A

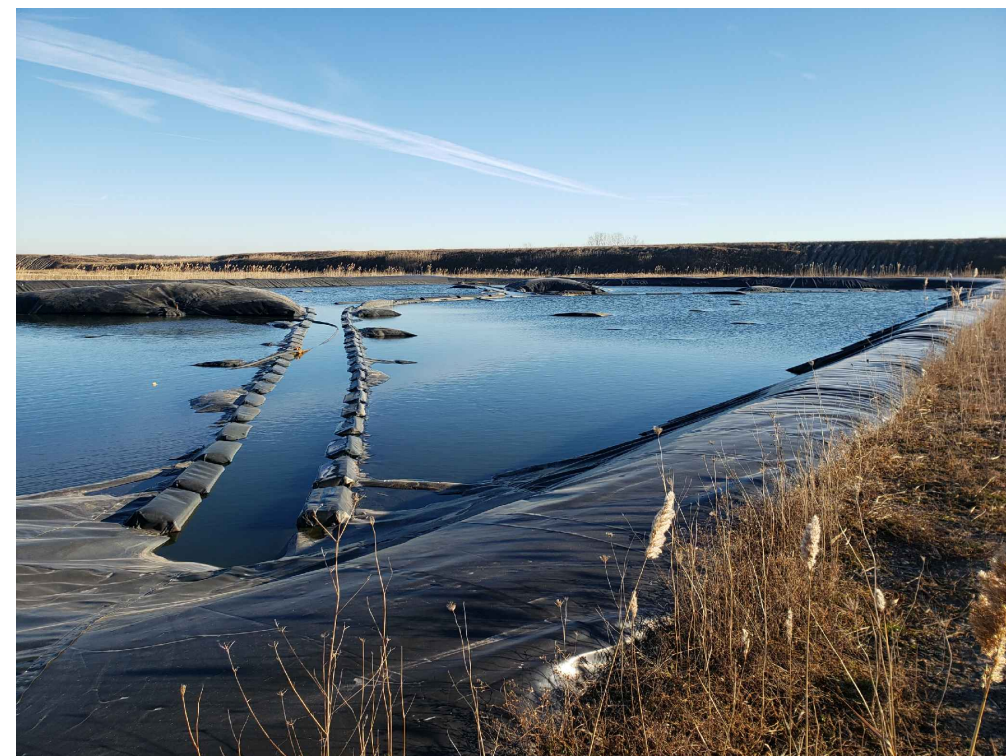
12 PONDED WATER ON WEST LEACHATE POND COVER
Fig 4A

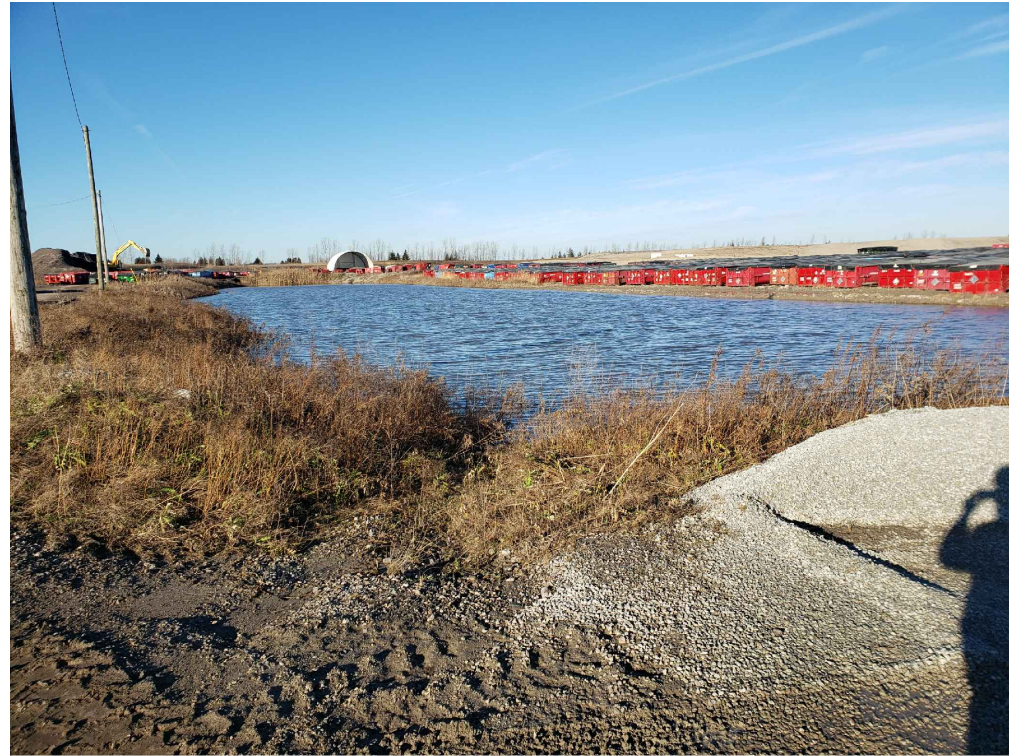
13 EAST PROCESS POND
Fig 4A
